**NATIONAL REGISTER OF HISTORIC PLACES
REGISTRATION FORM**

historic name: COLUMBIA GREEN HISTORIC DISTRICT

Description Columbia Green Historic District 7-1
Columbia, CT

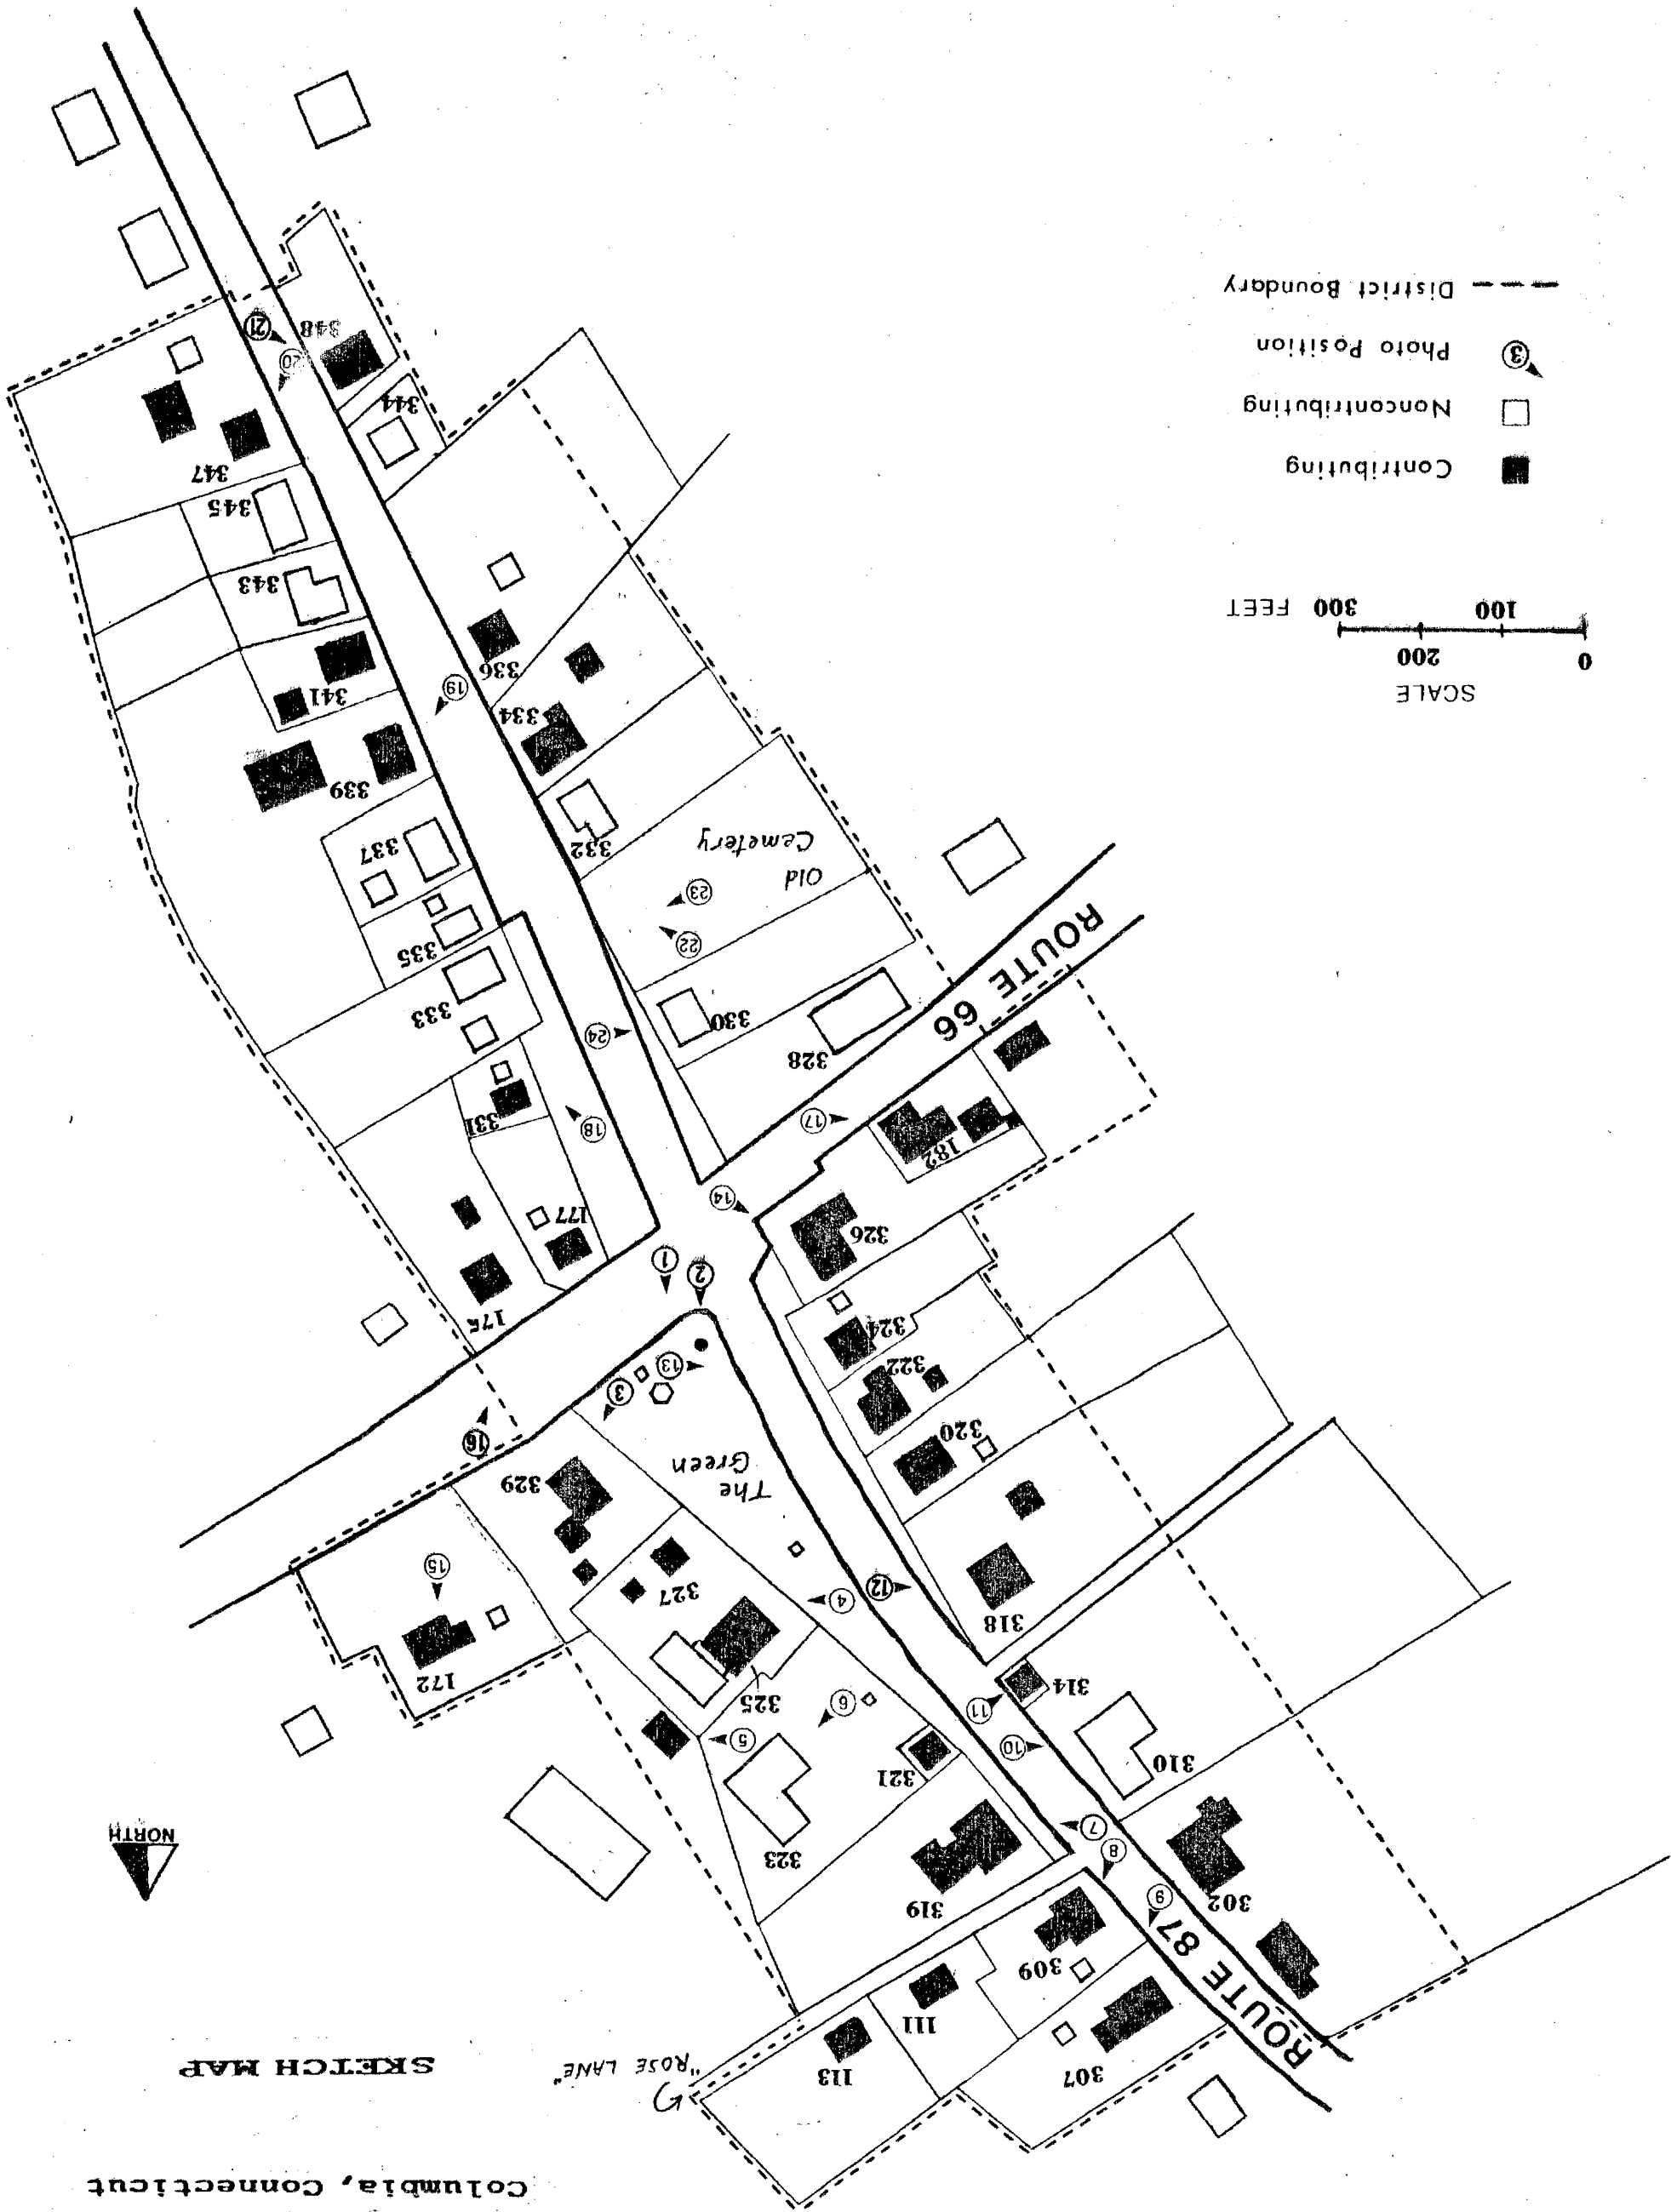
SKETCH MAP

The boundary is shown on the accompanying map, scale 1"=200', traced and reduced from Columbia Assessor Maps 16 and 17.
