National Register of Historic Places Registration Form

Historic name: Mager Mortgage Company Building

Street & number: 231 Northwest 10th St.

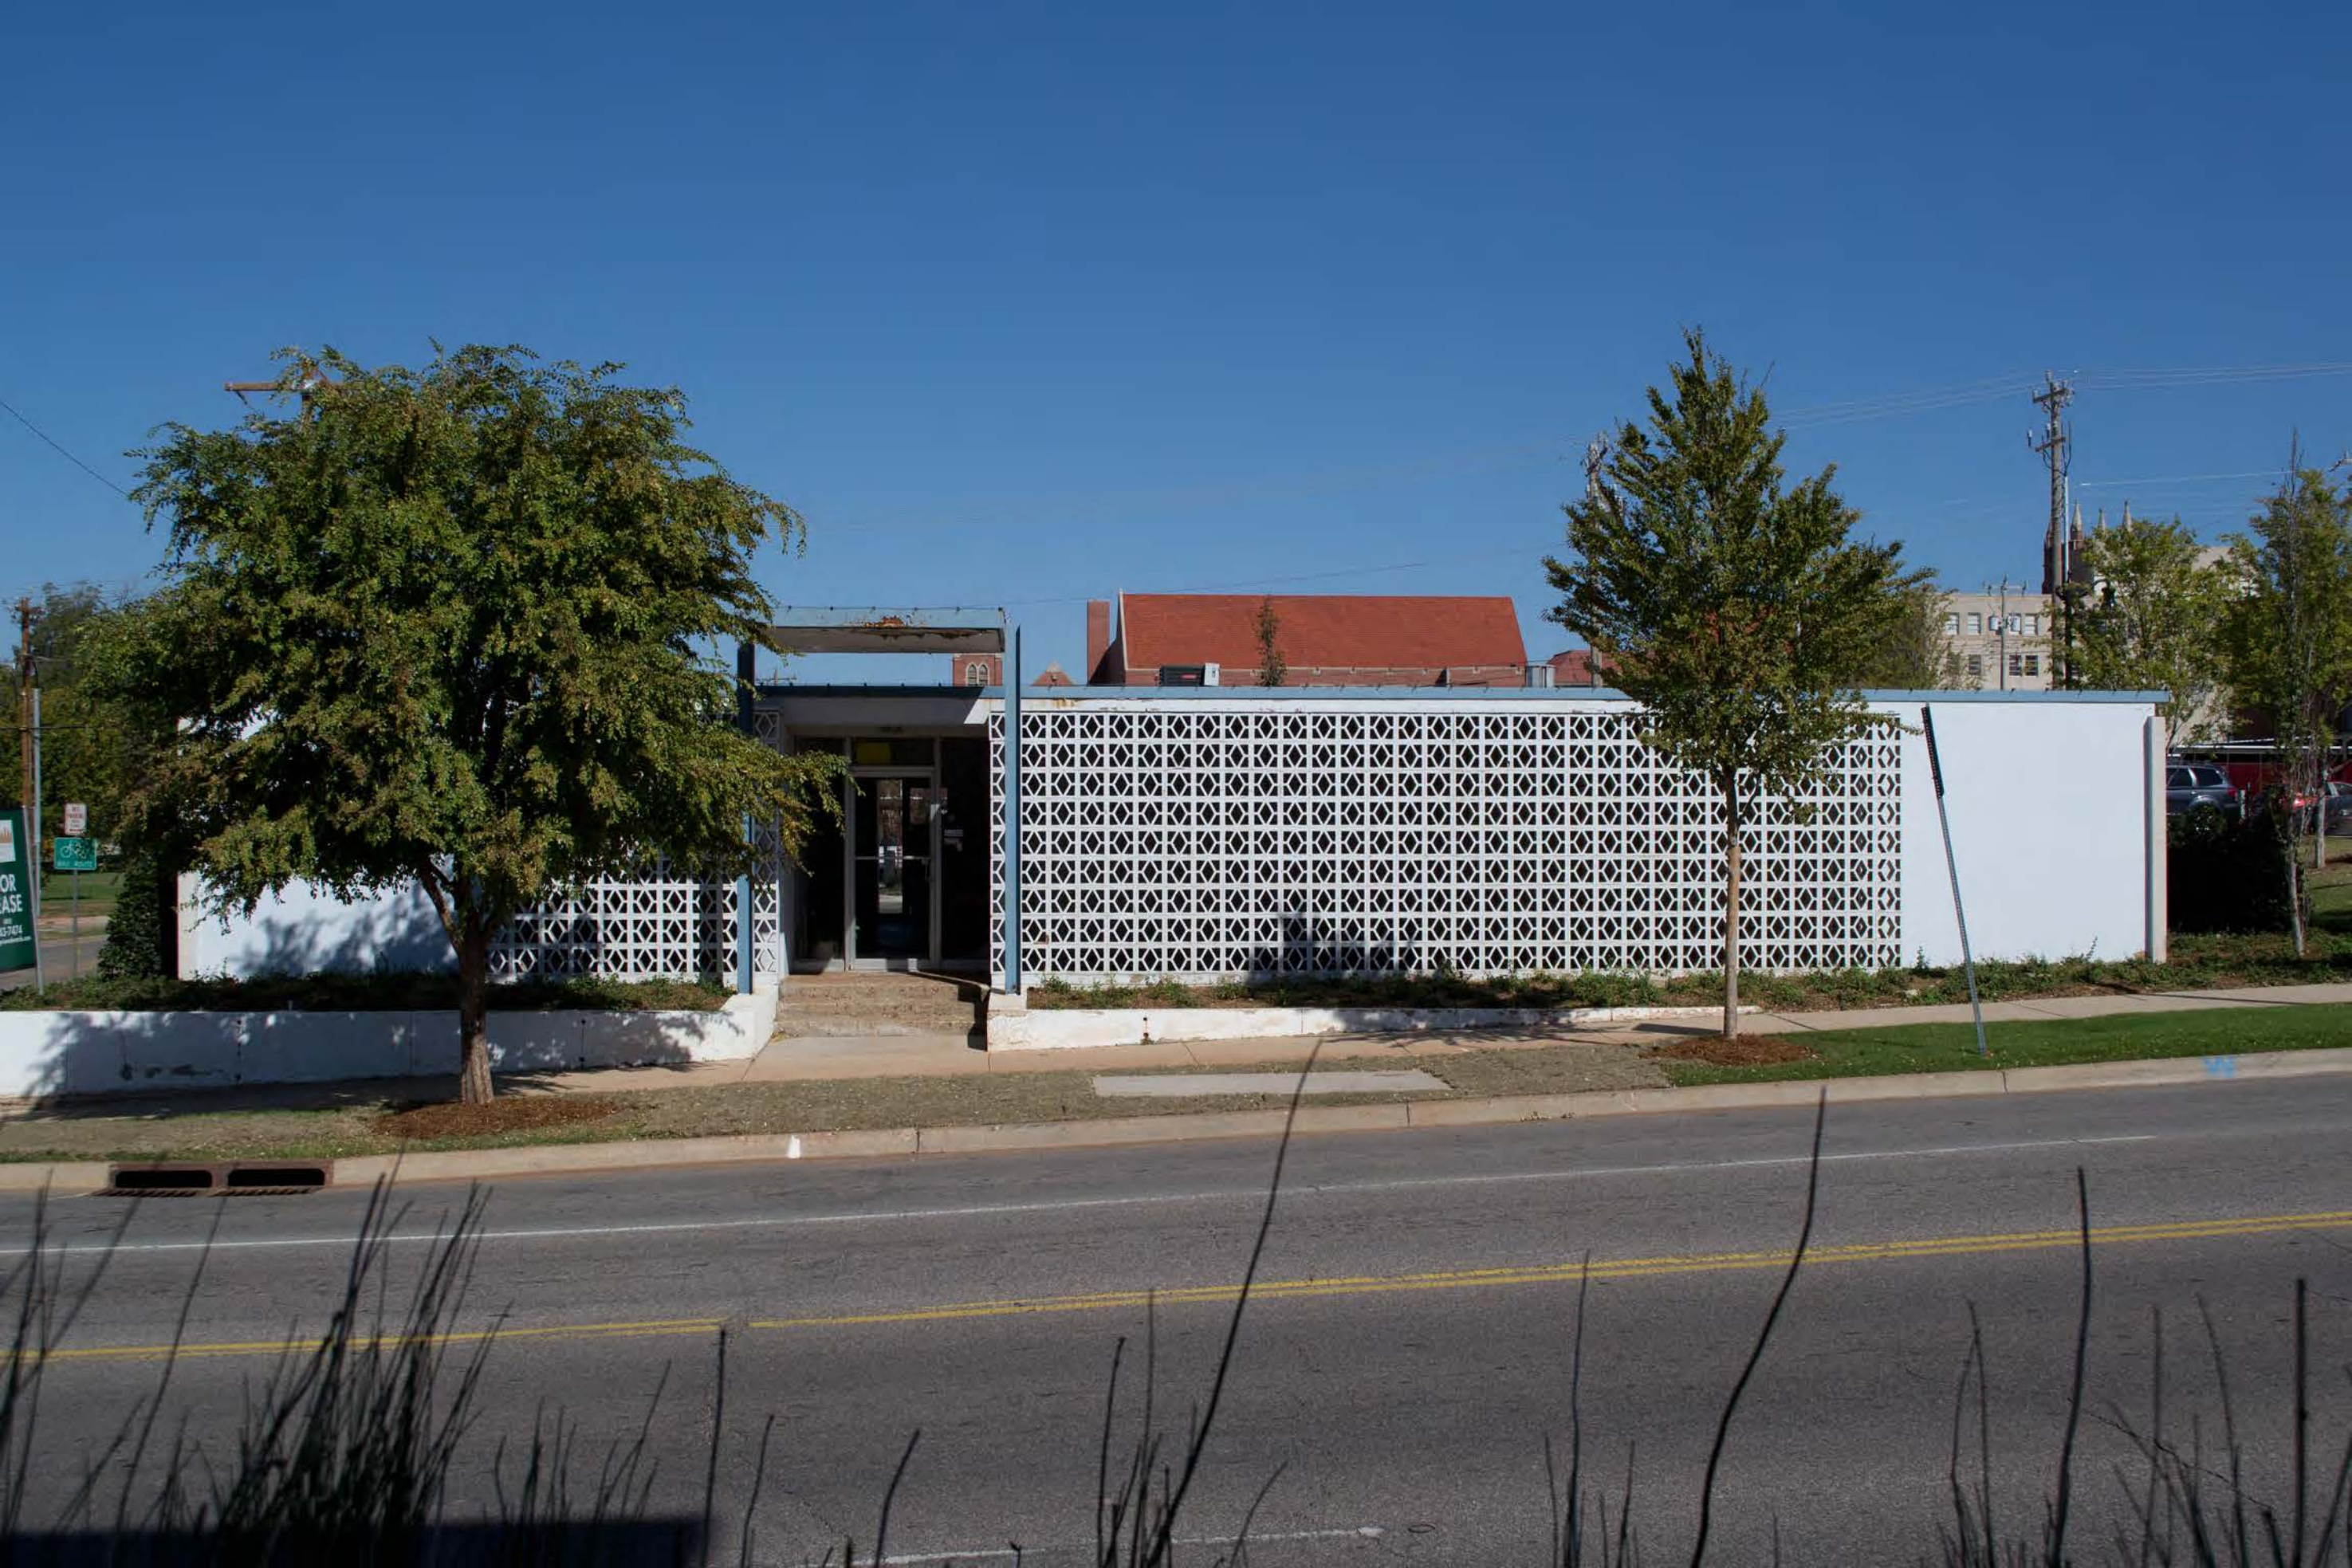
Photo 0001 South elevation, camera facing north

This description will proceed from the south (main) elevation and around the west, north, and east elevations, respectively. The asymmetrical south elevation has a recessed entry with an aluminum-frame glass door with a fixed transom above and flanked by full-height side lights. On either side of the entry, the walls are primarily comprised of full-height windows. These are concealed on both sides of the entry, by a decorative concrete-block "solar screen," set out from the building wall about twelve inches. Each block is approximately twelve inches square and is cut-out in a diamond pattern. The solar screens are the same height as the building. A metal canopy, or awning, marks the entrance. The canopy is two feet higher than the roofline, projecting slightly back over the roof and outward six feet past it. The canopy is supported by six-inch-by-six-inch vertical I-beams set eight feet apart on the walkway. There are three steps up from the walk to the entry.

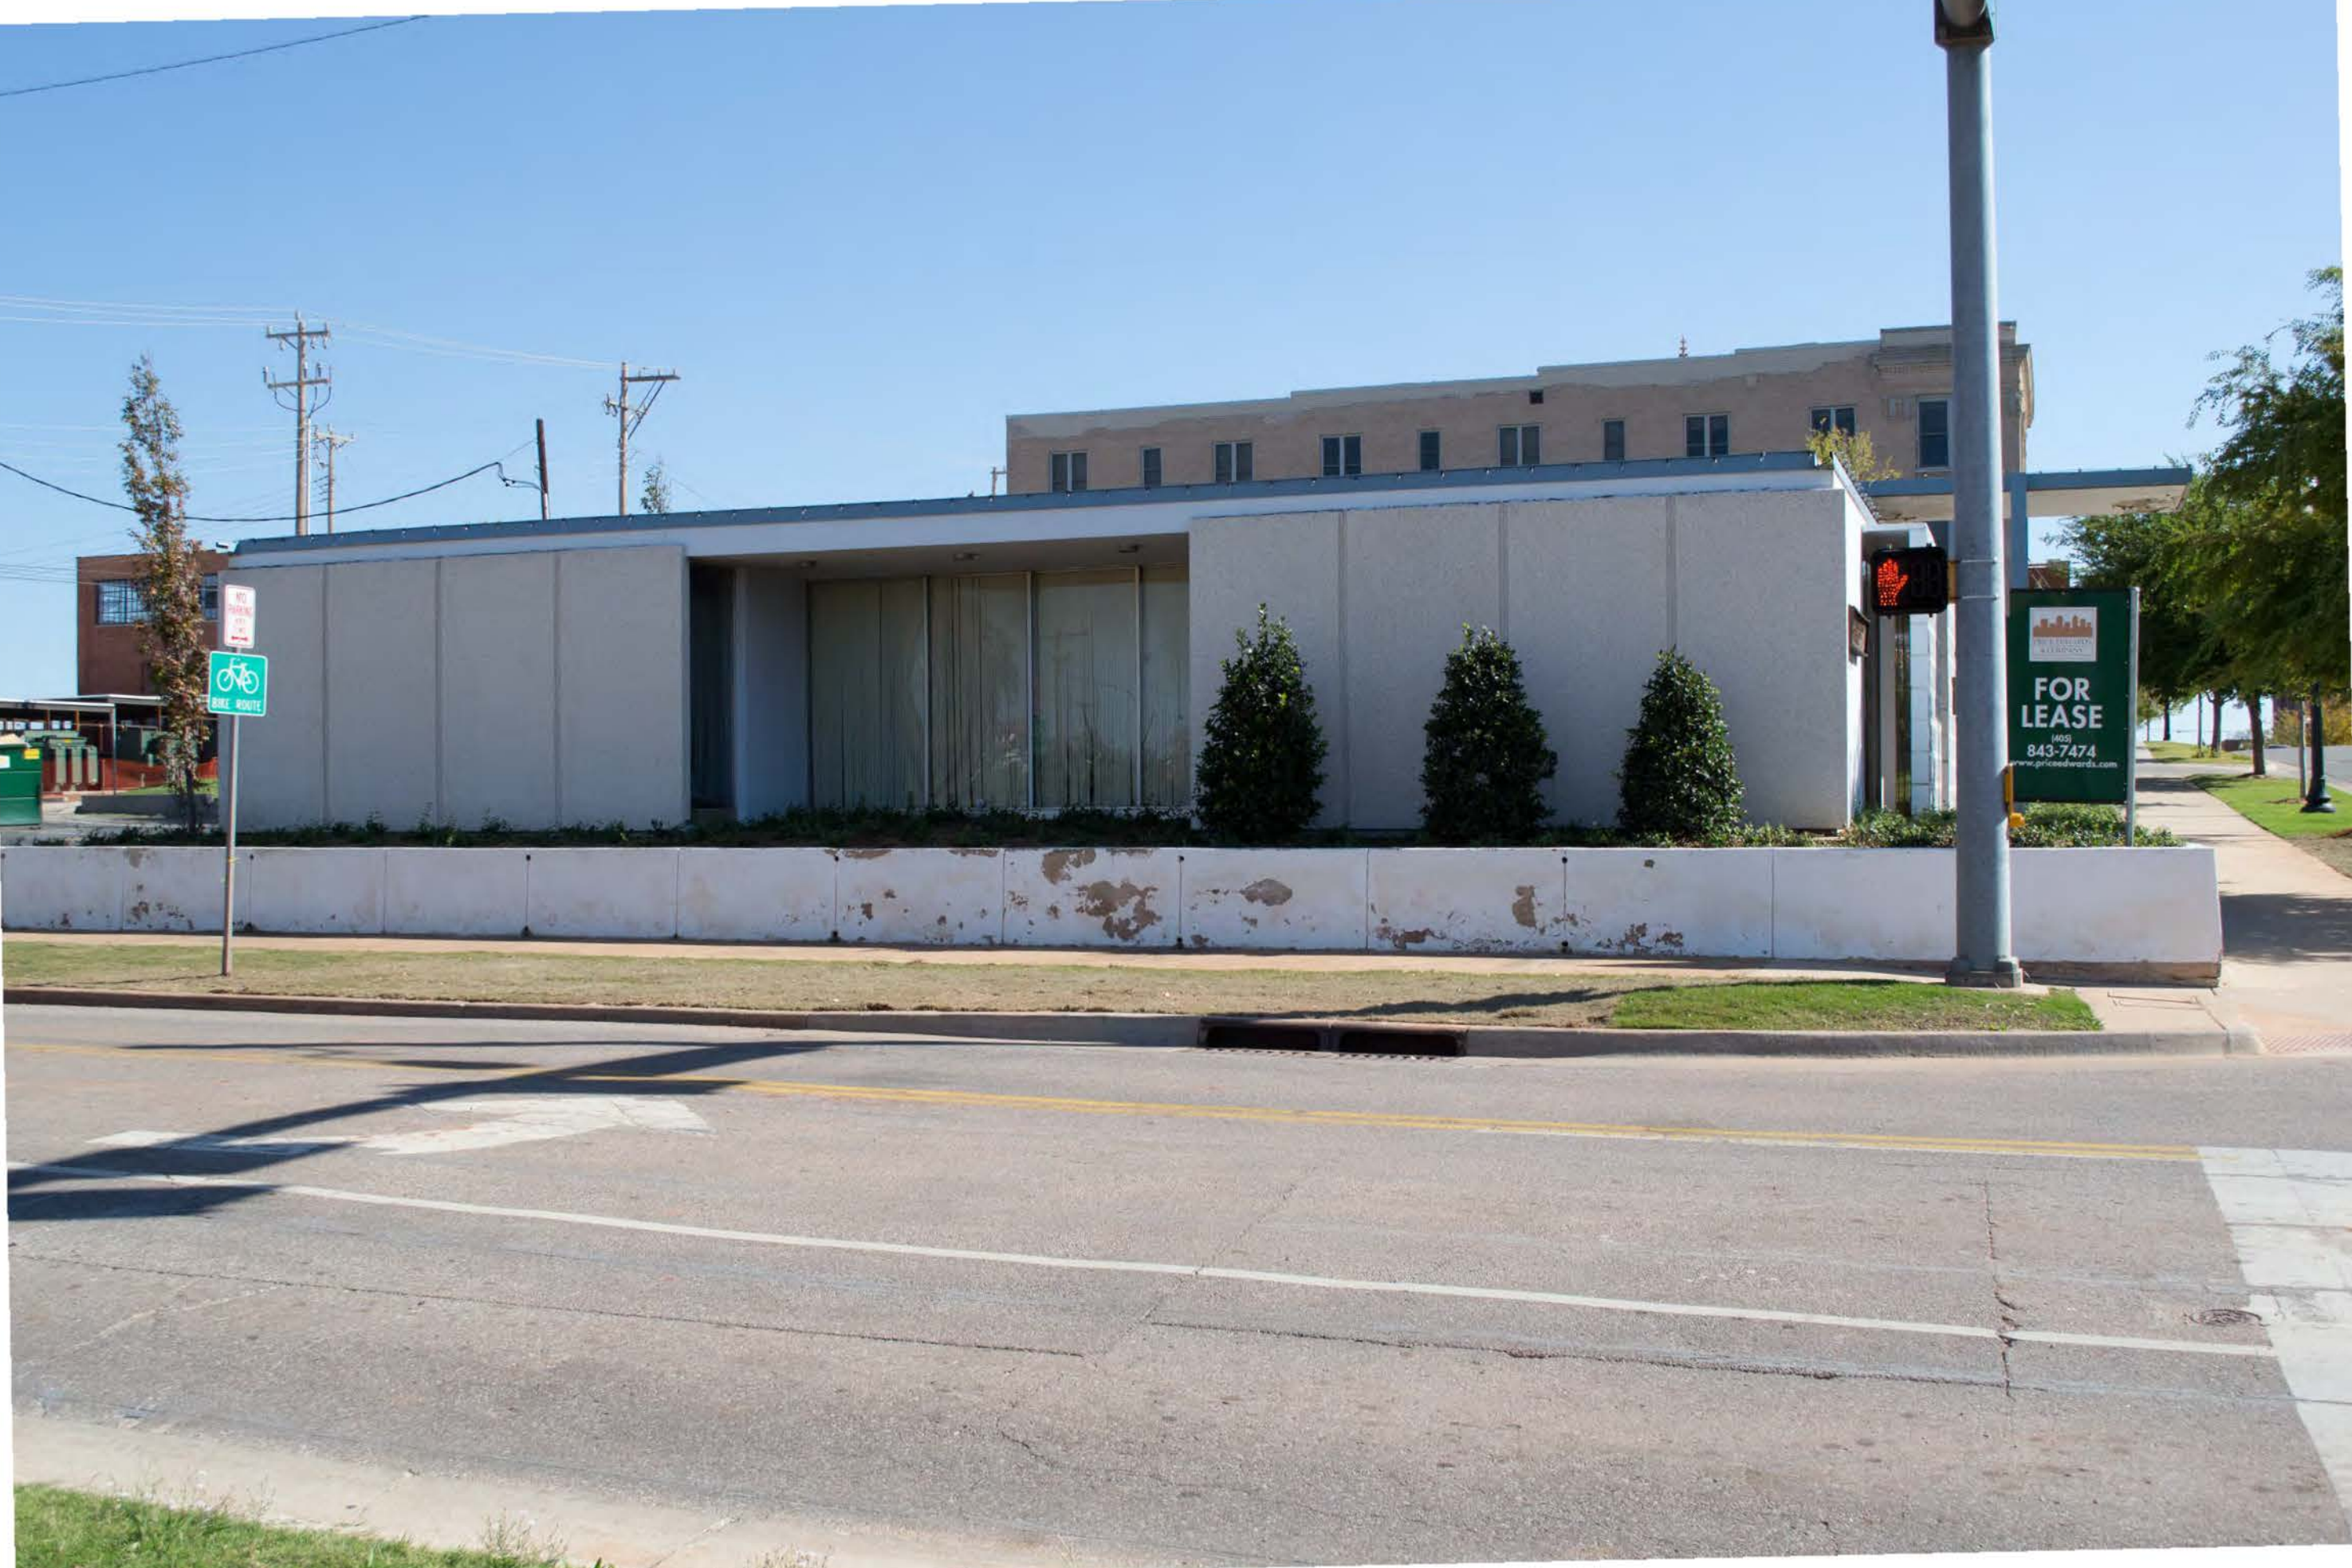
Photo 0002 West elevation, camera facing east

The symmetrical west elevation is in three approximately equal sections. There are four pre-cast aggregate/concrete panels on each side of a recessed window area (no door). Shallow reveals separate the panels. The windowed area has four units facing west and one each on the north and east sides. Inner walls of poured concrete provide support.

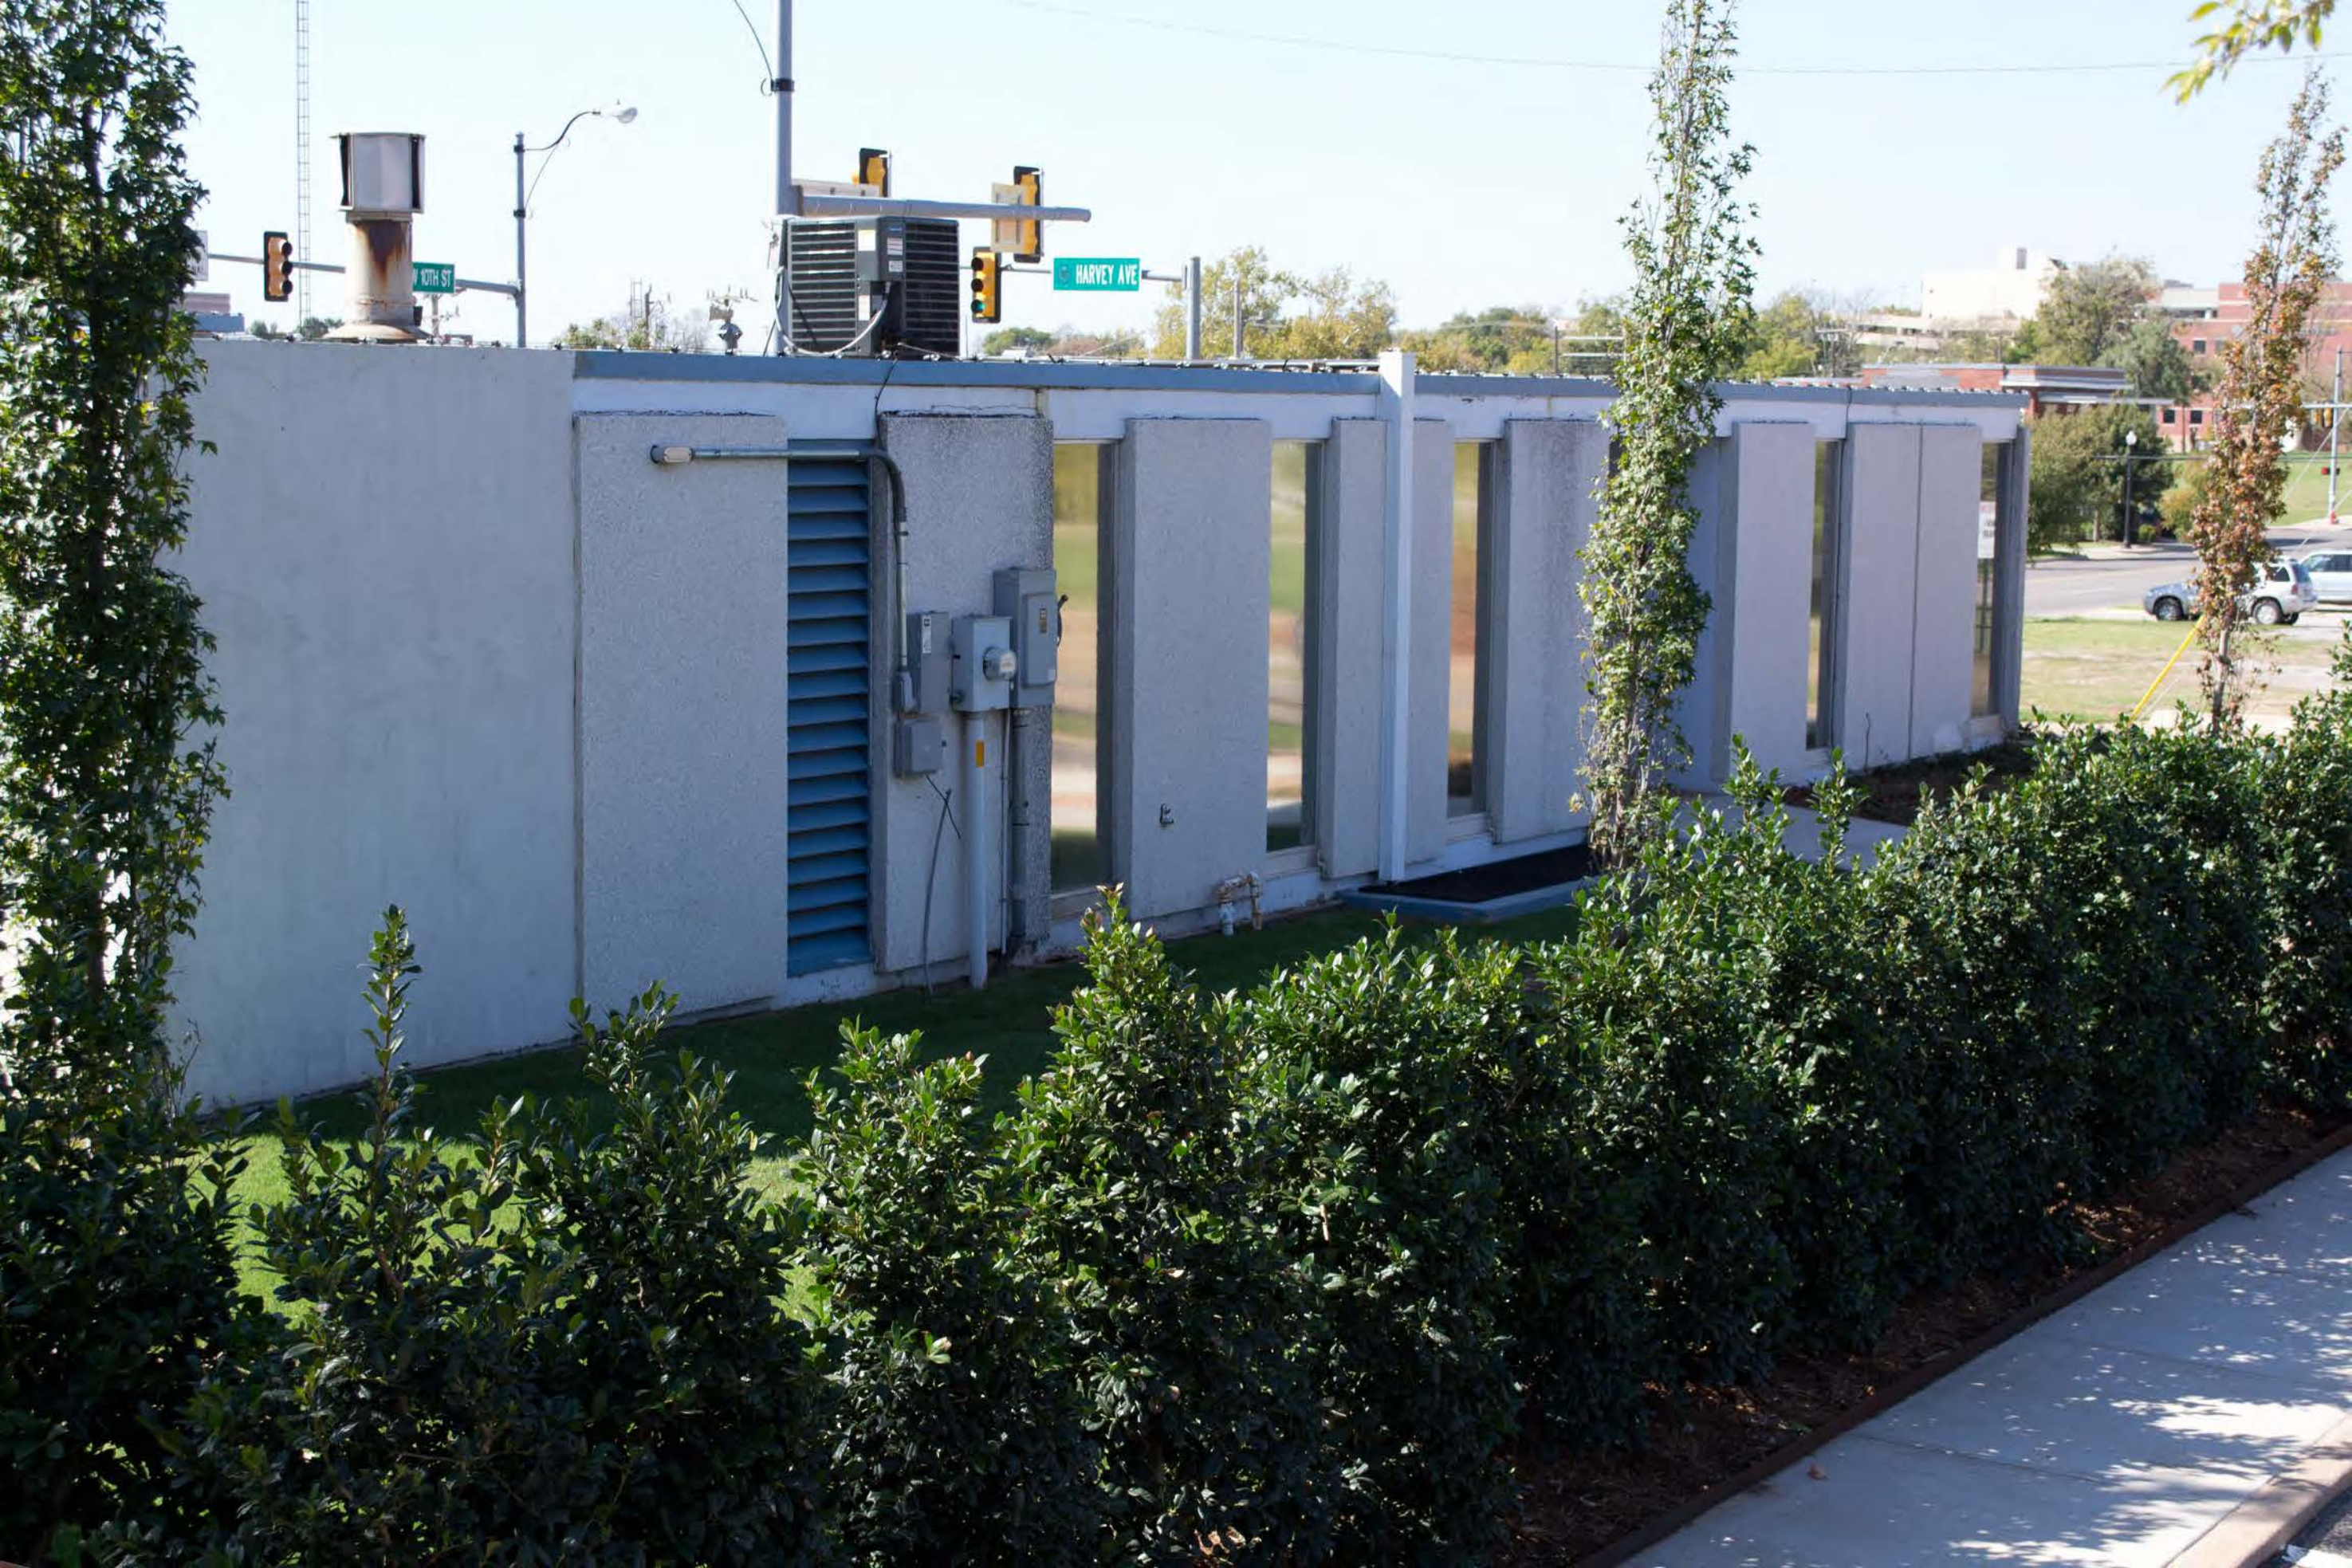
Photo 0004 North elevation, camera facing southwest

The asymmetrical north elevation has a recessed entry set slightly to the west. The entryway has a door with a fixed transom, and flanking windows. To the left of the door are three of the pre-cast panels and two windows. To the left of the door are five pre-cast panels separated by three windows and a louvered opening. The west end of this elevation has been altered by the removal of two windows, replaced at an unknown date by a stuccoed wall. A large downspout is placed against the north wall.

On the east part of the north elevation, two windows were removed circa 1975 or later, when the building's occupant became a medical clinic. They were replaced with a wall of unknown material that is faced with stucco. The room behind that section of wall was altered in order to create an X-ray area. Interior rooms have seen a considerable change from the original floor plan. On the exterior, the Mager Mortgage Company Building retains a very high degree of architectural integrity and is an excellent example of basic Modern Movement visual characteristics applied to a small commercial building.

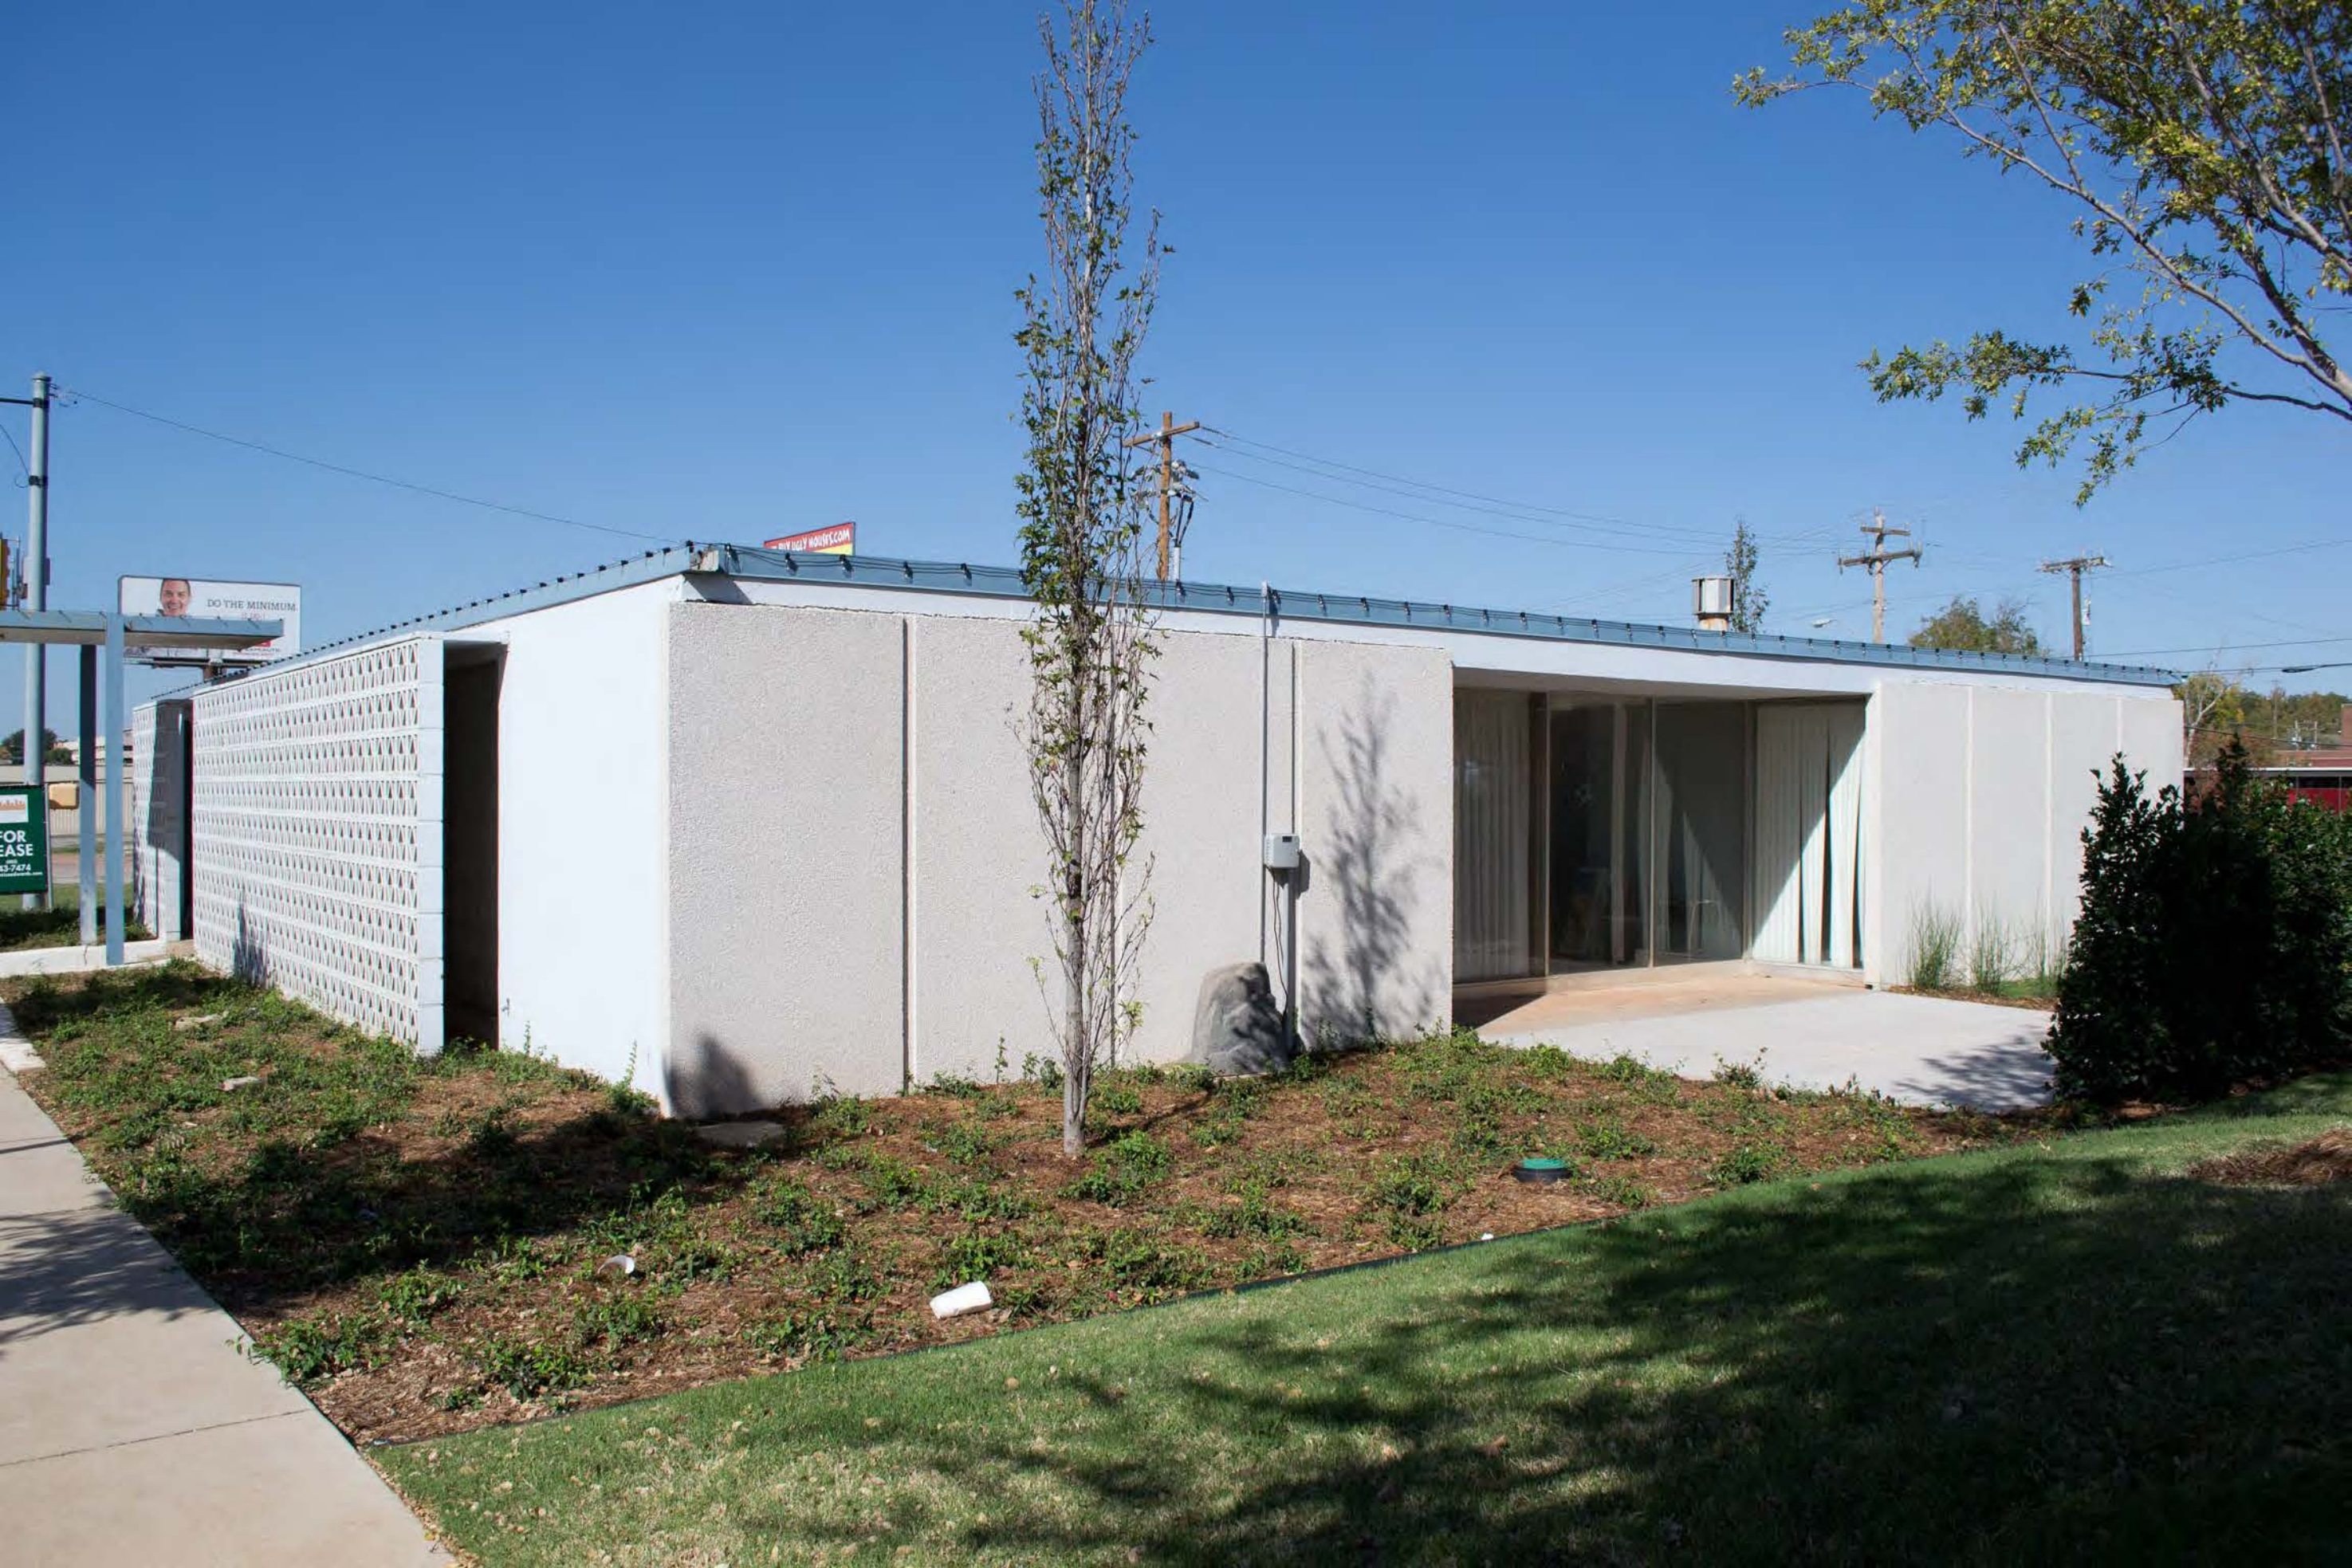
Photo 0005 South elevation (left), East elevation (right), camera facing northwest

The symmetrical east elevation has three approximately equal sections, two of which comprise four pre-cast panels with reveals; the central section is similar to that on the west side, with the addition of a glass door and side light on the south end and a full window on the north, instead of a concrete wall.
