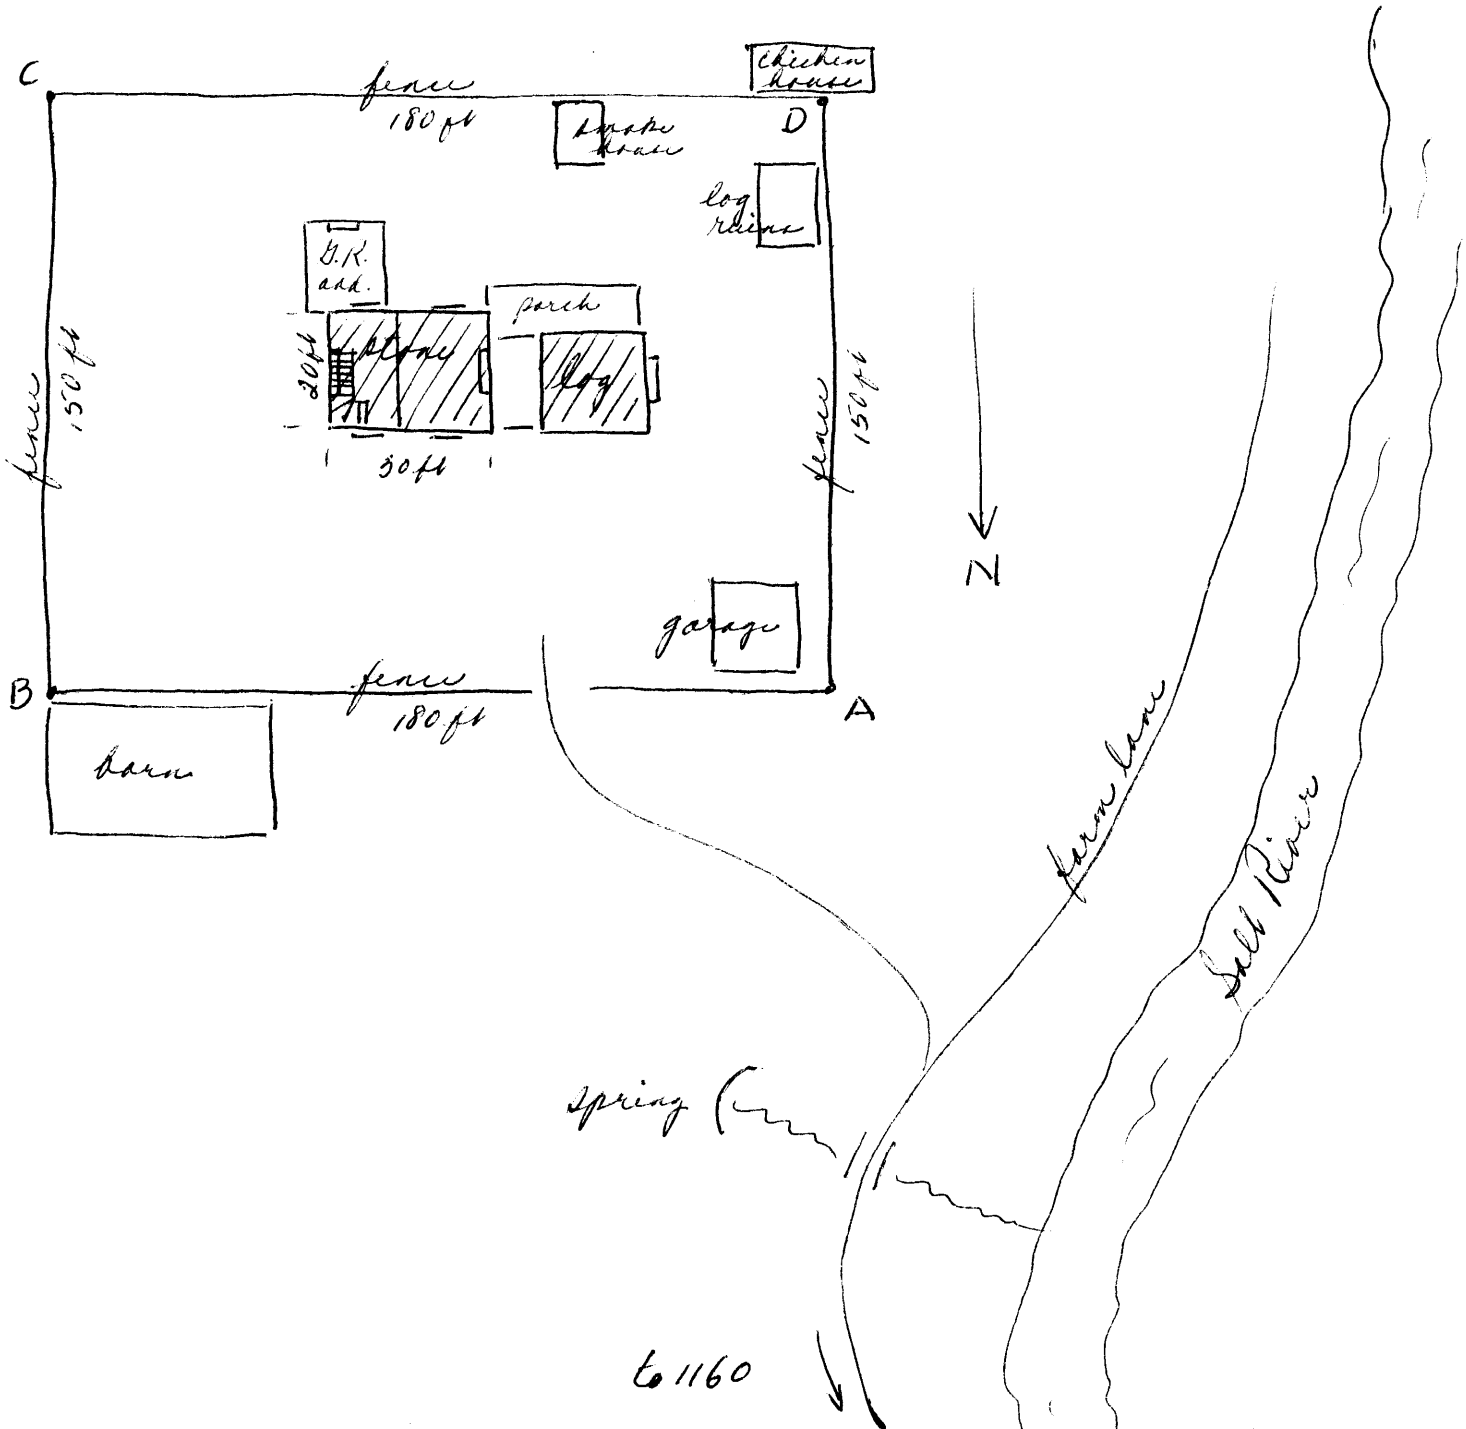
SKETCH MAP OF SITE SHOWING BOUNDARIES AND KEY BUILDINGS AND FEATURES WITH NORTH ARROW.

Beginning at A at a fence post in the NW corner of the yard, then with fence, E 180 ft ^{to B}, S 150 ft ^{to C}, W 180 ft ^{to D} and N 150 ft ^{to beginning}, enclosing the stone house, log house, smoke house and log ruins - about 2/3 acre.
