- Photo 2
1. Fort Christian
  2. Charlotte Amalie, St. Thomas, USVI
  3. M. Barnes
  4. May 1997
  5. Neg - NPS Atlanta
  6. View of late 17th map of St Thomas showing Fort Christian & Skytsborg tower on Baggerberg hill to the north of the fort.
  7. Photo. I

1. FORT CHRISTIAN
2. Charlotte Amalie, St. Thomas USVI
3. M. Barnes
4. MAY 1997
5. Neg - NPS Atlanta
6. View of 1827 plan of fort showing ravelins projecting fort on west, north and east sides of fort - these were removed ~~in~~ in the 1870s
7. Photo 2

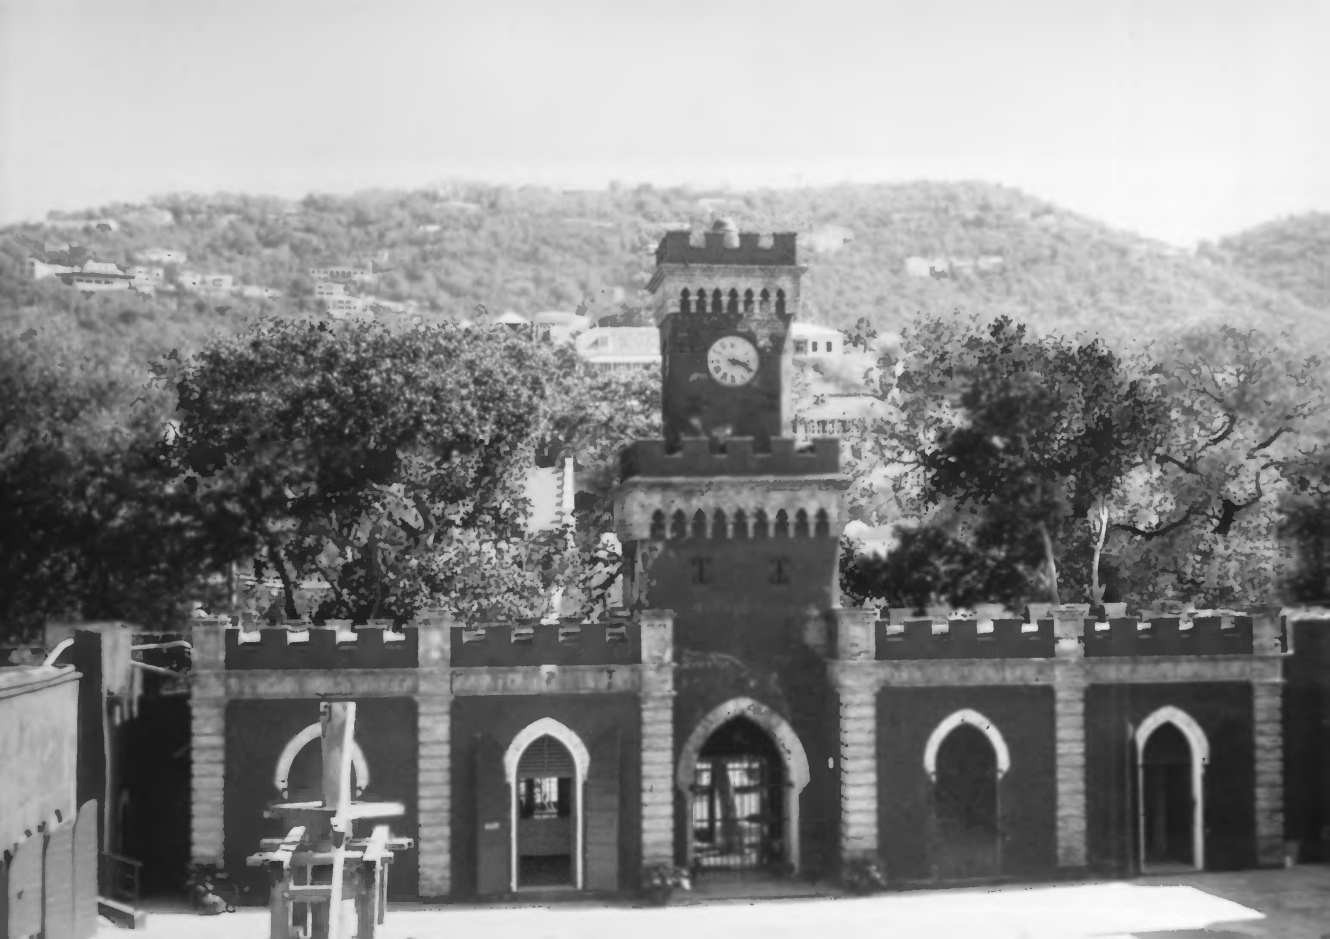
1. Fort CHRISTIAN
2. Charlotte Amalie, St. Thomas, USVI
3. M. BARNES
4. MAY 1997
5. Neg - NPS Atlanta
6. View of June 17, 1872 dated drawing of the new north curtain wall and clock tower.
7. Photo 4

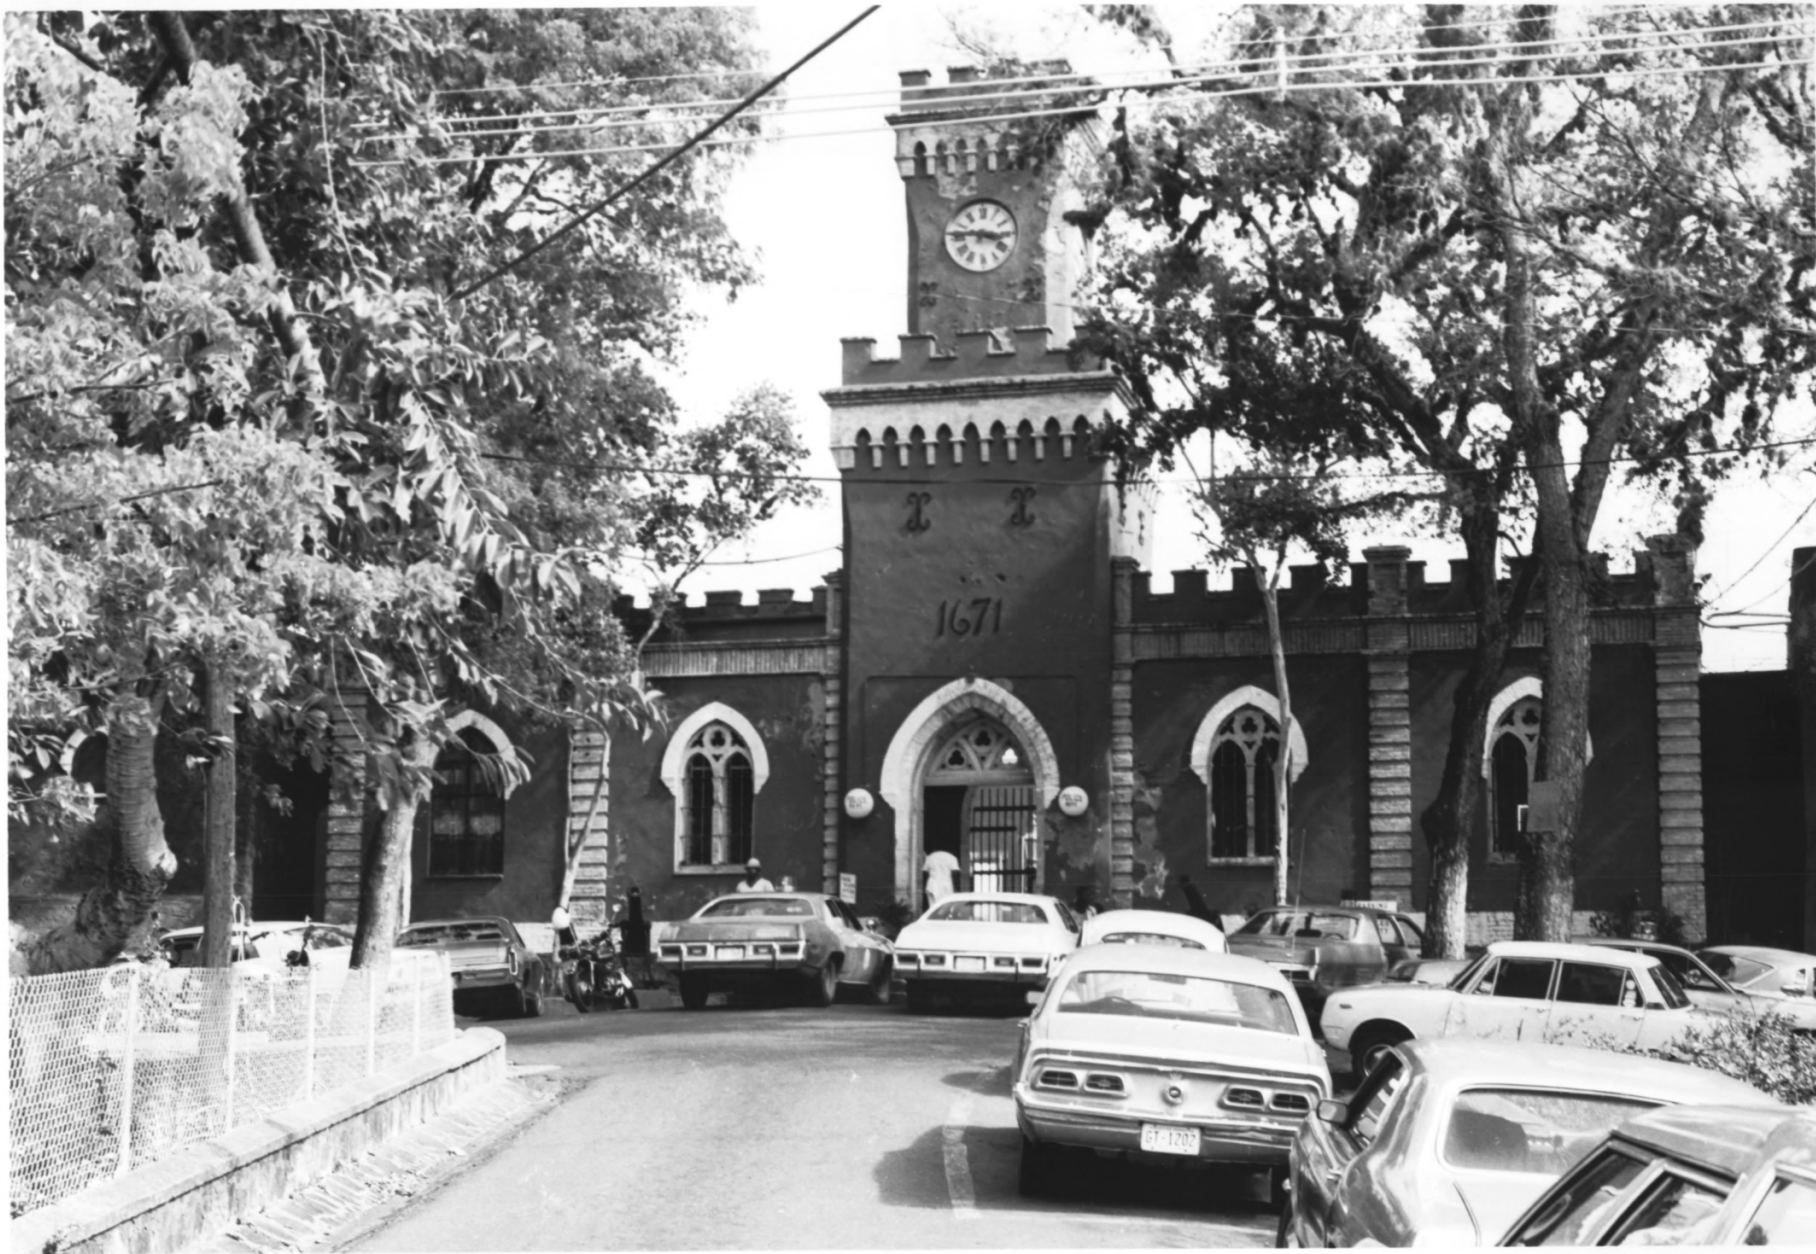
1. FORT CHRISTIAN
2. Charlotte Amalie, St. Thomas, USVI
3. Photographer Unknown
4. MAY 1979
5. Neg- NPS Atlanta
6. View of the north side of fort.  
Shows 19th century entrance. Looking  
south.
7. Photo 14
