National Register of Historic Places
Registration Form

historic name Parnell Hall

street & number 2400 West Markham ☐ not for publication

city or town Little Rock ☐ vicinity

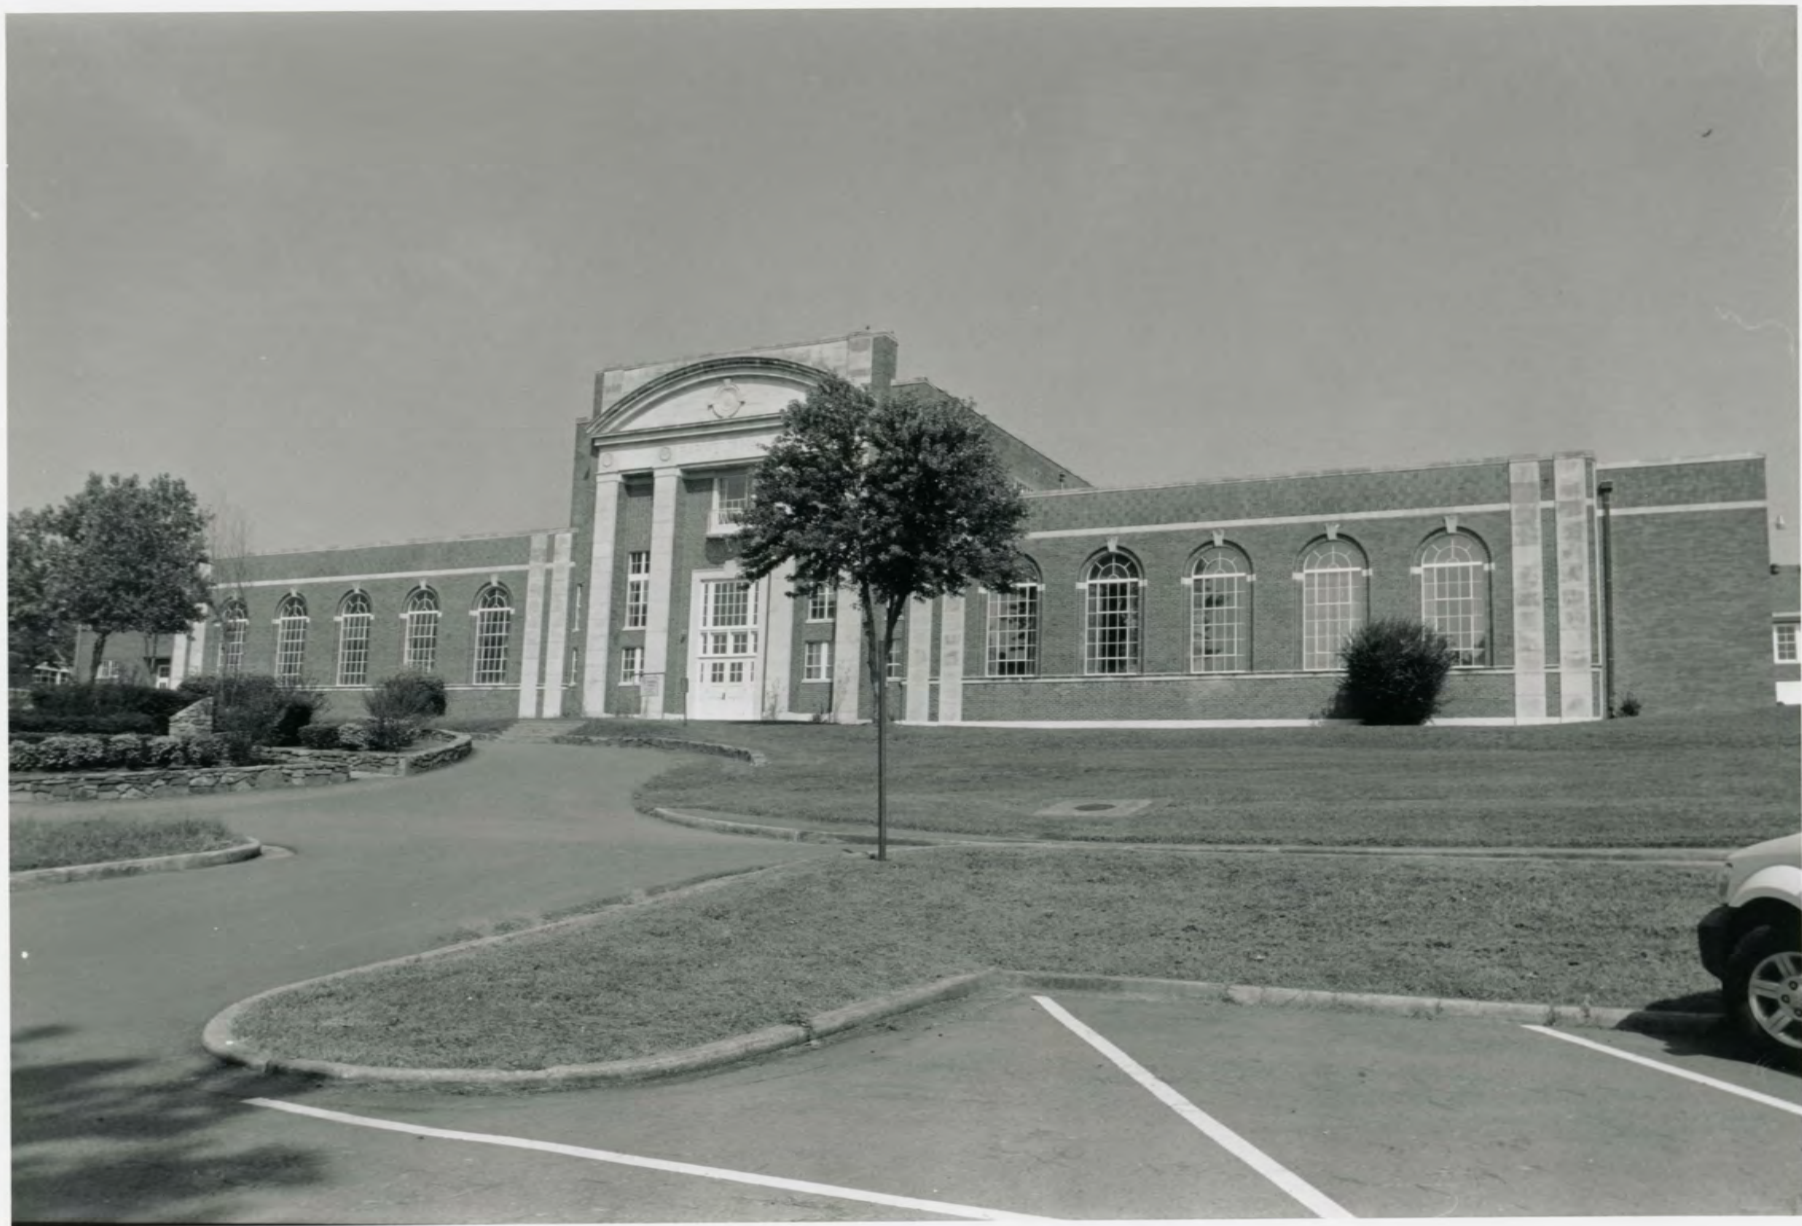
- ① Parnell Hall
- ② Pulaski County, AR
- ③ Sarah Jampole Marks
- ④ October 2007
- ⑤ AHPP
- ⑥ South elevation, looking north
- ⑦ #1

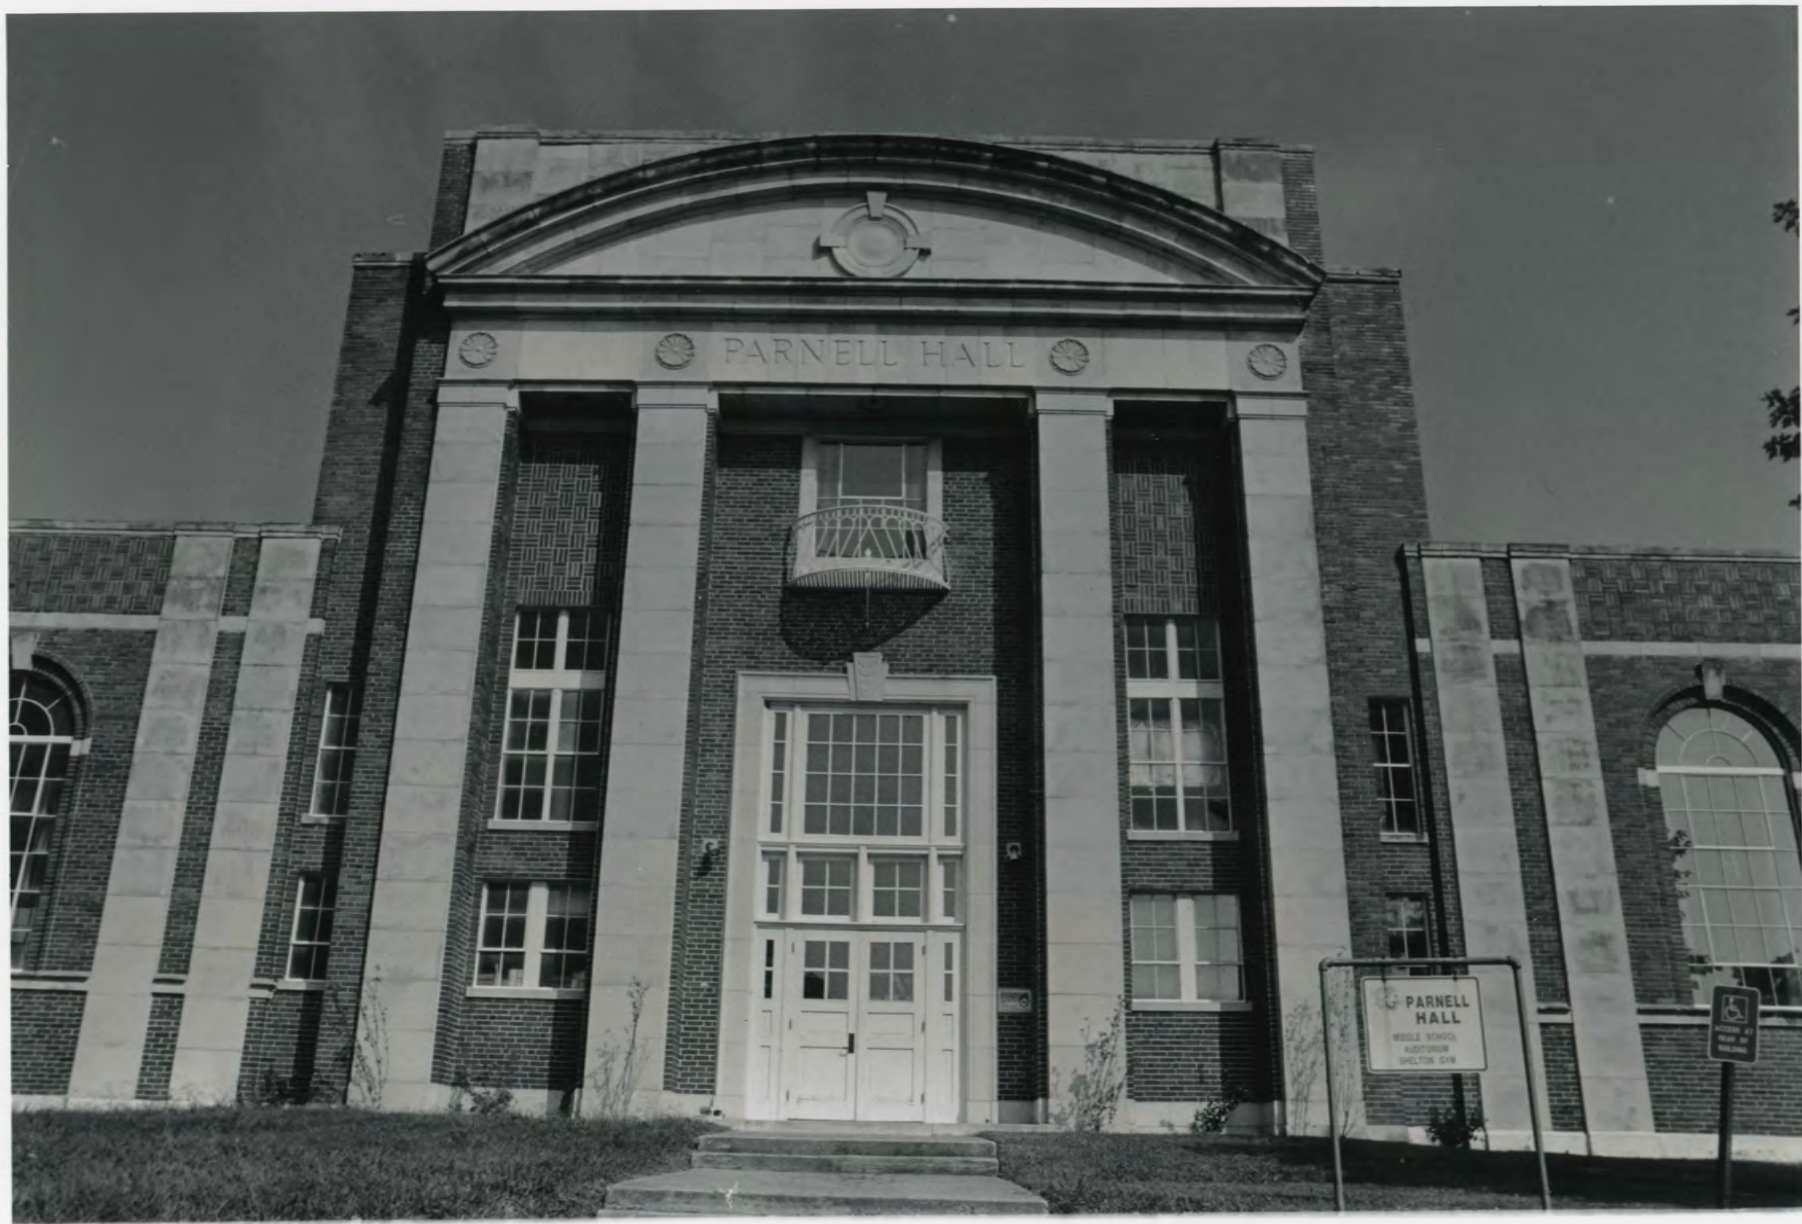
- ① Parnell Hall
- ② Pulaski County, AR
- ③ Sarah Jampole Marks
- ④ October 2007
- ⑤ AHPP
- ⑥ South facade of center block, looking north
- ⑦ #2

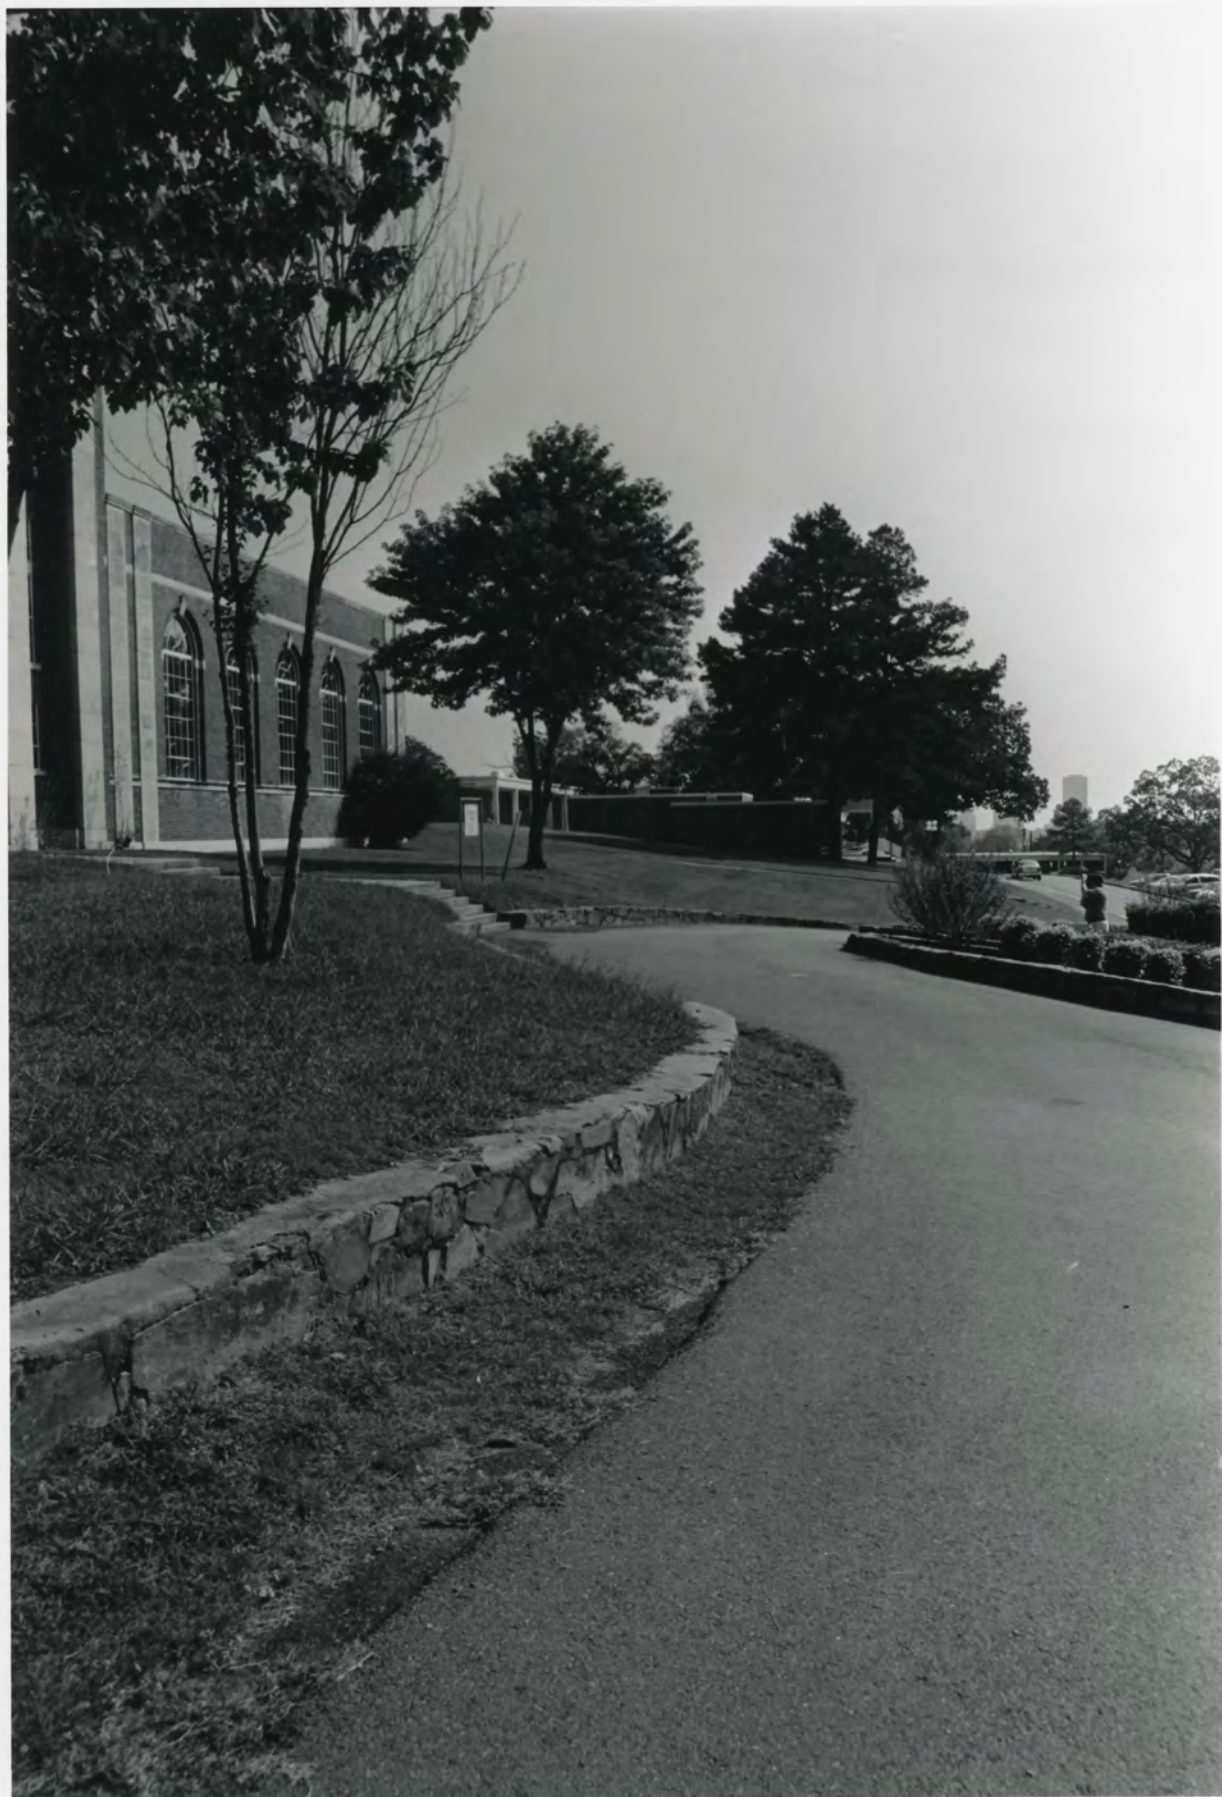
- ① Parnell Hall
- ② Pulaski County, AR
- ③ Sarah Jampole Marks
- ④ October 2007
- ⑤ AHPP
- ⑥ Contributing rock climbing @ south elevation, looking northeast
- ⑦ #3

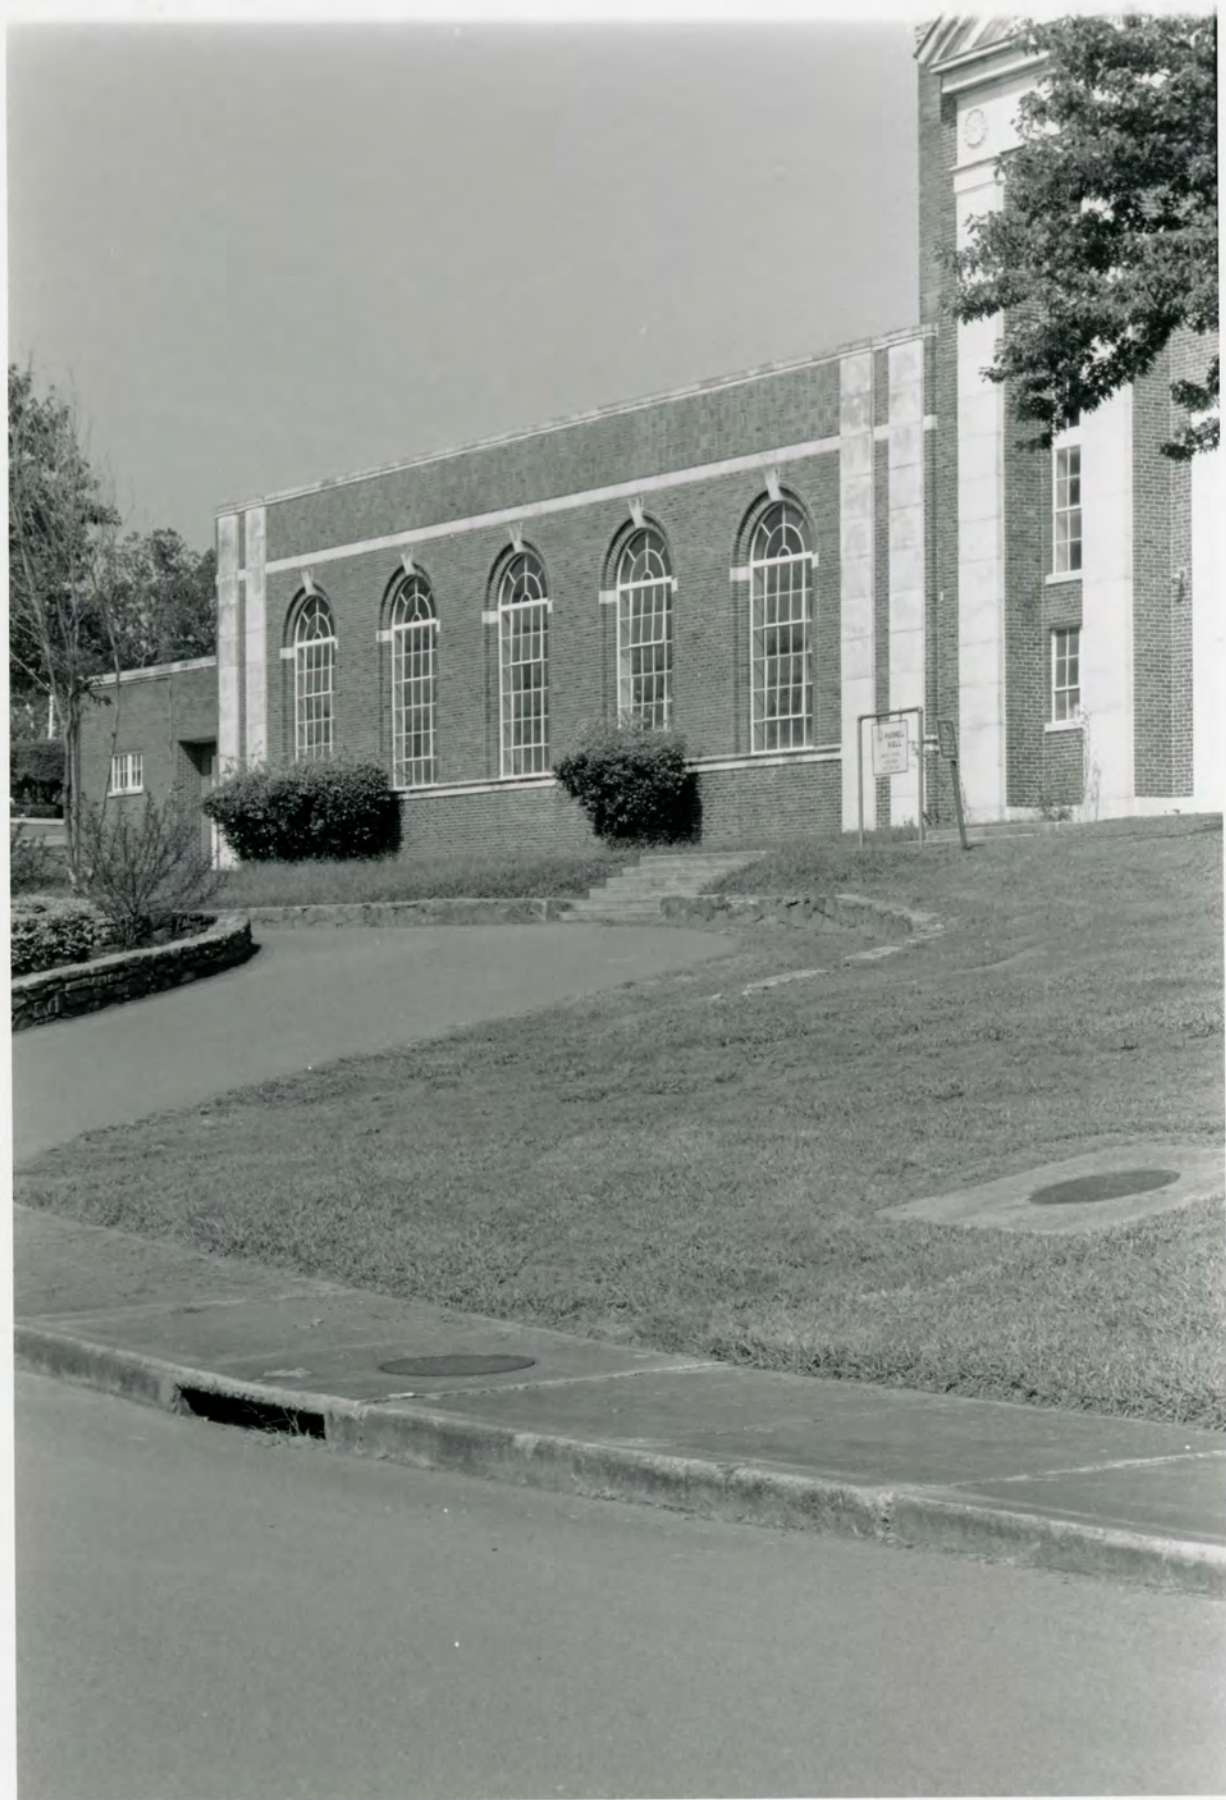
- ① Pamell Hall
- ② Pulaski County, AR
- ③ Sarah Jampore marks
- ④ October 2007
- ⑤ AHPP
- ⑥ West west of south elevation, looking
Northwest
- ⑦ #4

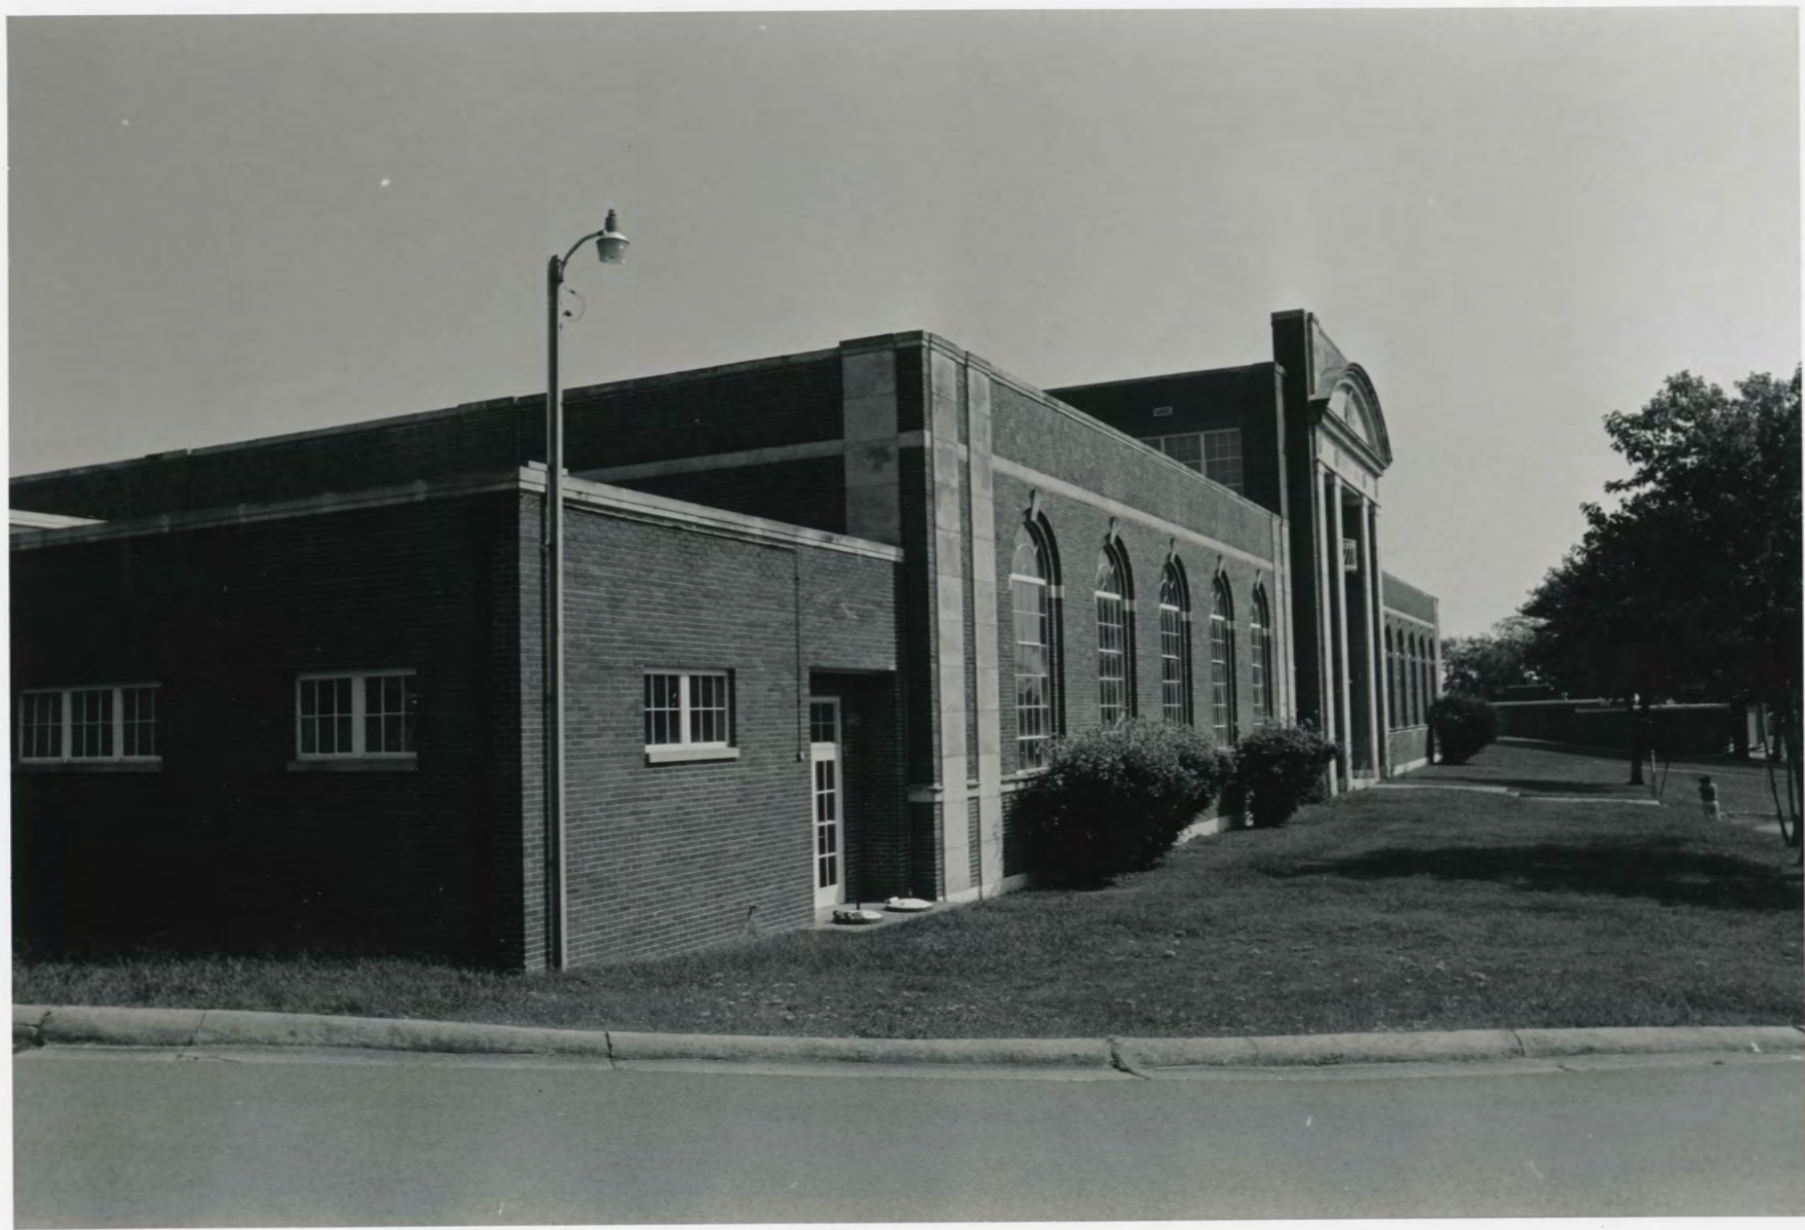
- ① Purnell Hall
- ② Pulaski County, AR
- ③ Sarah Jampole Marks
- ④ October 2007
- ⑤ AHPP
- ⑥ South façade and partial west elevation,
looking northeast
- ⑦ #5

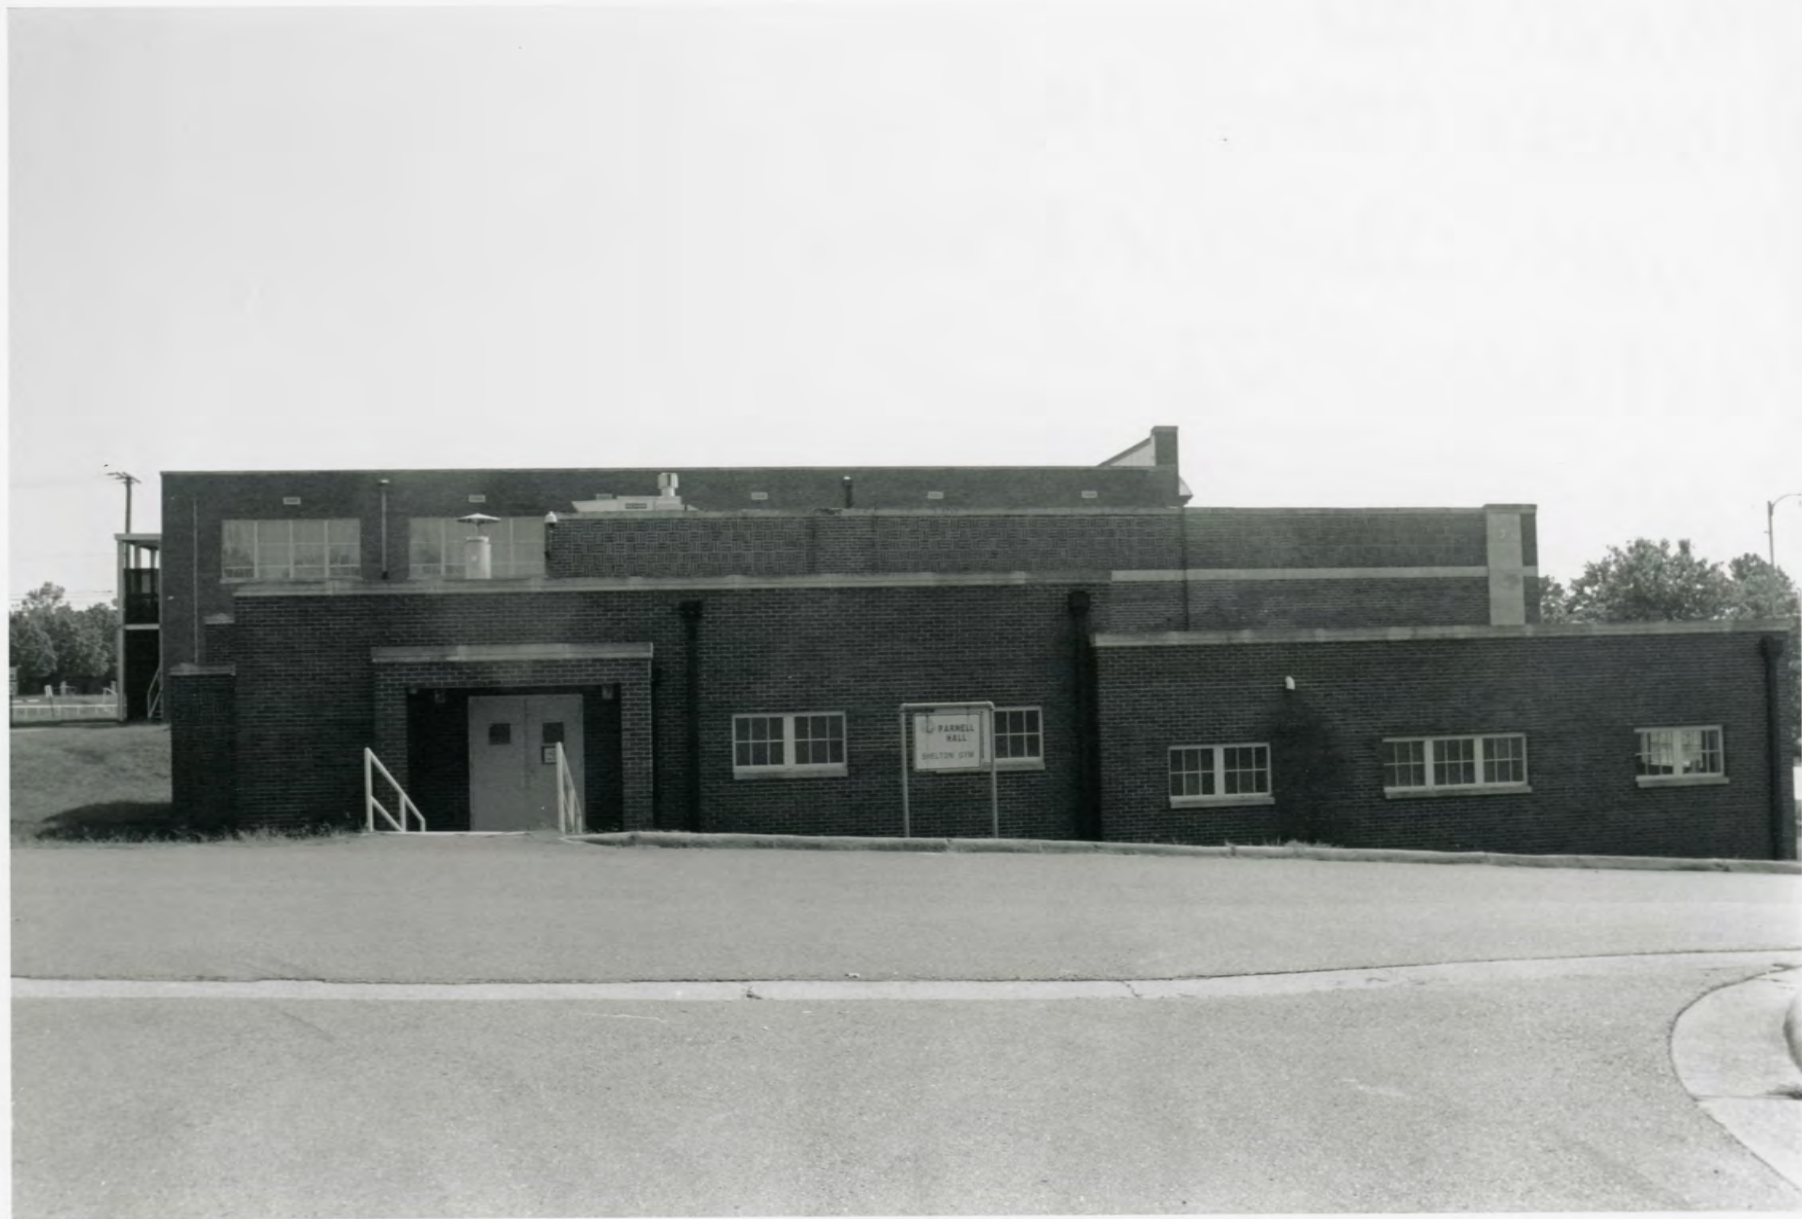
- ① Pamell Hall
- ② Pulaski County, AR
- ③ Sarah Jampole Marks
- ④ October 2007
- ⑤ AHPP
- ⑥ West elevation, looking east.
- ⑦ #6

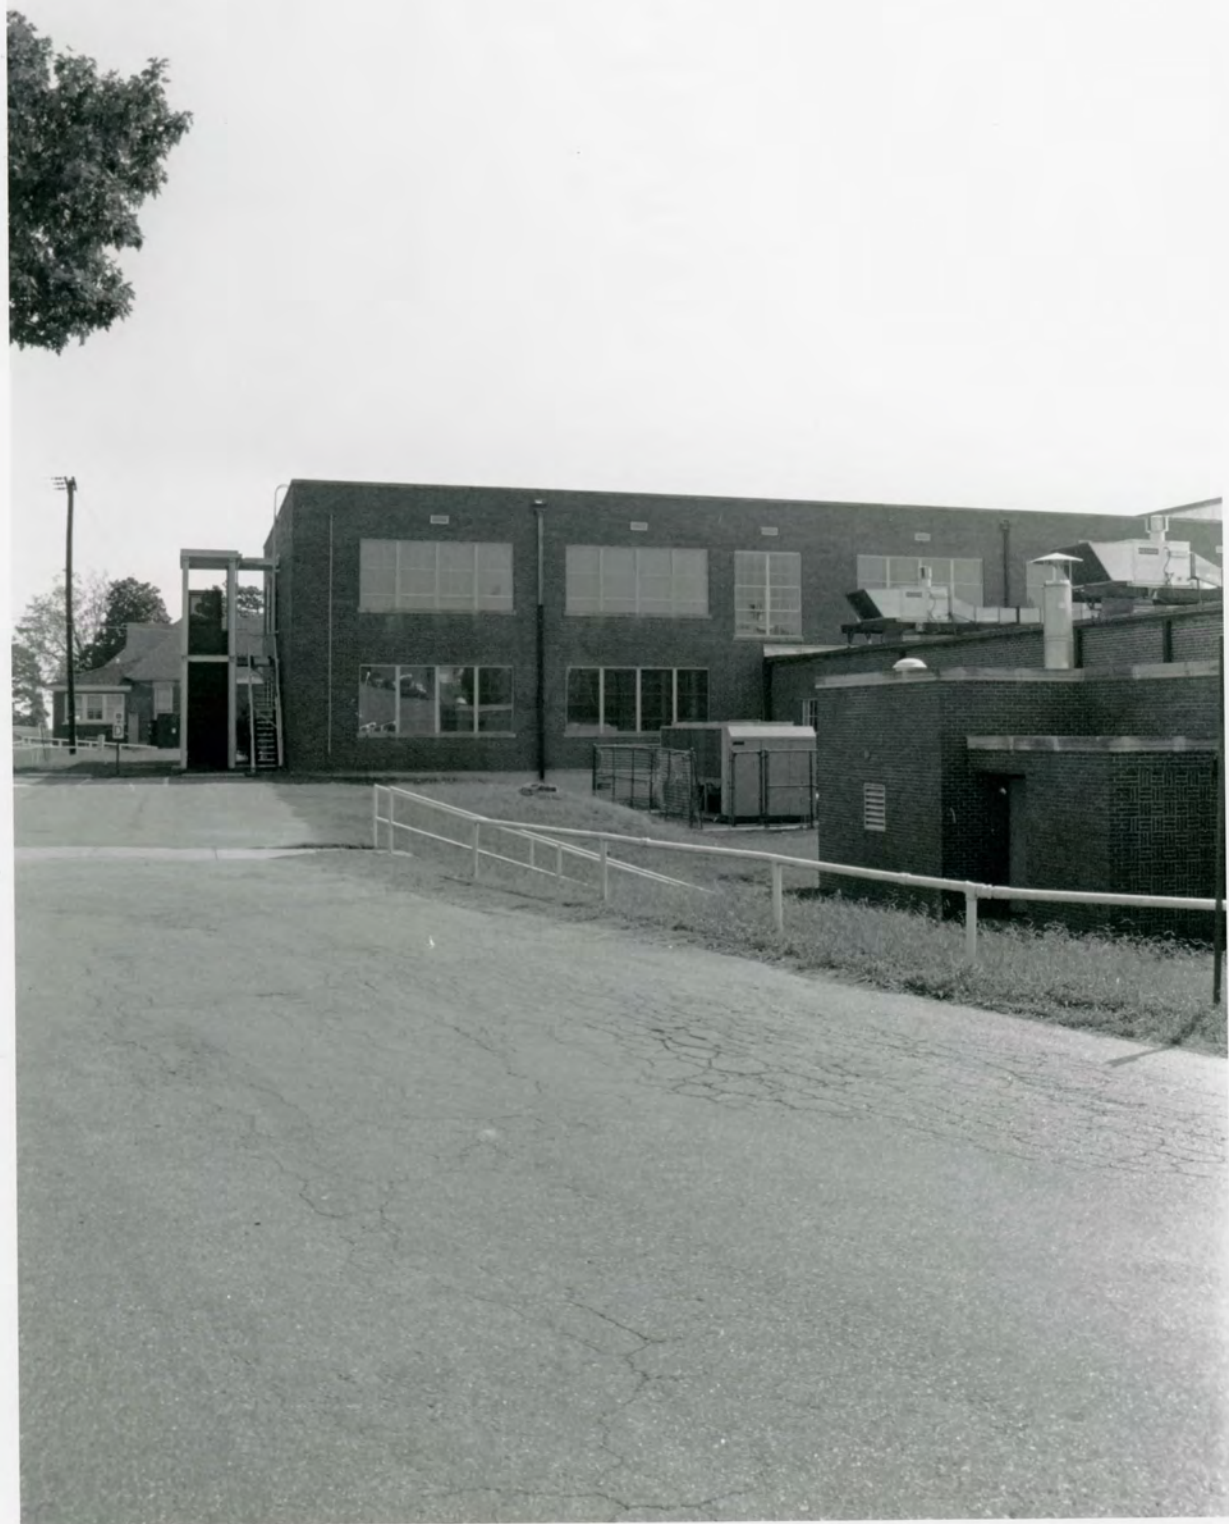
- ① Parnell Hall
- ② Pulaski County, AR
- ③ Sarah Jampole Marks
- ④ October 2007
- ⑤ AHPP
- ⑥ North facade, looking northeast
- ⑦ #7

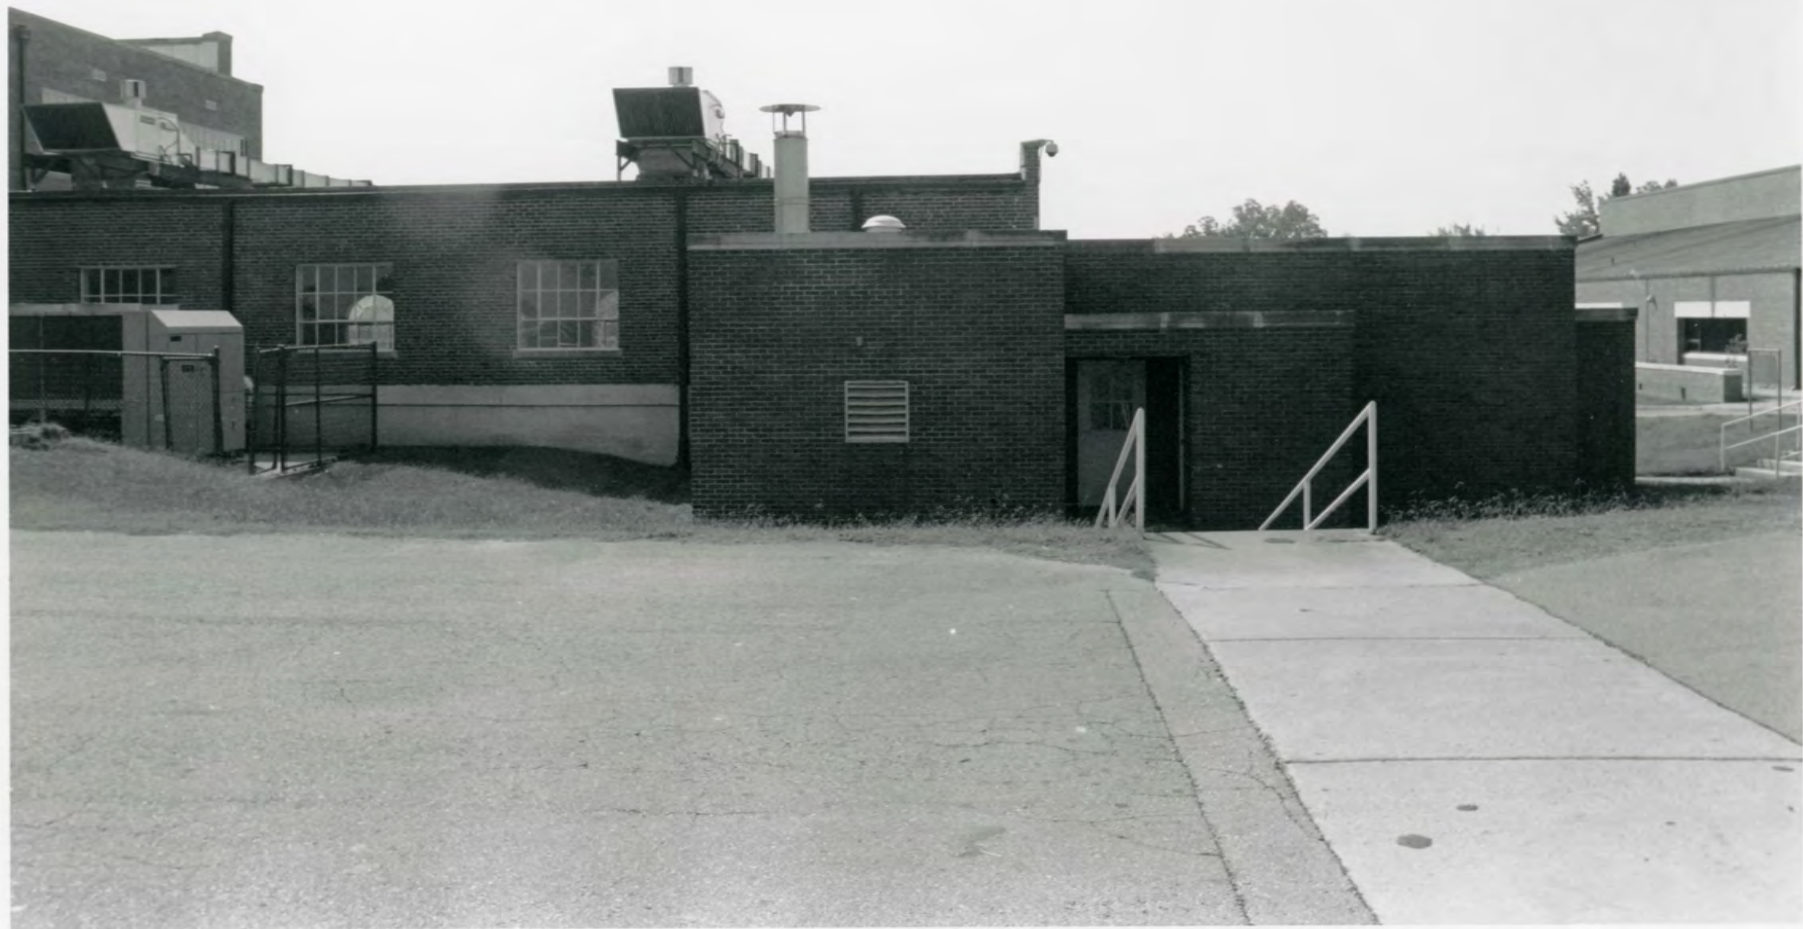
- ① Parnell Hall
- ② Pulaski County, AR
- ③ Sarah Jampole Marks
- ④ October 2007
- ⑤ AHPP
- ⑥ North facade of west wing, looking south
- ⑦ #8

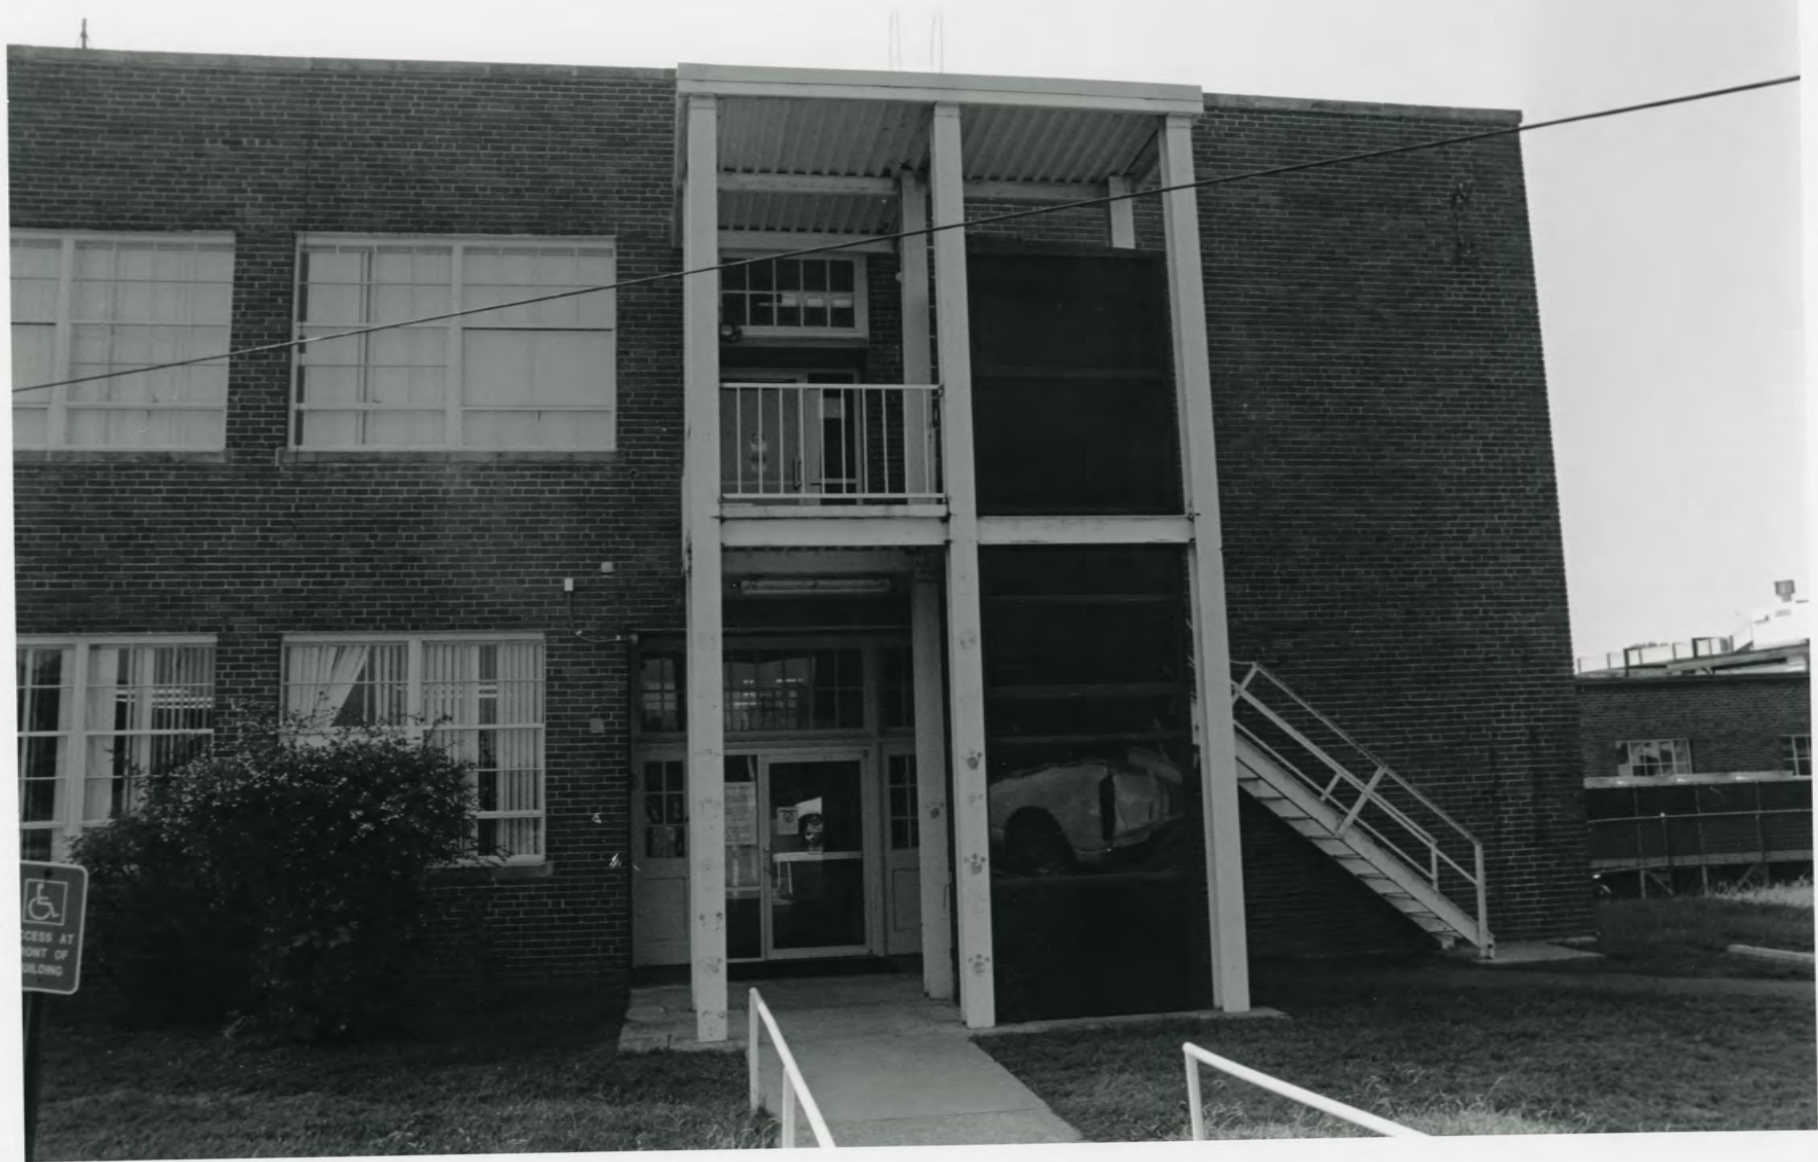
- ① Parnell Hall
- ② Pulaski County, AR
- ③ Sarah Jampole Marks
- ④ October 2007
- ⑤ AHPP
- ⑥ North facade of center block, looking
south
- ⑦ #9

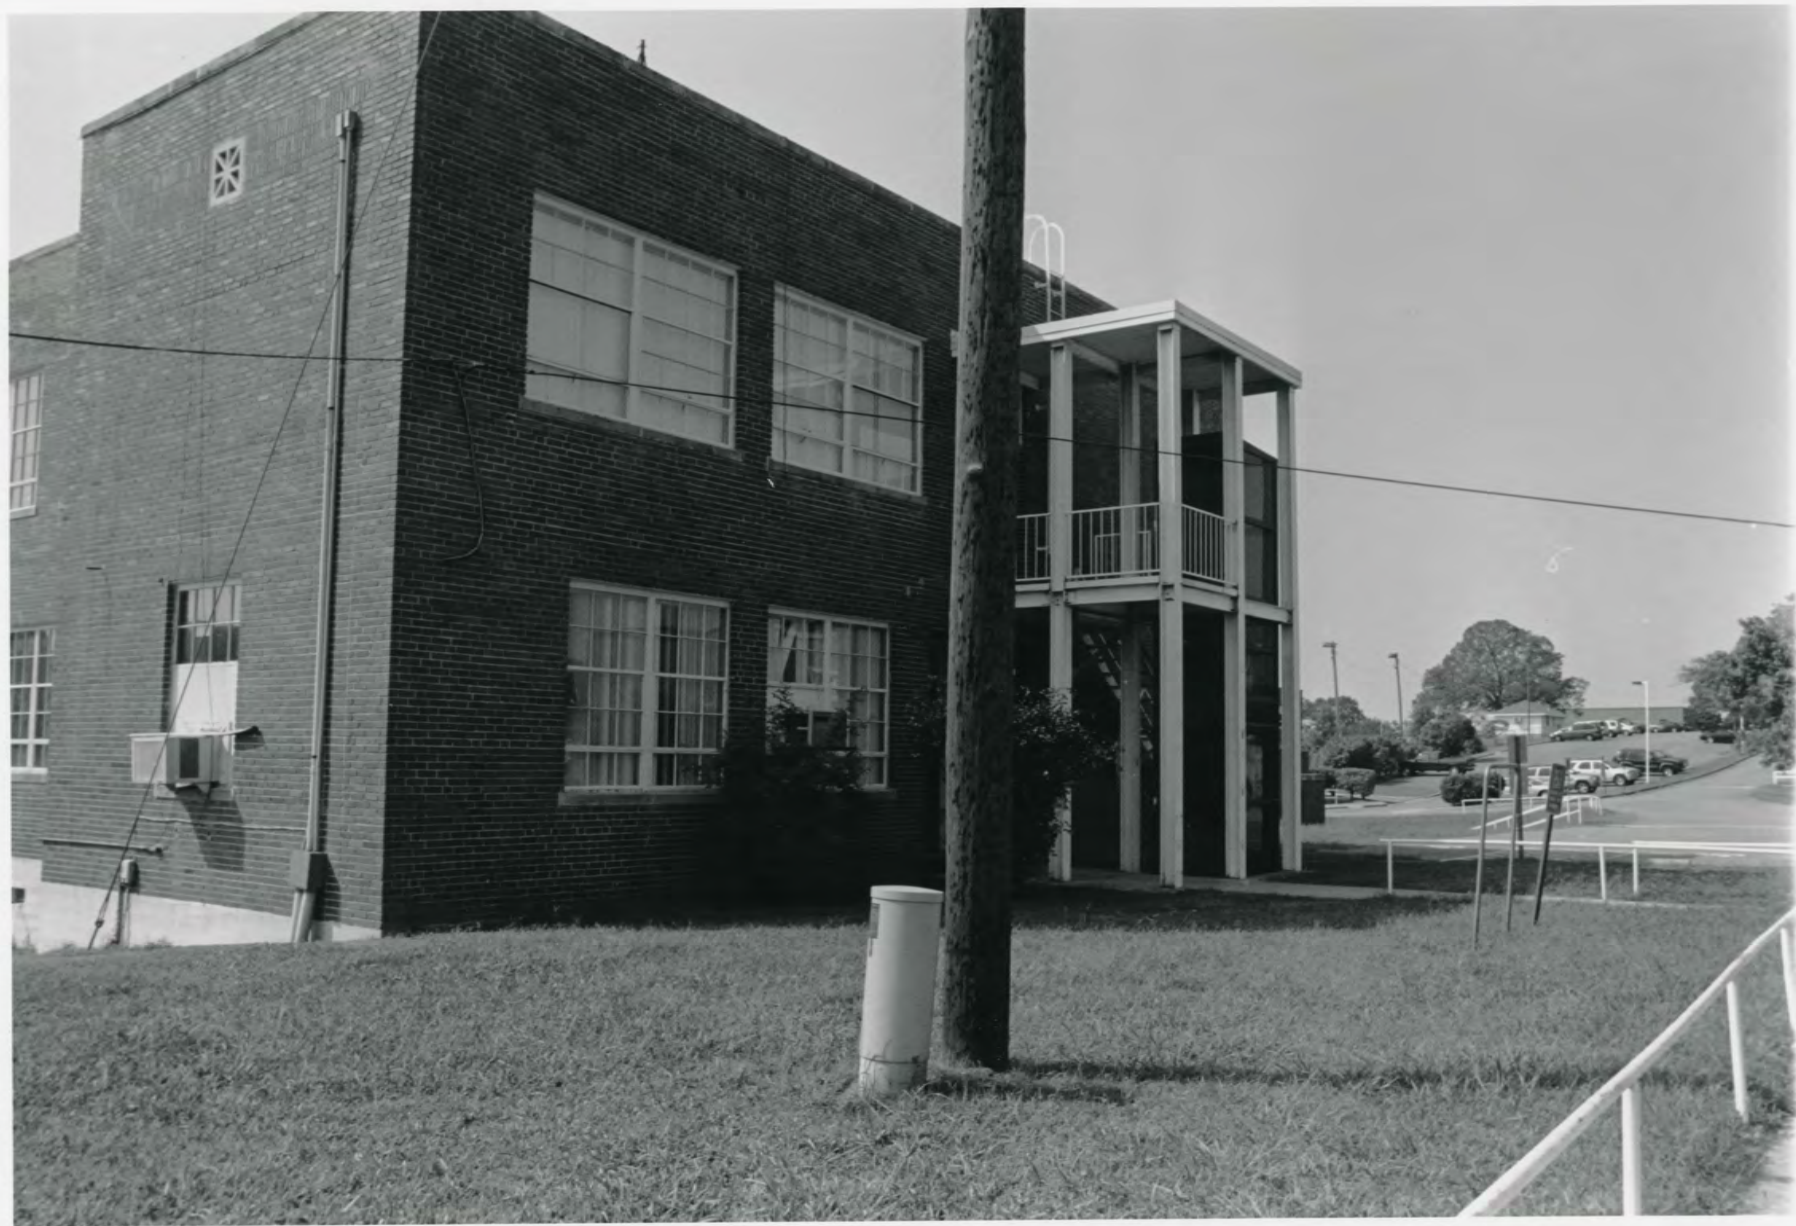
- ① Parnell Hall
- ② Pulaski County, AR
- ③ Sarah Jampole marks
- ④ October 2007
- ⑤ ~~HTH~~
- ⑥ North facade and ^{partial} east elevation of central block, looking south west
- ⑦ # 10
