National Register of Historic Places
Registration Form

historic name Parnell Hall

street & number 2400 West Markham ☐ not for publication

city or town Little Rock ☐ vicinity

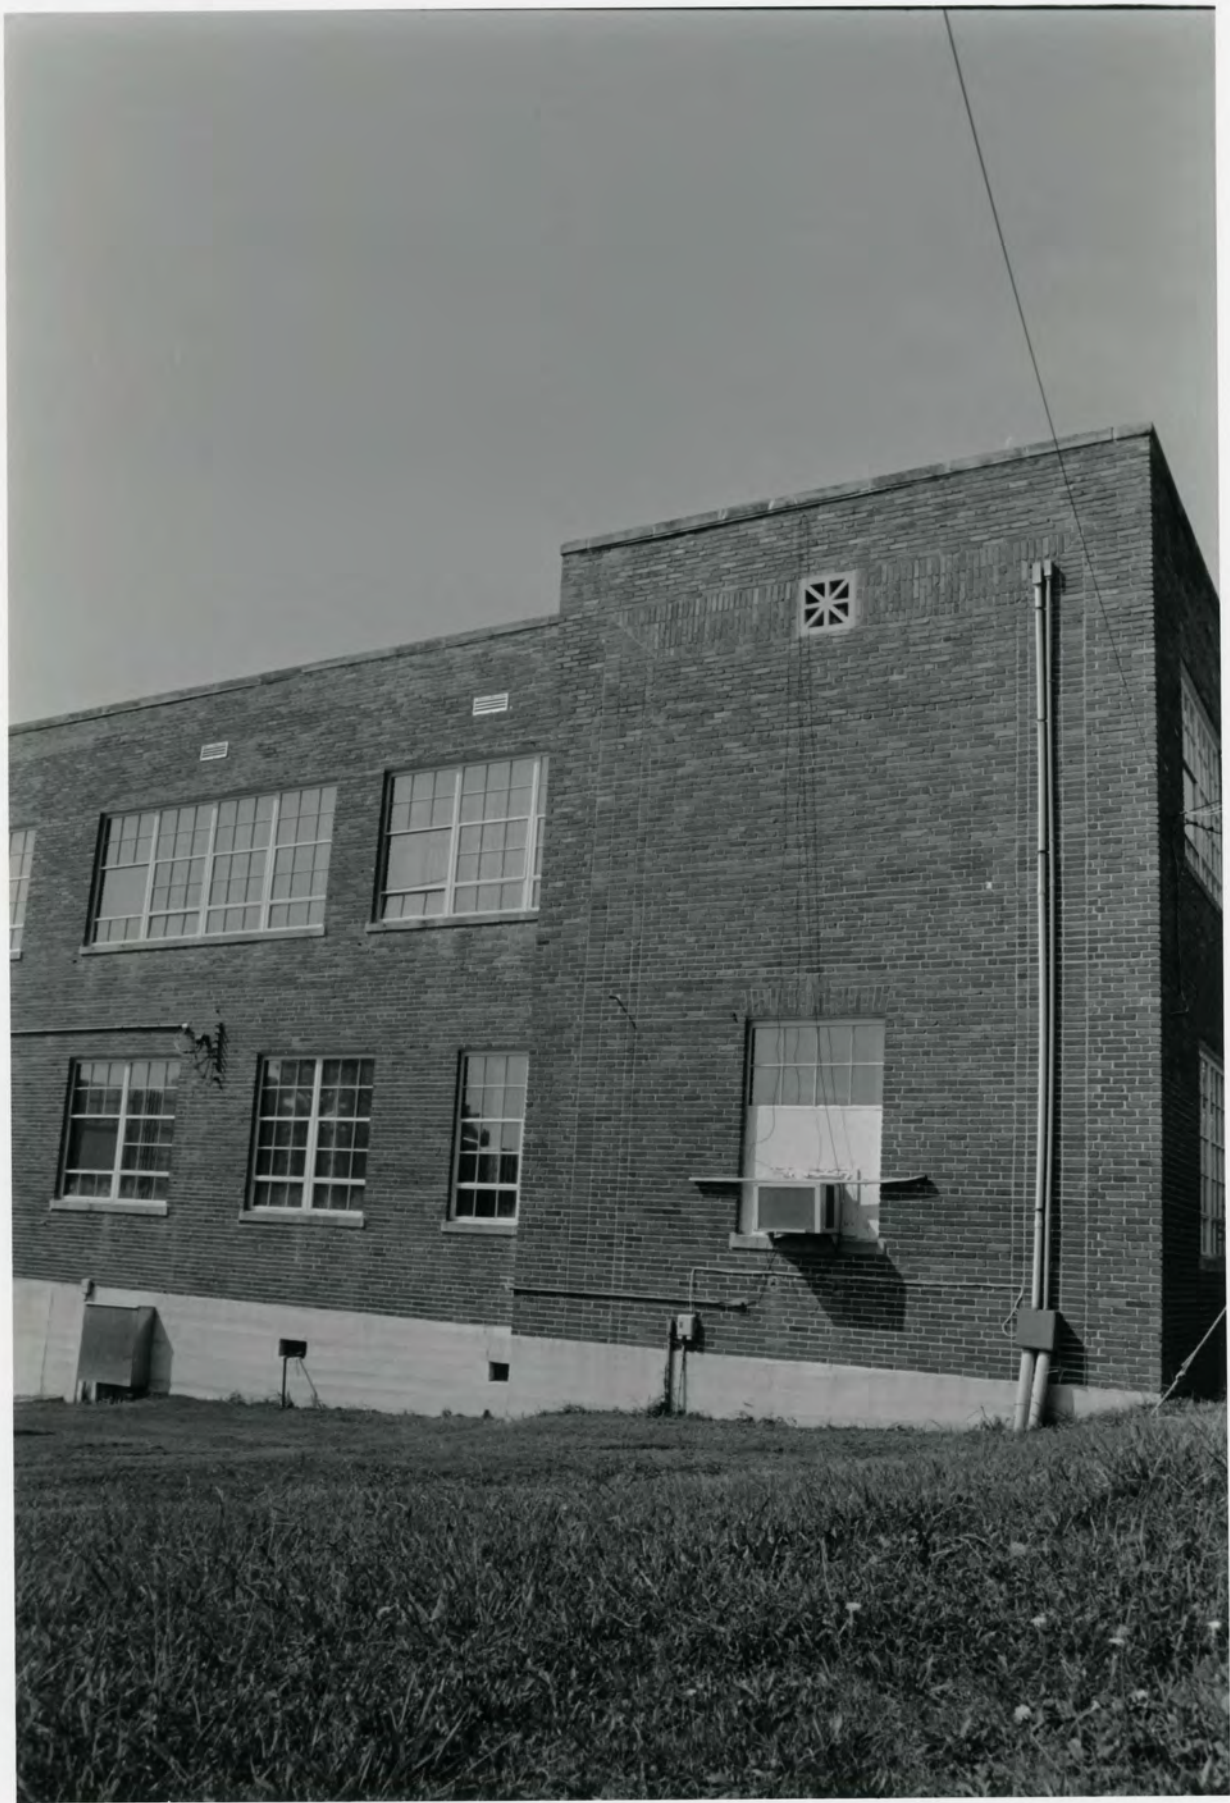
- ① Pamell Hall
- ② Pulaski County, AR
- ③ Sarah Jampole marks
- ④ October 2007
- ⑤ ~~ATTP~~
- ⑥ East facade of centre block, ^{rear} looking west
- ⑦ #11

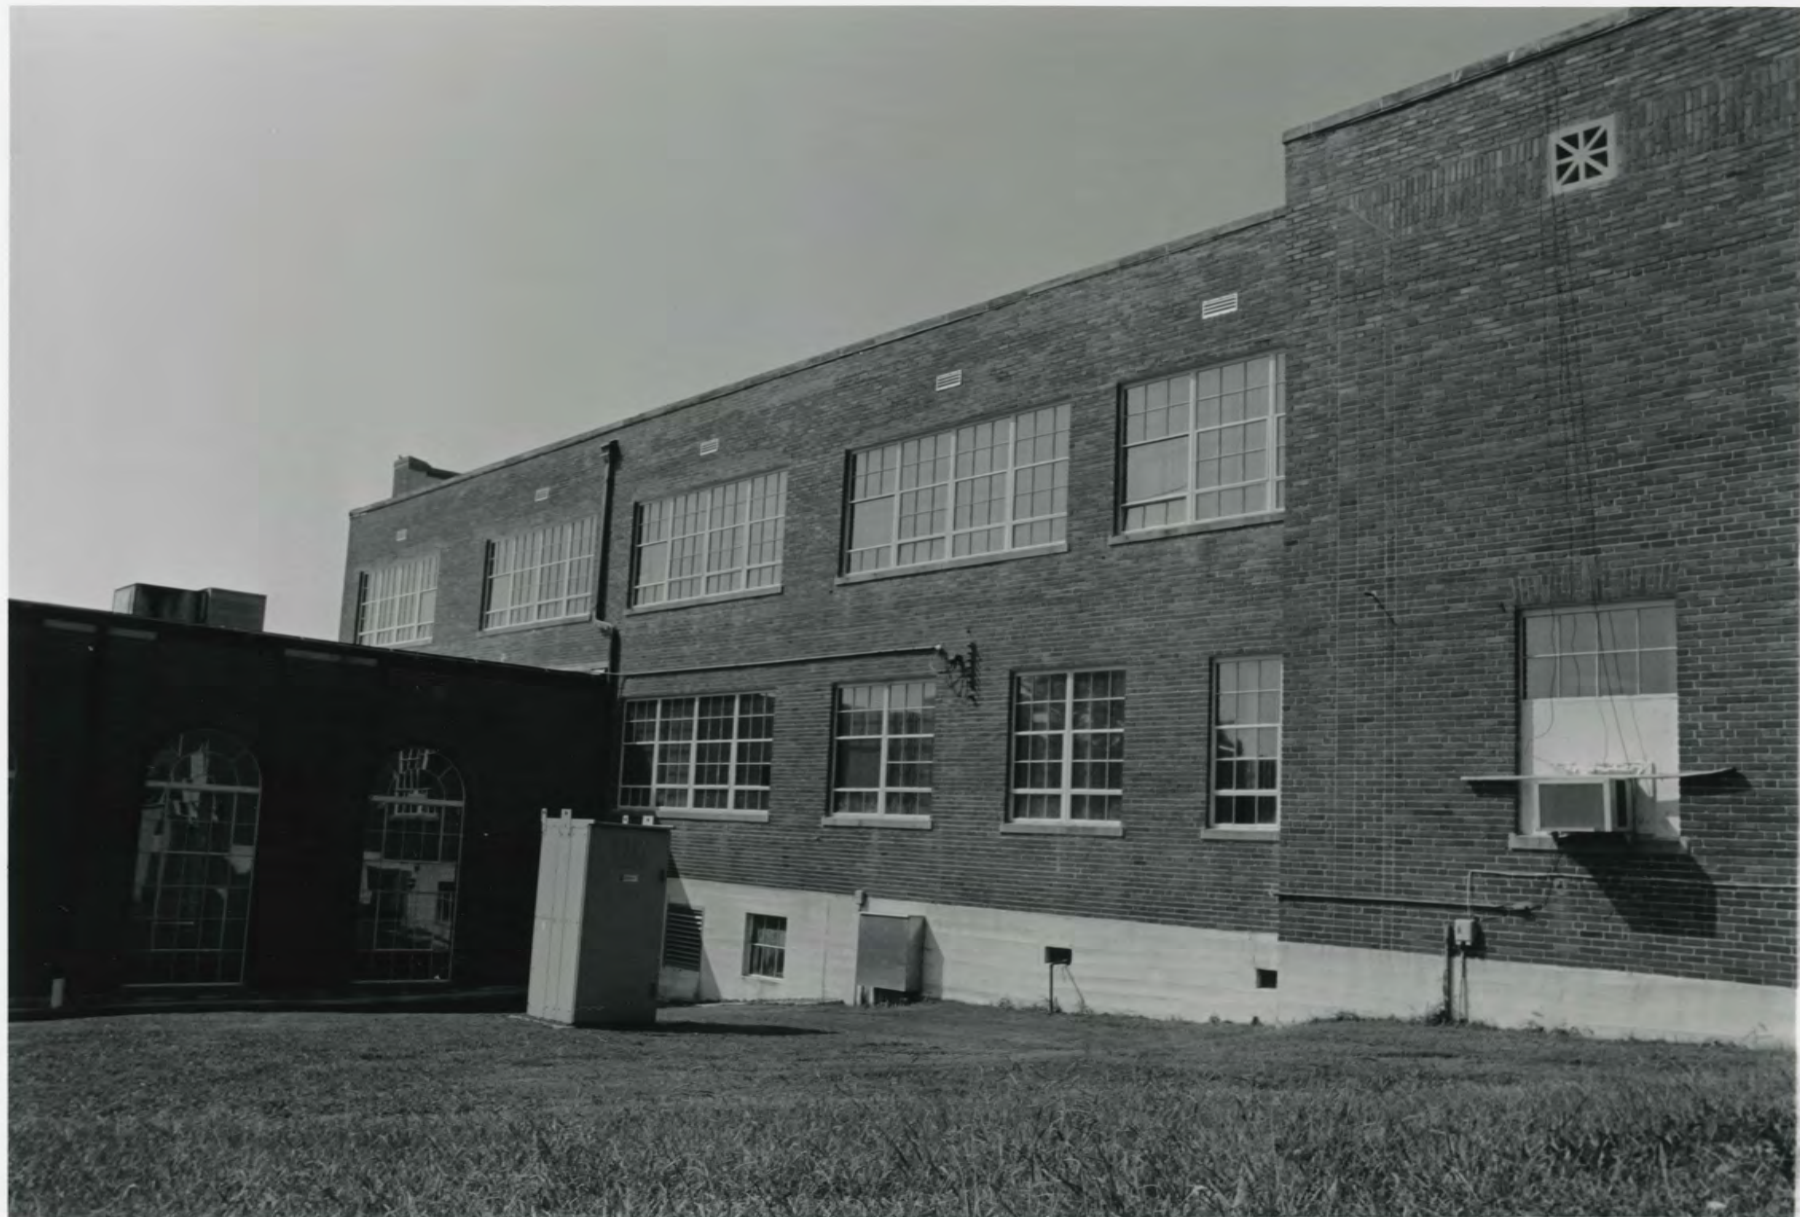
- ① Parnell Hall
- ② Pulaski County, AR
- ③ Sarah Jampole marks
- ④ October 2007
- ⑤ AHPP
- ⑥ East elevation of central block, and
partial north elevation of east wing, looking
southwest
- ⑦ # 12

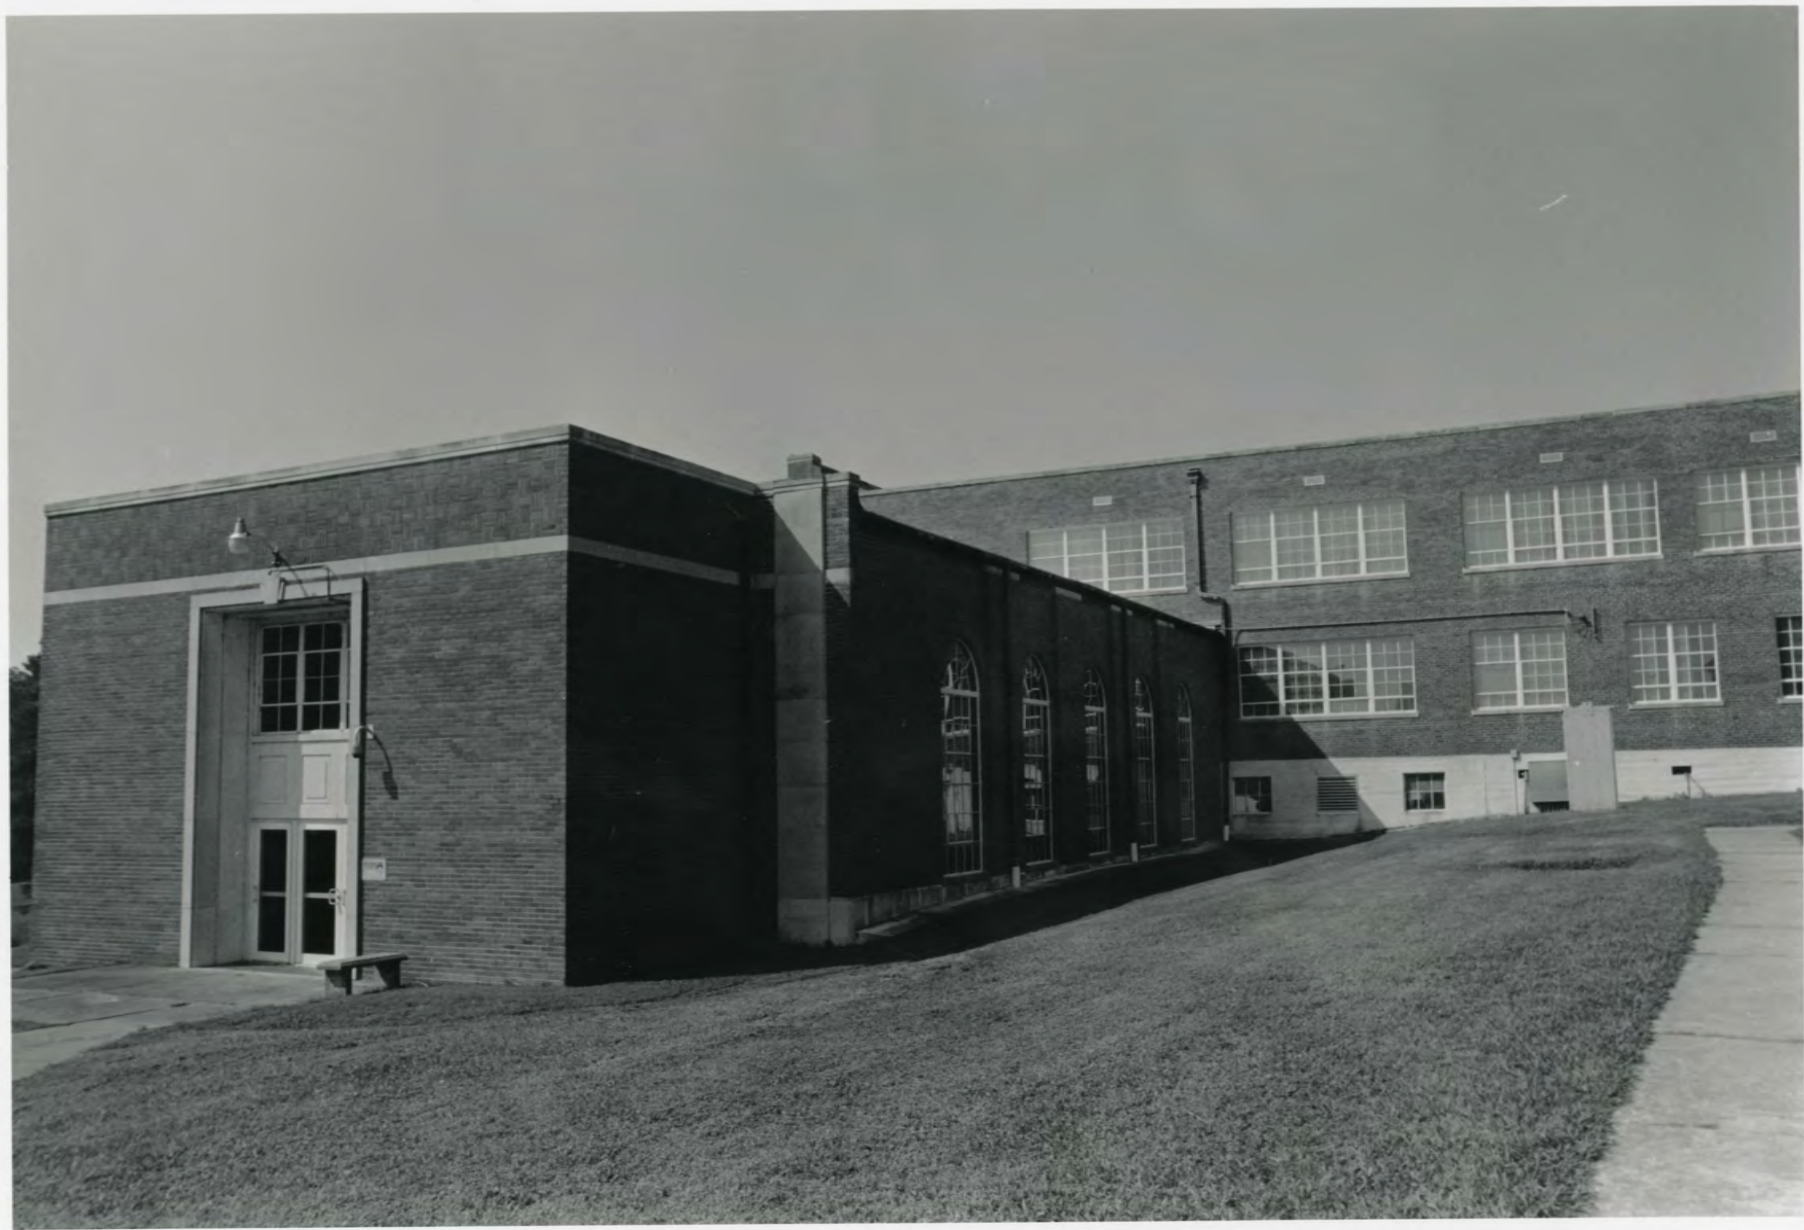
- ① Darnell Hall
- ② Pinal County, AZ
- ③ Sarah Jampole marks
- ④ October 2007
- ⑤ AHPP
- ⑥ ^{partic} East facade of central block, north elevation
of east wing, and east facade of east wing -
looking southwest
- ⑦ #13

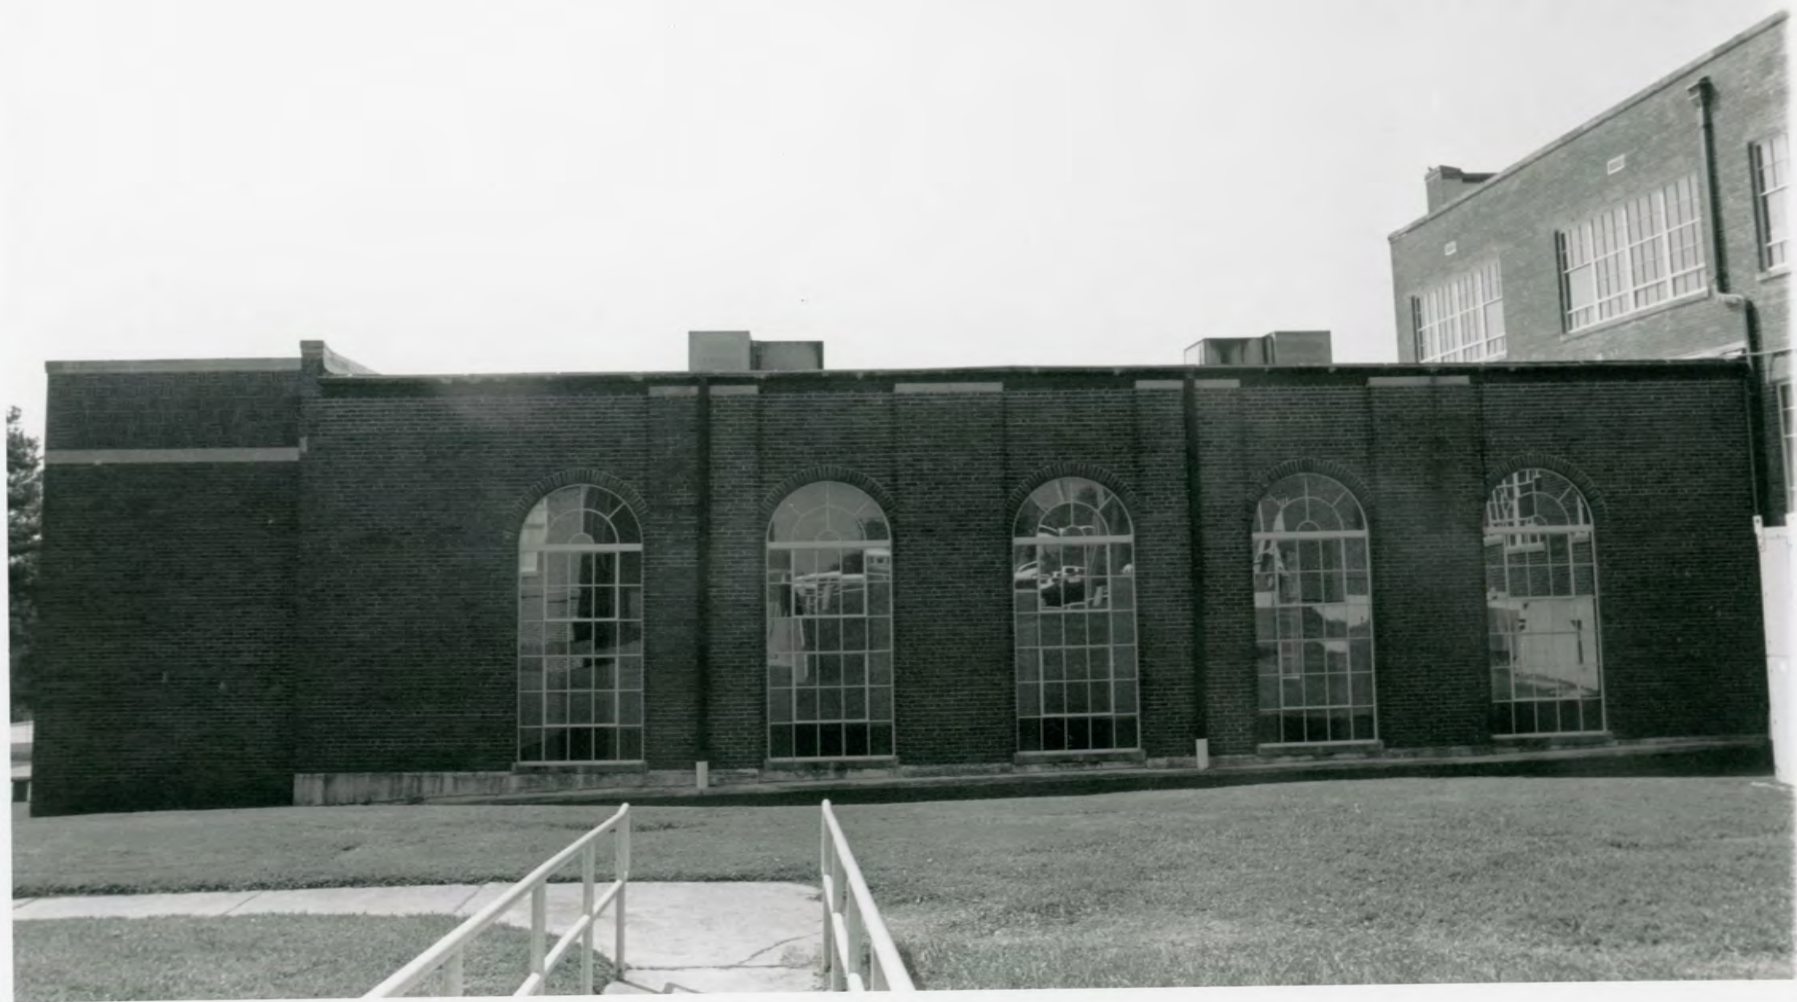
- ① Parnell Hall
- ② Pulaski County, AR
- ③ Sarah Jampole marks
- ④ October 2007
- ⑤ AHAP
- ⑥ North elevation of east wing, looking south
- ⑦ #14

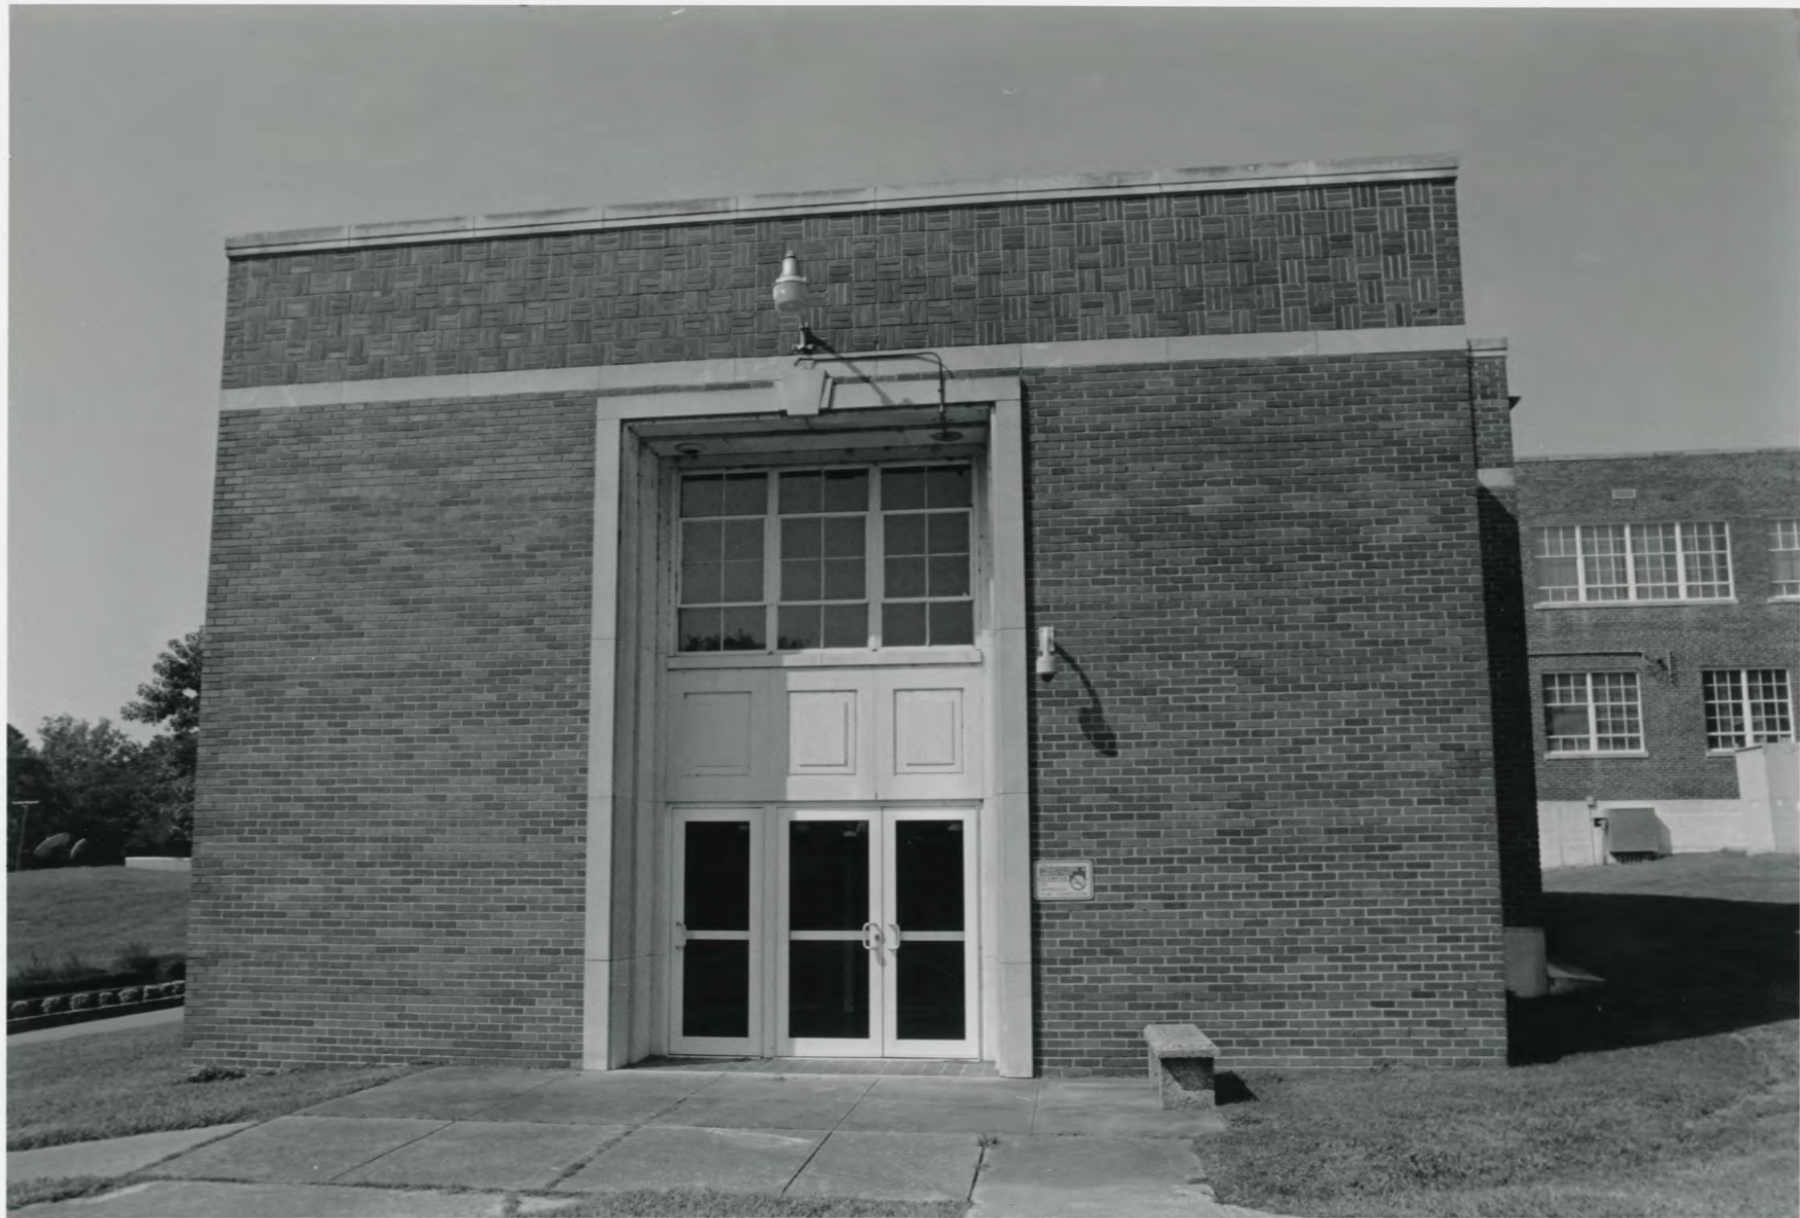
- ① Parnell Hall
- ② Pulaski County, AR
- ③ Sarah Jampole Marks
- ④ October 2007
- ⑤ AHPP
- ⑥ East elevation (side entrance) of
east wing
- ⑦ #15

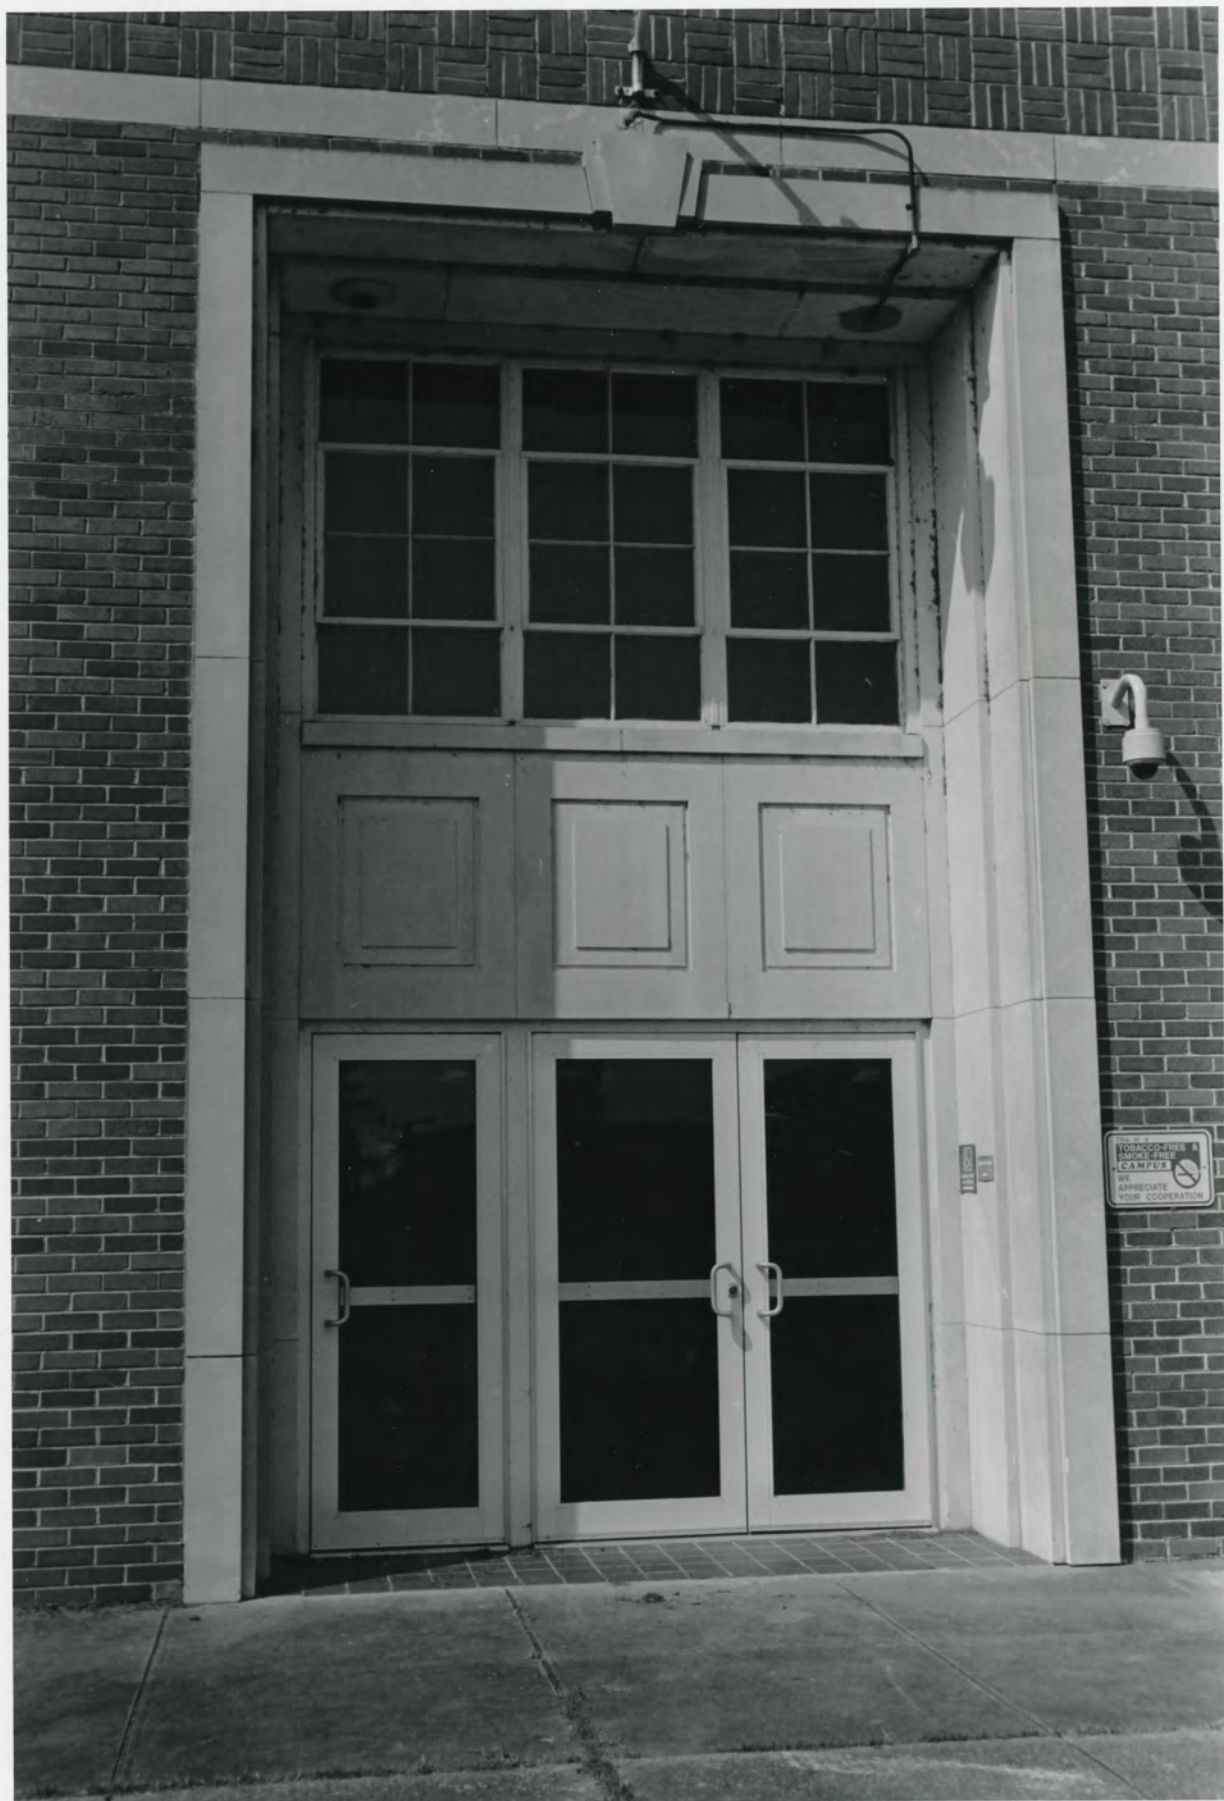
- ① Parnell Hall
- ② Pulaski County, AR
- ③ Sarah Jampole Marks
- ④ October 2007
- ⑤ ~~ATTP~~
- ⑥ East wing, last facade entry door
- ⑦ #10

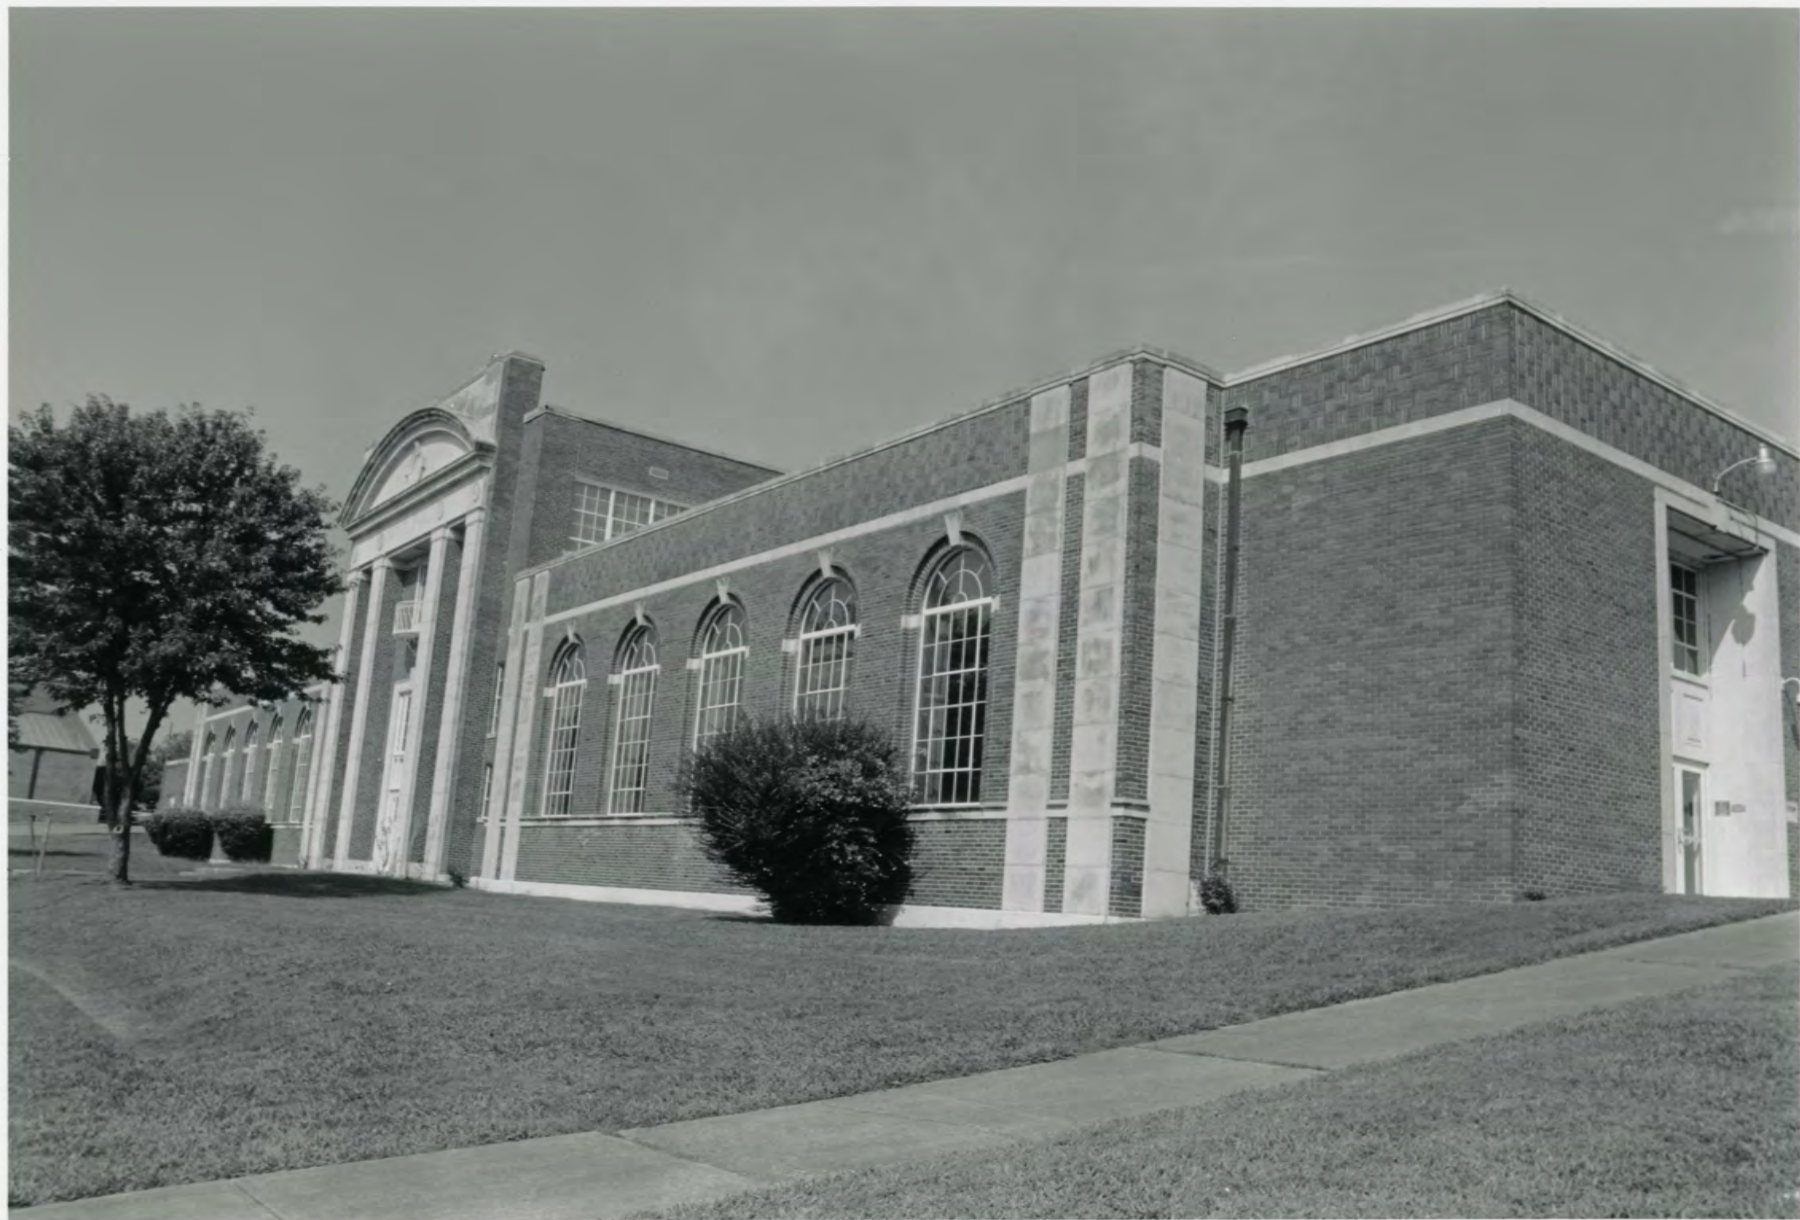
- ① Darnell Hall
- ② Pulaski County, AR
- ③ Sarah Jampole Marks
- ④ October 2007
- ⑤ AHPP
- ⑥ South facade and east side entry of east wing, looking west.
- ⑦ #17

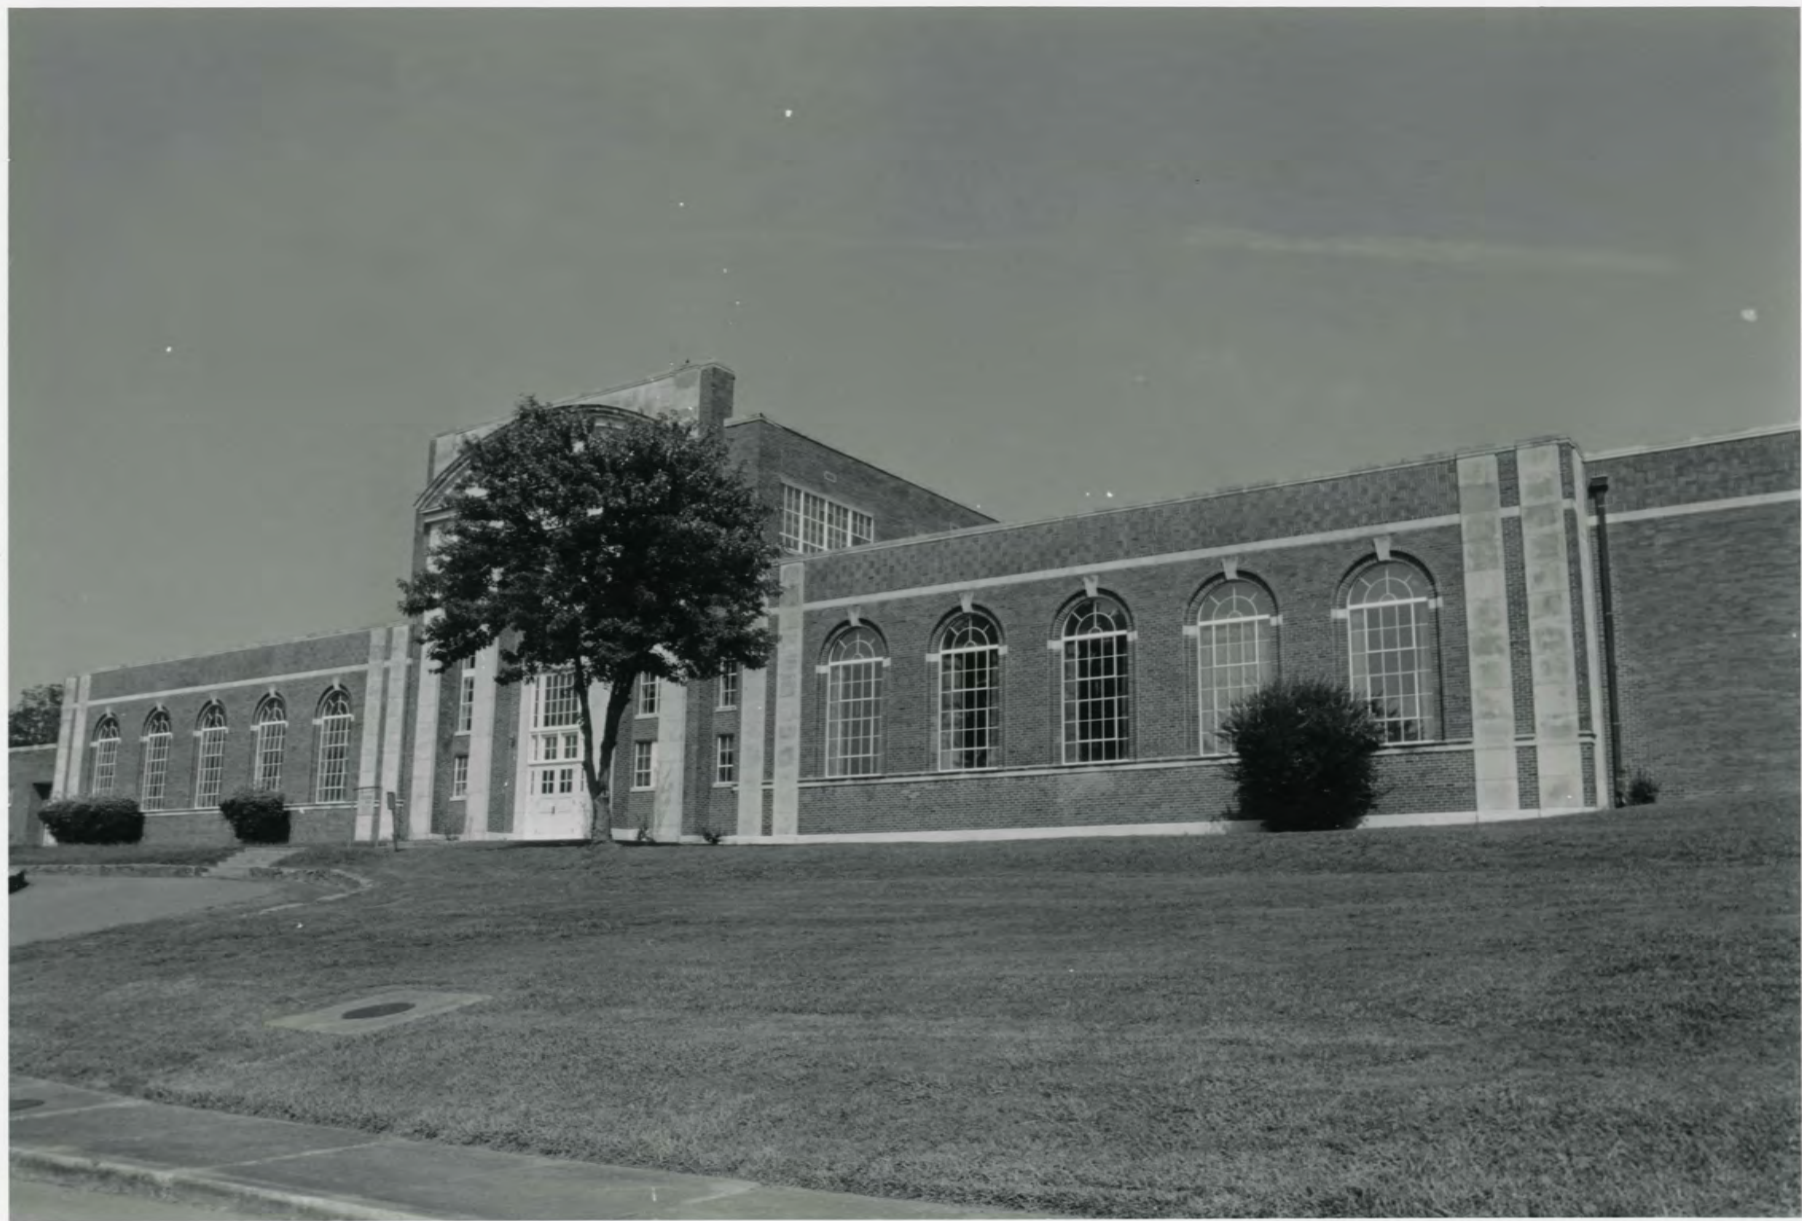
- ① Parnell Hall
- ② Pulaski County, AR
- ③ Sarah Jampole Marks
- ④ October 2007
- ⑤ AHPP
- ⑥ South elevation, looking northwest
- ⑦ #18
