National Register of Historic Places Registration Form

historic name William and Anna Fay House
other names/site number 5CF.2855

street & number 201 South Colorado Avenue N/A not for publication
city or town Buena Vista N/A vicinity
state Colorado code CO county Chaffee code 015 zip code 81201

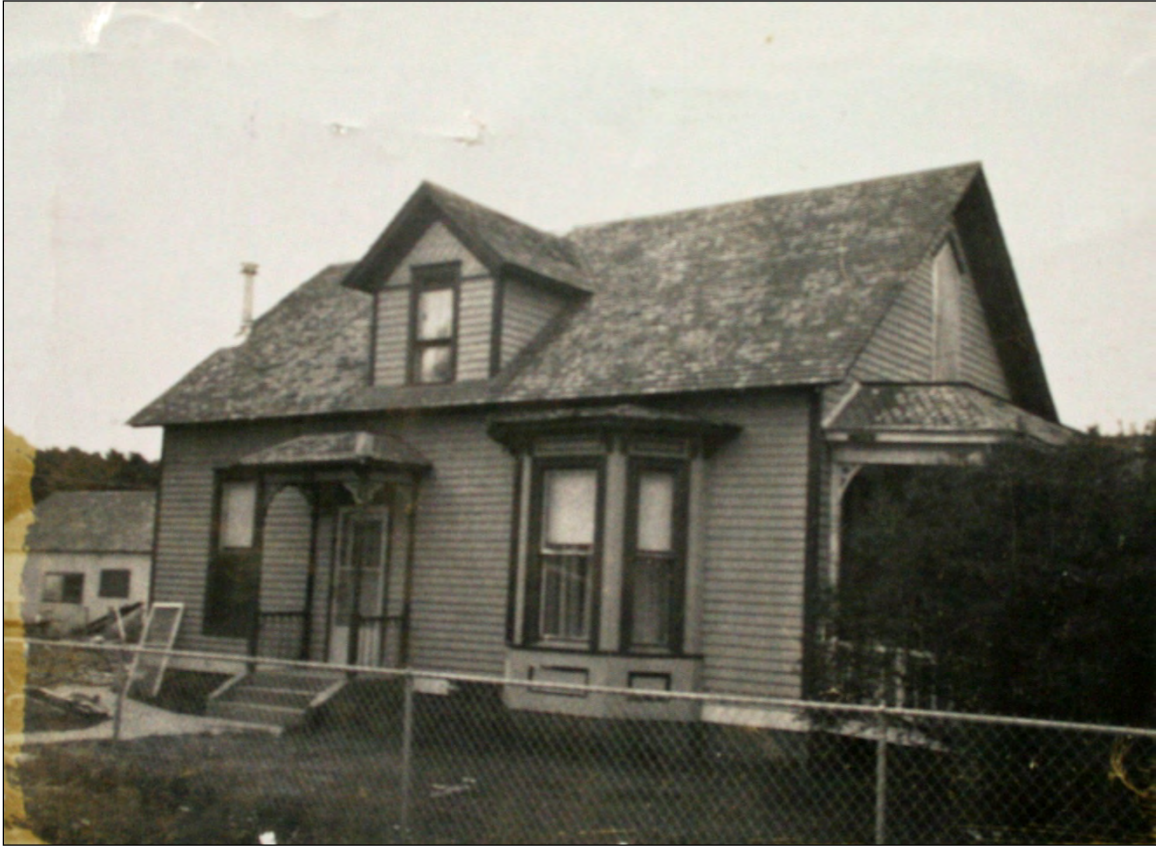
Figure 5. This 1970s-80s Assessor appraisal card shows the north wall of the house with the garage in the distance to the left (view southeast). Courtesy of Chaffee County Assessor, Salida, Colorado.
