# National Register of Historic Places Registration Form

historic name Our Lady of Guadalupe Church and Medina Cemetery

other names/site number La Yglesia de Nuestra Señora de Guadalupe/5LA.1966

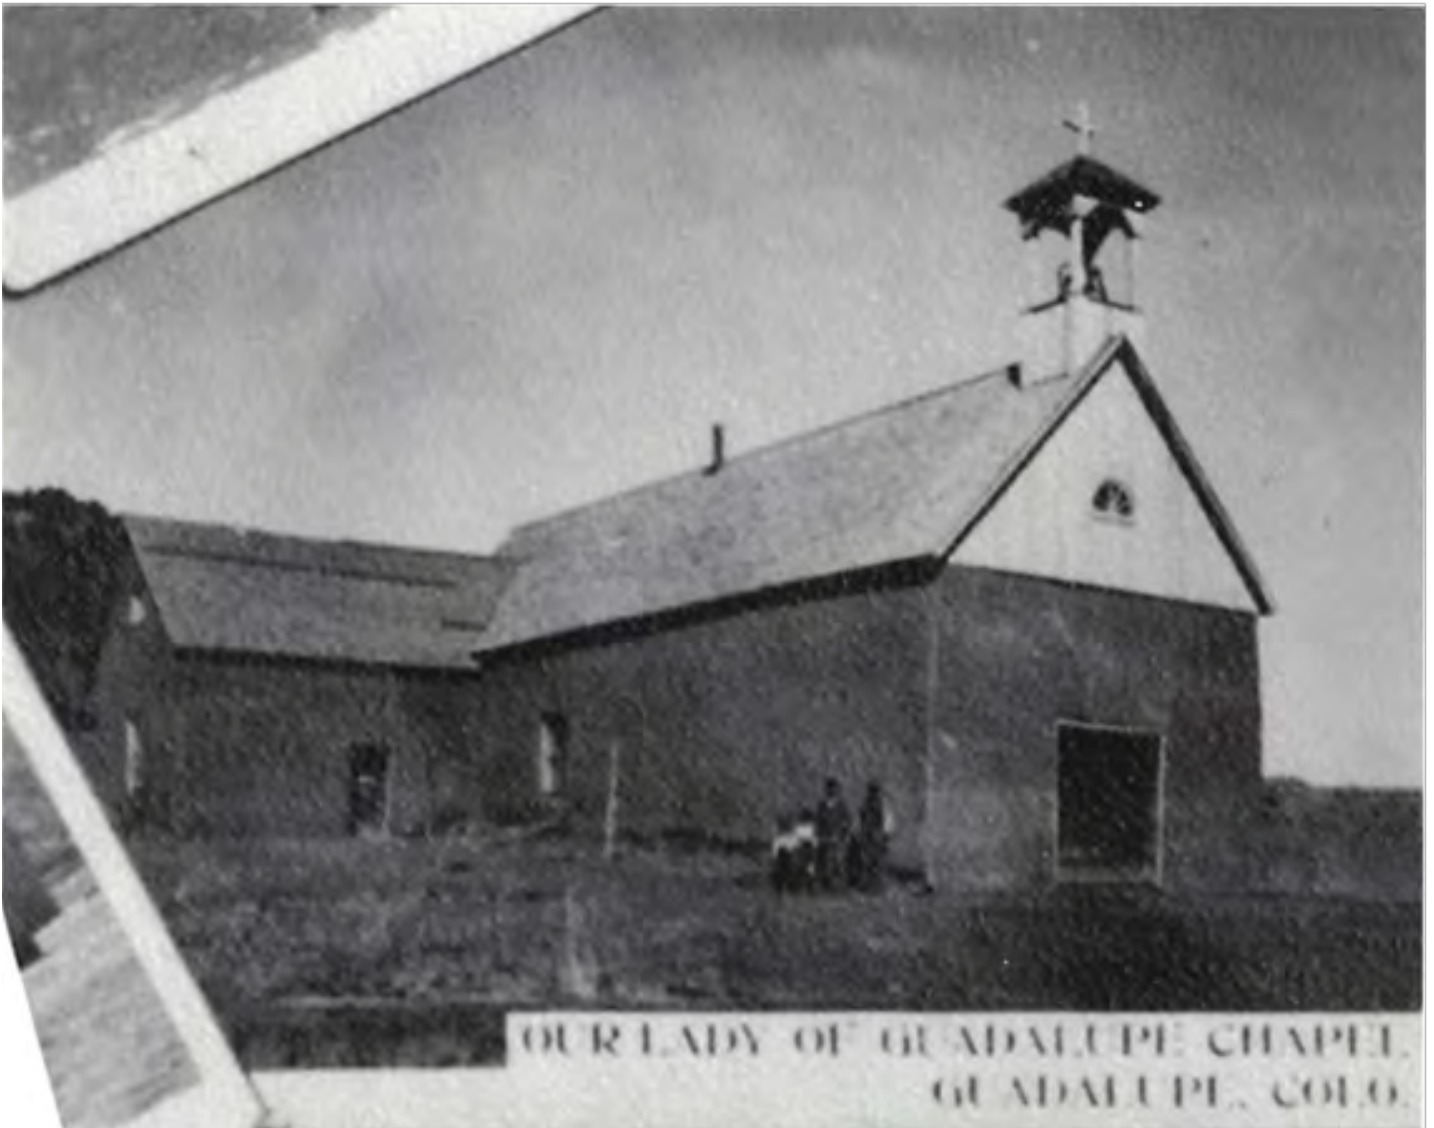
Figure 2: Detail from Figure 1, documenting the Our Lady of Guadalupe Chapel mission church in Guadalupe, Colorado, ca. 1900-10. According to the Medina family, the community of Medina Plaza was historically known as Guadalupe and this photograph documents Our Lady of Guadalupe Church prior to the remodeling of its roof, gable ends, and belfry to their current appearance. Source: History Colorado, Stephen Hart Library, Accession 84.193.916.

The roof may have been flat when the church was first constructed and has been reconfigured at least once. A ca. 1900-10 photograph captioned "Our Lady of Guadalupe Chapel/Guadalupe, Colo" (Figure 2), is thought to be the earliest known photograph of the church and documents a more steeply pitched roof over the main portion of the church, a fan window in

the gable over the front entrance, a belfry of different design, and a gable roof over the rectory.<sup>2</sup> The roof depicted in the ca. 1900-10 photograph was apparently reconfigured sometime before 1936 when the church was documented with the current roof design, belfry, and gable ends by the Historic American Building Survey (HABS). The impetus for these changes is unknown.

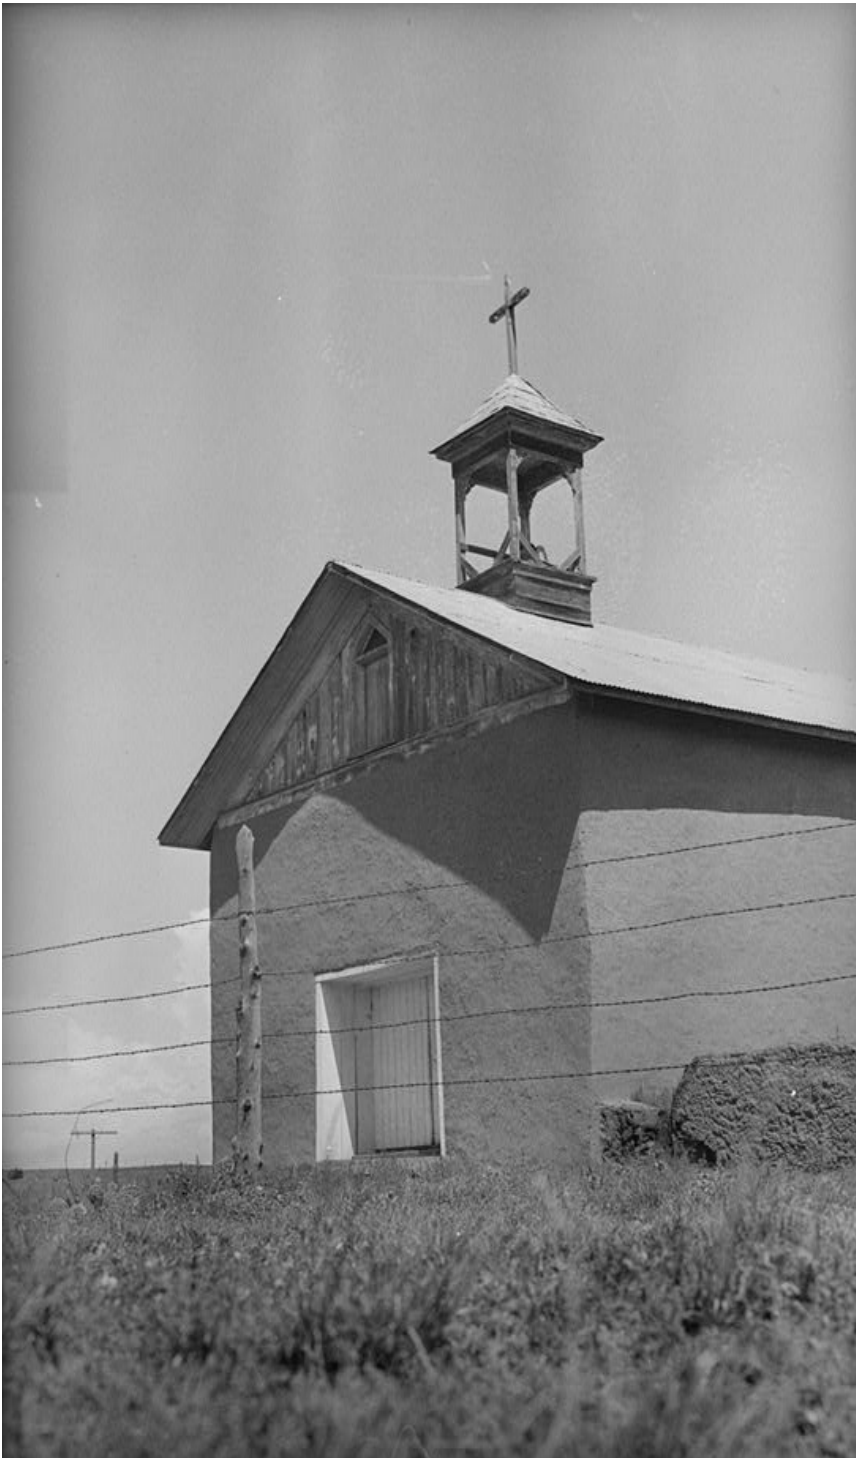
Figure 4: Photographer Frederick D. Nichols documented the church in August 1936. Source: Library of Congress, Historic American Buildings Survey # CO-57.

Between ca. 1900-10 and 1936, when the church was photographed by HABS, the gable roof over the main portion of the church was apparently replaced with a less steeply pitched gable roof, a new belfry installed, the gable ends remodeled,

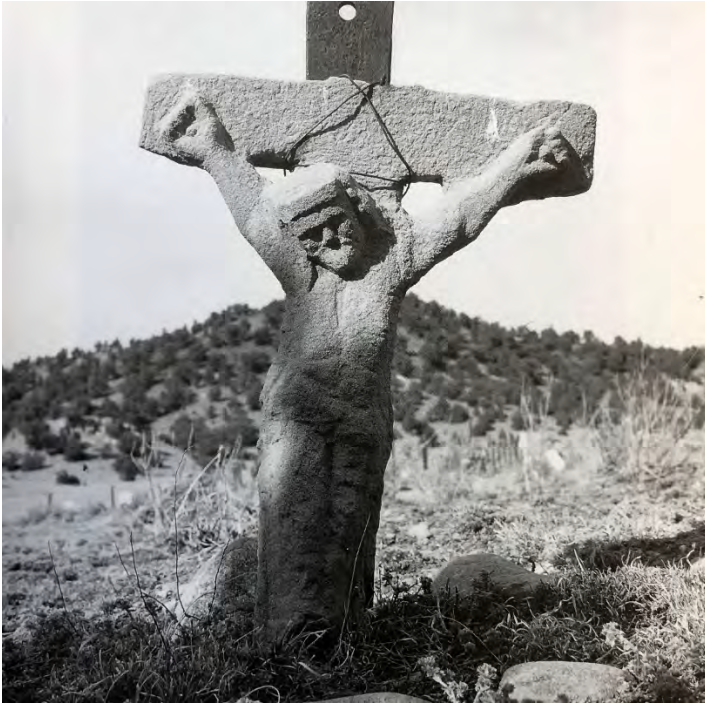
Figure 7: Sandstone cemetery marker in Medina Cemetery, photographed by Robert Adams in 1974. Source: *The Architecture and Art of Early Hispanic Colorado*.

Monuments represent a variety of eras, materials, designs, styles, and sizes. Most are small to medium in size and relatively simple in design. The majority of historic headstones are hand-carved or incised natural stone, with a few made of metal (Photos 22 and 25). Several graves are marked with simple tin crosses with nameplates that may have replaced deteriorated wood markers (Photo 1). A number of monuments appear to be homemade and some have unique designs. A few of the more elaborate headstones display a small inset oval photograph of the deceased. About ten military headstones mark the graves of veterans, including that of Medina Plaza founder Agapito Medina (Photo 23). The dates on about ten legible stones can possibly be attributed to the Influenza Pandemic of 1918-19.

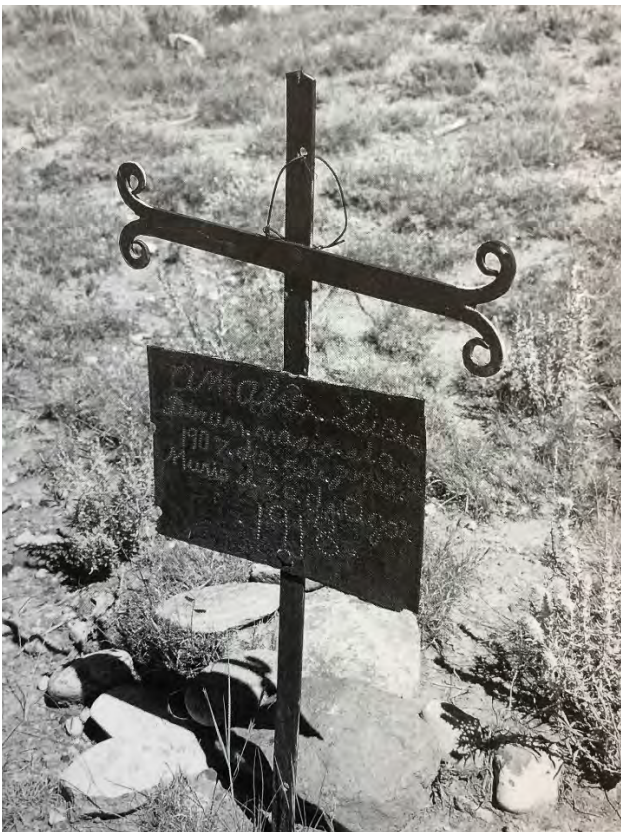
Figure 8: Wrought iron cemetery marker in Medina Cemetery, photographed by Robert Adams in 1974. Source: *The Architecture and Art of Early Hispanic Colorado*.

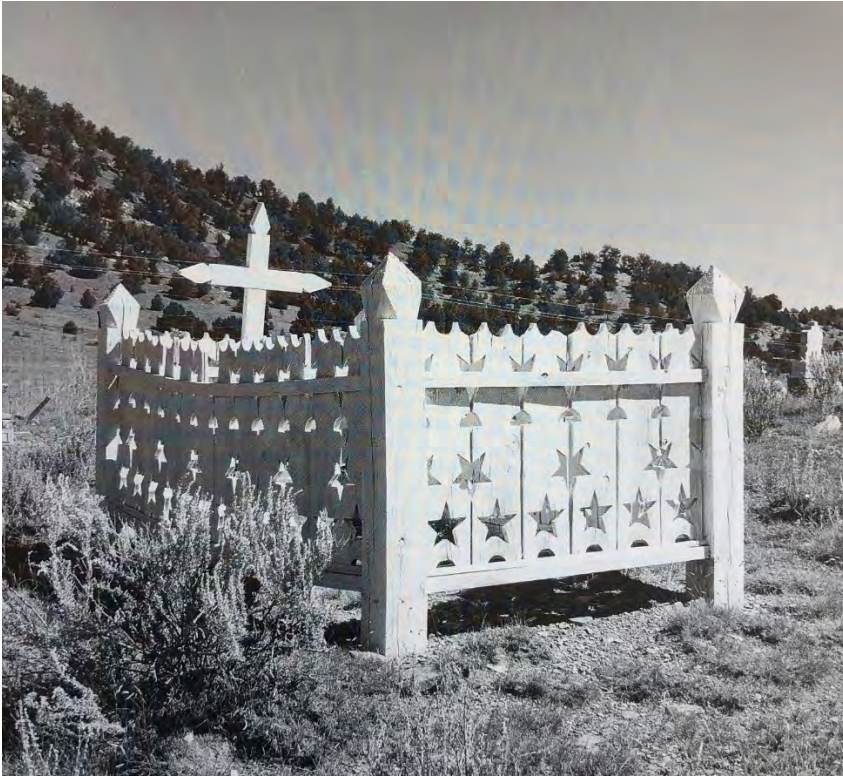
Figure 9: A *cerquita* (wood picket grave fencing), photographed in the Medina Cemetery by Robert Adams in 1974. Source: *The Architecture and Art of Early Hispanic Colorado*.

*Alterations:* Principal changes to the resource are the result of age and exposure to the elements, including fallen, broken, or missing grave markers and deteriorated grave fencing. Wood crosses were the preferred means of marking Hispano

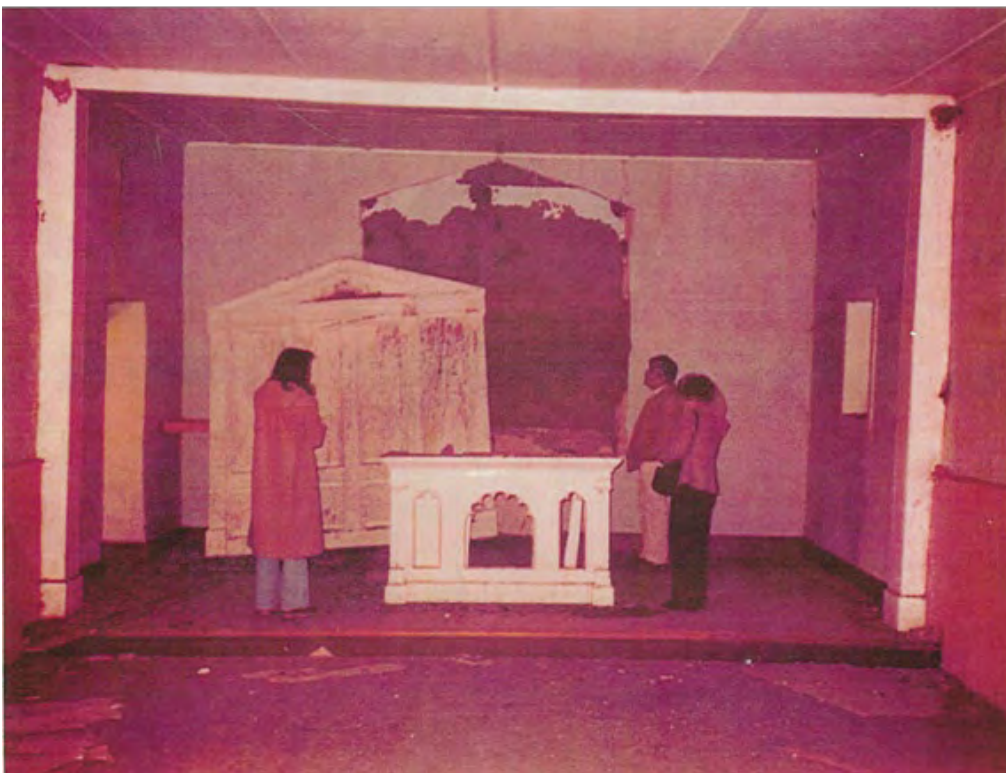
Figure 10: Altar and retablo, circa 1970s-80s. Source: Daniel Medina

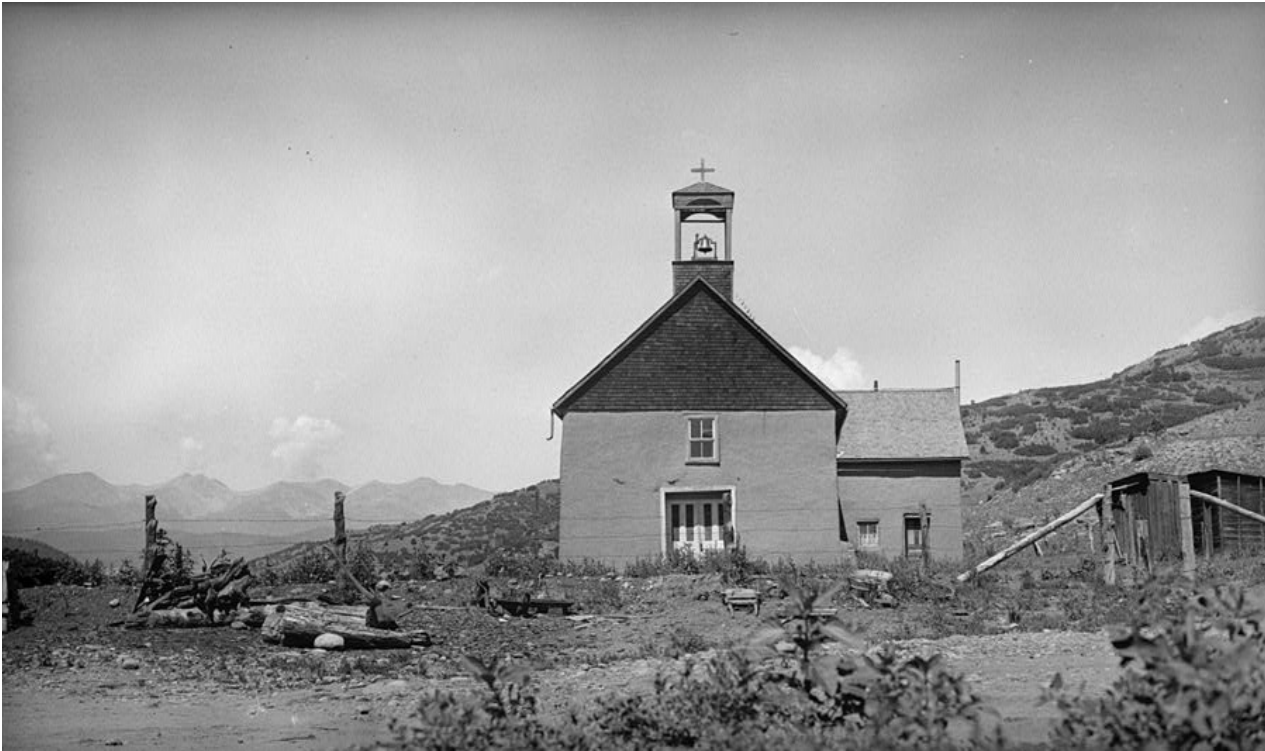
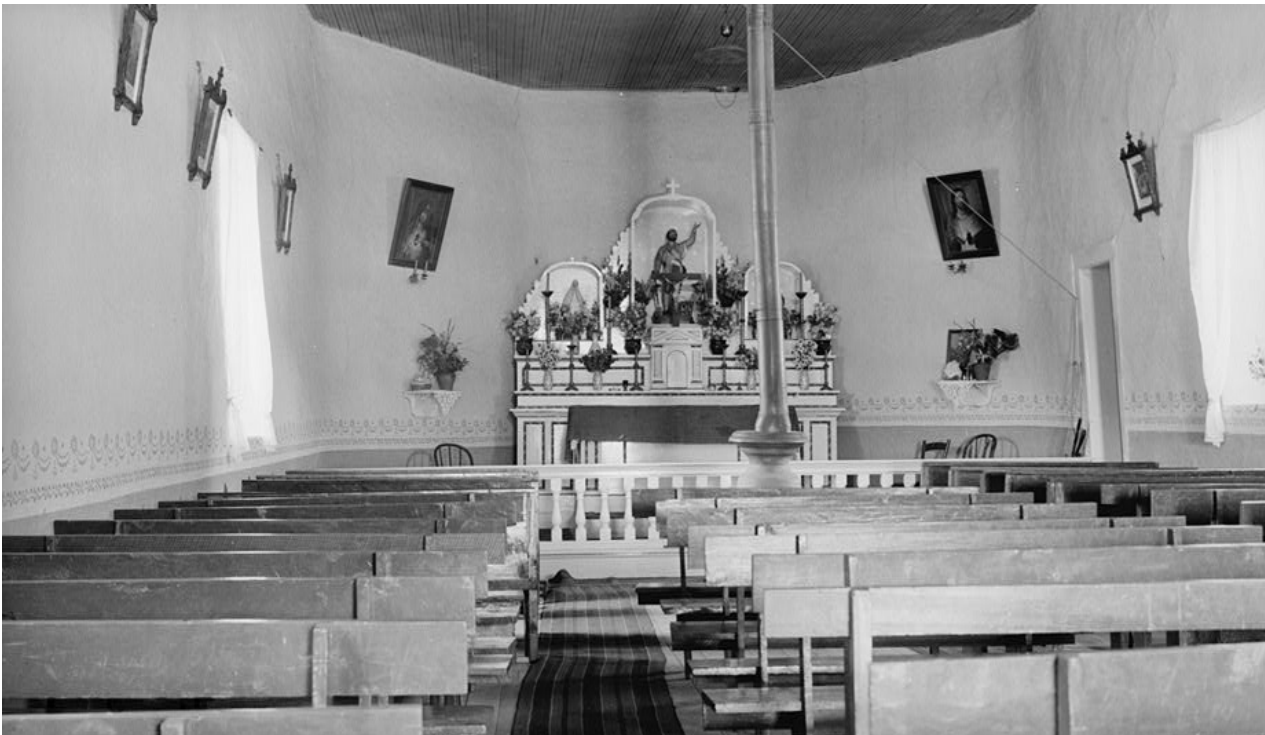
Figure 11: Exterior and interior of San Isidro Church in Vigil Plaza, documented by photographer Frederick D. Nichols in August 1936. Source: Library of Congress, Historic American Buildings Survey # CO-57

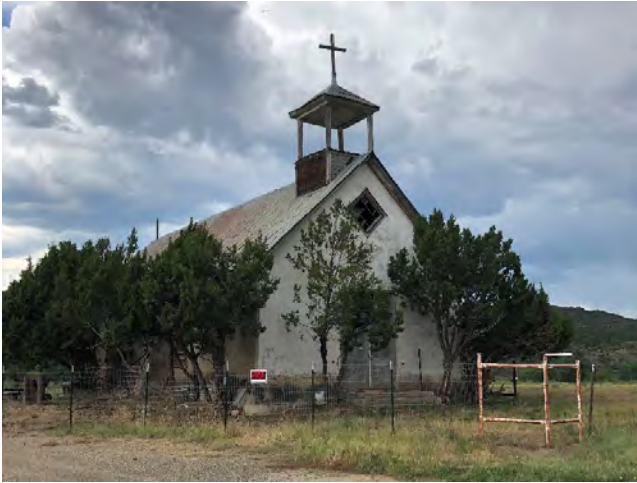
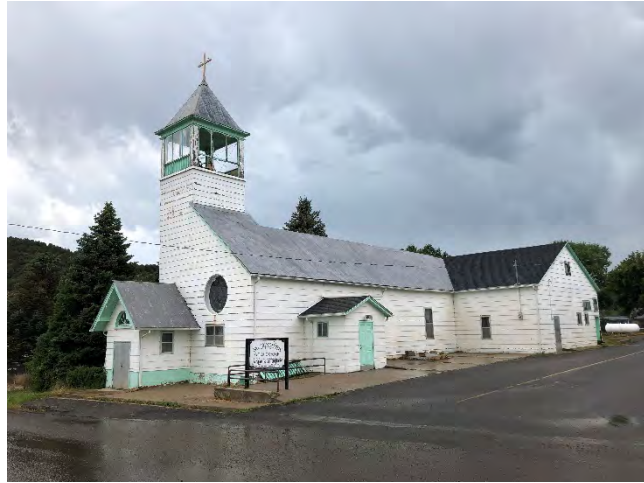
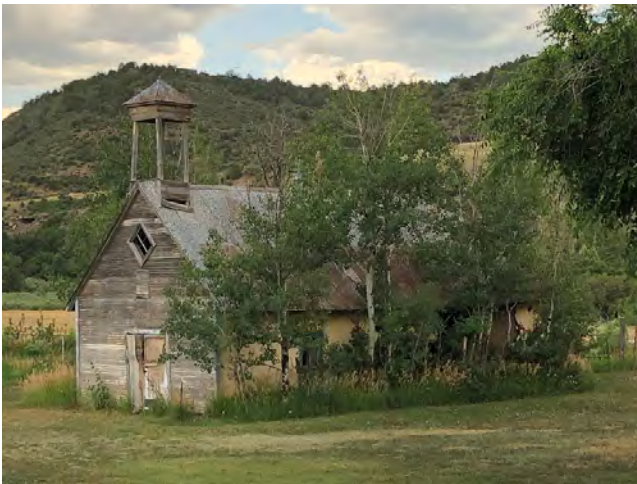
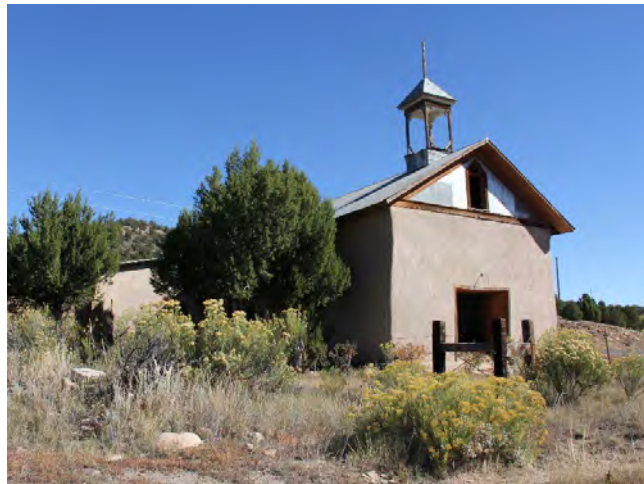
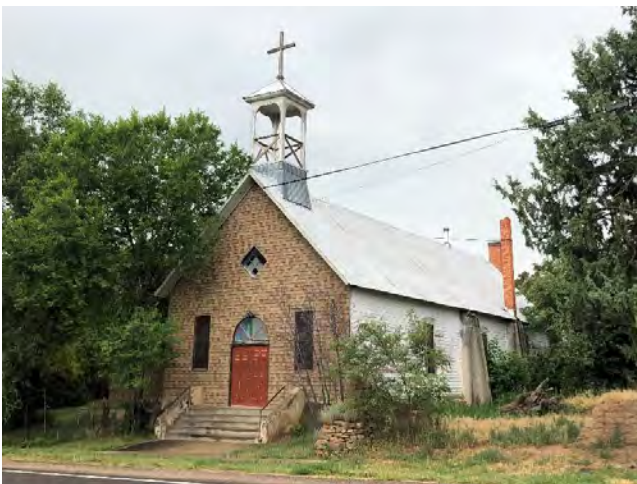
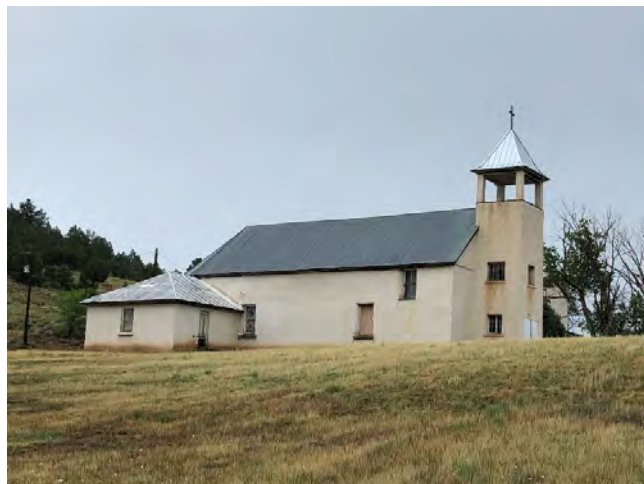
Figure 13: Surviving Hispano churches in the plaza settlements along State Highway 12 between Trinidad and Stonewall. Clockwise from top left: Holy Child Chapel at Tijeras Plaza (5LA.1970); St. Ignatius Catholic Church at Segundo (Los Barros); Our Lady of Guadalupe Church at Medina Plaza (5LA.1966); San Isidro Church at Vigil Plaza (5LA.1105); Our Lord of Esquipula Church at Weston (formerly La Junta Plaza) (5LA.5929); Our Lady of Mount Carmel Chapel at Cordova Plaza (5LA.5923). Our Lady of Guadalupe Church photograph by Marsi Mason, all others by Amy Unger, August 2019.

*Alterations:* The presence of *vigas* suggests that the church may have had a flat roof when first constructed. In *Some Family Recollections*, J.F. Cordova, notes that the nearby Our Lady of Mount Carmel Chapel (5LA.5923), built ca. 1871-78 at Cordova Plaza, "originally was a flat-roofed structure as was then customary."<sup>6</sup> According to Cordova, a gable roof replaced the flat roof at Our Lady of Mount Carmel ca. 1910-12. If the original roof at Our Lady of Guadalupe Church was flat, it was likewise replaced by the more practical steeply-pitched gable roof and belfry documented ca. 1900-10 in Figure 2.<sup>7</sup> The one-story, gable-roof rectory on the church's west side, also documented in Figure 2, is structurally different from the main body of the church and was likely added shortly after the church was constructed. These changes, if not part of the original construction, brought the church's design in line with the other Hispano adobe churches constructed along the Purgatoire River during the latter half of the nineteenth century (Figures 1, 2, 13, and 16).

During early Hispano settlement of the Purgatoire River Valley in the 1860s and 70s, a number of adobe churches were built to serve the small *plazas* established along the river between Trinidad and Stonewall. A 1995 map published in *Nuestras Raíces*, the Journal of the Genealogical Society of Hispanic America, documents the historic churches of the Purgatoire Valley (Figure 1). Of the churches noted on the map, at least five are known to be constructed of adobe and associated with early Hispano *plazas* on the banks of the Purgatoire River: Holy Child (*Santo Niño de Atocha*) Chapel (5LA.1970) at Tijeras Plaza (ca. 1876), Our Lady of Mount Carmel Chapel (5LA.5923) at Cordova Plaza (ca. 1871-78), Our Lord of Esquipula Church (5LA.5929) at La Junta Plaza (now Weston) (ca. 1893), San Isidro Church (5LA.1105) at Vigil Plaza (ca. 1870), and Our Lady of Guadalupe Church at Medina Plaza (ca. 1867).<sup>22</sup> These churches share common characteristics and constitute a distinct and discernable type, the Hispano Adobe church as constructed in the Purgatoire River Valley during its early settlement (Figure 13).<sup>23</sup>

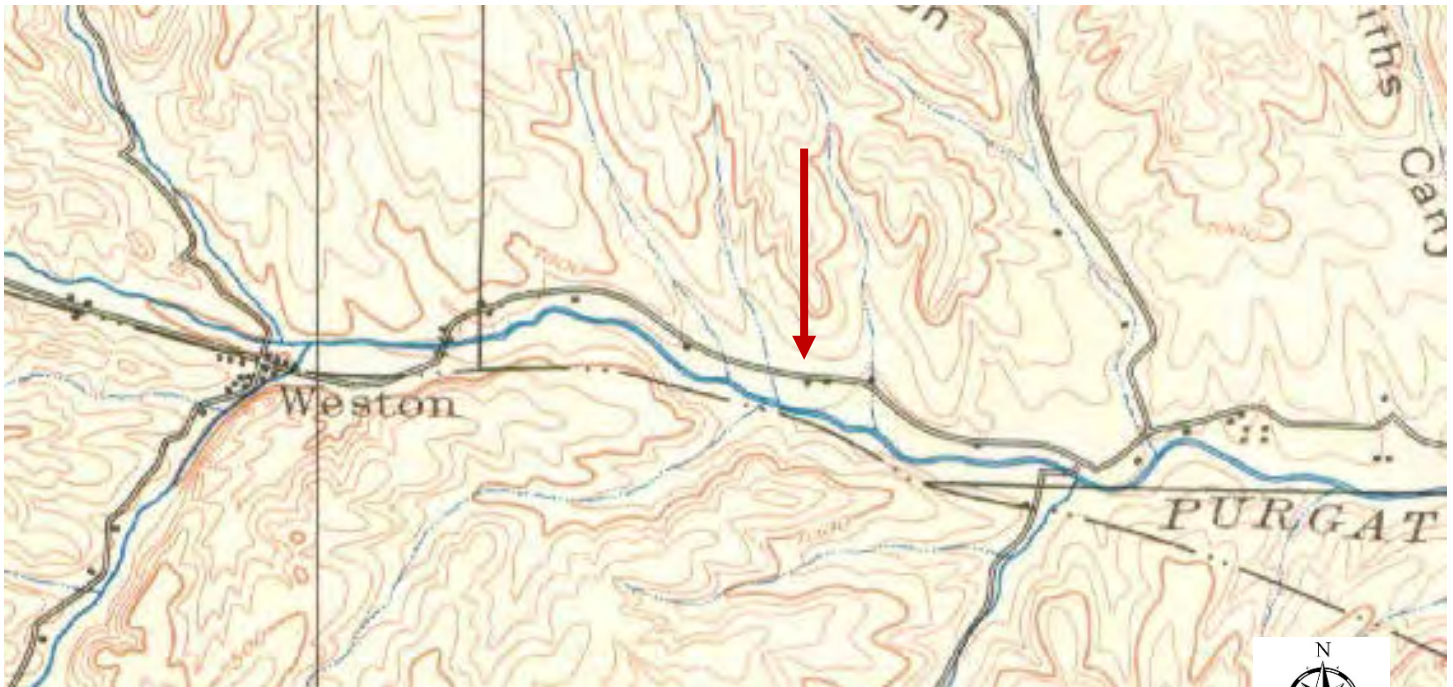
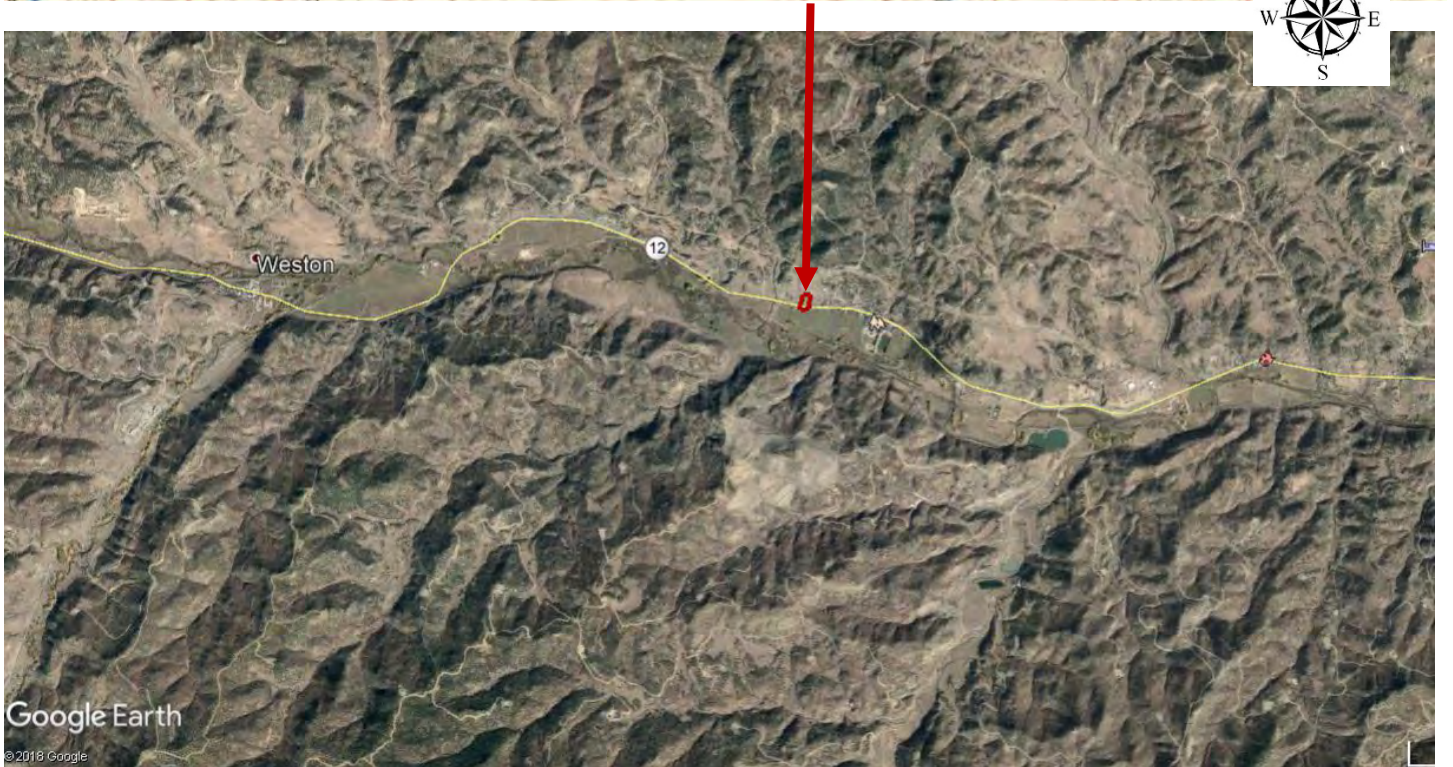
Figure 14: A comparison of the 1895 USGS topographic map (top) and with current conditions (bottom) shows that the alignment of State Highway 12 has changed very little since the 1890s. Arrows indicate the location of Our Lady of Guadalupe Church and Medina Cemetery. Source: <https://ngmdb.usgs.gov/topoview/> and Google Earth.
