KENTUCKY HISTORIC RESOURCES
Individual Inventory Form

Resource # Be-322
Boone County

1. Name of Resource: East Bend Church

5. Location: 12341 Lower River Road, Union, KY

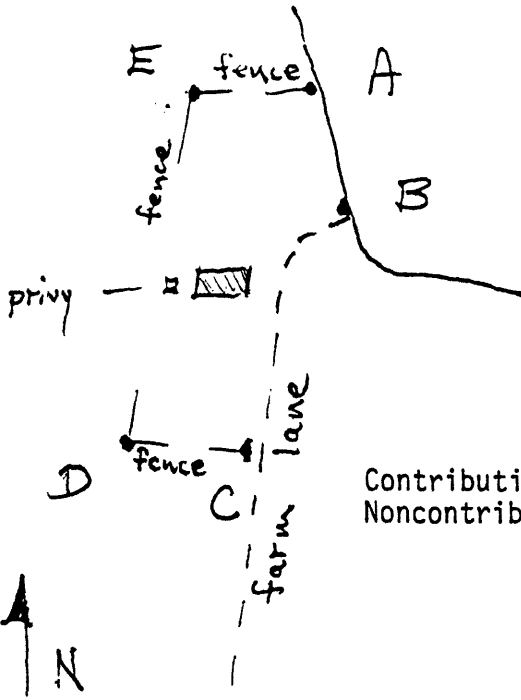
42. Total Acreage in Present Property: 2 43. Acreage included in proposed N.R. boundary: 1 1/2
 44. Site Plan (and boundary description and justification for N.R. sites):

Contributing: 1 building
 Noncontributing: 1 building (privy)

The boundary, indicated by points A, B, C, D and E, include the church and privy and the two cemeteries, north and south of the church. The acreage, contained within the fences is sufficient to provide a setting for the church. Boundary A-B is on the west side of Lower River Road, while the boundary B-C is on the west side of a farm lane.

Beginning at a point on the west side of Lower River Road at the east property line (B), proceed 350' south along the lane to the rear property line (C). Then proceed 130' along the fence line to the west property line (D), turning north for 500' along the property and fence line (E). Then proceed east along the fence line to the west side of Lower River Road (A), turning southeast along the road 200' to the point of origin.

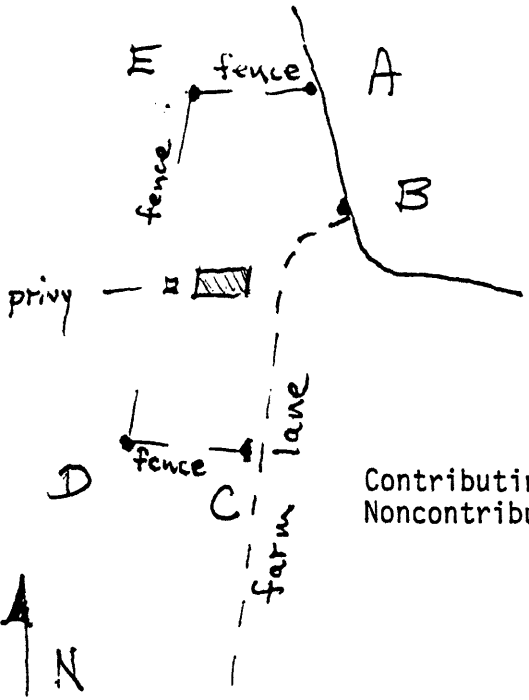
42. Total Acreage in Present Property: 2 43. Acreage included in proposed N.R. boundary: 1 1/2
 44. Site Plan (and boundary description and justification for N.R. sites):

Contributing: 1 building
 Noncontributing: 1 building (privy)

The boundary, indicated by points A, B, C, D and E, include the church and privy and the two cemeteries, north and south of the church. The acreage, contained within the fences is sufficient to provide a setting for the church. Boundary A-B is on the west side of Lower River Road, while the boundary B-C is on the west side of a farm lane.

Beginning at a point on the west side of Lower River Road at the east property line (B), proceed 350' south along the lane to the rear property line (C). Then proceed 130' along the fence line to the west property line (D), turning north for 500' along the property and fence line (E). Then proceed east along the fence line to the west side of Lower River Road (A), turning southeast along the road 200' to the point of origin.
