National Register of Historic Places Registration Form

historic name Japanese Jail Historic and Archaeological District

street & number Chichirica Avenue and Ghyobw Street not for publication

city or town Garapan vicinity _____

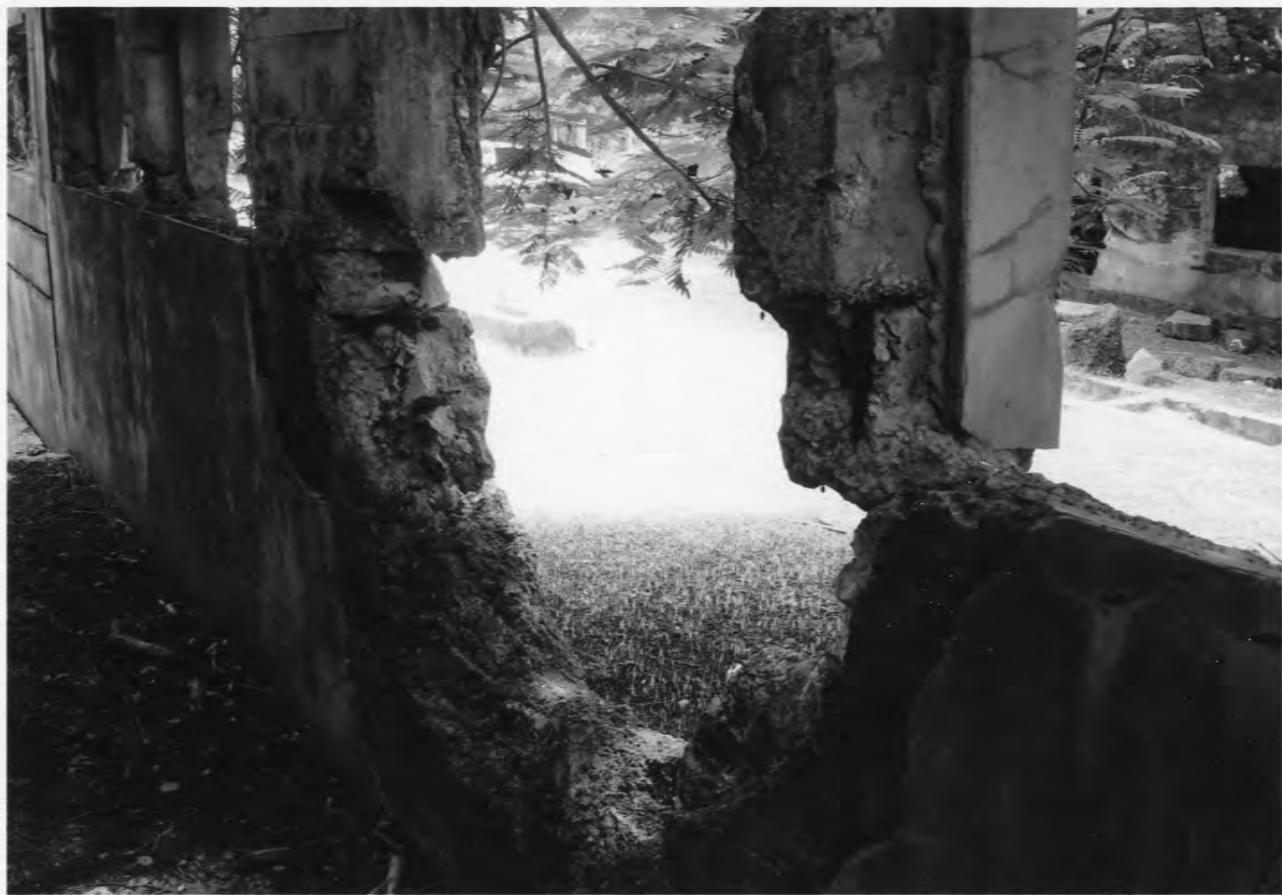
Japanese Jail CNMI 26.

1. Site name: Japanese Jail Historic and Archaeological District
2. Location: Saipan, Commonwealth of the Northern Mariana Islands
3. Photographer: Jeffrey Tripp
4. Date: July 2009
5. Location of Negative: Digital image, University of Hawaii, HPO Office, Saipan
6. View and direction: Feature 1, Detail, shell damage, View SW
7. Photo number: 26

The structure is in stable condition, although damaged both by the war and by later deterioration due to rainwater and the presence of vegetation. Large trees now grow within the walls of the structure, especially at the west side. There is clear evidence of damage from shells, both small arms and guns.
