National Register of Historic Places Registration Form

historic name Bush House

street & number 308 5th Street

city or town Index

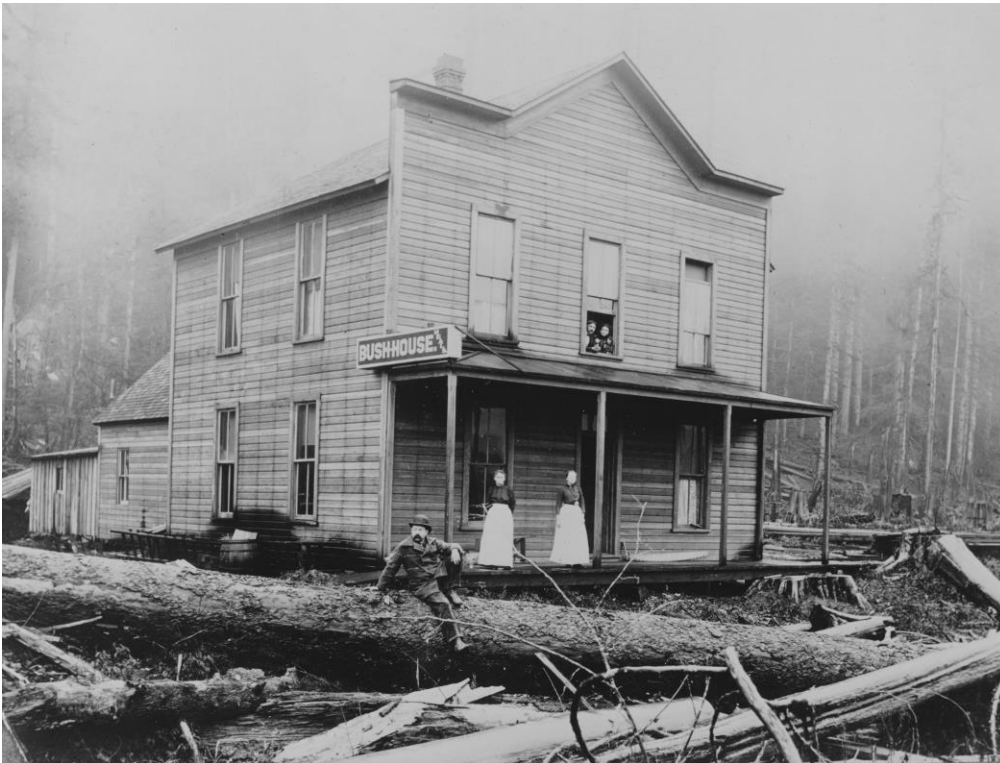
Bush House showing initially constructed portion of constructed in 1899. Taken near the intersection of Index Avenue and the BNSF railroad crossing.
Photographer: Lee Pickett, c.1900

The Bush House is a 2 ½ story rectangular structure and was built in two-phase; the first in 1899, then an addition c. 1901. The building rests on a new poured concrete foundation and its slightly above grade. The original portion of the hotel features a western false front façade with a parapet wall which hides the gable roof. The addition features a side gable roof with three gable dormers. The roof has recently been re-sheathed in cedar shingles. Three simple brick chimneys puncture the north and south slopes of the addition. A flat-roofed front porch supported by simple rectangular posts, wraps nearly all the facades of first floor, and creates a covered walkway along the length of the structure parallel to and abutting Index Avenue. The underneath side is beadboard and the deck is horizontal laid cedar planking. The building's exterior is finished with beveled-cut shiplap cedar siding (painted white), and wide simple cedar trim boards (painted dark green). New two-over-two double hung wood windows are placed symmetrically on the main façade. The three original half-light, paneled wood doors are highlighted by transom windows. The upper 2nd floor of the east end of the building and original portion of the building on the south facade also boasts door openings to the porch roof. These exits are created via a hinged fixed sash window.

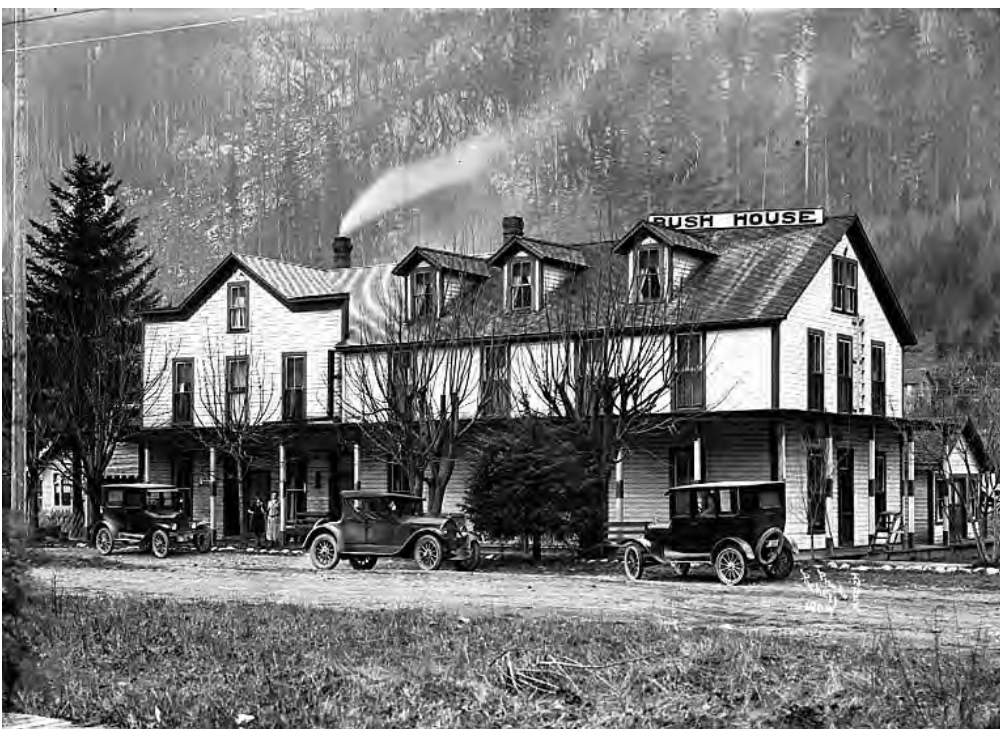
Front view of the Bush House, taken near the intersection of Index Avenue and the 5th Street.
Photographer: Lee Pickett, c.1908

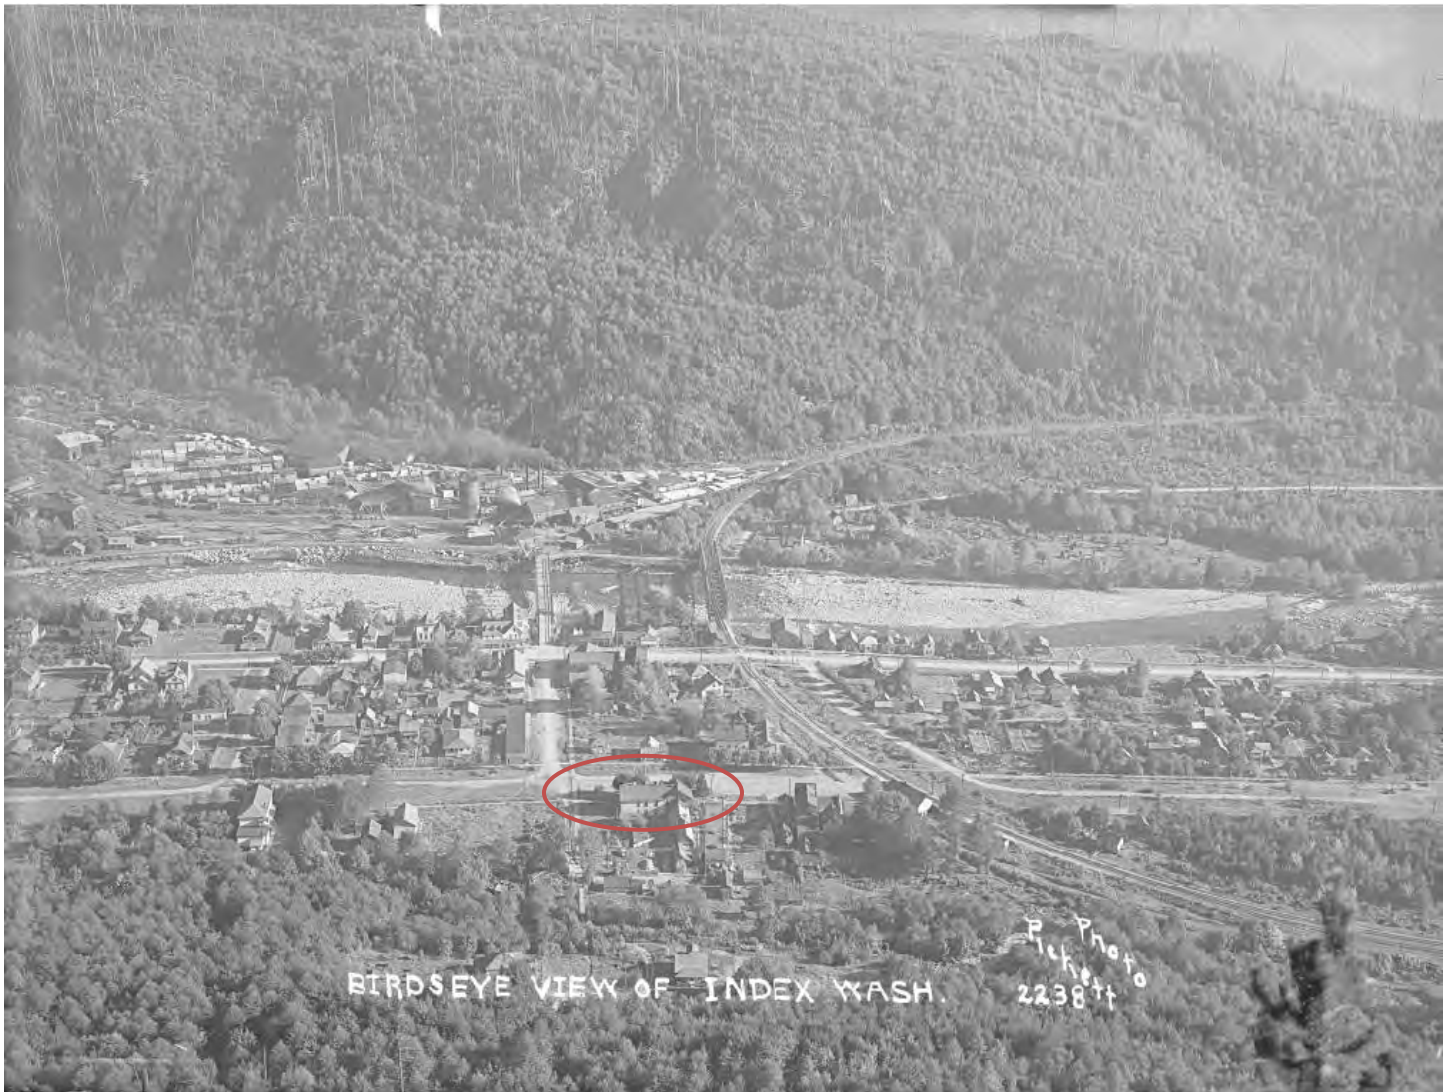
Birds eye view of the Town of Index and rear view of the Bush House, with the railroad and depot directly to the south. Note the rear addition to the Bush House. Also of interest – several other buildings in this image are of similar design to the Bush House. Photo taken from the "Index Town Wall".

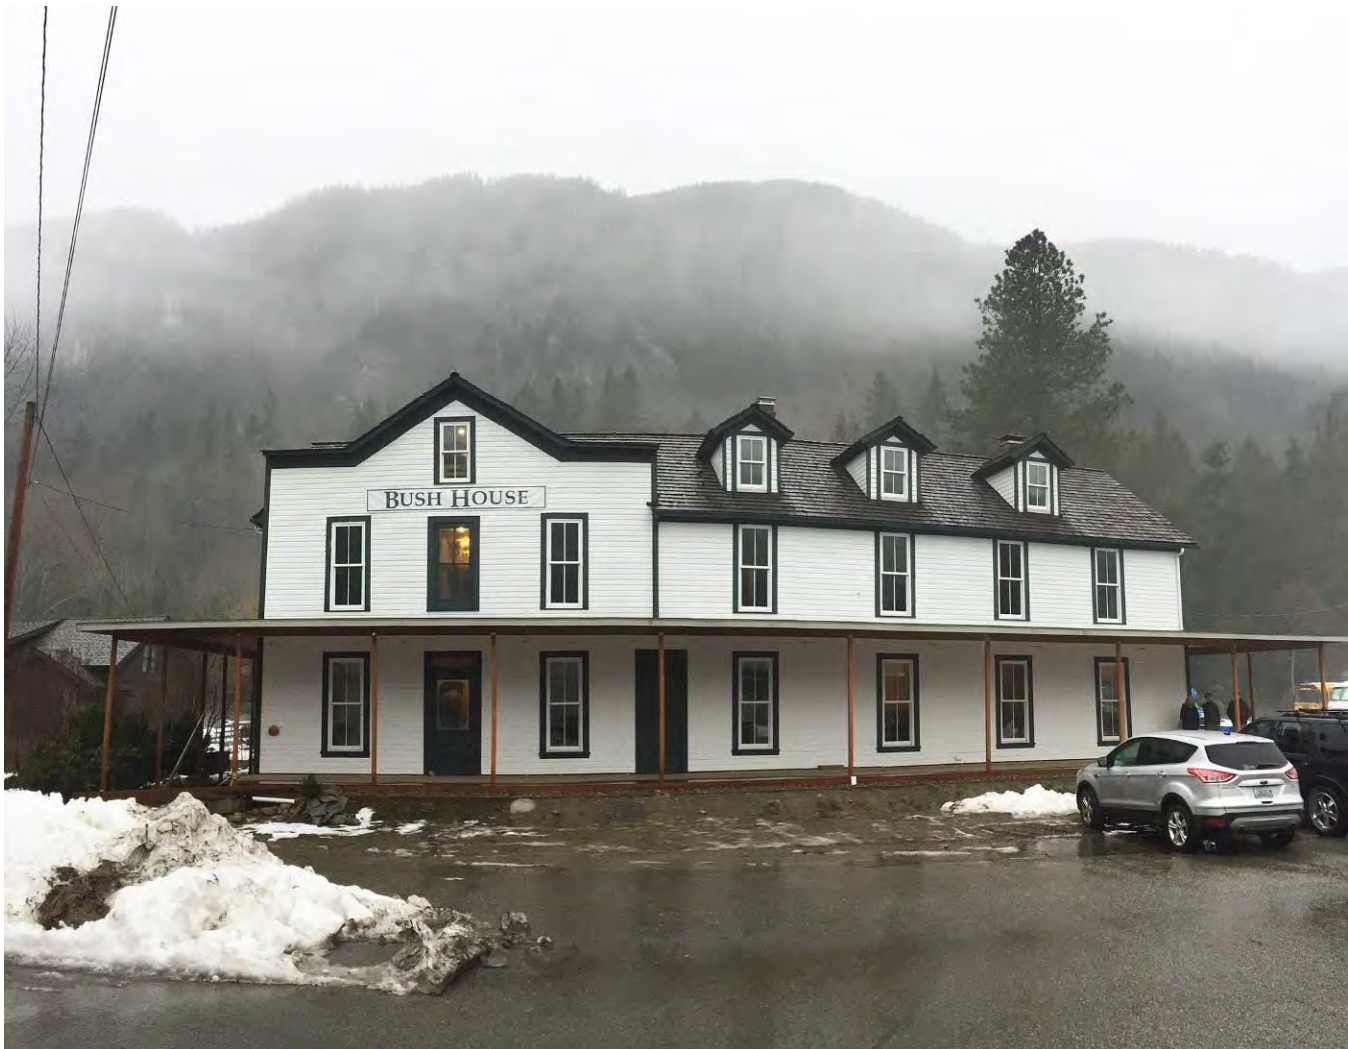
1 of 22 – Bush House, Main Facade

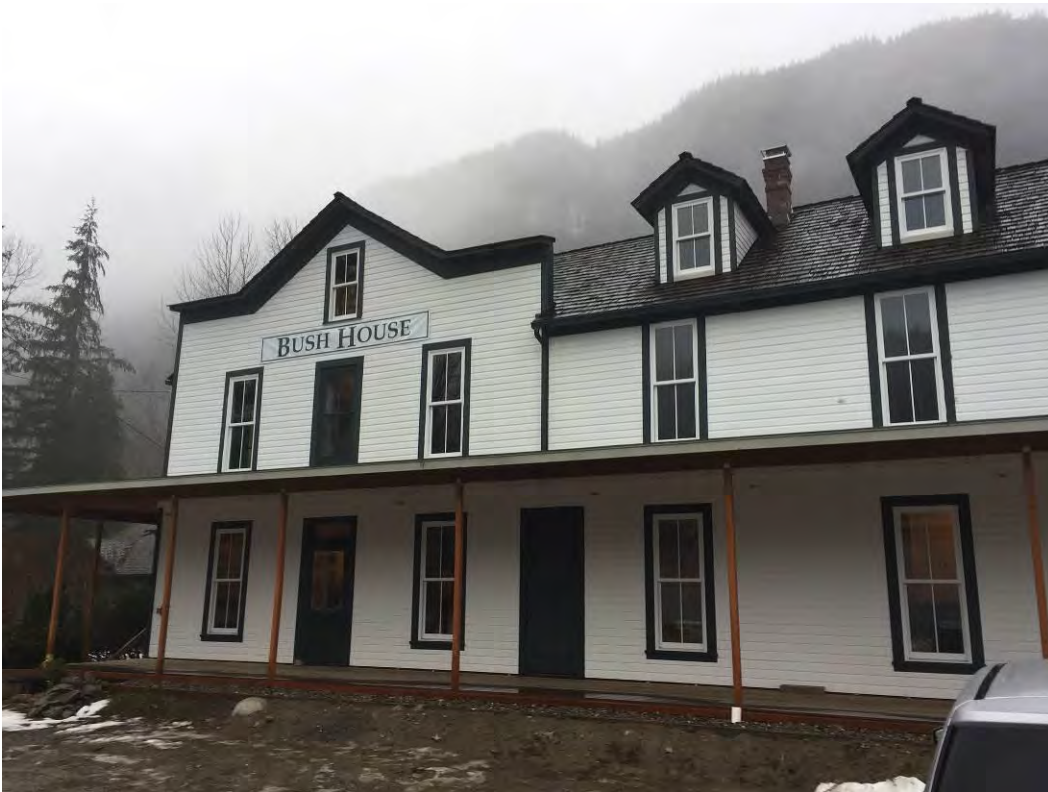
2 of 22 – Bush House, Main façade detail.

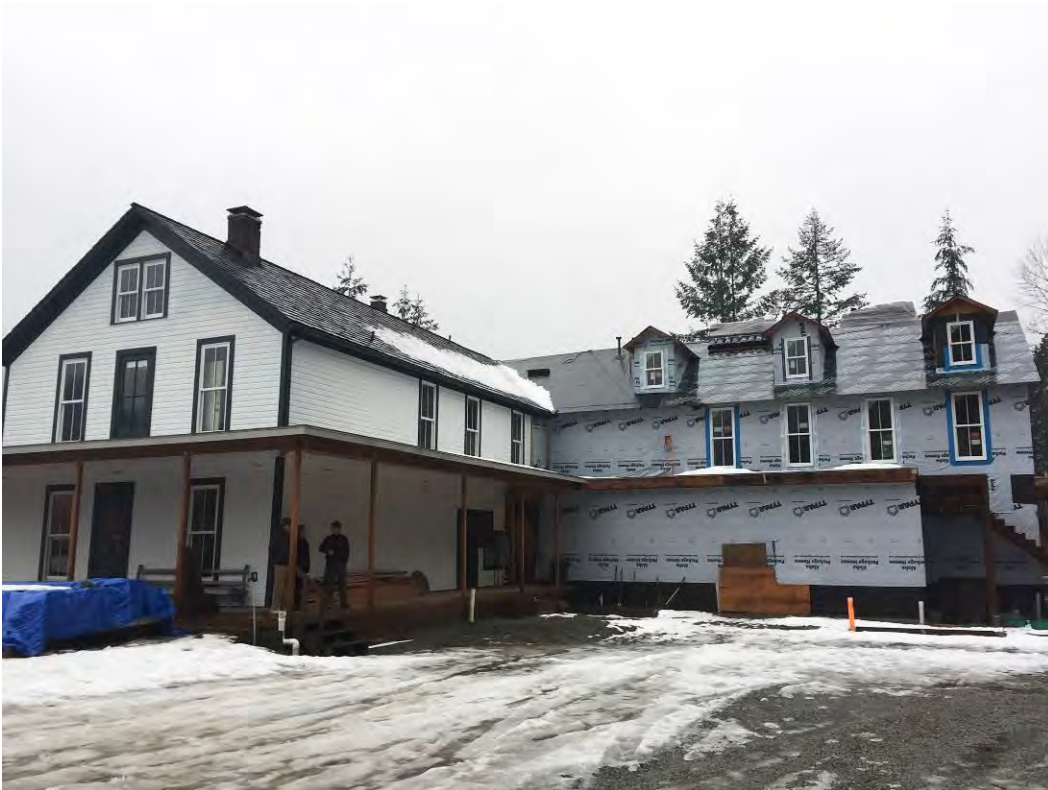
3 of 22 – Bush House, North Elevation show new rear wing.

At the rear northwest corner a new 2 ½ story addition has been constructed. This mimics the original rear ell in spirit, but the footprint is larger and is more detailed. Still under construction at the time of listing, the addition boasts details similar to the 1901 wing with three gable dormers on the east and west elevations. The rear façade has a full width porch, matching the porch on the main façade but shelters a window wall of floor to ceiling sliding door units.

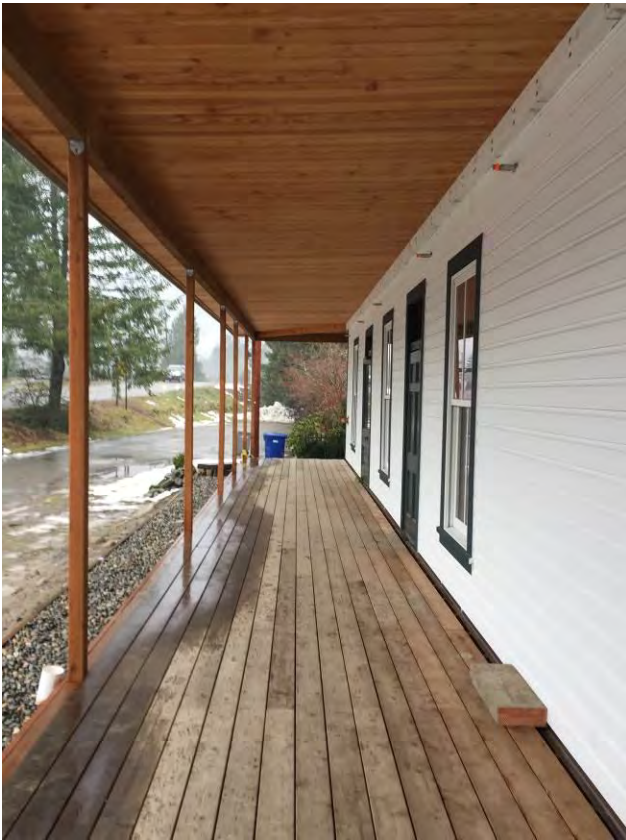
4 of 22 – Bush House, Reconstructed porch detail.

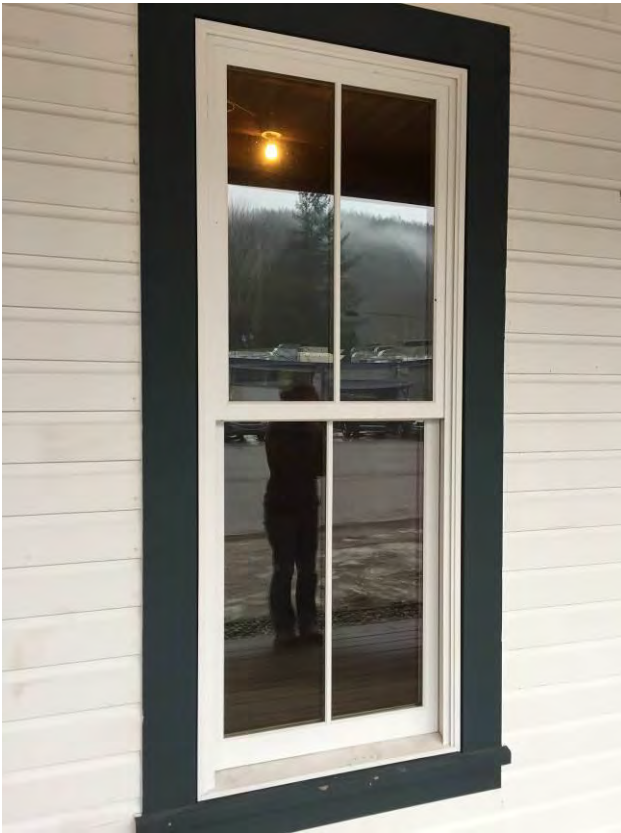
6 of 22 – Bush House, Window detail.

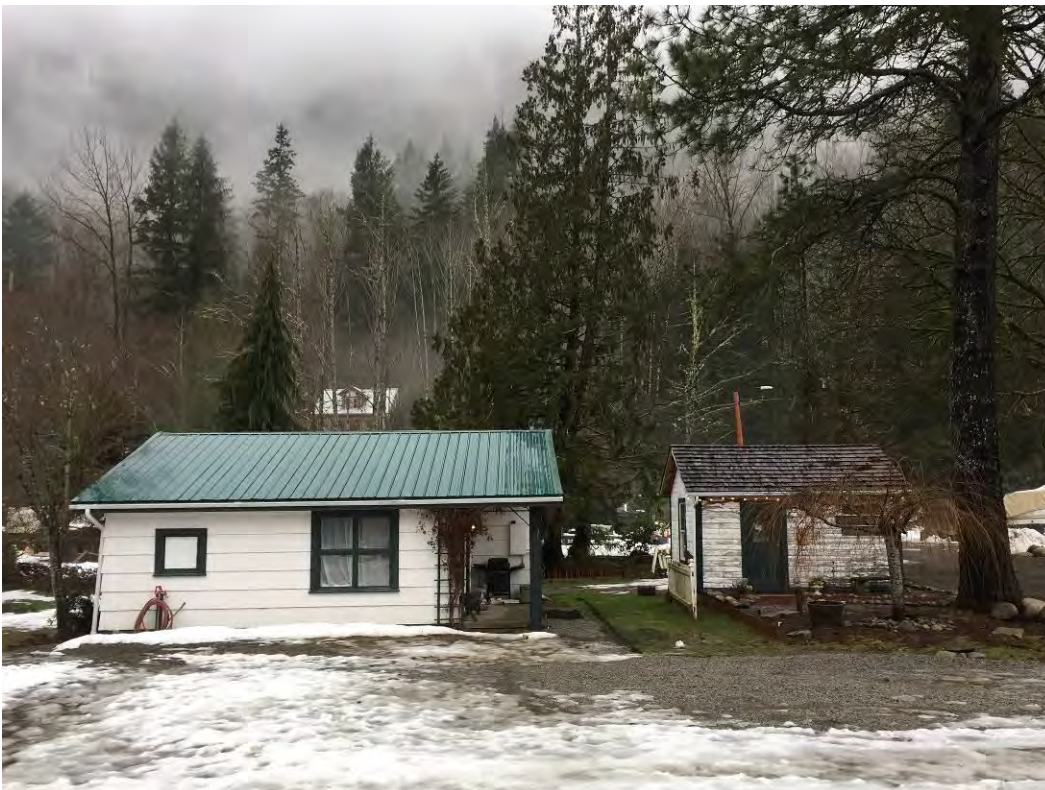
7 of 22 – Bush House, Caretakers house (left), garage (right).

Behind the main building in the northeast corner of the lot and accessible from 5th Street sits 2 non-contributing buildings thought to be built around 1935. The first is a modest single-story caretakers cabin. This building has a front facing gable roof covered in standing seam metal. The exterior clad with wide exposure weatherboard. The cabin has a small inset covered porch on the southeast corner. Windows are simple one-over-one double hung units.

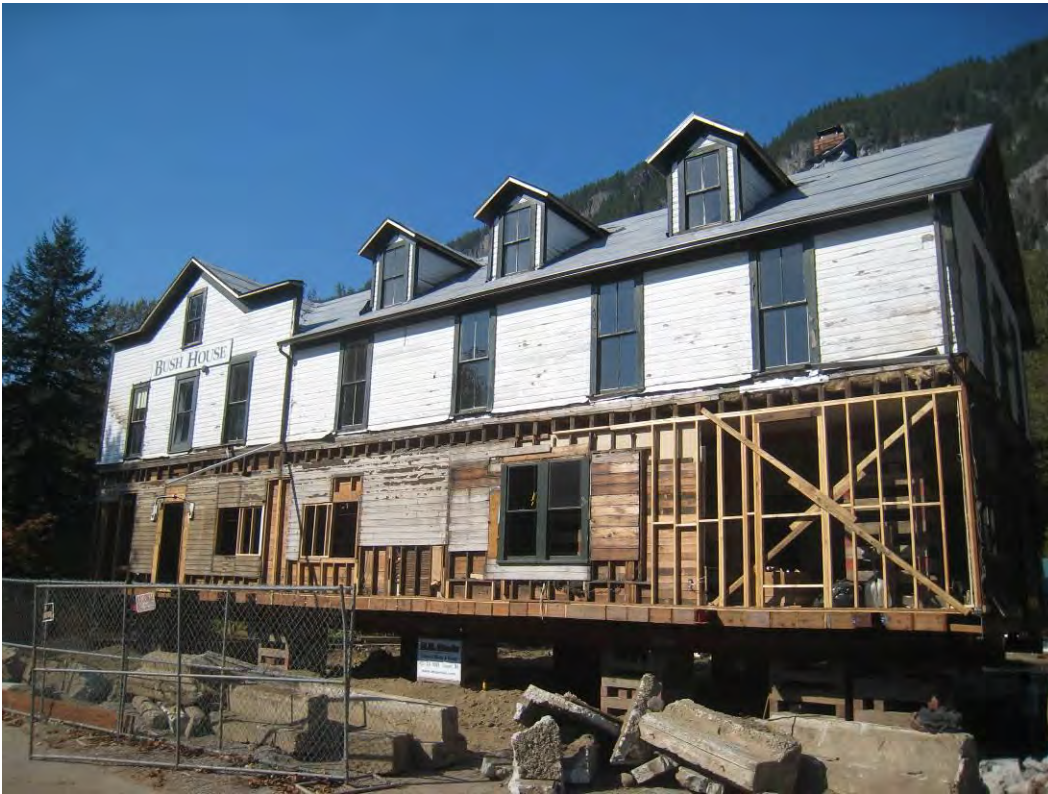
8 of 22 – Bush House, Elevated in preparation for new foundation. 2015.

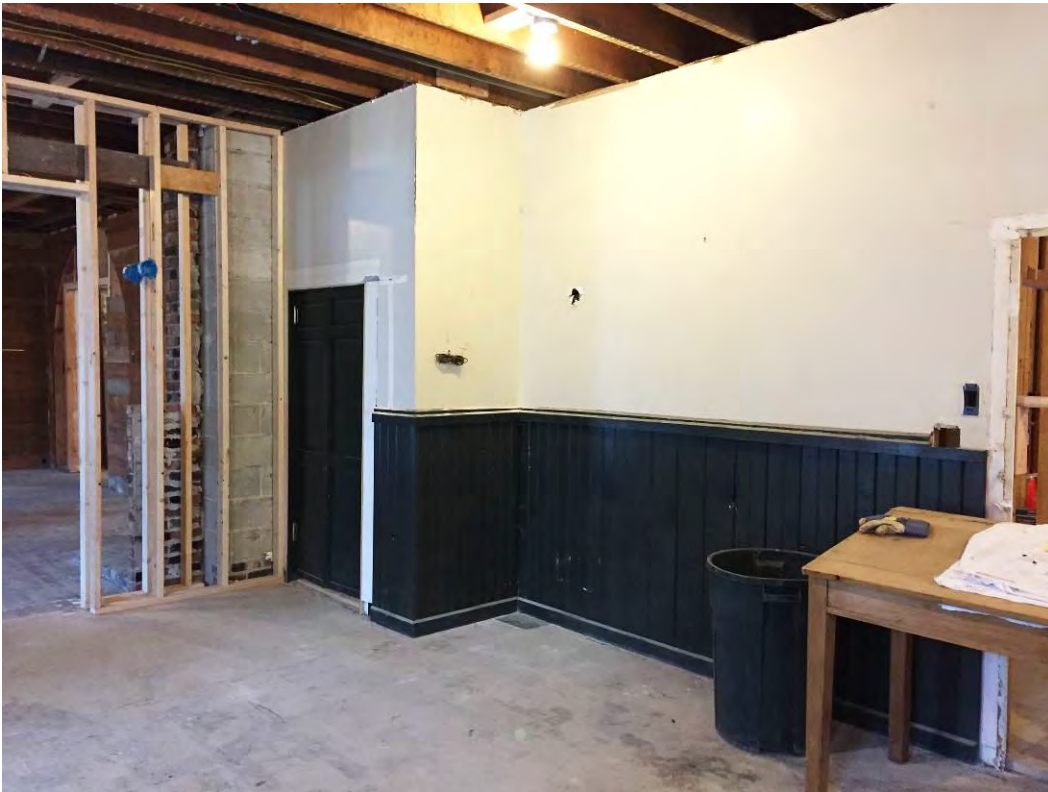
12 of 22 – Bush House, Interior dining, west wall showing original beadboard – view looking southwest.

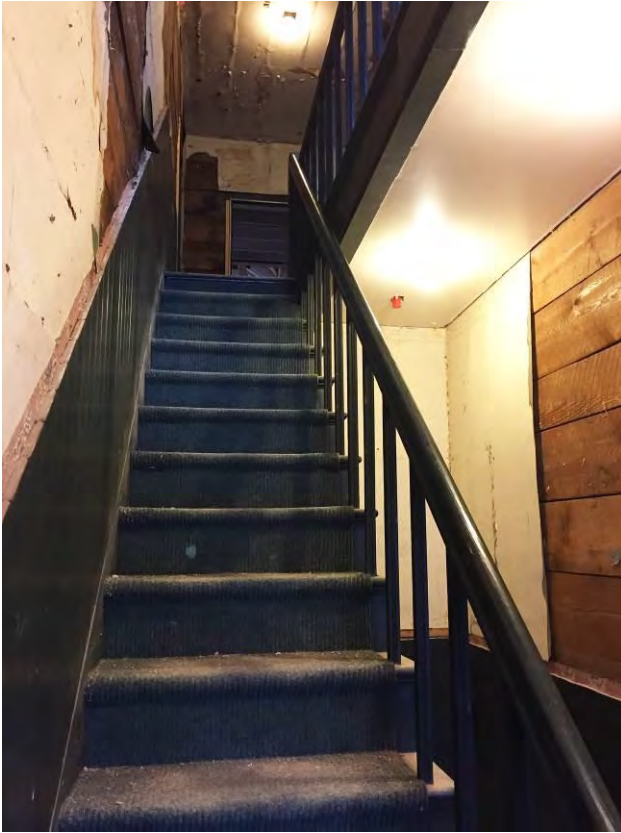
14 of 22 – Bush House, Main Stair from first floor.

While altered throughout the years the interior still features many of its character defining features such as many sections of wood fir flooring, a steep and narrow open wooden staircase (with original wooden baluster), wide trim around the double-hung windows and doorways, and tongue and groove wainscoting. Remnants of the various layers of original wallpaper can be found. While the floorplan of the main floor has been changed over the years, the second floor hallways and the rhythm of nine hotel room entrance doors remain. Here original lath and plaster walls are highlighted by tongue and groove painted wainscoting. Both floors have nearly 10' ceiling heights. The third floor was most likely private space and was remodeled in the 1930s. It currently is one large open space with a small bathroom tucked into one corner. The new addition is unfinished but features an open first floor room with 10' deep stage area. The second floor is a large open vaulted space with exposed structural members.

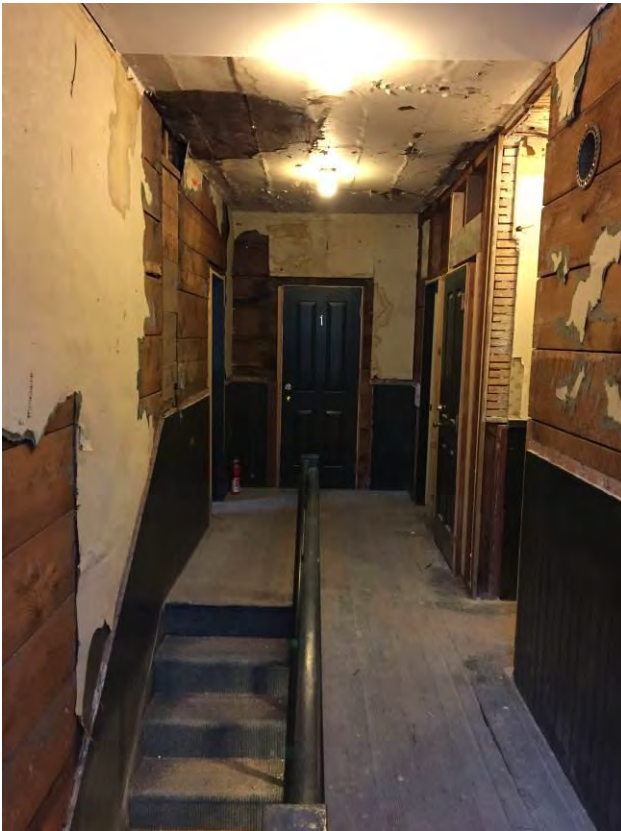
15 of 22 – Bush House, Main Stair from second floor.

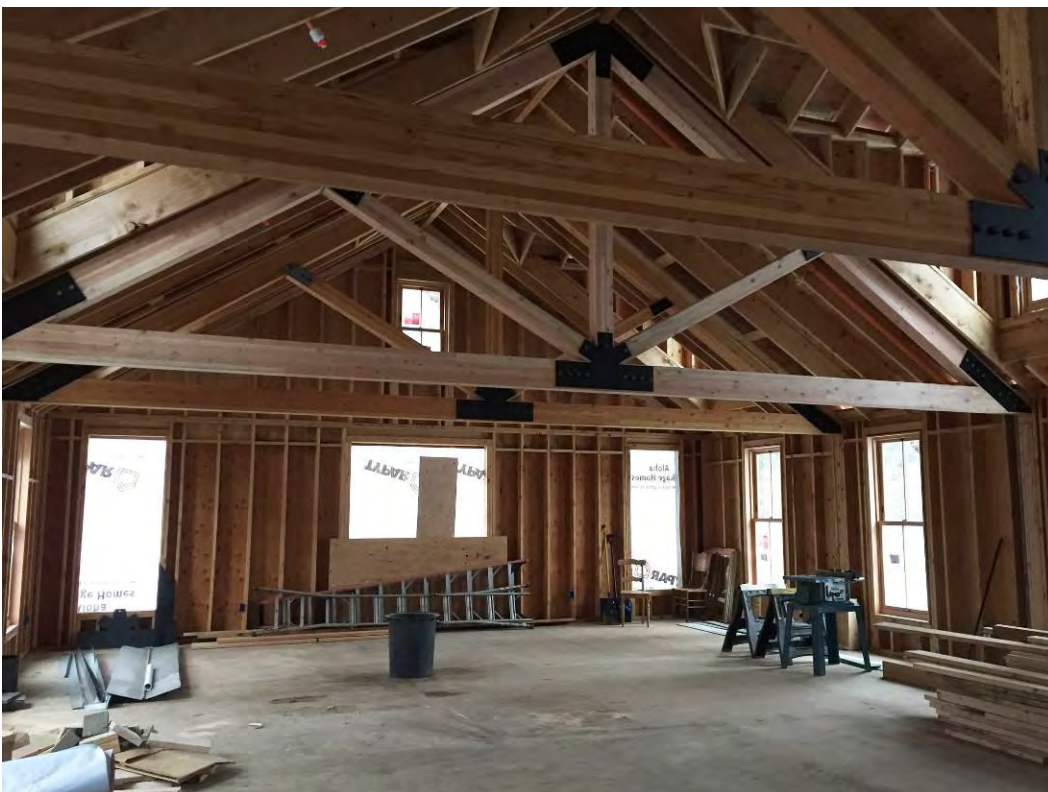
21 of 22 – Bush House, New rear wing, second floor – view west.

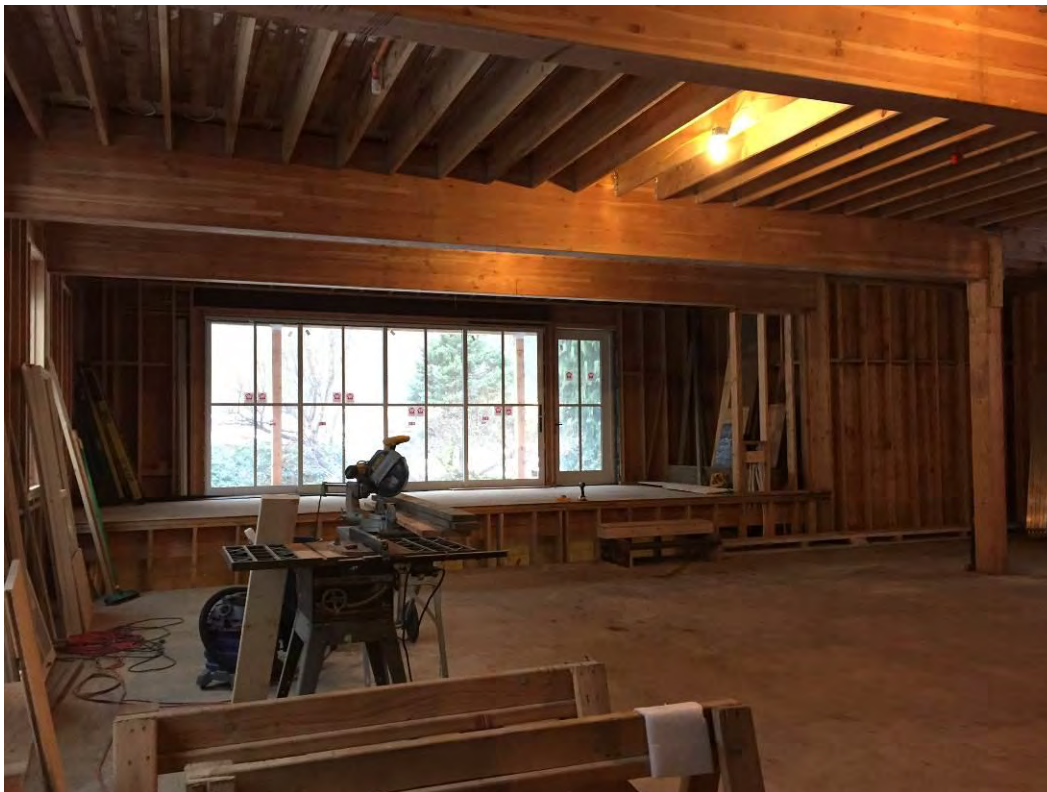
22 of 22 – Bush House, New rear wing, first floor – view west.
