# National Register of Historic Places Registration Form

Historic name: Lower Meeting House and East Bethel Cemetery			
Other names/site number: East Bethel Church, Union Church			
Name of related multiple property listing:			
(Enter "N/A" if property is not part of a multiple property listing)

2. Location			
Street & number: 1797 Intervale Road			
City or town: Bethel State: Maine County: Oxford			
Not For Publication: n/a Vicinity: n/a			
3. State/Federal Agency Certification			
As the designated authority under the National Historic Preservation Act, as amended, I			
hereby certify that this $\underline{x}$ nominationrequest for determination of eligibility meets the			
documentation standards for registering properties in the National Register of Historic Places			
and meets the procedural and professional requirements set forth in 36 CFR Part 60.			
In my opinion, the property <u>x</u> meetsdoes not meet the National Register Criteria. I			
recommend that this property be considered significant at the following level(s) of significance:			
national statewide <u>x</u> local			
Applicable National Register Criteria:

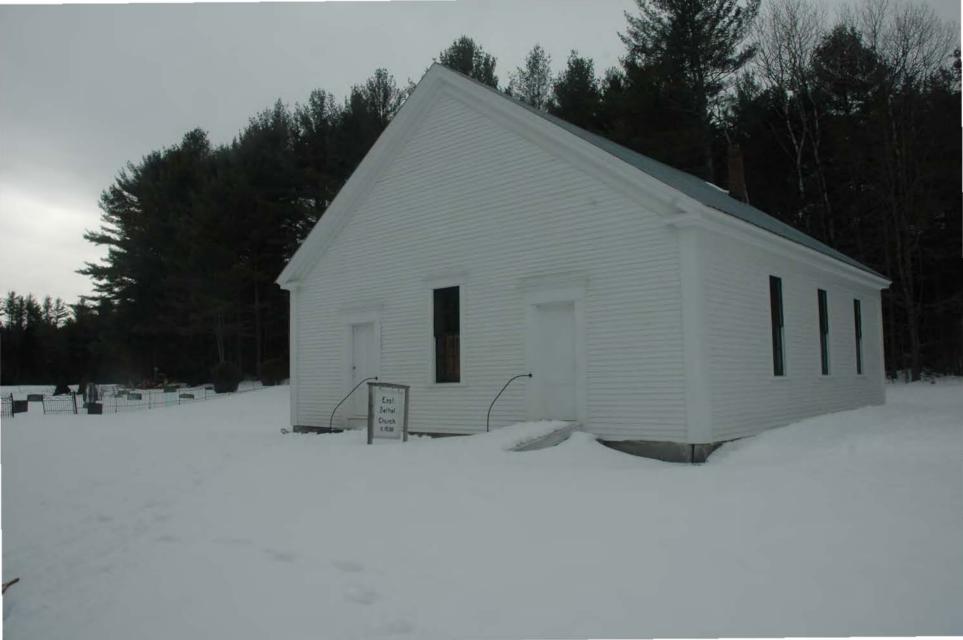
1 of 7 ME\_OxfordCounty\_Lower Meeting House\_0001.TIFF

Lower Meeting House façade and north elevation, and East Bethel Cemetery at

left; facing southwest.

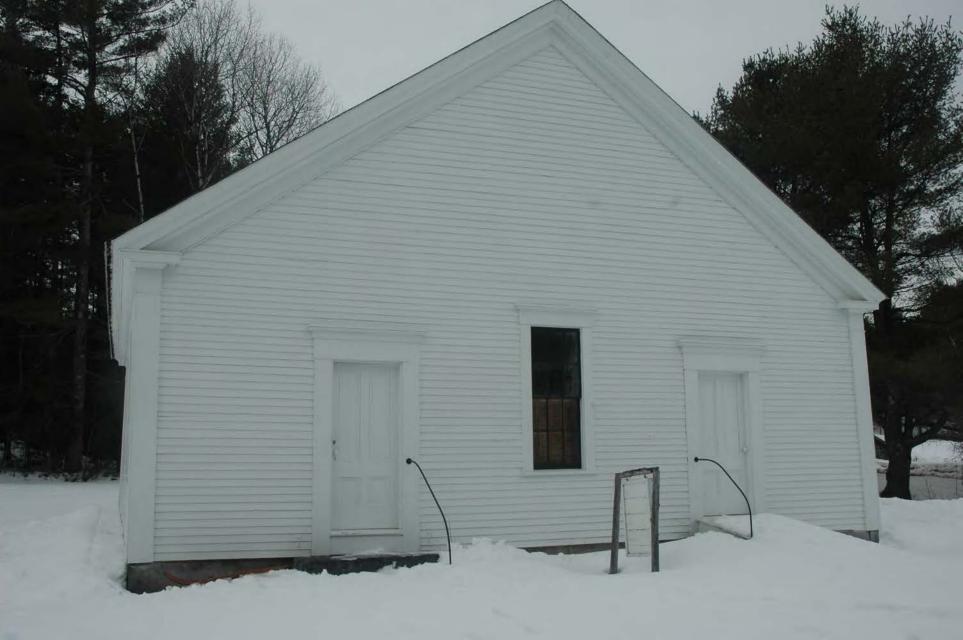
2 of 7 ME\_OxfordCounty\_Lower Meeting House\_0002.TIFF

Lower Meeting House façade; facing west.

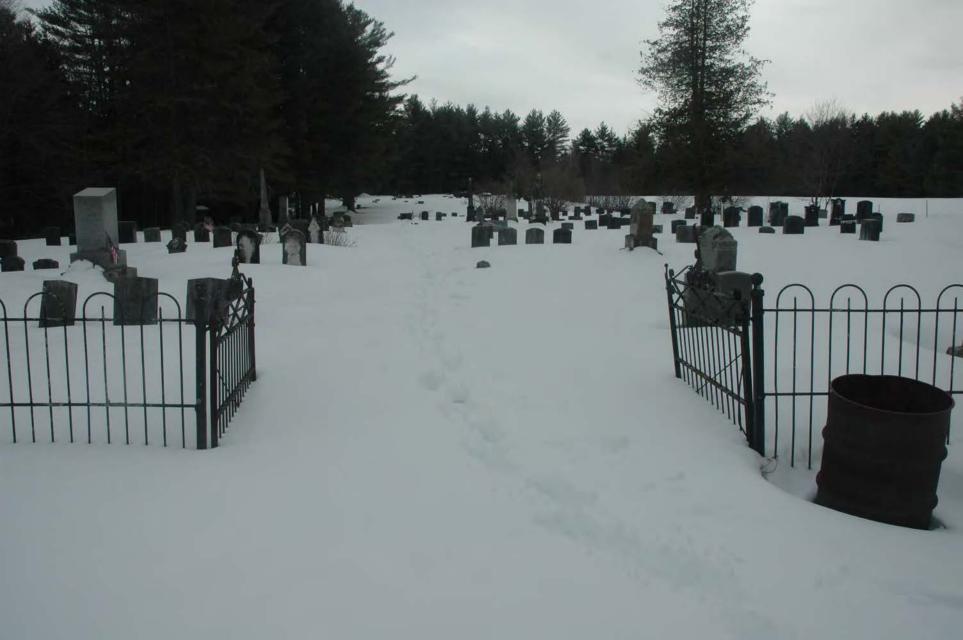
3 of 7 ME OxfordCounty Lower Meeting House 0003.TIFF

East Bethel Cemetery; facing south.
