NATIONAL REGISTER OF HISTORIC PLACES
REGISTRATION FORM

historic name: Alderson-Coston House

street & number: 204 Pine Bluff Street

city/town: Malvern

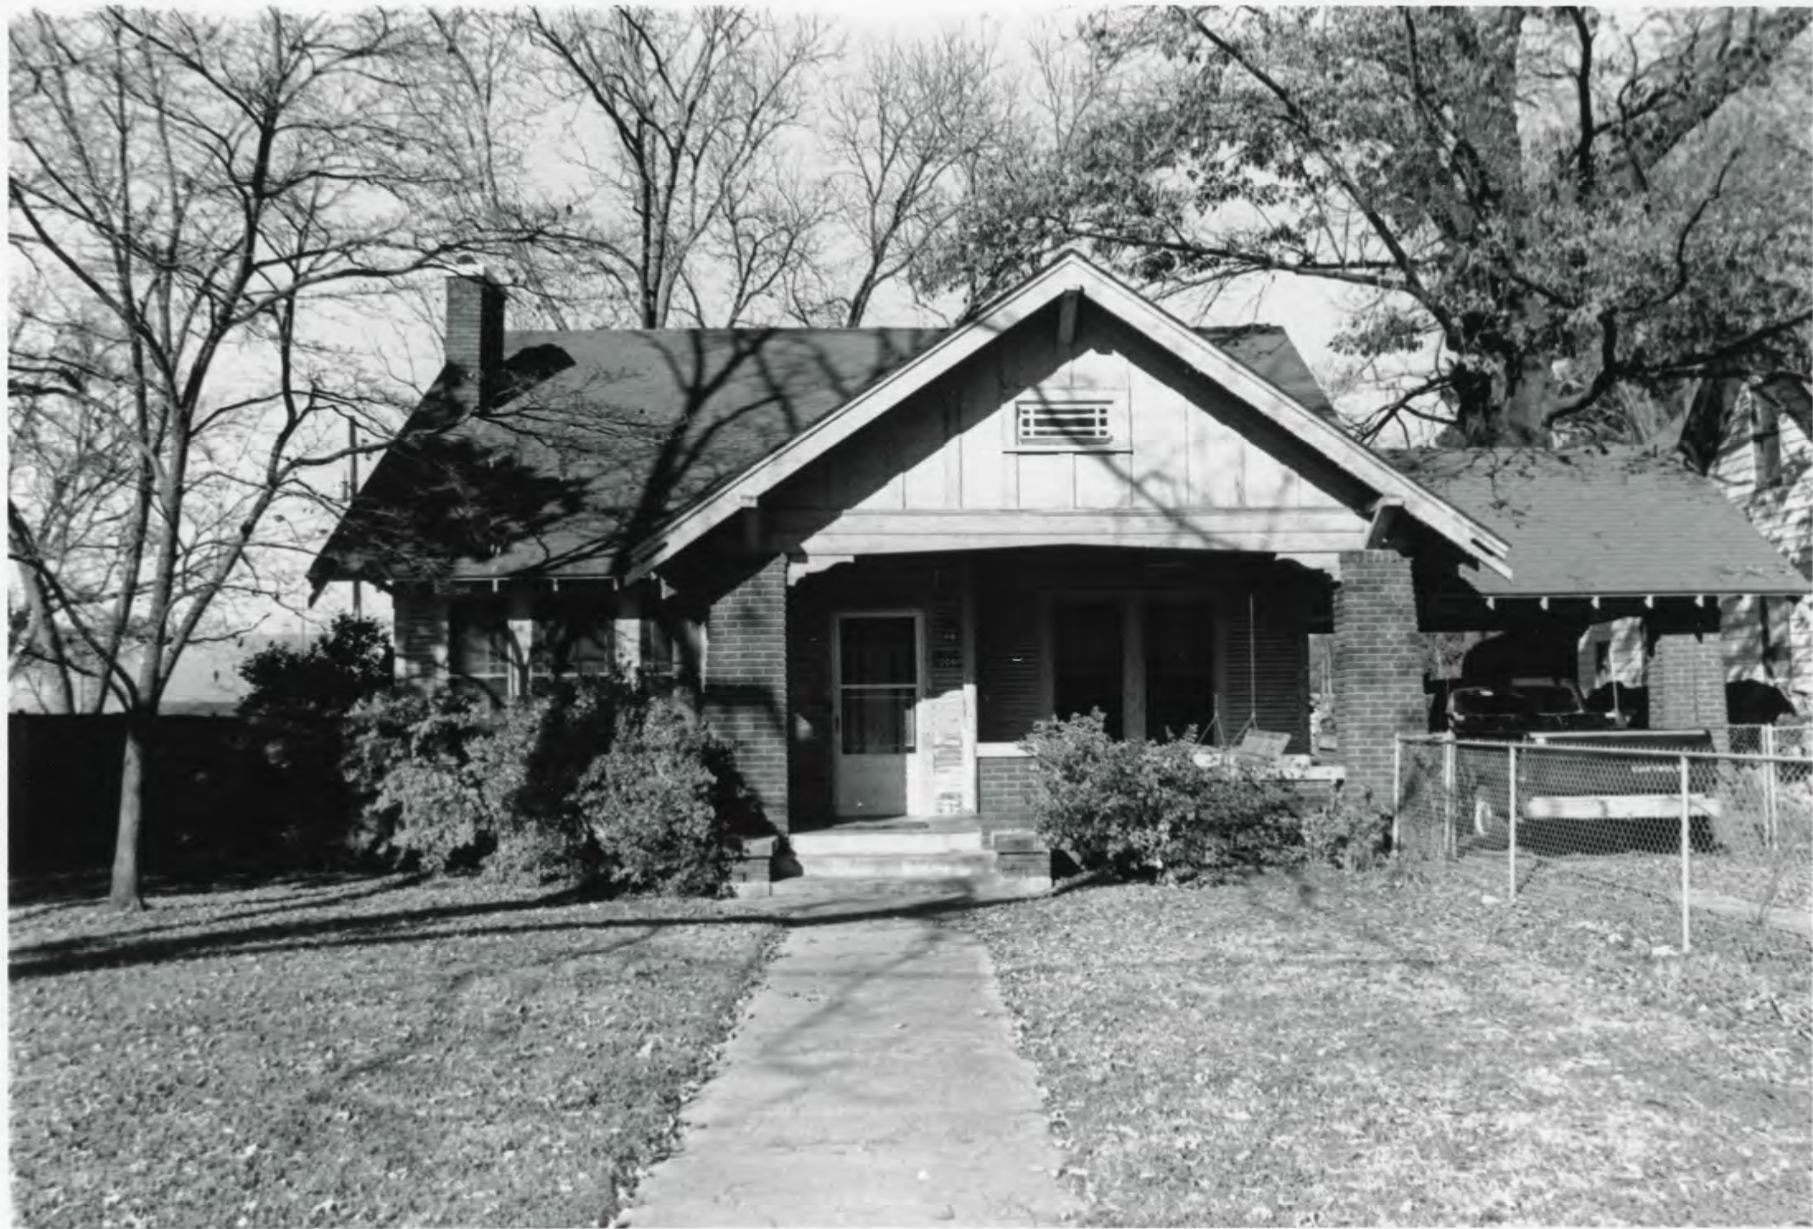
Alderson-Coston House.
Malvern, Hot Spring County, Arkansas.
Photographed by: Helen Barry 12/19/94
Negative at AHPP
View of South Elevation.

The southern or front elevation is dominated by a low-pitched front gable which spans about two-thirds of the facade. The gable is supported by two battered red brick piers which run the full height of the porch and rest on the concrete porch foundation. Each pier is flanked by decorative brackets which frame a shallow segmented arch over the porch area. This arch supports a plain horizontal wood frieze which forms the base of the elongated pediment of the gable.

The southern gable over the porch contains Tudor false half-timbering, and three triangular knee braces. A horizontal Craftsman style window with nine lights is located at the center of the low horizontal gable. All four gables, the dormer roof, and bay window roof are flanked by notched exposed rafters on either side which are elongated at the front, and shorten to the average rafter length behind. The wide overhanging eaves contain exposed rafter ends

At the base of the porch a low, solid brick balustrade with a concrete top extends from the east porch support and ends at the point where the steps in front of the door begin. The nine light Craftsman style single leaf entry door is located under the porch on the west side. The original ornamental Craftsman style porch light and decorative house number plate are located to the east of the front door. A pair of nine-over-one windows are also located under the porch to the east of the front door. The wall which contains the windows is set back from the rest of the facade with the break located just to the east of the main entrance area, thus increasing the porch depth in this eastern area. The only other fenestration on the facade are three windows which are located to the west of this southern porch. These windows are all of the nine-over-one type, as are all the others on the house. The only exception are the casement windows on the second storey of the northern projection.

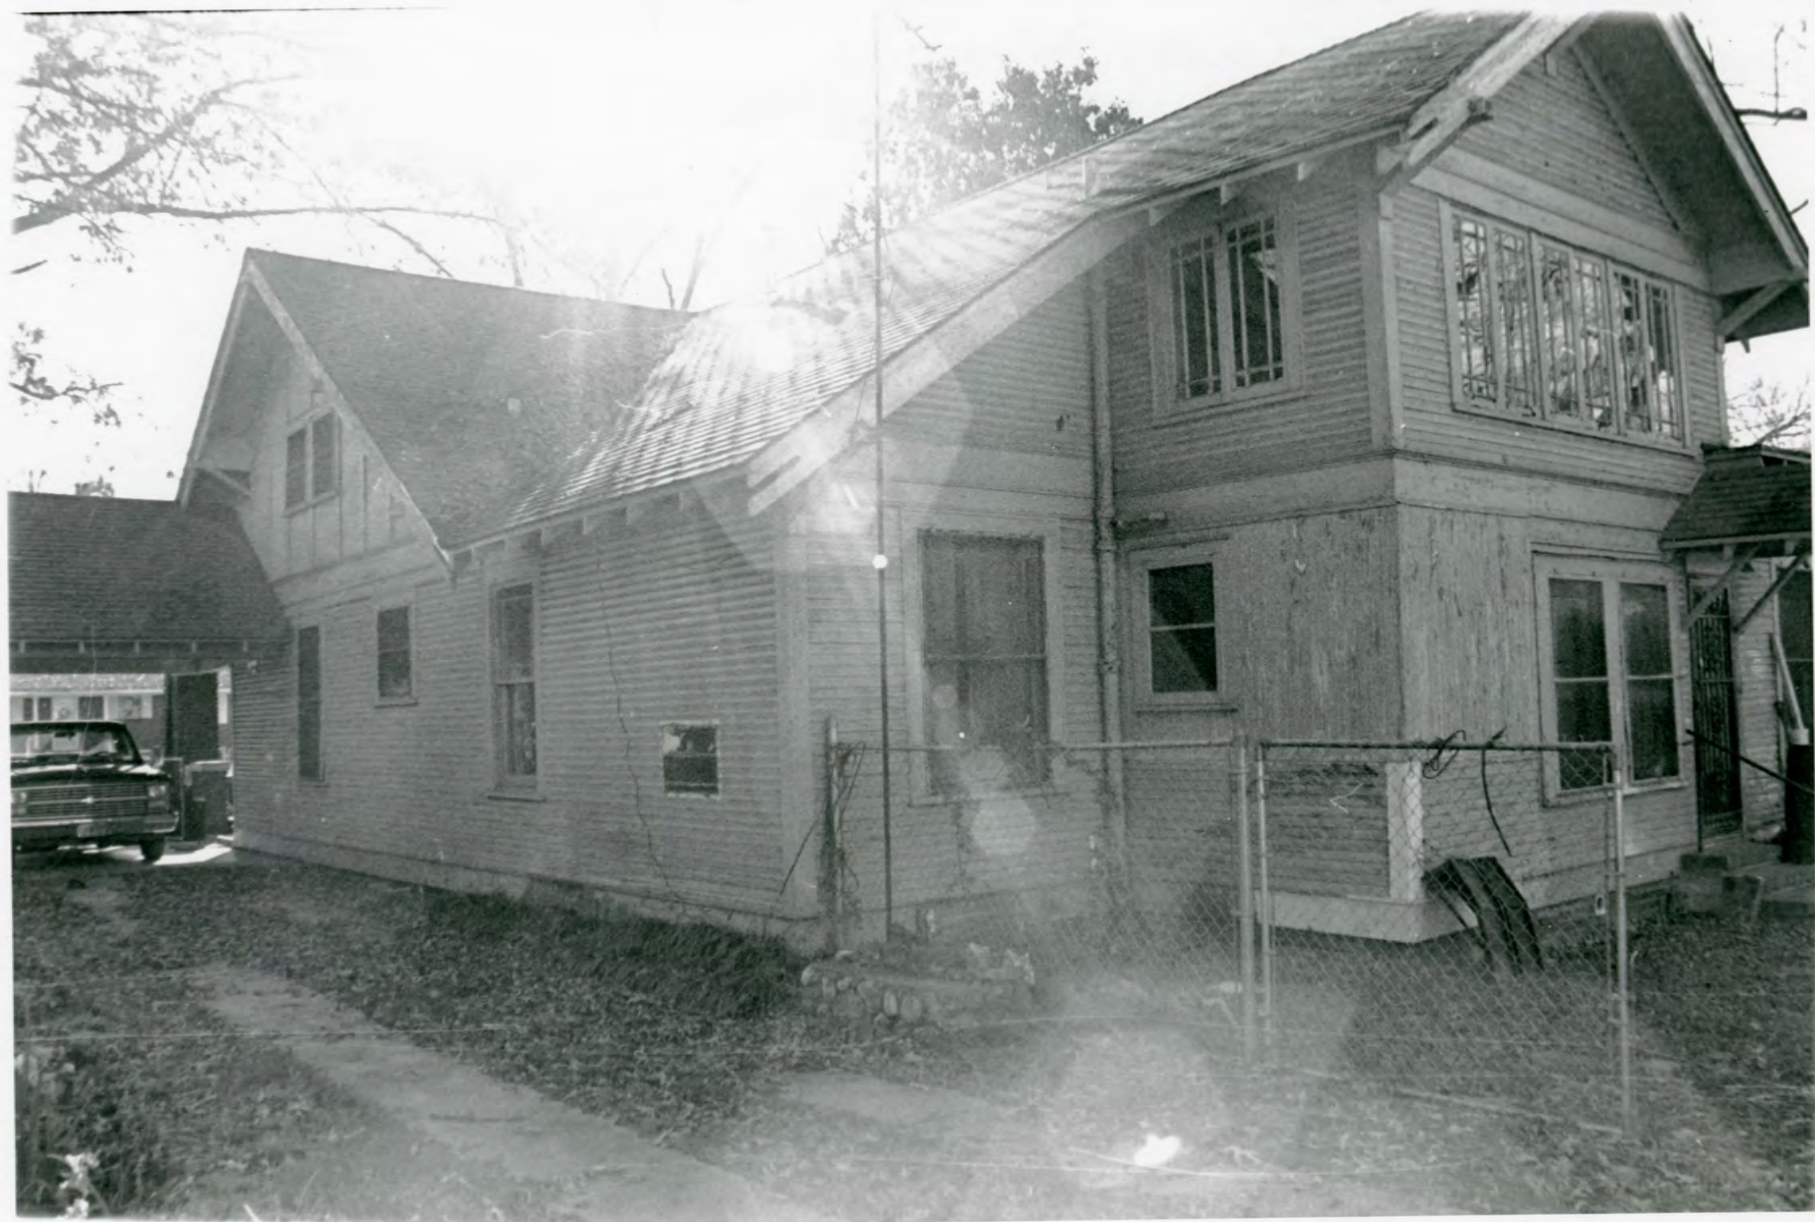
View of Northwest corner of house.

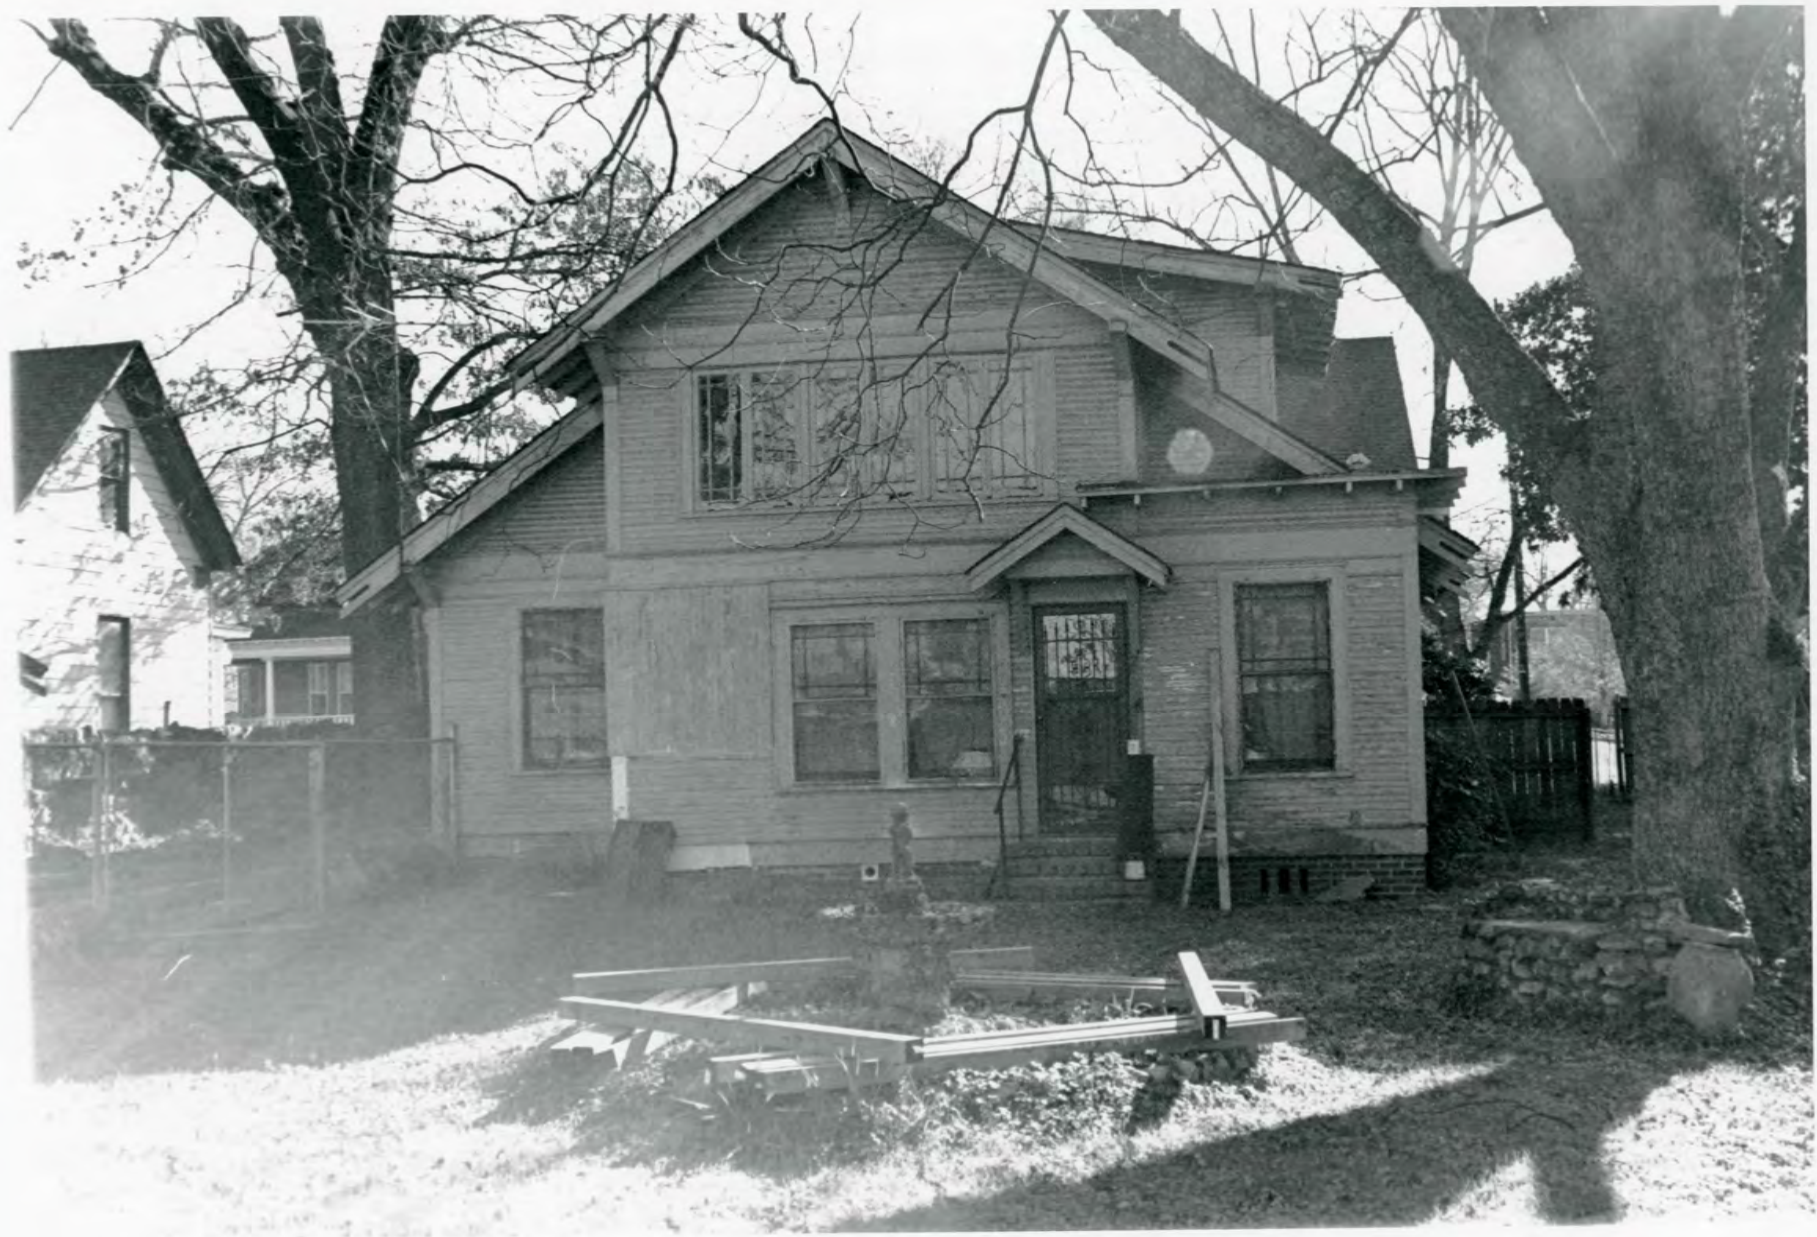
Alderson-Coston House 204 Pine Bluff Street
Malvern, Hot Spring County, Arkansas
photographed by: Helen Barry 12/19/94.
Negative at AHPP
View of North Elevation.

The northern elevation contains a two storey projection at the center of the main rear gable. A small one-storey flat roof addition was added to this projection on the west side about 1950. This addition extends to the wall of the western elevation. The northern projecting gable is covered in weatherboard with three knee brackets. A horizontal wood frieze is located between the gable end and the row of casement windows below. Another horizontal wood frieze separates the first and second stories on the back projection, and another frieze continues around the house framing the gables and defining the first storey. The second storey of this projection was originally a sleeping porch, but was enclosed with weatherboard and nine-by-nine casement windows in 1927.

The first floor of this elevation contains a single leaf entrance door which is capped by a gabled bracketed porch roof with a knee brace support on either side. The door is flanked by a pair of windows to the east and a single window to the west. There is also a small window on the east wall of the projection which was added at some point. The area around this small window and around the corner on the north side was infilled at some point with vertical beaded board wood panels which do not match the weatherboard seen elsewhere on this elevation.

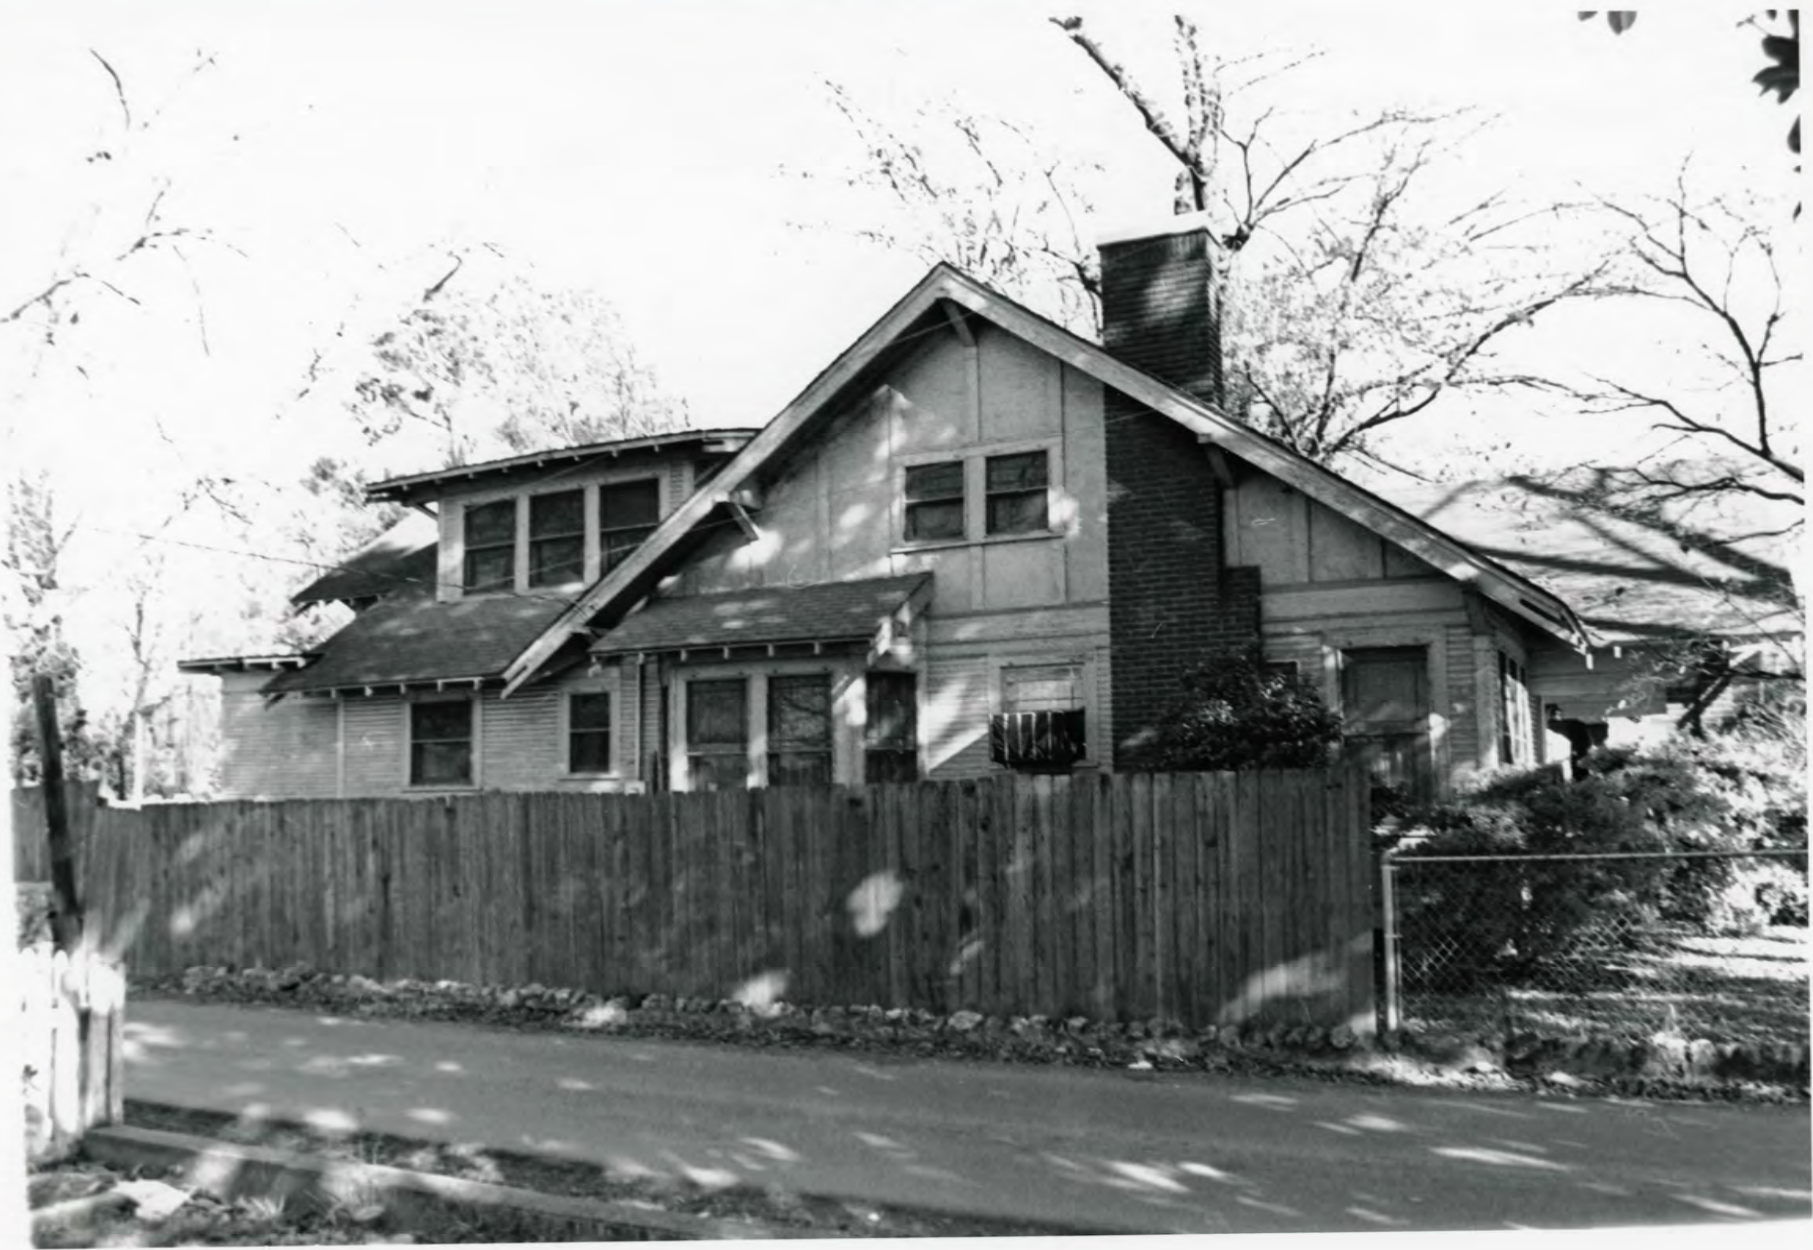
View of West Elevation.

The western elevation is dominated by a gable end to the south. This gable contains Tudor false half-timbering and five knee brackets. It also contains a pair of small windows at the center, as does the opposing gable on the eastern end of the house. Below the gable on the northern side of this section there is a four window bay which lights the dining room. This bay is covered with a shed roof with exposed rafter ends. Located to the south of this bay, are single windows on either side of the external chimney which rises above the roof, to the north of the ridge.

To the north of this section on the western elevation there is a shed dormer which rests on the western slope of the projecting northern gable. This dormer contains three windows and the projecting dormer roof contains exposed rafter ends and knee braces at each side. Below this dormer on the first floor elevation of this rear wing there are two windows of varying size.

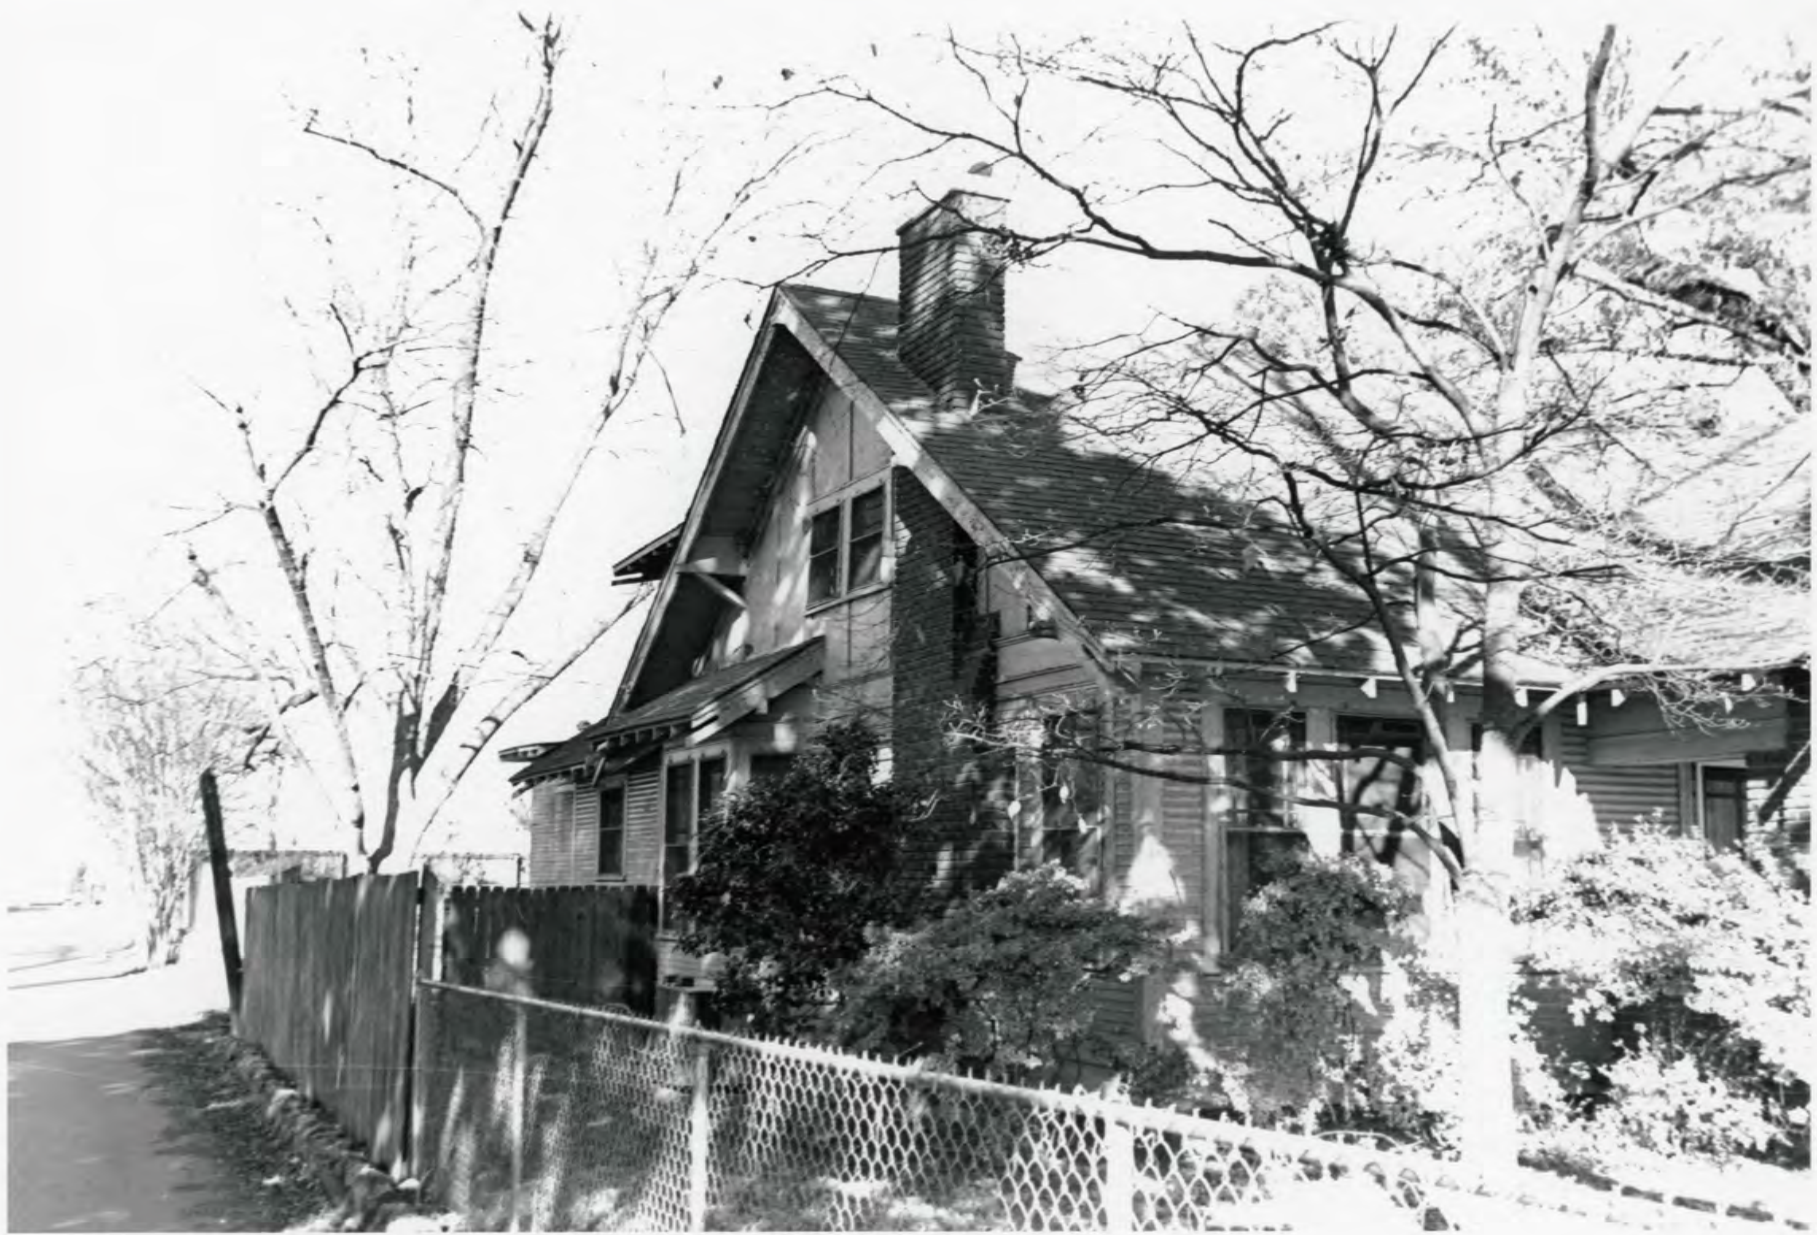
View of Southwest corner of house.

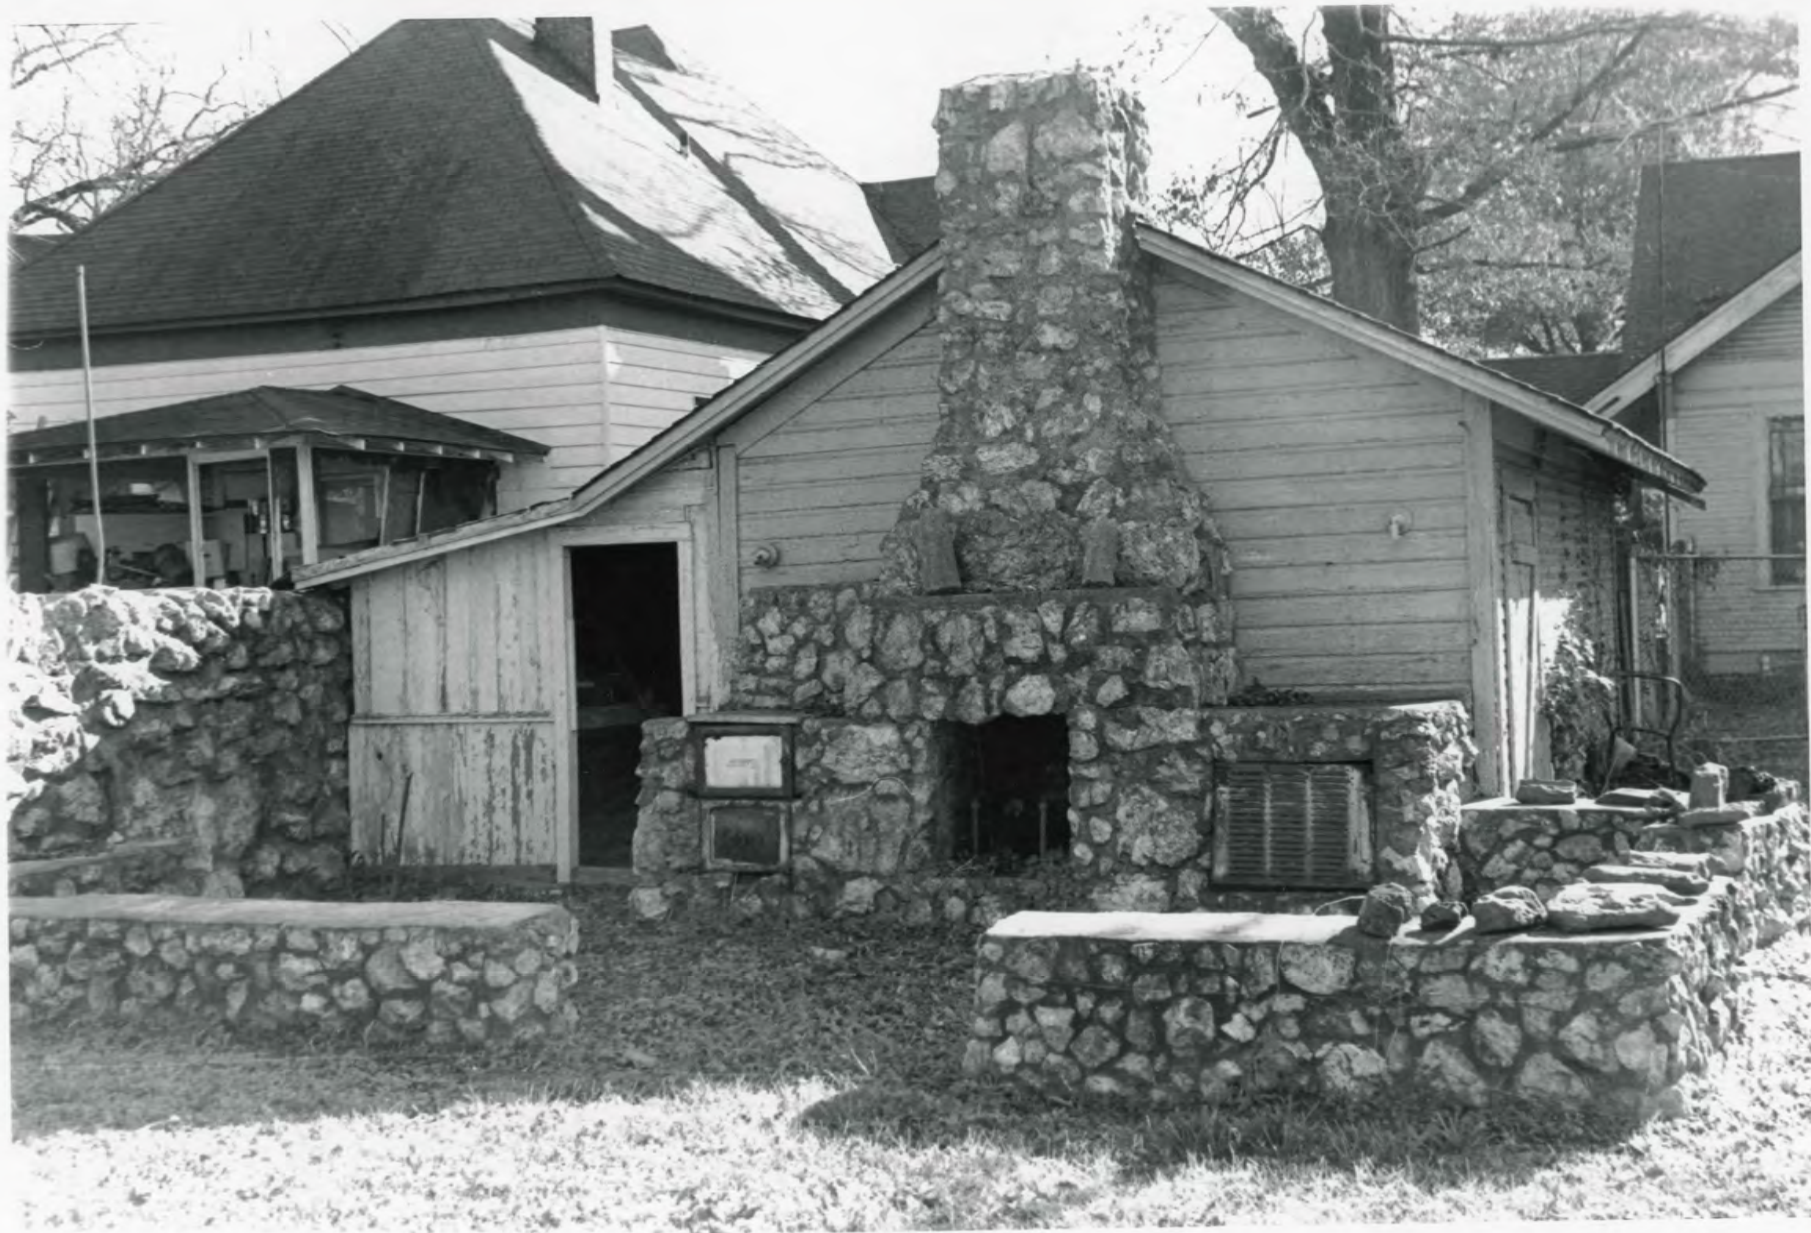
View of Entertainment Area on North
Side of garage.

A large uncoursed uncut fieldstone chimney is located at the center of the northern elevation of the garage. This chimney ventilates the fireplace which is the focal point of the back yard entertainment area. An oven and a cooking area are connected to either side of the fireplace. An uncut stone seating area partially surrounds the chimney, forming a rectangular arrangement for entertaining around the fireplace. Photographs document that this entertainment area was built sometime before July 1937.

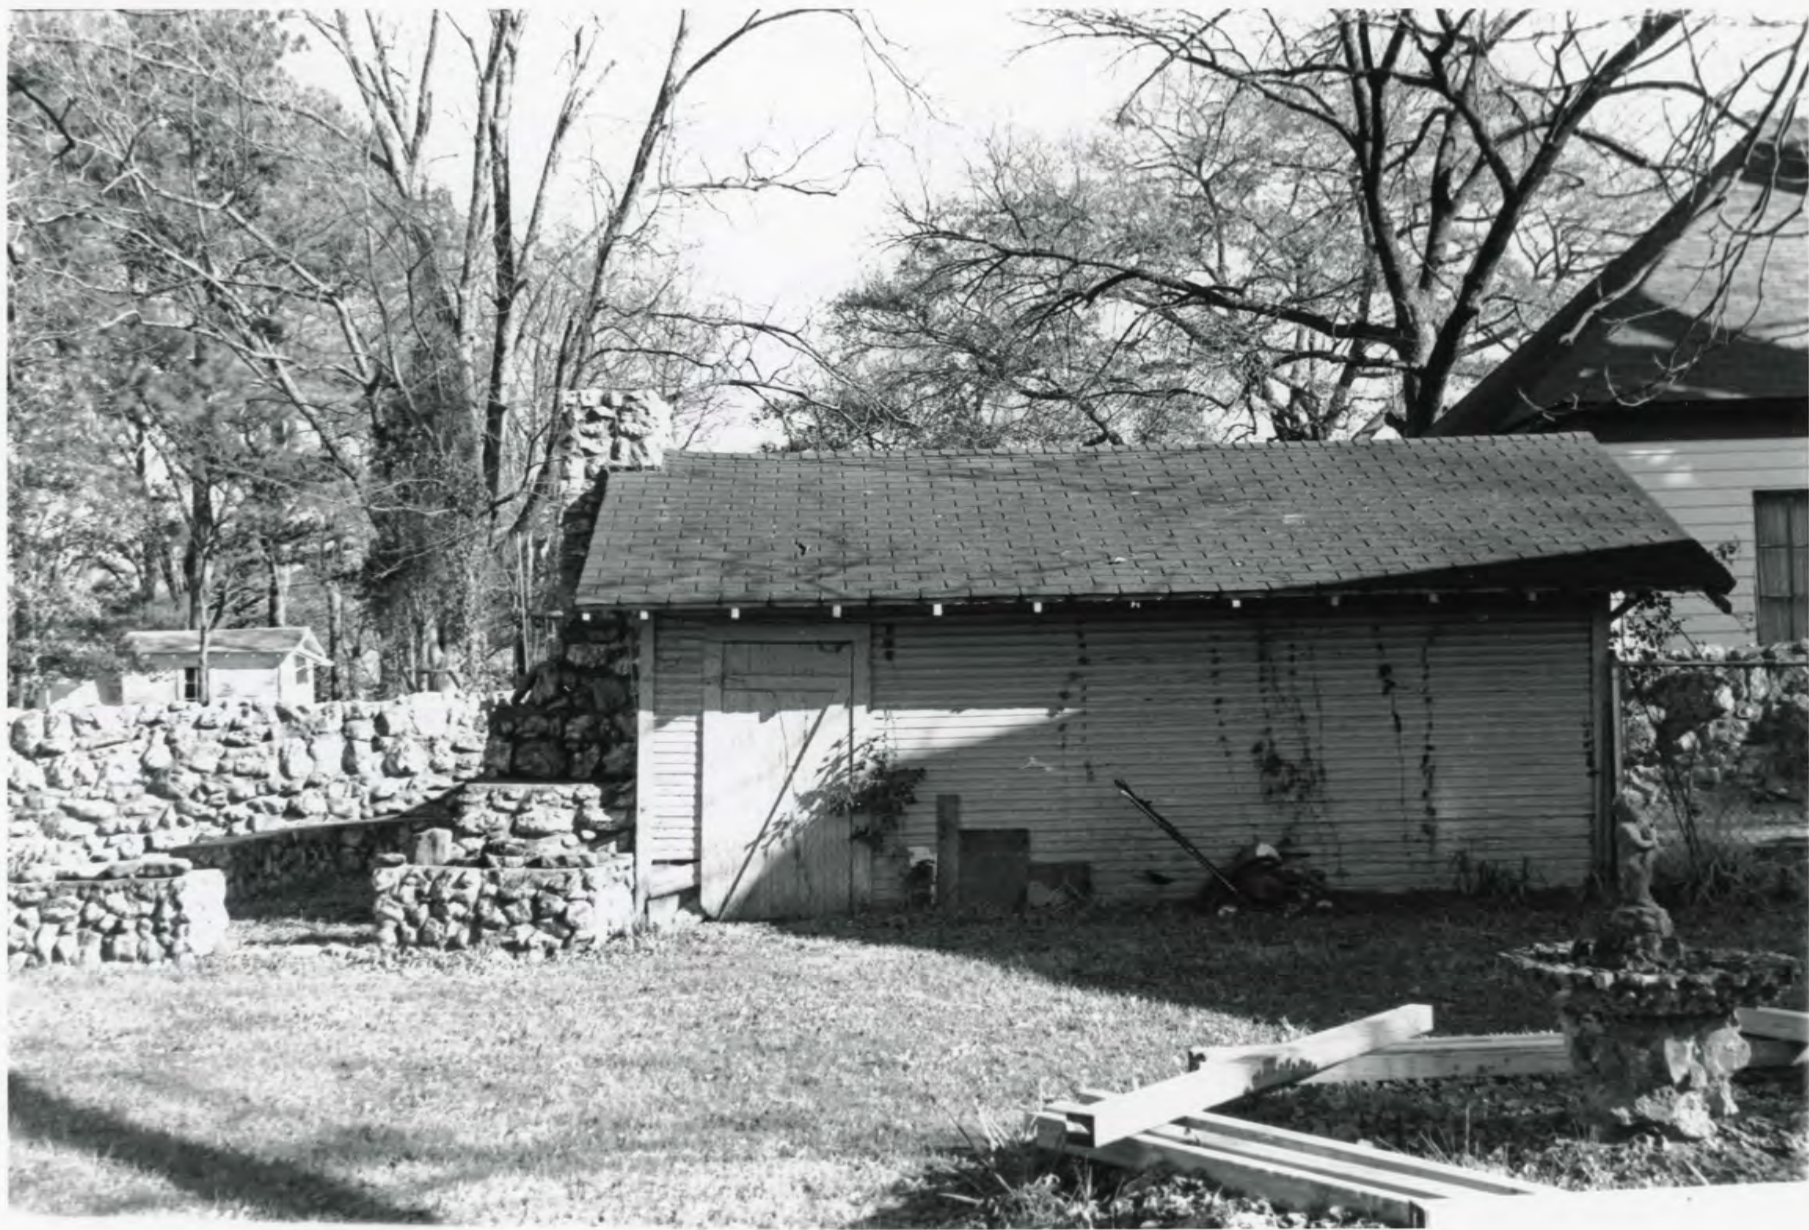
Alderson-Coston House
Malvern, Hot Spring County, Arkansas.
Photographed by: Helen Barry, 12/19/94.
Negative at AHPP.
View of West Elevation of Garage.

The only other structure included in this nomination is a one car garage which is located to the northeast of the main house. The garage is a simple gable roof structure with a shed addition. The structure is covered in weatherboard, except for the northern end which is covered in wide drop wood siding. The southern gable end contains false half-timbering at the top with three knee-braces and notched exposed rafters at either side. The garage door below is a double leaf "Z" braced door. The western elevation of the garage contains a simple single leaf door with a "Z" brace at the northern end. A plain shed addition spans the entire length of the eastern wall of the garage, with a simple single leaf door at the north and south ends. This addition is currently painted white which separates it from the garage which is green in color.

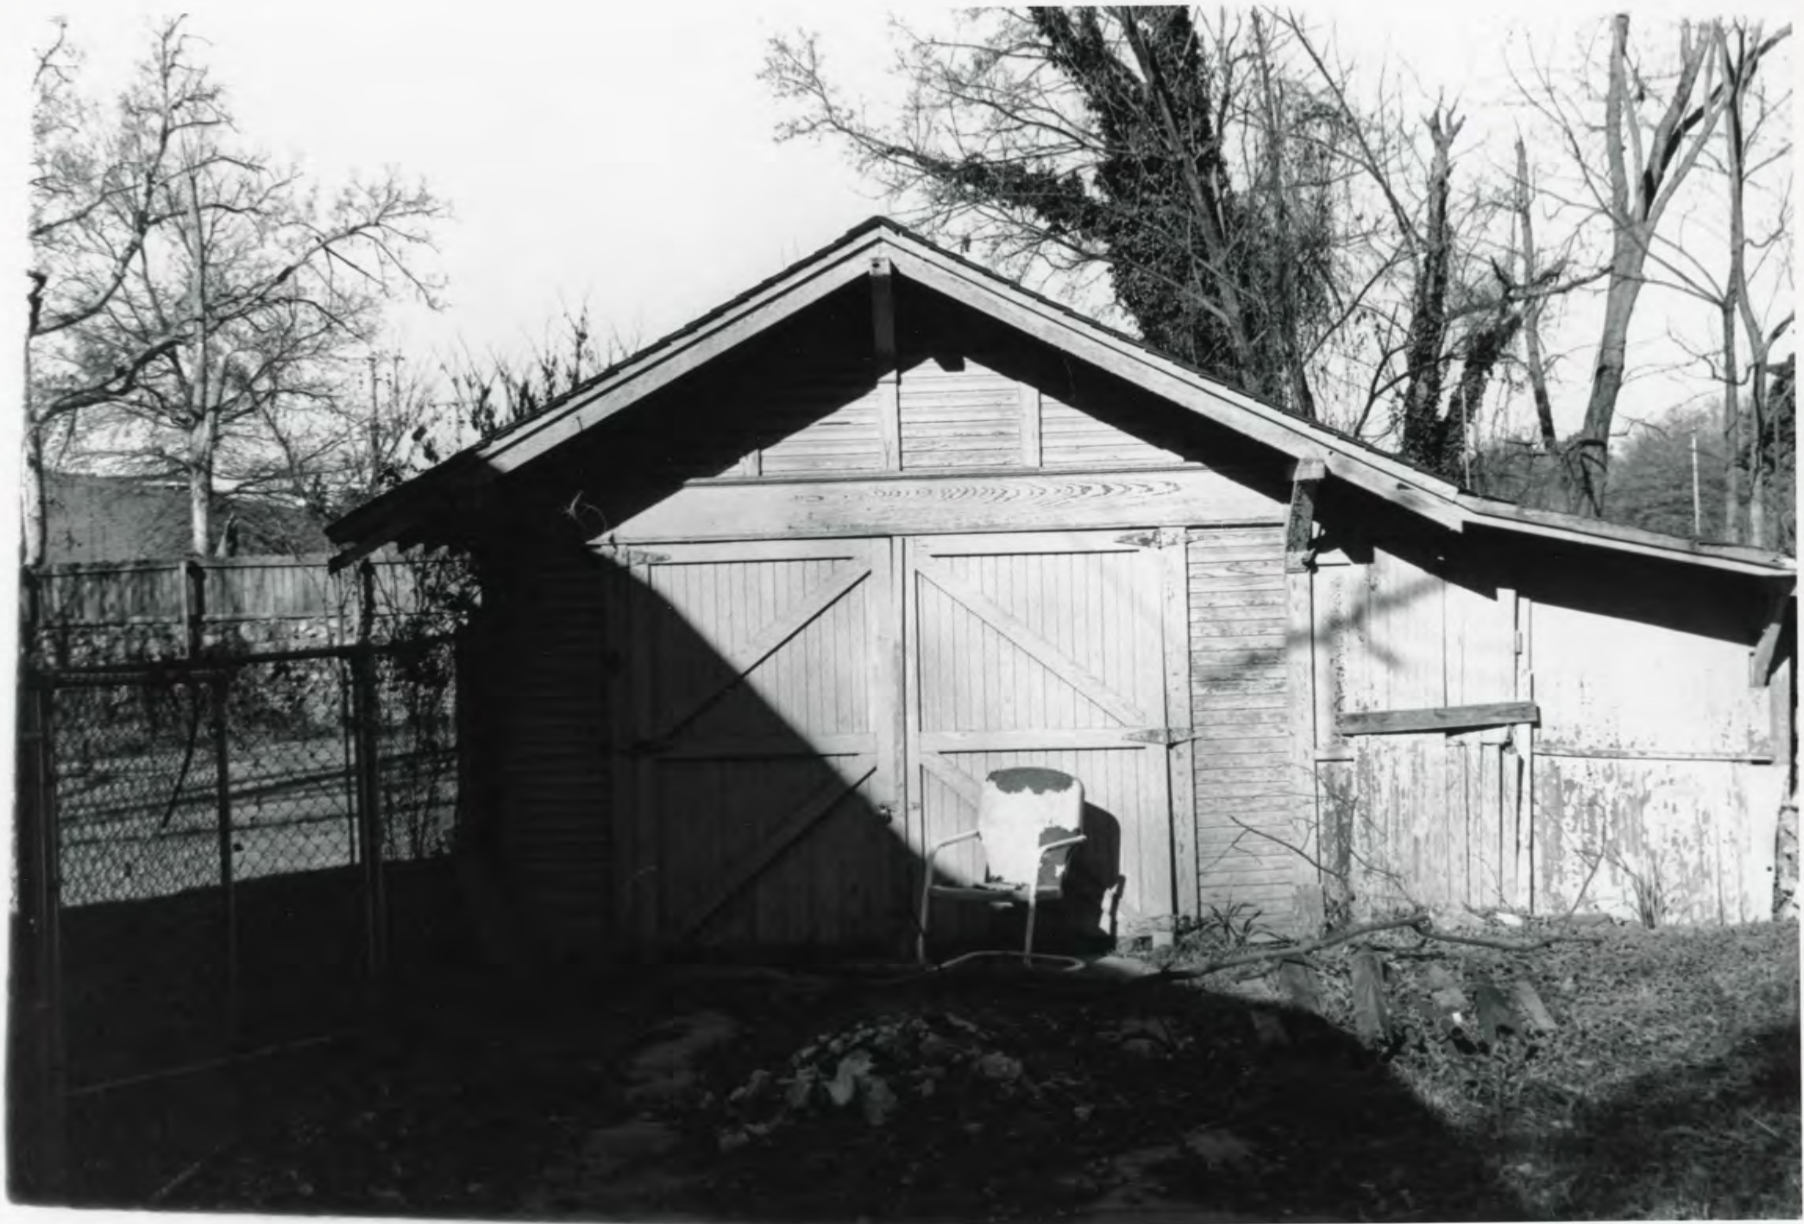
South Elevation of garage.

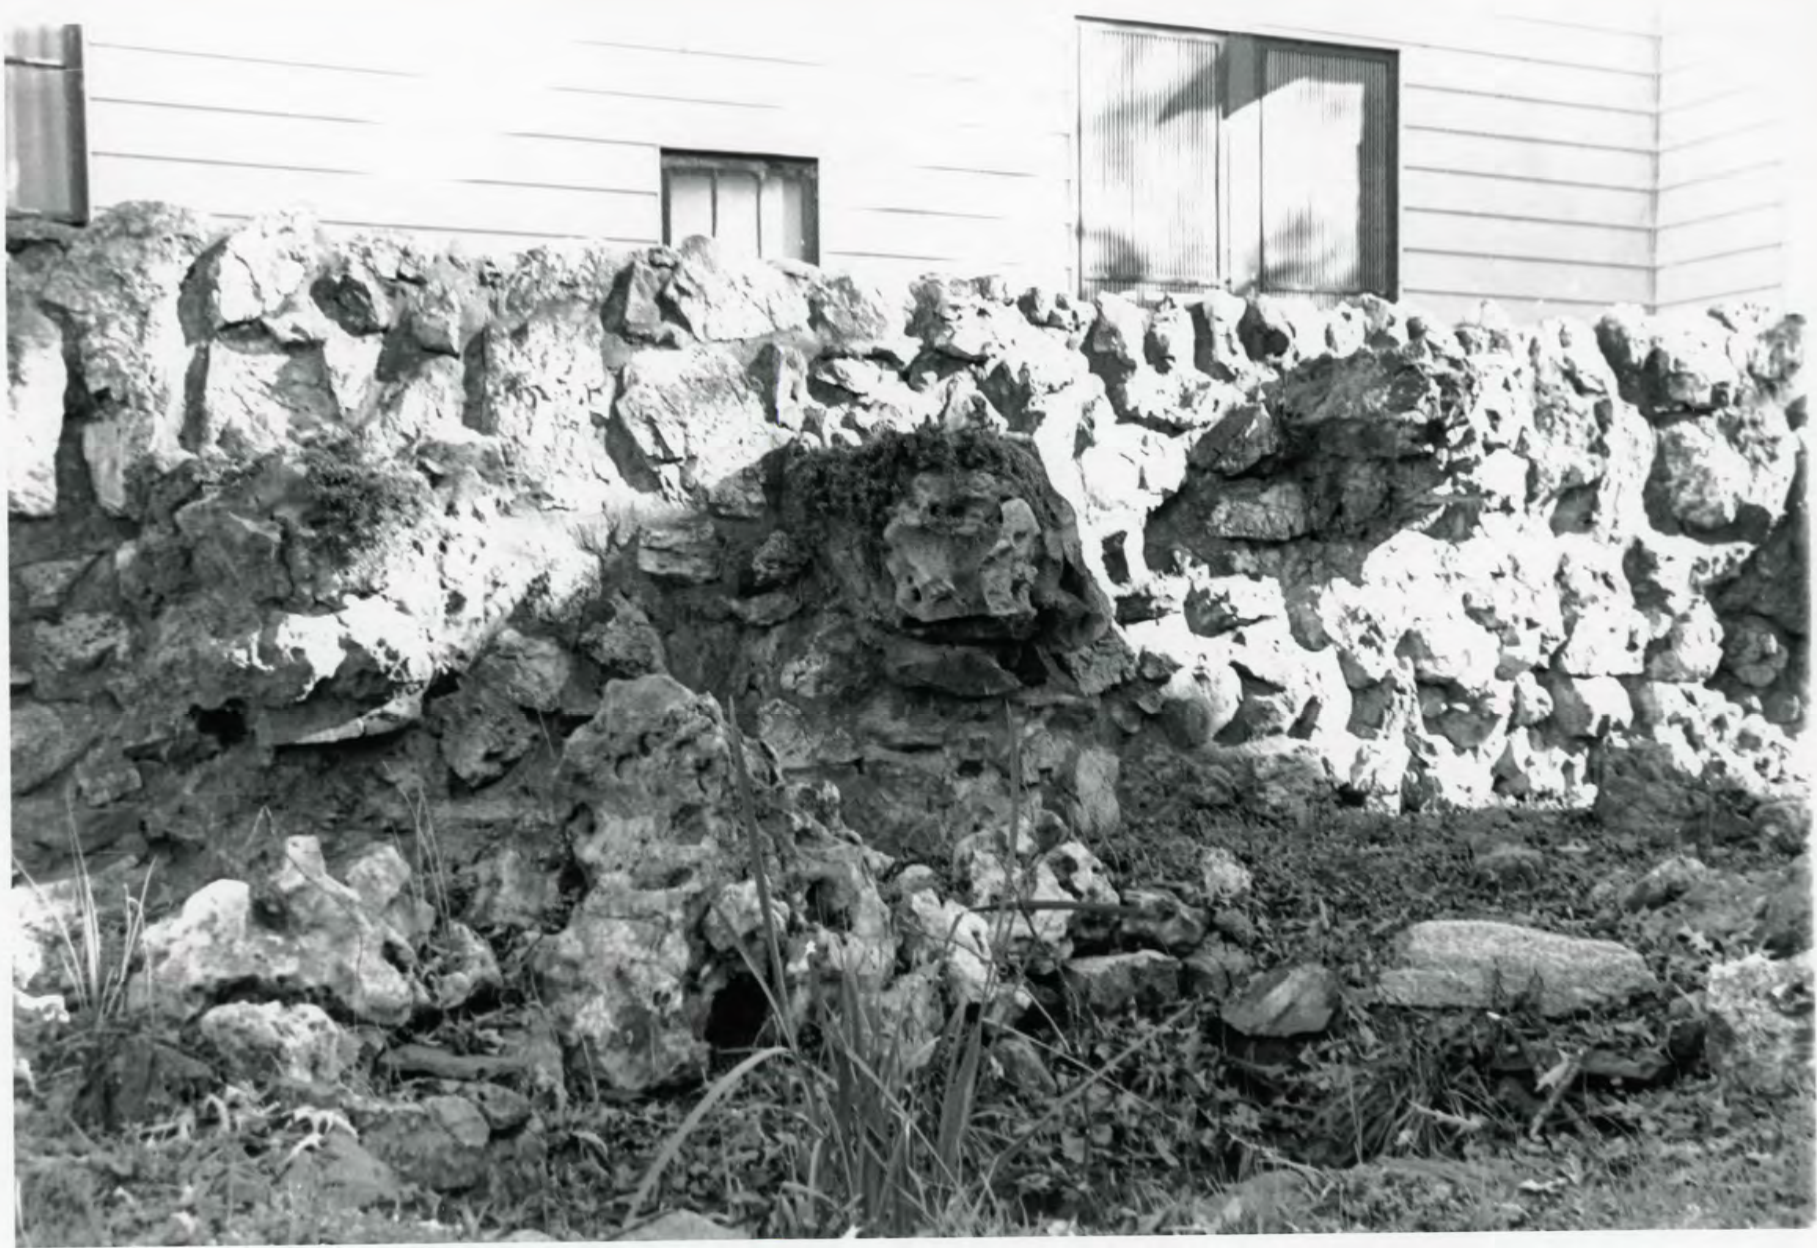
view of rock wall east of house.

There are other interesting landscape features which were constructed at different dates out of the same uncoursed uncut fieldstone. A tall uncut fieldstone wall begins at the *porte-cochere* on the east and continues around the backyard along the northern boundary. A low fieldstone wall is located along the western boundary of the backyard. Photos indicate that the northern and western walls were built between July 1936 and June 1937. The eastern wall contains large round fieldstone planters which are located at varying heights and intervals along the wall between the *porte-cochere* and the garage. A small pond and waterfall are located in front of this wall. The backyard contains a circular fish pond near the center. There is also a rock garden with a stone birdbath at the northwest corner of the yard. Thus, the landscape features of the Alderson-Coston house exemplify the organic Rustic style of construction which is closely akin to the Craftsman style, as both are indicated by natural materials and restrained adornment.
