**National Register of Historic Places
Inventory—Nomination Form**

historic Shaw Mansion
and/or common Shaw Mansion

AL-VI-C-118

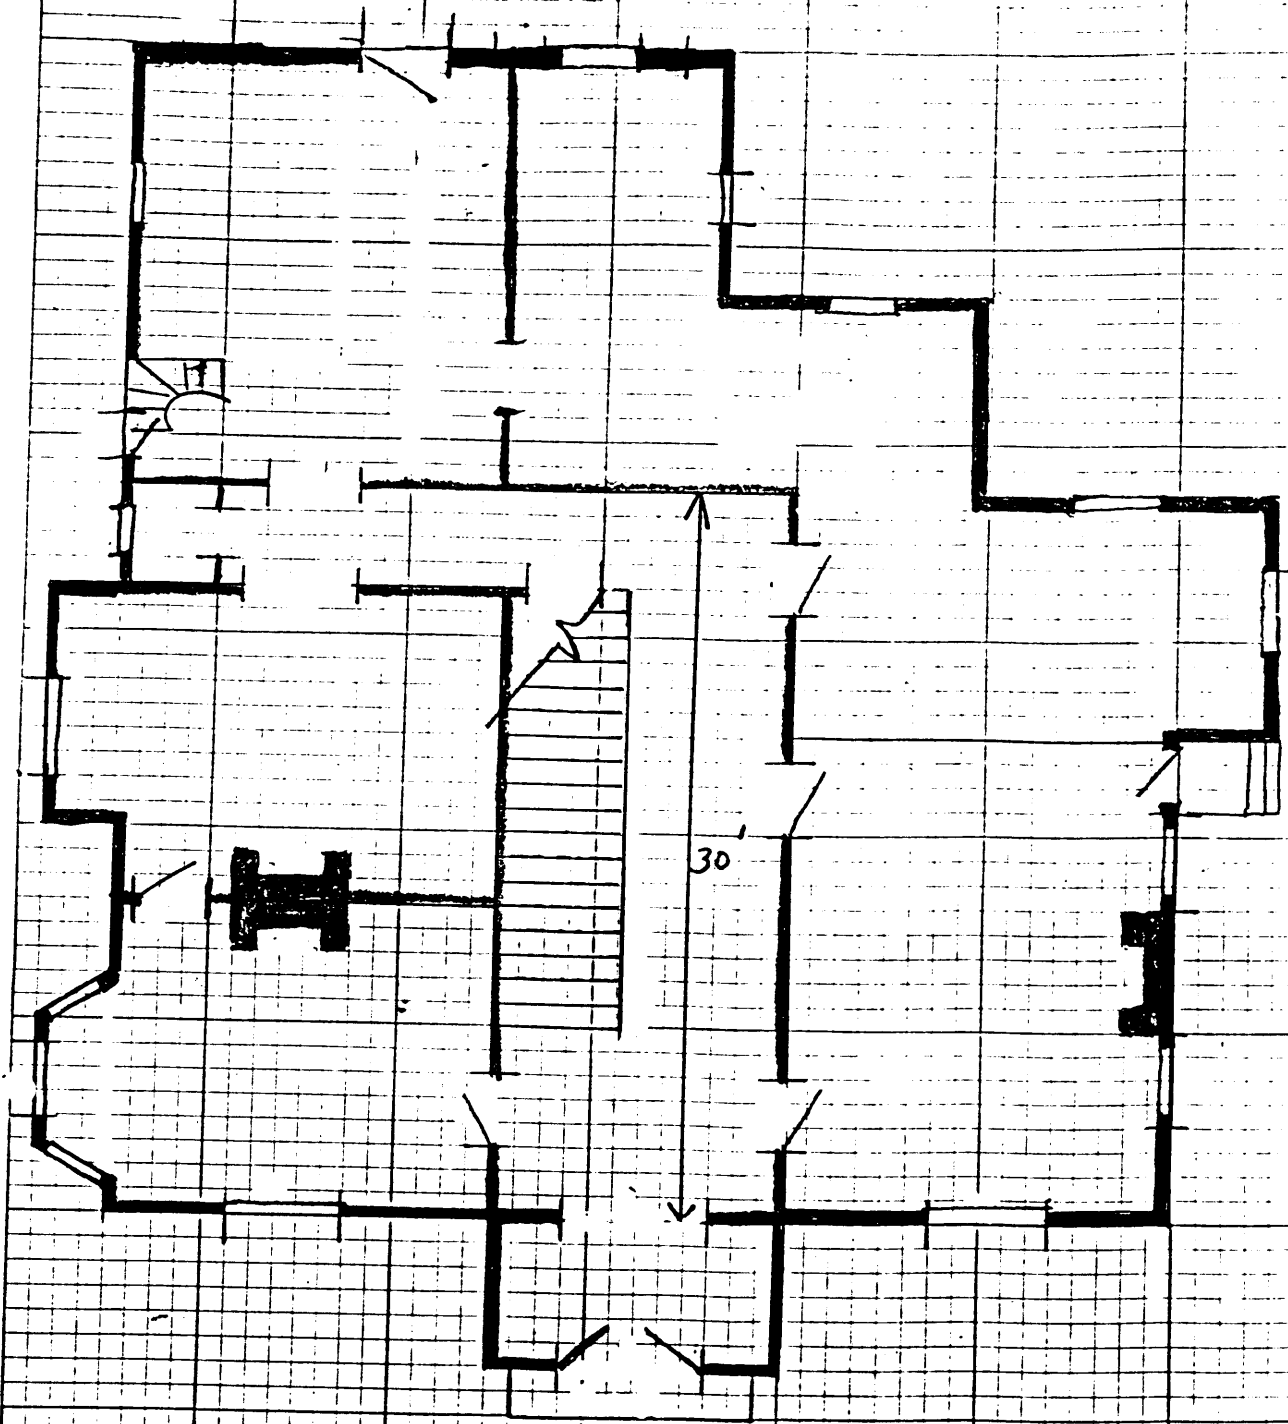
ME VIT C-118
SHAW MANSION
Rt 36, Barton
Alleghany County, Maryland

30'

44'

Sketch Plan - Not to Scale

The Shaw Mansion is a large brick mansion constructed in 1872 with a modified, asymmetrical cruciform plan. It is 2½ stories high on a full stone foundation, with a combination of hip and pitched gable roofs.

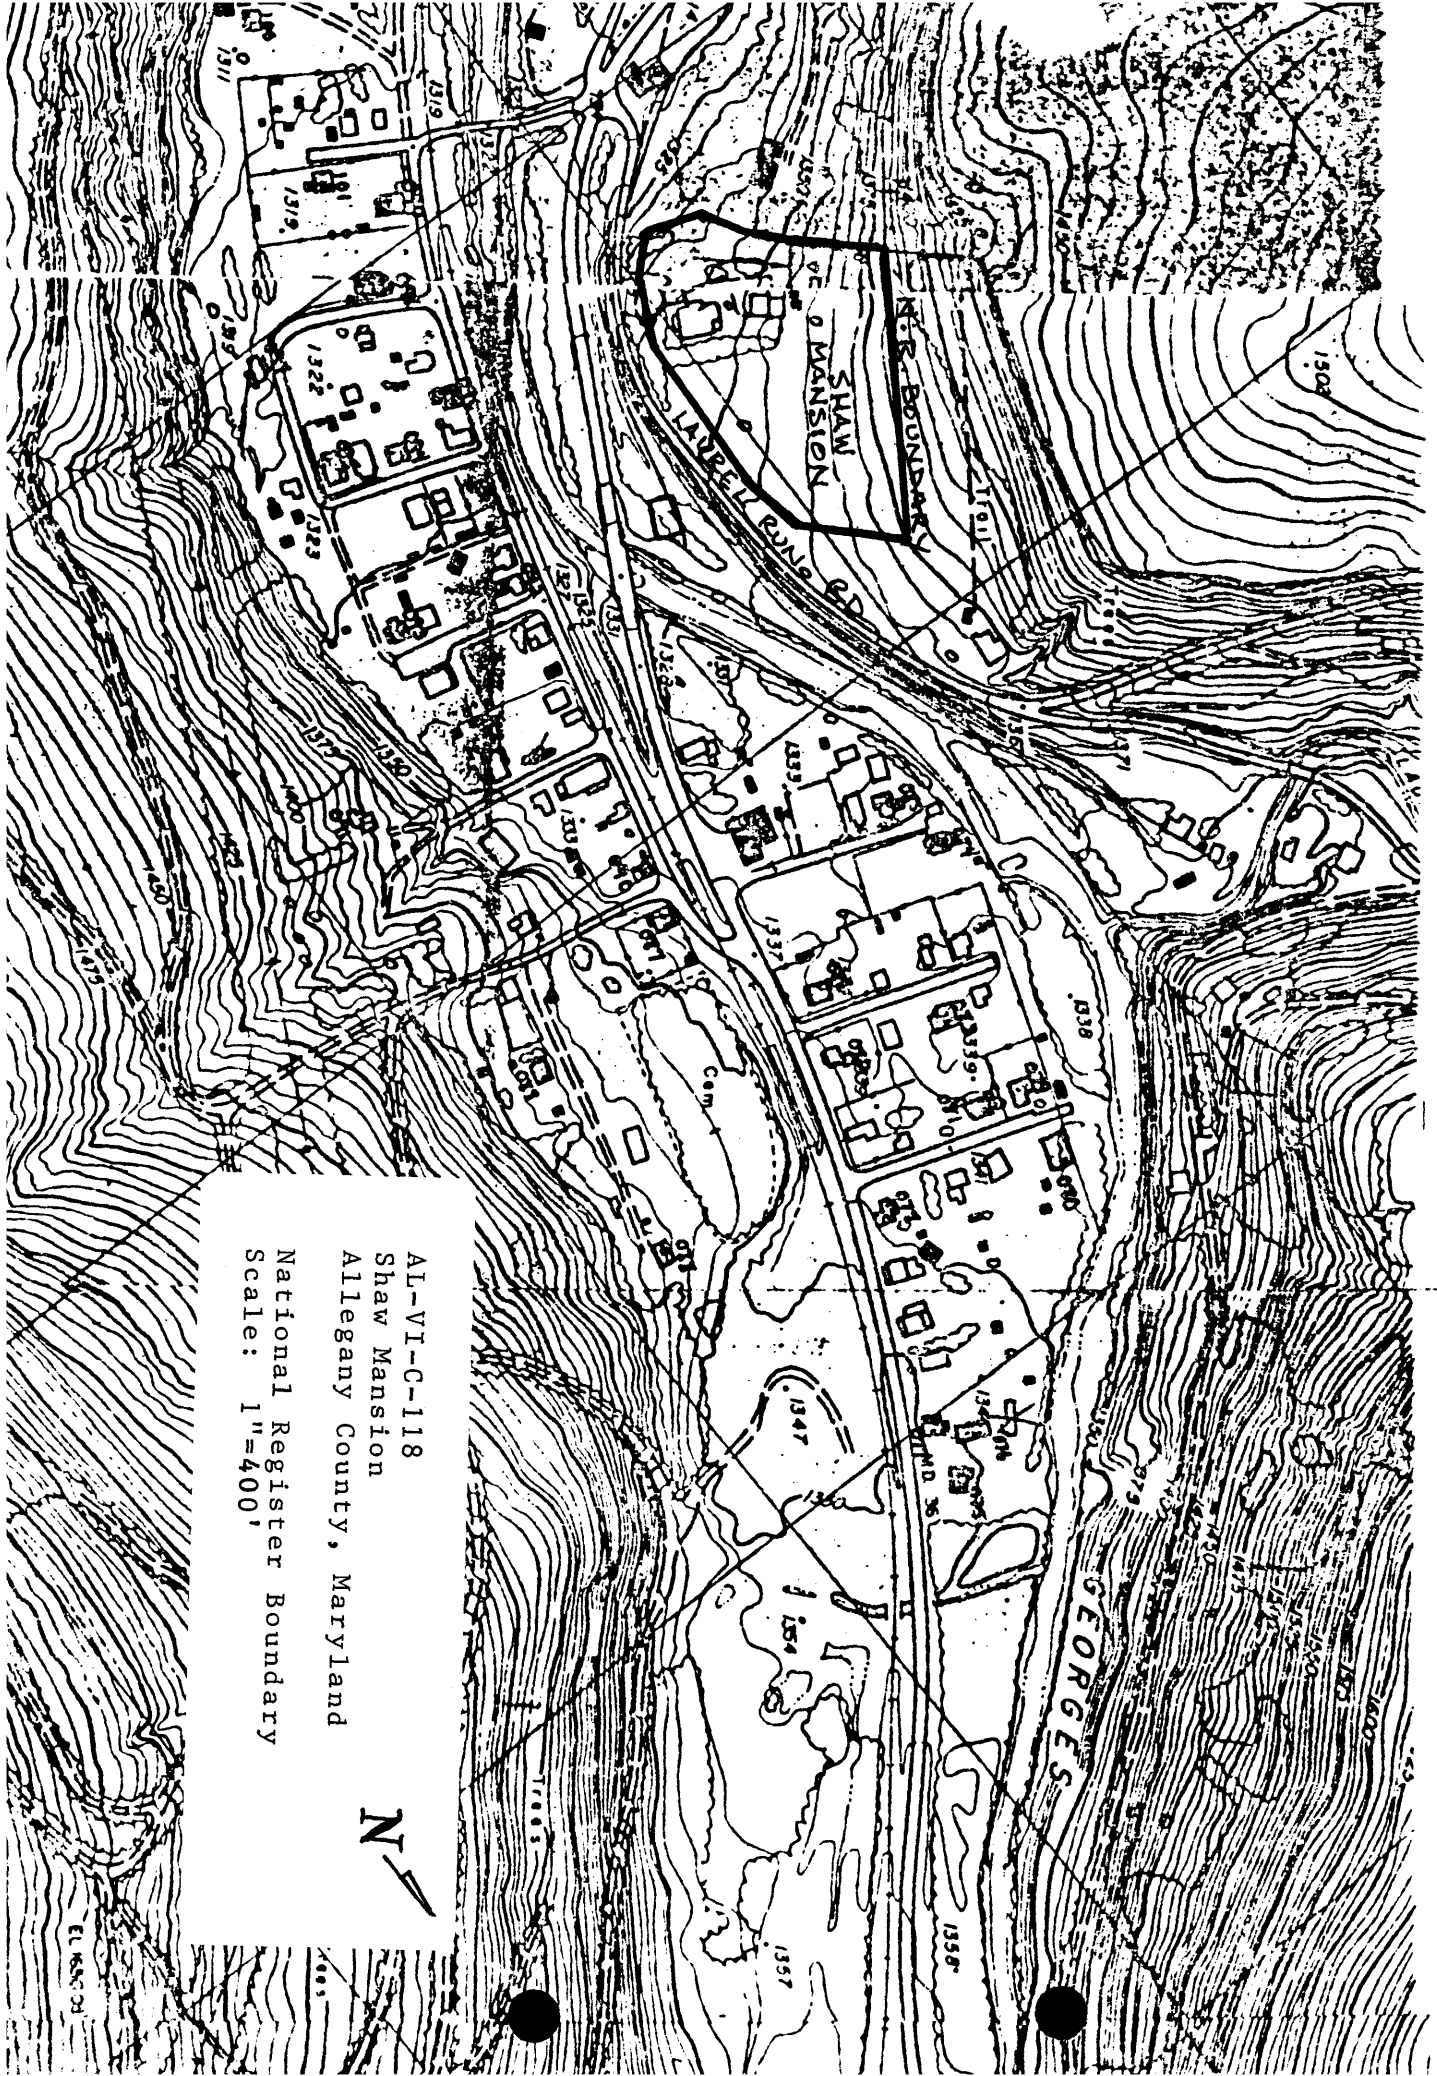
AL-VI-C-118
Shaw Mansion
Allegany County, Maryland
National Register Boundary
Scale: 1"=400'

Beginning at a gate post on the west side of a farm access road, said gate post being also 110 feet west from the corner stone of Military Lot No. 3733, and running thence South 32 degrees 13 minutes West 615.6 feet to a stake, thence South 46 degrees 23 minutes East 218.5 feet to a point, thence South 31 degrees 30 minutes East 140.6 feet to a stone wall, thence with the meanders of said stone wall, South 68 degrees 55 minutes East 121.8 feet, thence North 48 degrees 30 minutes East 75.6 feet to a driveway entering Laurel Run Road, thence North 27 degrees 40 minutes East 146 feet, parallel with the centerline of said Laurel Run Road, thence North 11 degrees 10 minutes East 46.8 feet, thence North 2 degrees 15 minutes East 279.4 feet, thence North 8 degrees 50 minutes West 124 feet, thence North 42 degrees 50 minutes West 212.3 feet to the place of beginning. (See sketch map attached), ,

The nominated property comprises the Shaw Mansion and outbuildings within their immediate setting. Boundaries utilize existing property lines, and correspond with fence lines on the southwest and with the right-of-way of Laurel Run Road on the east. Steeply-rising topography defines the northwest boundary, which roughly follows the 1380' contour line.
