ARIZONA STATE HISTORIC PROPERTY INVENTORY

SURVEY AREA NAME: Safford, Arizona
 HISTORIC NAME: Buena Vista Hotel
 ADDRESS/LOCATION: 322 Main
 CITY/TOWN: Safford
 TAX PARCEL NUMBER: 102-22-256 / <1 ACRE(S)
 OWNER: Avanti Mortgage Corporation
 OWNER ADDRESS: 2180 N. Central Ave.
Phoenix, AZ 85004
 HISTORIC USE: Hotel
 PRESENT USE: Vacant
 BUILDING TYPE: Commercial
 STYLE: Mission Revival
 CONSTRUCTION DATE: 1928
 ARCHITECT/BUILDER: H.O. Jaastad/McGinty Const.
 INTEGRITY: Minor alterations
 CONDITION: Fair

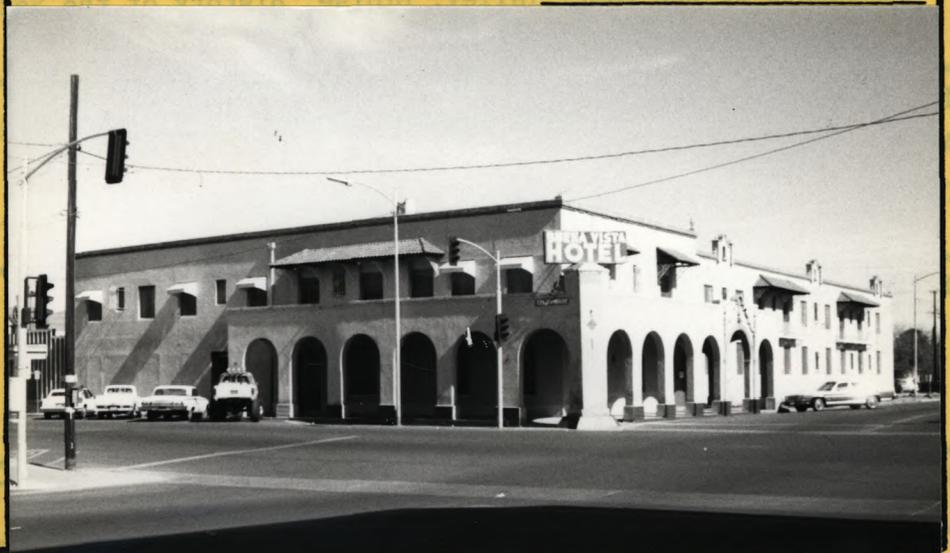
PHOTOGRAPH

ROOF TYPE: Flat
 ROOF SHEATHING: Unknown, spanish tile on awnings
 EAVES TREATMENT: Corbeled brick stringer parapet with finials at corners
 WINDOWS: Boarded shut with plywood
 ENTRY: Arched entry with decorative tile jambs; main arched entry has baroque..
 PORCHES: Two arched arcade
 STOREFRONTS: See above

STORIES: 2 DIMENSIONS: (1) 80' (w) 100'
 STRUCTURAL MATERIAL: Steel frame
 FOUNDATION MATERIAL: Concrete
 WALL SHEATHING: Stucco
 APPLIED ORNAMENT: Three curved mission style parapets with stucco coping, spanish tile..

NOTABLE INTERIOR: Some original detailing still exists
 OUTBUILDINGS: None
 ALTERATIONS: Windows and doors boarded shut, metal replacement awnings

PHOTOGRAPHER: Linda Laird & Associates
 DATE: Jan, 1987 VIEW: NE, FF
 NEGATIVE NUMBER: R:CC F:16
