National Register of Historic Places  
Inventory—Nomination Form

historic Thankful Baptist Church

# THANKFUL BAPTIST CHURCH

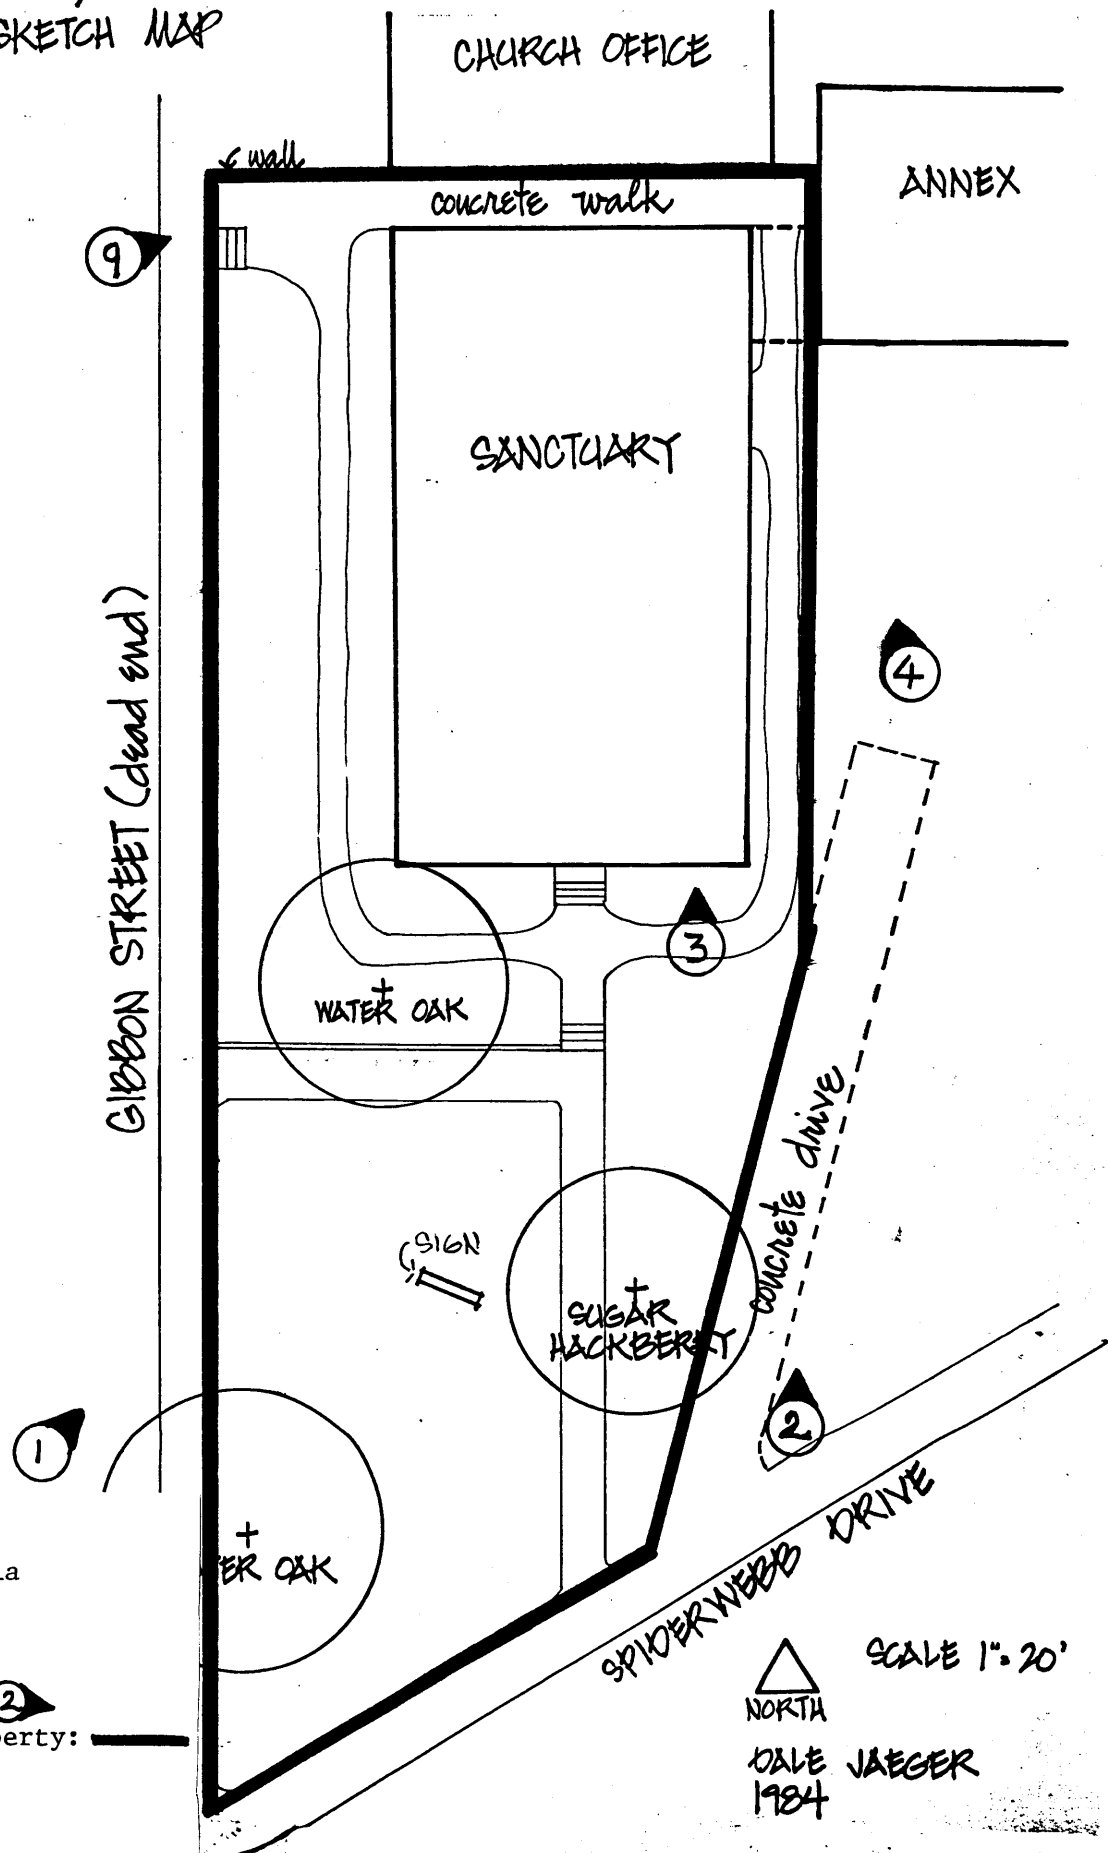
ROME, GEORGIA  
SKETCH MAP

Property/Sketch Map:  
Scale: 1 inch = 20 feet  
Direction of photograph: ②  
Boundary of nominated property: ———  
North: ↑

The boundary of the nominated property is comprised of the historic church building and its surrounding landscape. It includes Gibbons Street to the west, Spiderwebb Drive to the south, the west side of the concrete drive and sidewalk on the east, and the brick retaining wall on the rear (north). It does not include the modern, detached church office or annex.

The boundary of the nominated property is indicated by a heavy black line on the enclosed "property/sketch map" and is justified in Section 7.

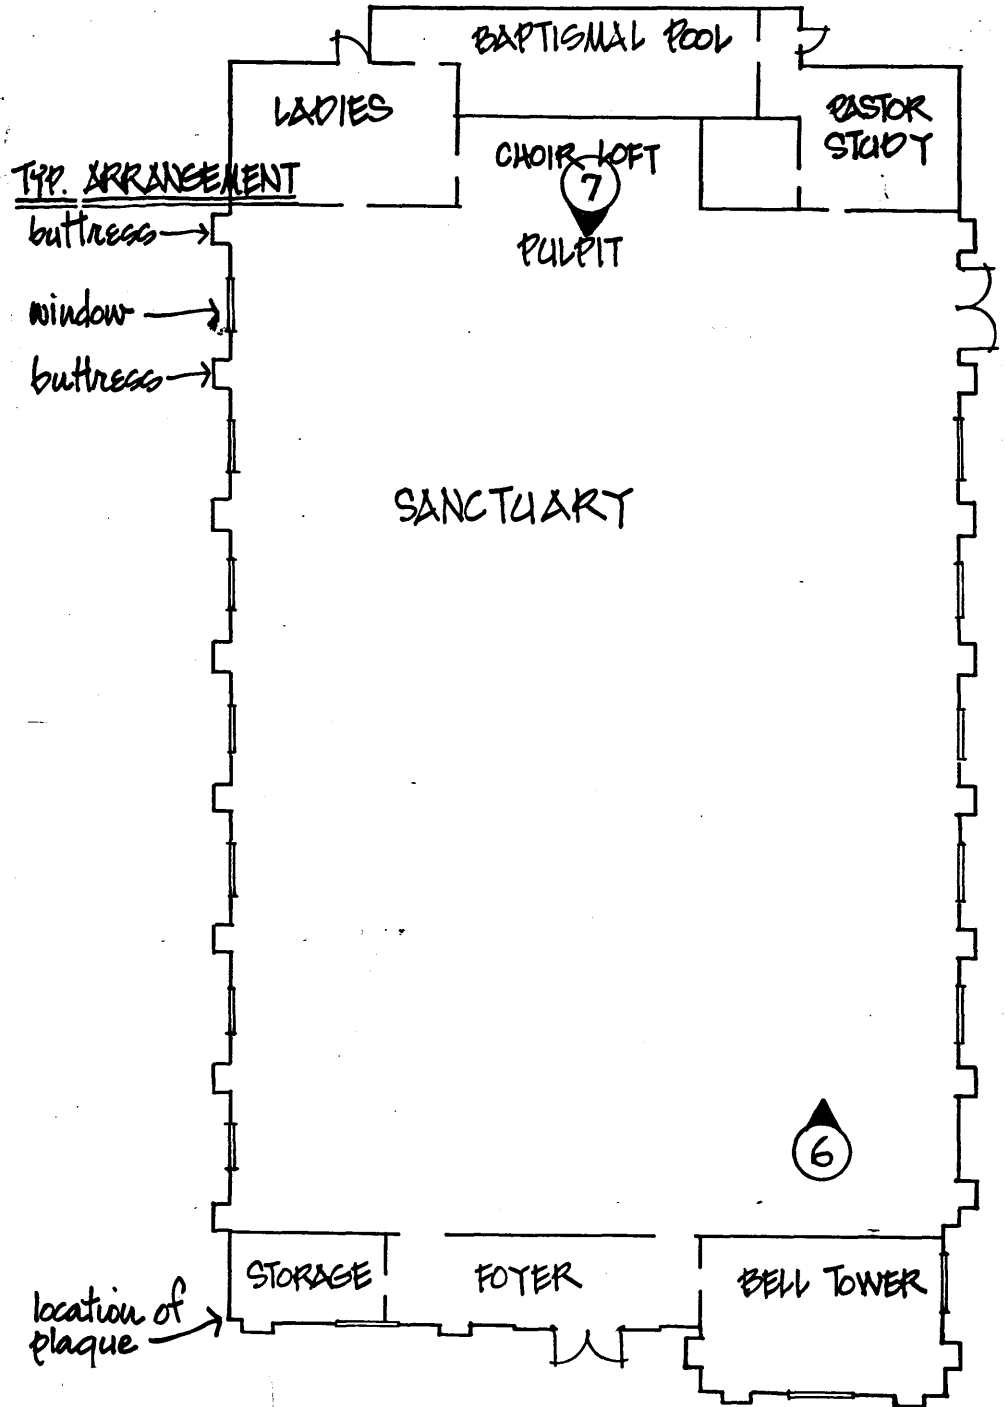
ROME, GEORGIA  
FLOORPLAN

Interior Plan:

Scale: 1 inch = 20 feet

Direction of photograph: (2)

The plan of the historic church consists of the narthex and the sanctuary. The interior of the sanctuary has original wooden pews and stained glass windows, plaster walls with wood paneled wainscoting, a pressed-metal central ceiling, and posts with exposed framing in the nave arcade. The wall behind the pulpit is original. The 1976 renovation of the church consisted of sanding and refinishing the original pews, adding a new HVAC system, sandblasting of the exterior brick, remodeling of the narthex, pastor's study, and ladies room which included the lowering of ceilings, the addition of wood paneling and carpeting. The pulpit area was also remodeled and wall paintings at the rear of the sanctuary and rear of the narthex were added.
