National Register of Historic Places Registration Form

High Street Commercial Block (Boundary Increa	ise)
Name of Property

Butler County, Ohio County and State

Sketch Map and Exterior Photo Key

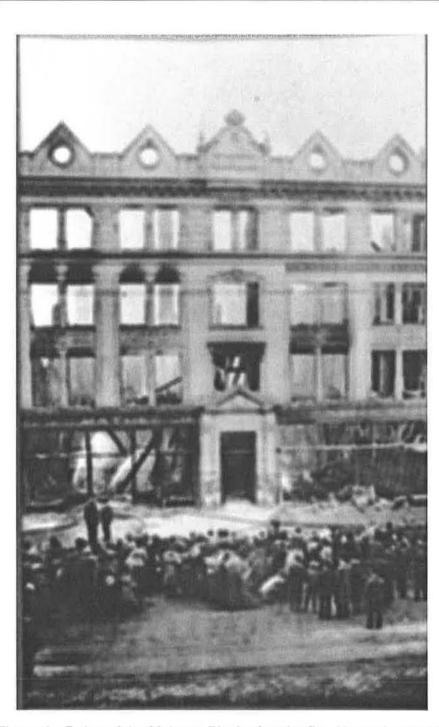
Figure 3: Ruins of the Mehrum Block after the fire, November 1906, Butler County Historical Society

As described above, the boundary increase includes two four-story red brick commercial buildings. The larger and older building, at 220-226 High Street, was historically known as the Mehrum Building. Originally built circa 1900, burned in 1906 and rebuilt in 1907, it is 70 feet and five bays wide by 202 feet and 11 bays deep. The Lindley Building, built between 1906 and 1913 at 216-218 High Street, is 23 feet and one bay wide by 74 feet deep.

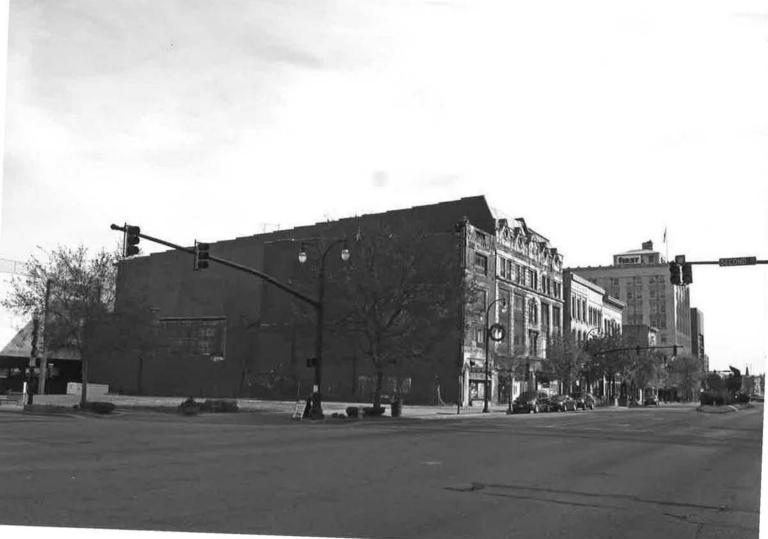
High Street Commercial Potock Forundamy Inculte strauss topp. Stone 1 of 15, Side (west) and Front (south) elevations looking north

- 1 of 15. Side (west) and Front (south) elevations, looking northeast
- 2 of 15. Side (west) and Front (south) elevations, looking northeast
- 3 of 15. Front (south) and side (east) elevations, looking northwest

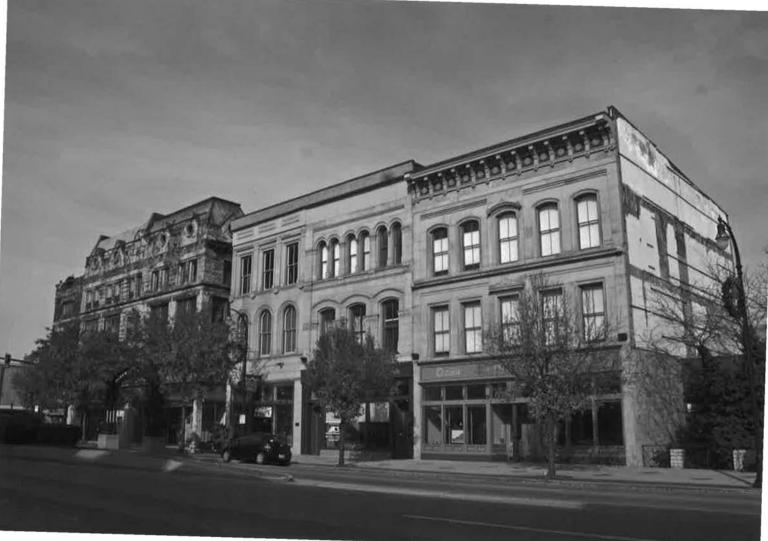
High St Commence Prock Proundary Increase Strauss Dept. Store 3 of 15. Front (south) and side (east) elevations, Hamilton, OH

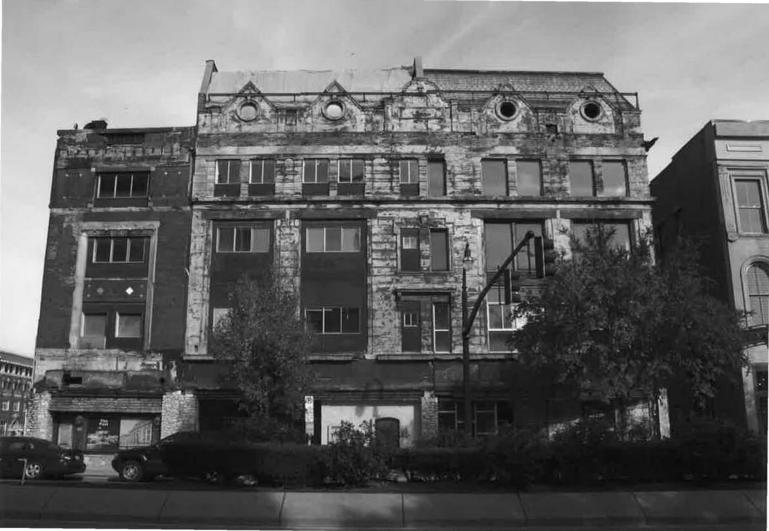
High St Commercial Boock Brundary Increase Straus Dept. Store Hamilton, OH 4 of 15. Front (south) elevation, looking northwest

The Mehrum Building is an excellent example of the French Renaissance Revival style. The storefronts have been completely remodeled but the upper façade is still substantially intact. The exuberant sandstone façade features two-story window bays with large paired window openings at the second and third floors, a rusticated fourth floor with paired one-over-one windows, and a patterned slate mansard roof dramatized by steeply gabled wall dormers with oculus windows. The façade is anchored by the more-solid center bay, which features paired windows with an entablature on the second floor and a keystoned flat arch on the third. The central dormer above has a shaped parapet and displays the date in raised letters, "A.1900 D." The space within the mansard was never occupied, thus the mansard was probably added to draw attention to the building within the streetscape.

The Lindley Building displays an early Commercial-style façade with the typical three-part façade—storefront base, unified two-story mid-section and a distinct top, with a lower frieze-like floor topped by a high parapet. The storefront has been completely remodeled; similar to the Mehrum Building, but most of the masonry façade still exists, with the exception of the cornice. Openings above the storefront are focused in a single bay in the center. The fourth floor is refined by corbelled brick panels flanking the central window. Historically the building was capped by a modillioned cornice (missing) and the parapet was punctuated in the center by a stone plaque with "LINDLEY" spelled out in raised lettering (currently hidden).

- 4 of 15. Front (south elevation, Lindley (on left) and Mehrum (on right) buildings
- 5 of 15. Detail showing date, (1900 A.D.) in gable
- 6 of 15. East elevation, looking northwest along Journal Alley

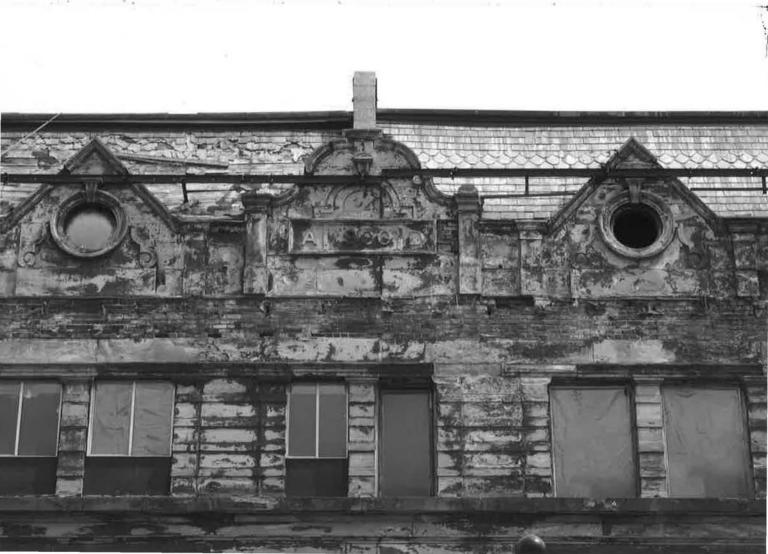
High St Commercial Block toowndary Increase Strairss Dept. Store Harrietton, OH 5 of 15. Detail showing date "1900 A.D." in sable, looking northwest

letters, "A.1900 D." The space within the mansard was never occupied, thus the mansard was probably added to draw attention to the building within the streetscape.

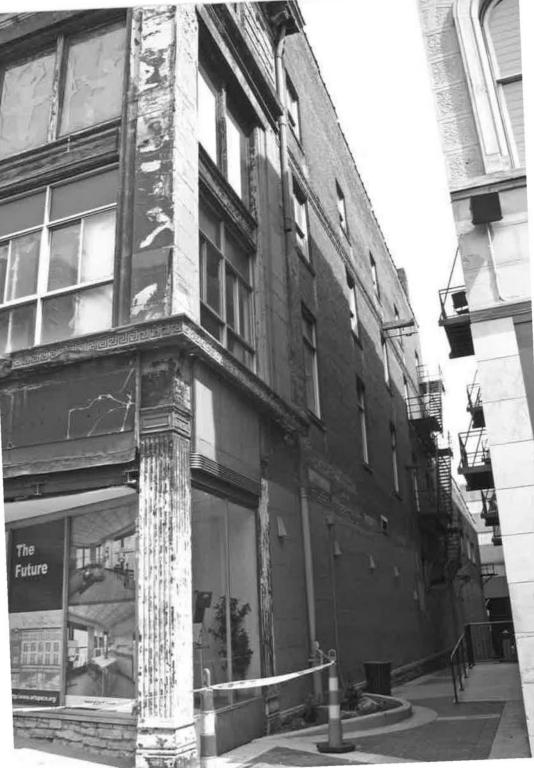
High St. Commercial Black Boundary increase Stramss Dept Store 6 of 15. East elevation, looking west along Hamilton OH

The side elevations of the Mehrum Block are simpler red brick walls; the east wall abuts Journal Alley (photos 8-11), and the west wall, a windowless party wall, is exposed behind the Lindley Building. On the east wall, all openings at the basement and most openings at the first floor on this elevation have been filled in with brick and painted over. Smooth stone lintels remain, marking the location of these former openings. The third and fourth floor openings are intact, with large two-over-two steel windows as well as some replacements.

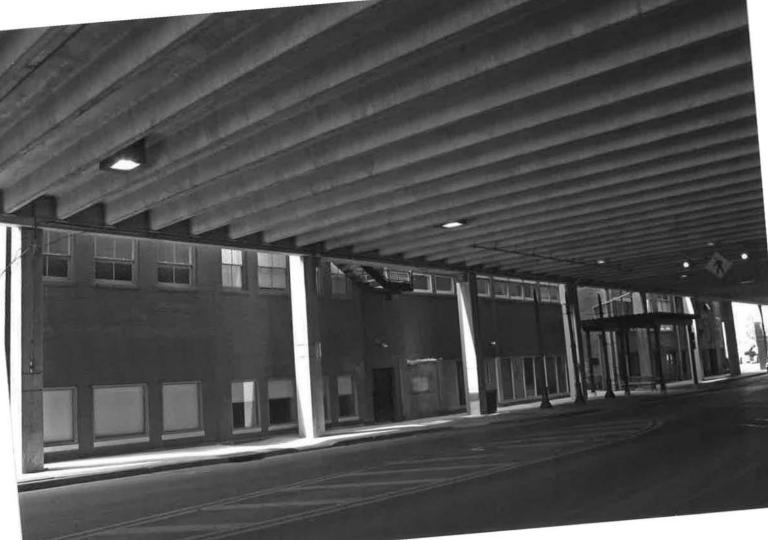
High St commercial Block Boundary Increase Straws bept. Store Hamilton OH 7 of 15, Rear elevations, High St Commercial Brock, looking south

- 7 of 15. Rear elevations, High Street Commercial Block, looking southwest
- 8 of 15. Rear elevation, Mehrum Building
- 9 of 15. Wall sign on west elevation, looking northeast

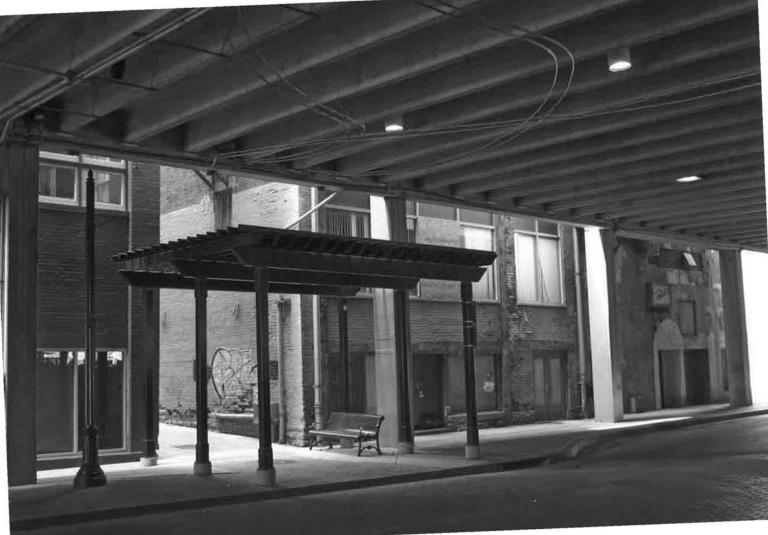
8 of 15, Rear elevation, looking south

On the north, a concrete parking garage extends over Market Street to within 40 inches of the Mehrum Building's rear elevation. The east section of the rear, at 224-226 High Street, has buff face brick and large single-pane aluminum windows with transoms (photo 12). The west section, at the rear of 220-222 High Street, has been refaced with pre-cast concrete panels and stucco, and the openings altered substantially. The basement was most recently occupied by a Mexican restaurant known as "Pedro's." The upper façade has pre-cast concrete panels (photo 13), and a fire escape provides a connection to the parking garage (photos 15-17).

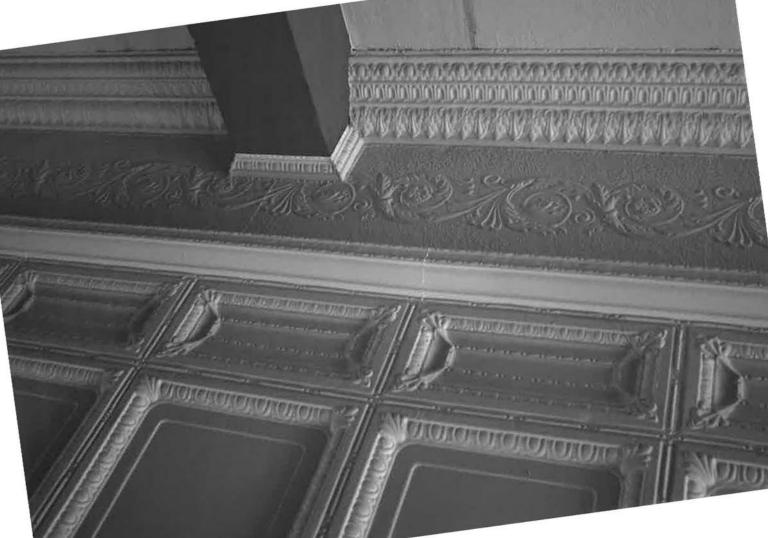
High St Commercial Block Boundary Increase Strauss Pept, Store Hamilton OH 15 of 15. 4th floor, detail of stamped metalceiling and comice molding, looking west

On the interior, both buildings probably had open floor plans. Interior spaces have been subdivided and refinished for conventions and office use with ceramic and wood tile floors, carpet, drywall, and suspended acoustic tile ceilings, except for the third and fourth floors of the 224-226 High Street (photos 22-73). The latter spaces, which are only about 100-feet-deep, were left unoccupied for many years and retain original wood floors, plaster walls, pressed metal ceilings (photos 52-56, 63-64) and two-over-two steel windows (photo 65). In addition, a cast-iron stair with an ornamental metal and wood railing is intact toward the rear of the building (photo 51). There is evidence also of an intact pressed metal ceiling, which appears to be intact above all or most of the suspended ceilings in the Mehrum Building.

- 13 of 15. Fourth floor, looking southeast toward light well
- 14 of 15. Fourth floor, looking southeast
- 15 of 15. Fourth floor, detail of stamped metal ceiling and cornice molding, looking west
