# National Register of Historic Places Registration Form

Historic name: Mount Vernon High School

Other names/site number: Original Mount Vernon High School

Street & number: 8333 Richmond Highway

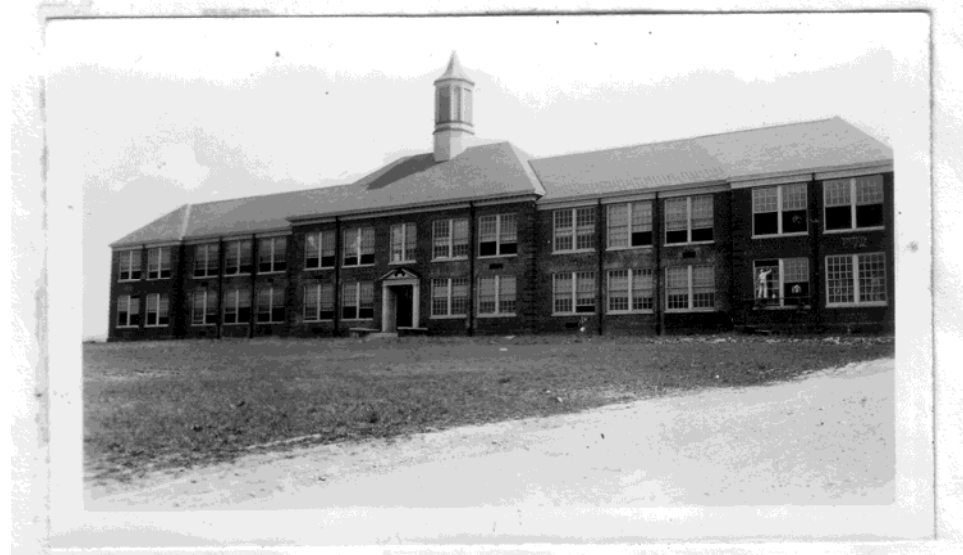
Figure 1. View of the north facade of the main building as viewed from northeast shown in the 1942 Surveyor Yearbook.

The original building is a two-story U-shaped Colonial Revival building constructed in 1939. The original section of the school is 235 foot-long rectangular multi-wythe brick building with two-stretcher brick Flemish bond, brick quoins, and grapevine tooled mortar joints. The original main building was initially constructed to house twelve classrooms, various administrative offices, and a mechanical space. The main entry is centered at the north façade, includes a double door with a twelve-lite transom surrounded by a decorative broken wood pediment with fluted pilasters and dentil details. The front façade is further defined with fifteen bays of large paired twelve-over-twelve double hung wood windows punctuating the facade. The building also features: a concrete foundation; slate hipped roof; white octagonal wood cupola with dentil molding under a copper roof; and spire. The cupola is located at the center of the roof ridge in line with the main entry doors.

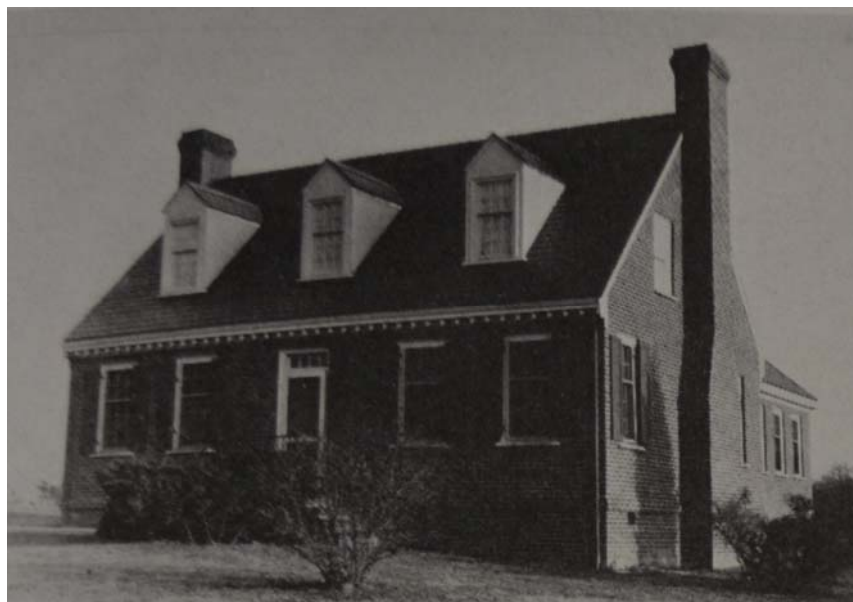
Figure 2. Historic photo from a 1943 yearbook of the original home economics building main facade, north, view from northeast.

The Home Economics Cottage was constructed in 1943 to the west of the main building. Designed with a Colonial Revival influence, the Home Economics Cottage was one of the first additions to the campus as part of the original PWA funding request. The original building was T-shaped with the main entry centered on the 3-bay wide north facade. The building is approximately 42 feet long extending southward.

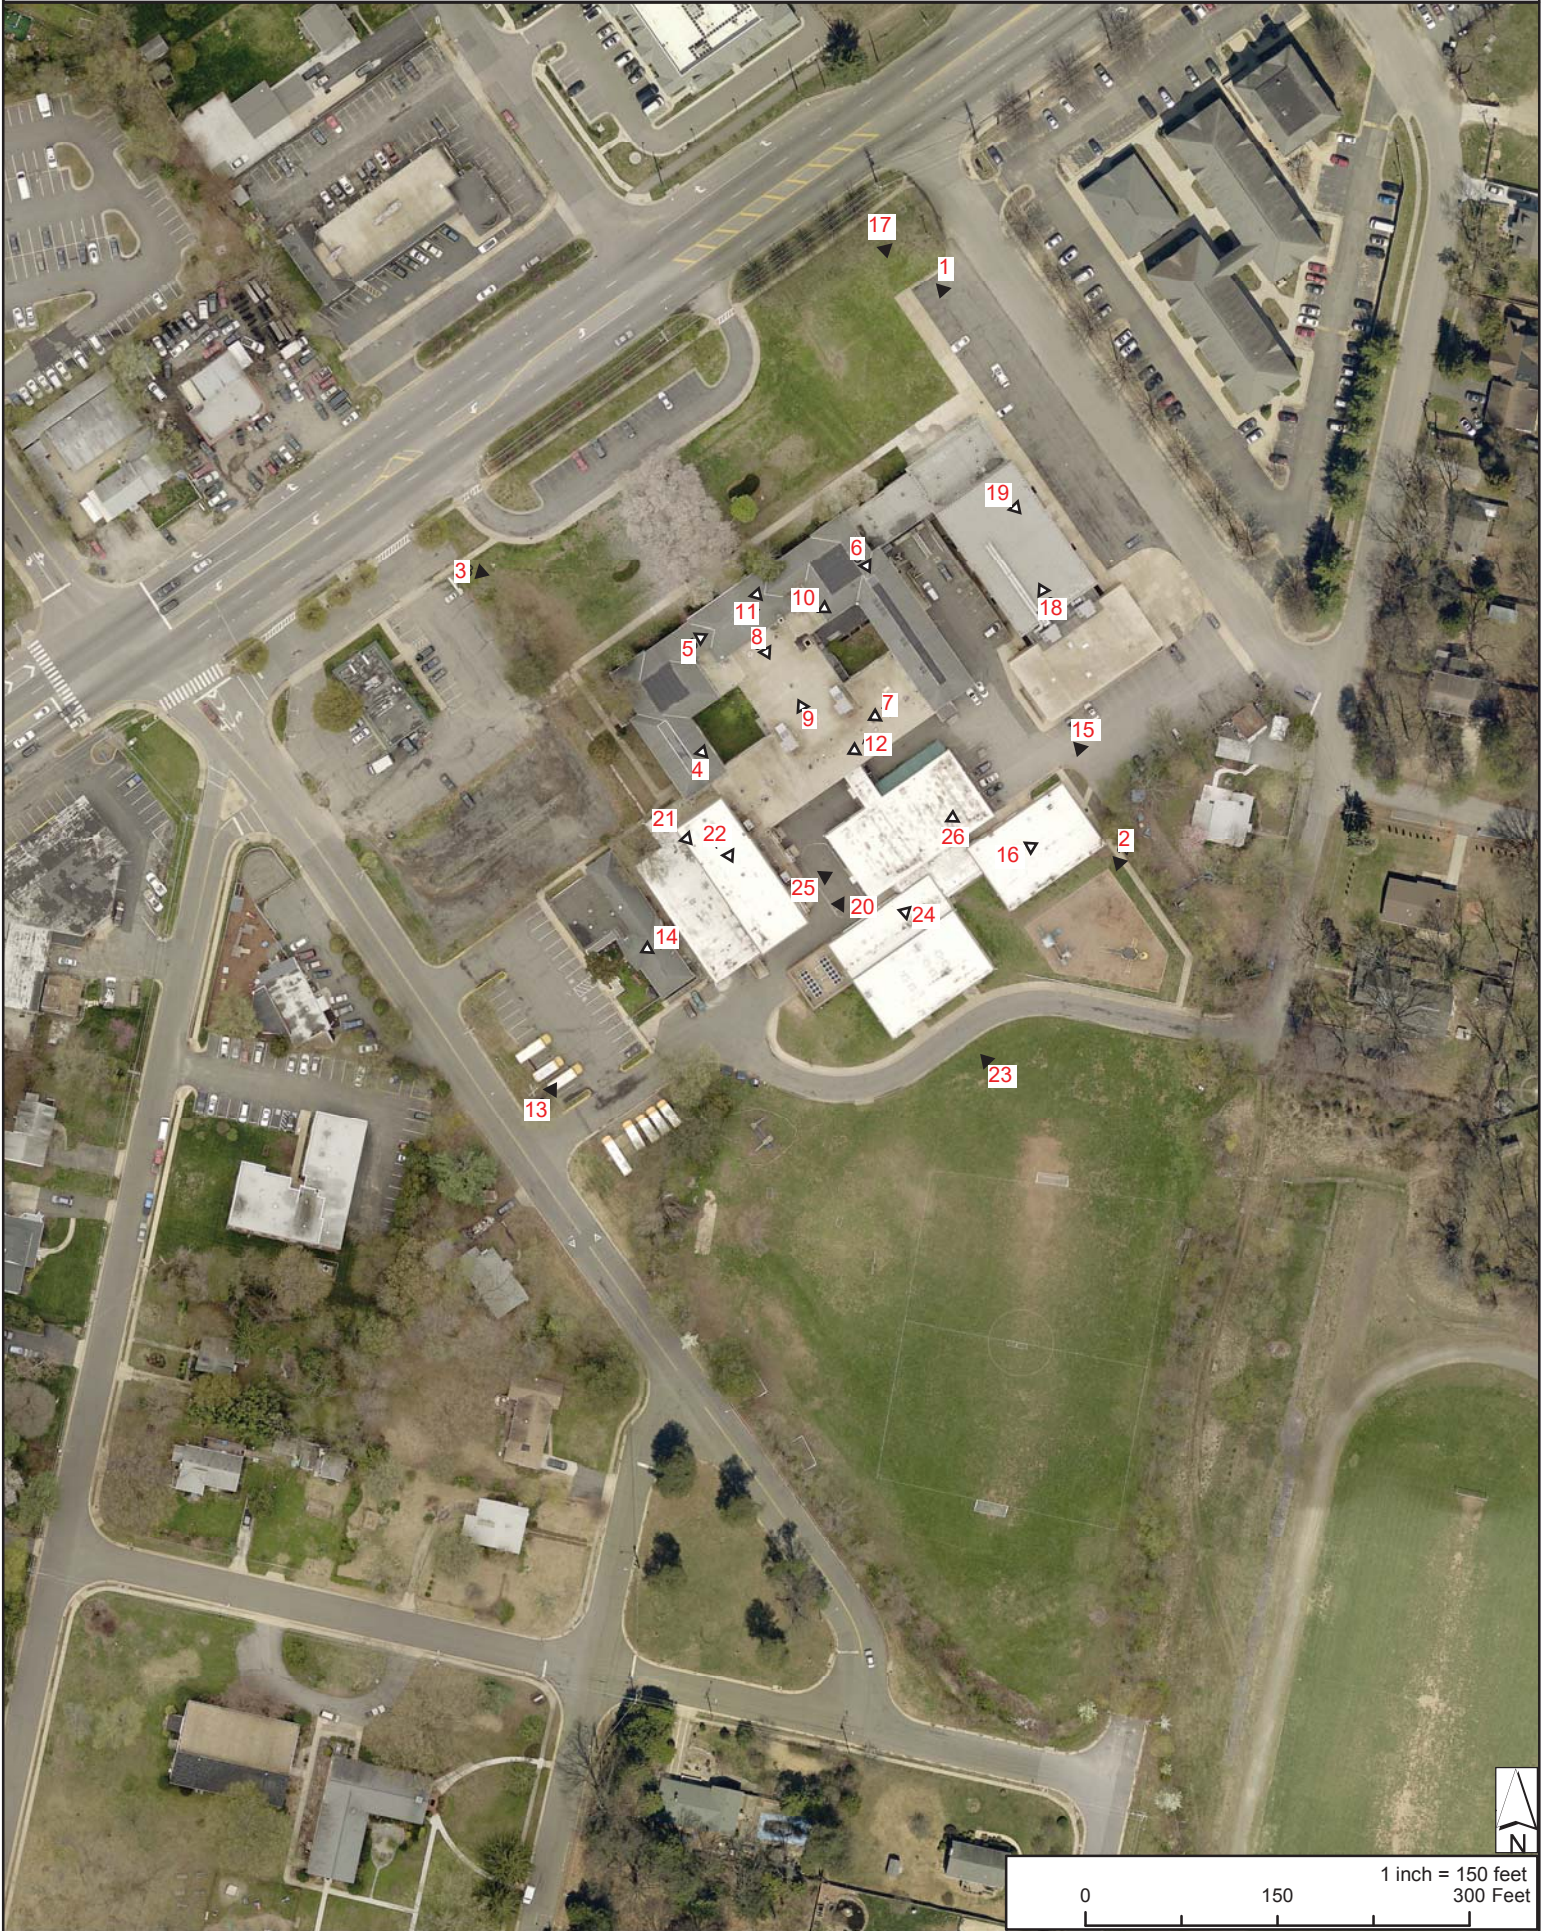
FLOOR PLAN - Original Drawings with 1988 Renovation Plan  
 Original Mount Vernon High School  
 Fairfax County, VA  
 DHR #029-0230  
 (Dark lines depict Original Walls; Light Lines depict New Interior Walls)
