National Register of Historic Places Registration Form

historic name Poland Spring Historic District

POLAND SPRING HISTORIC DISTRICT

The Poland Spring Historic District is a nineteenth- and twentieth-century commercial resort and spring water extraction facility located on approximately 236 discontinuous acres in the Androscoggin County town of Poland, Maine. The district includes cottages and inns, an exhibition hall, chapel, recreational buildings and sites, a designed landscape and two cemeteries, support structures, and a water bottling plant and springhouse.¹ Of the thirty-nine resources within the district, thirty contribute to the areas and period of significance. Twenty-five of these resources are new; five have already been listed in the National Register. Most of the district, both in terms of acreage and number of resources, is located on Ricker Hill (elevation 800') overlooking Lower Range Pond to the north. All but one of the buildings are on the east side of Route 26, as is the golf course which dominates the center of the hillside site. With few exceptions, the contributing resources are generally located on two interior roads; Ricker Road, a U-shaped road that be

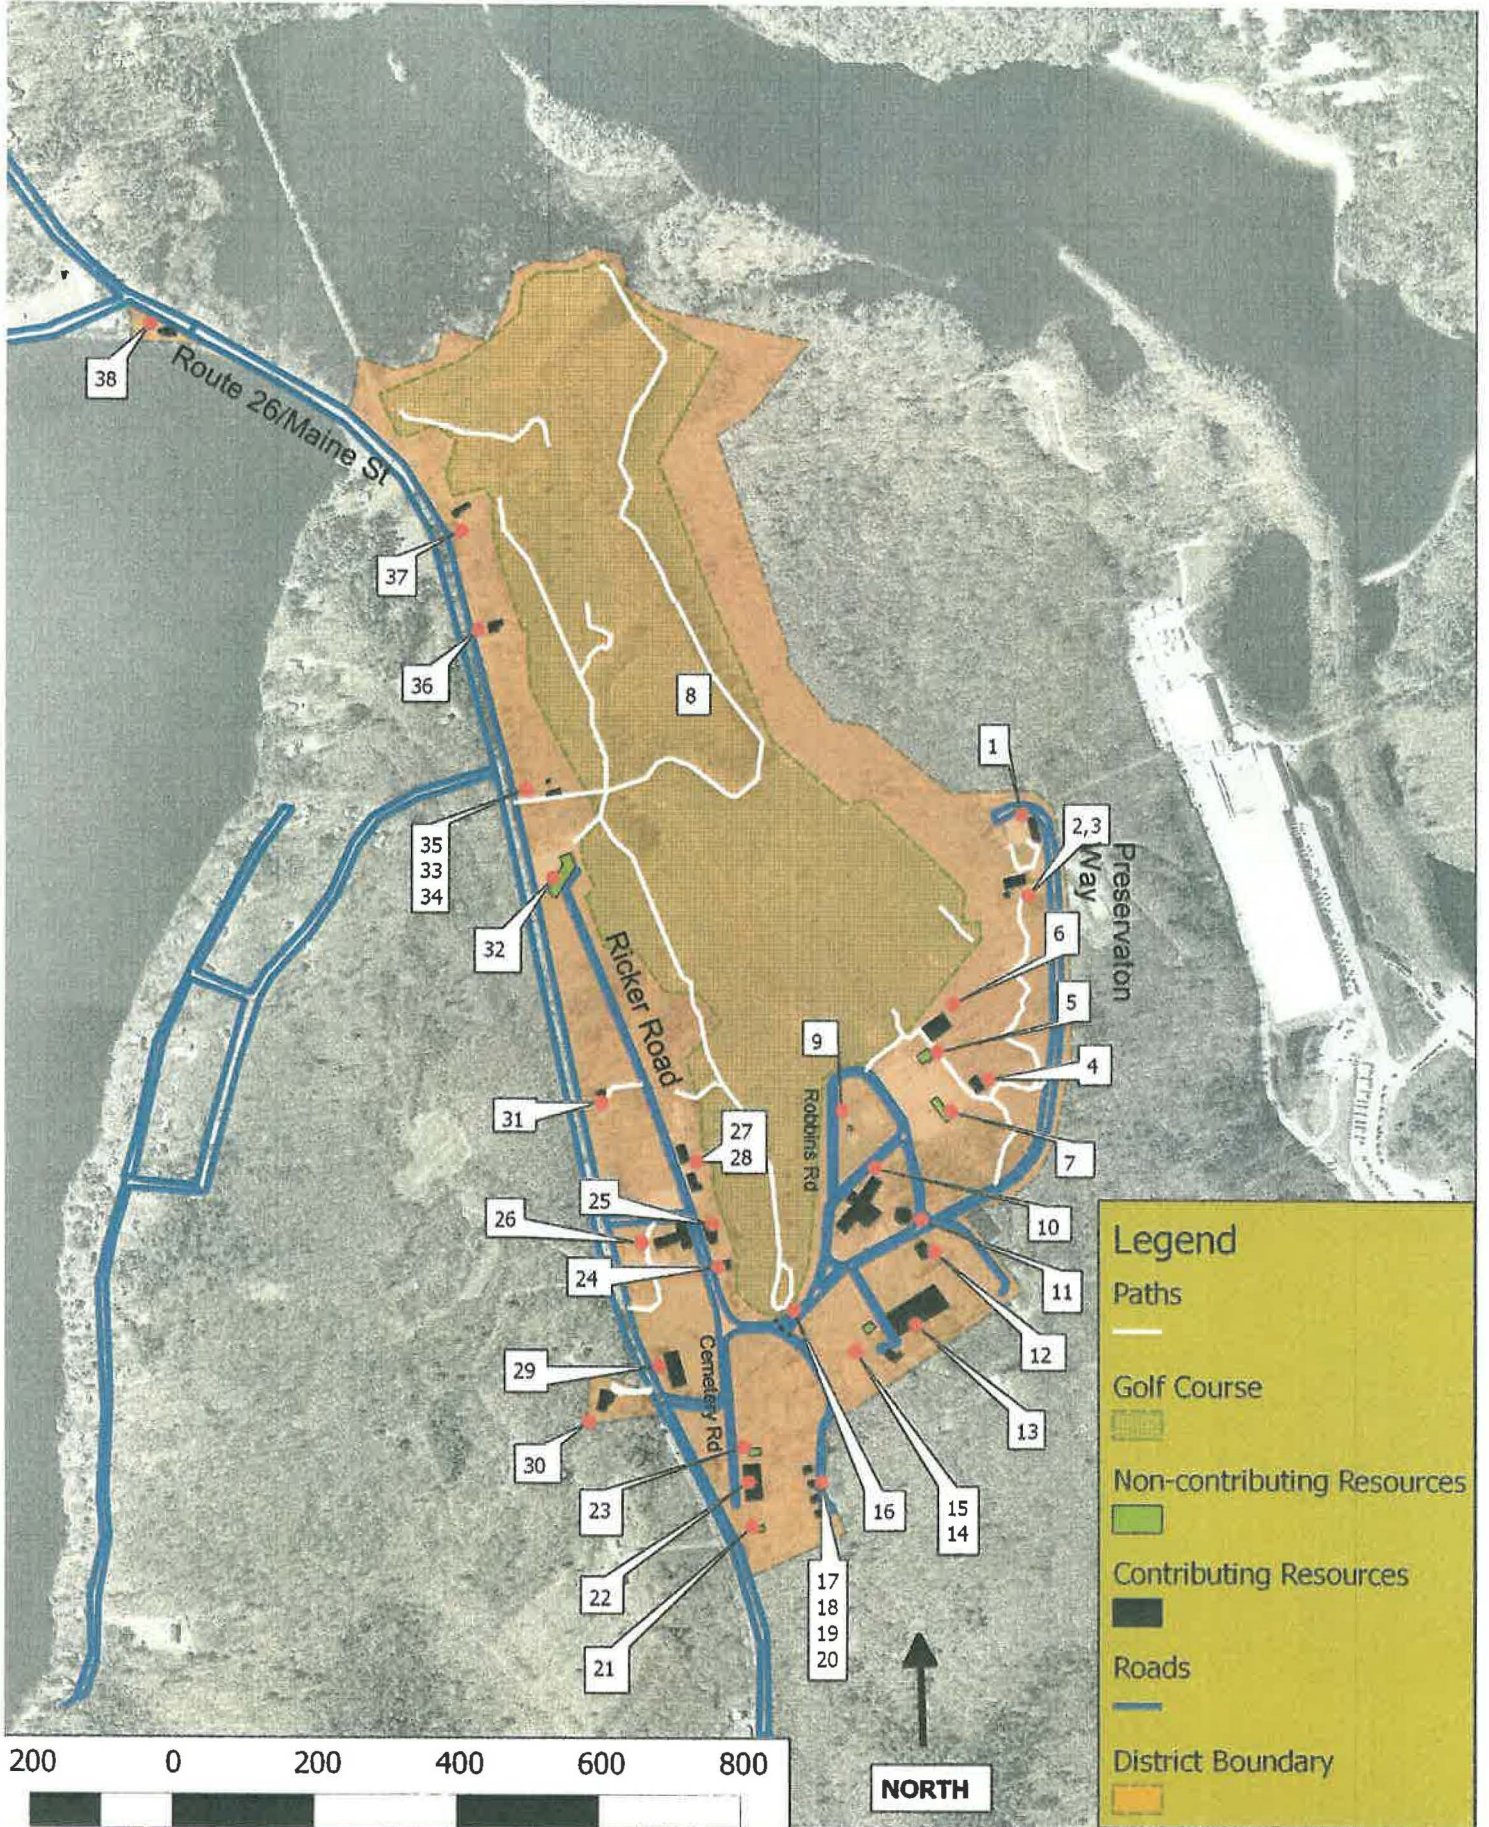
**POLAND SPRING HISTORIC DISTRICT
RESOURCE MAP**

Overall Site Description:
(See *Poland Spring Historic District Resource Map* for location of each resource).

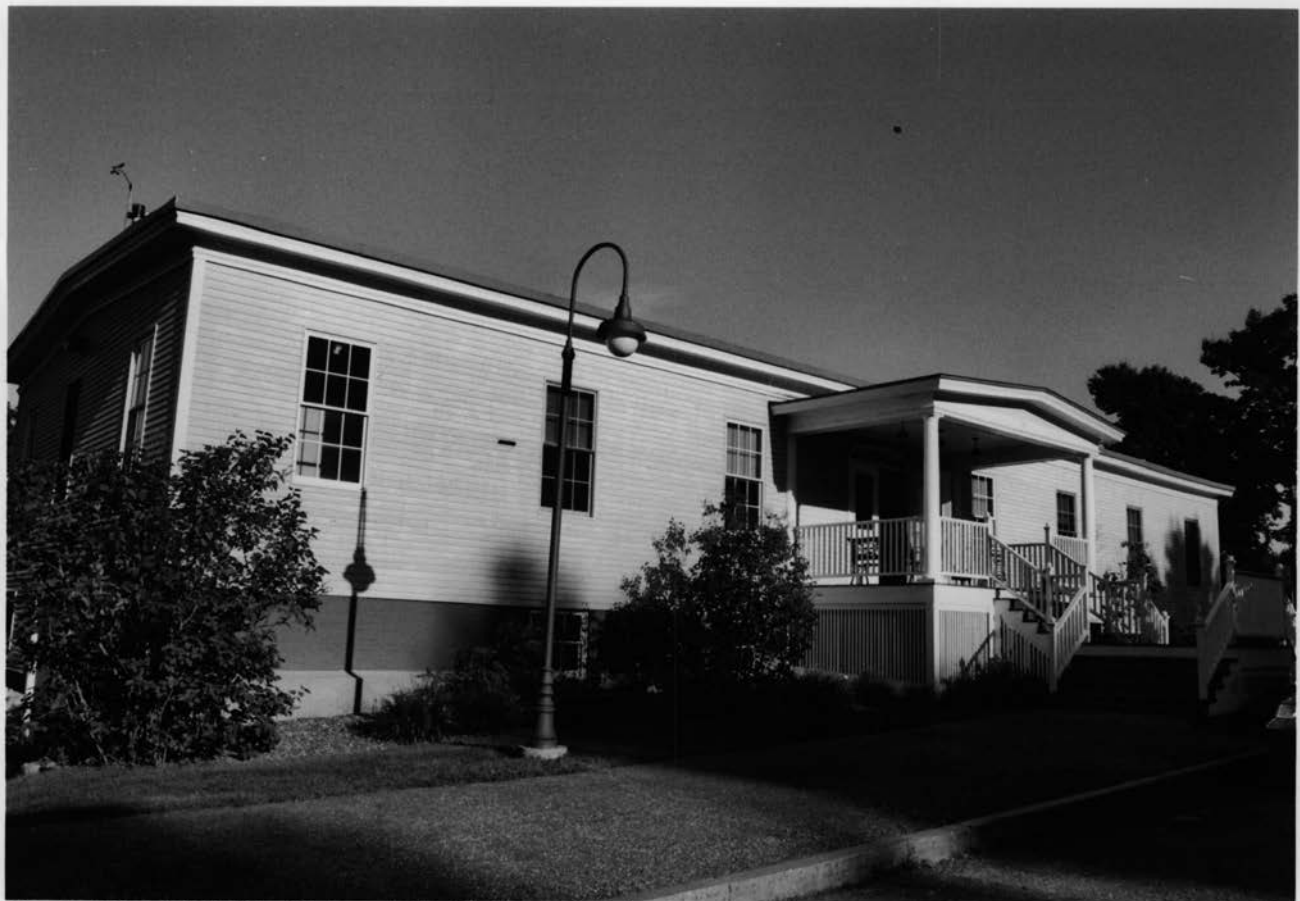
POLAND SPRING H.D.; ANDROSCOGGIN CO., ME

1. **General Storehouse, 1905.** 123 Preservation Way. Contributing building
Known as Nettie Ricker Conference Center since 2002.
(Photo # 1)

The is a single-story, shallow-pitched, side gabled building with an asphalt roof. Its exterior walls have been covered with synthetic siding and all of its windows have been replaced with six-over-six vinyl windows. A new vinyl door with a shallow fanlight is in its façade and a raised entrance porch has been added at this entry. The entry porch has a shallow peaked roof supported by two wooden columns. Eight-bays long and three bays deep, it has minimal Classical Revival accents seen in the pediment, frieze and Doric pilasters on the porch as well as the fan light over the entrance. A simple wooden balustrade surrounds the concrete porch floor, which is accessed by concrete steps that are flanked by wooden balustrades. A slat wooden skirt surrounds the raised porch. Another raised porch is located at the building's north elevation, which is similar in design to the façade porch. The assumed balloon framed building sits on a raised brick foundation.

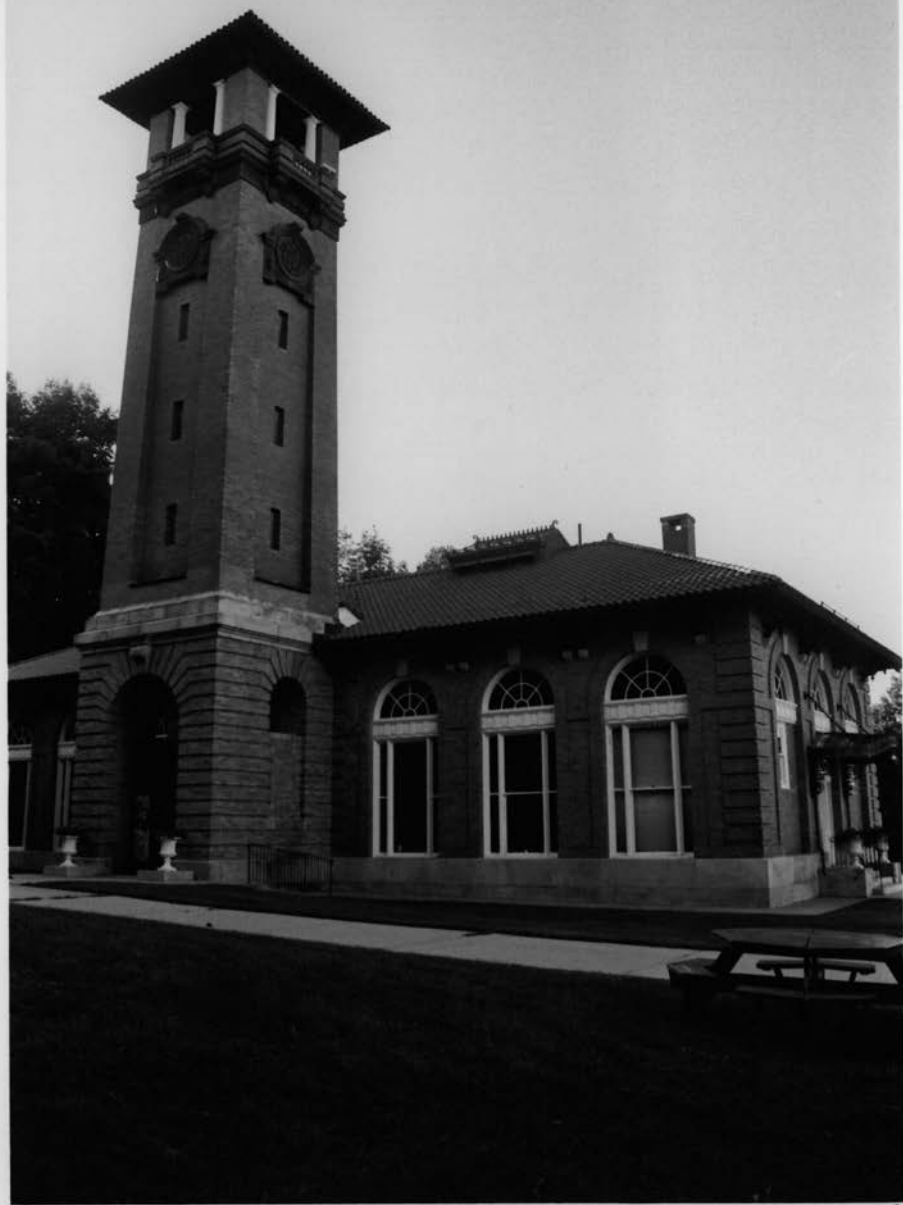
FOLAND SPRING H.D. ; ANDROSCOGGIN CO., ME 20F38

2. **Bottling Plant, 1907.** 115 Preservation Way. Contributing building
 Harry C. Wilkinson, Washington, DC, Architect
Listed in the National Register with the Poland Spring Spring House in 1984.
(Photos # 2, 4)

The Poland Spring Bottling Plant is a Renaissance Revival style building constructed of light tan brick with a green tile roof and a granite foundation. It is rectangular in shape with round arched windows and a hipped roof with over-hanging eaves supported on brackets. Its main decorative feature is a tall tower located in the center of its southeast façade. The base, which is rusticated brick, contains a round arched entrance. The shaft of the tower is unornamented except for decorative metal medallions which adorn all four sides. In the top of the tower are openings in each elevation which contain Tuscan columns in antis. A hipped roof with wide overhanging eaves tops the tower. A secondary entrance, located on the northeast side of the building, has an ornate copper marquee hanging over the door.

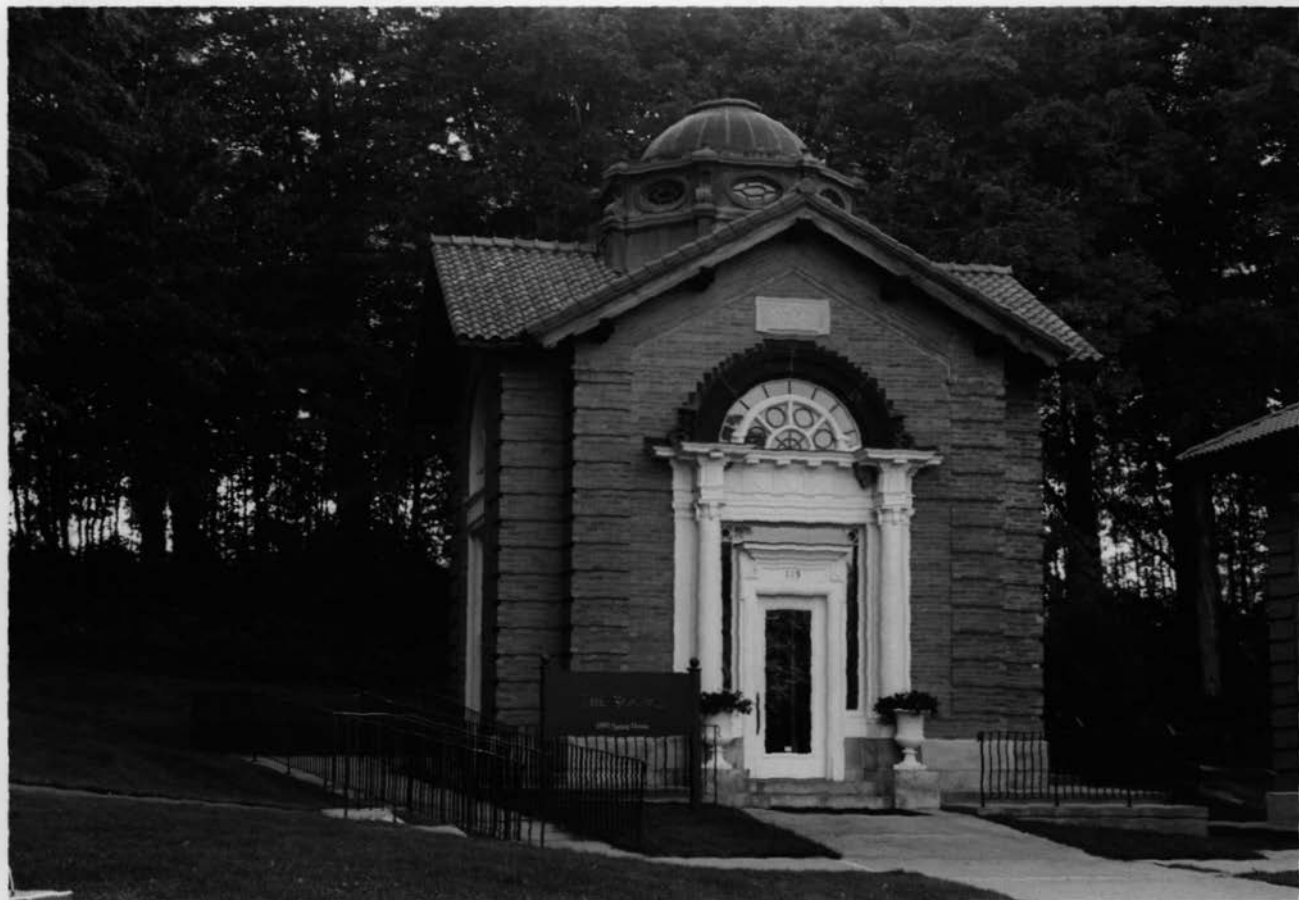
30F38

- 3. Spring House, 1907.** 115 Preservation Way. Contributing building
 Harry C. Wilkinson, Washington, DC, Architect
Listed in the National Register with the Poland Spring Bottling Plant in 1984.
(Photos # 3,4)

The Poland Spring Spring House is a Renaissance Revival building constructed of light tan brick with a green tile roof and a granite foundation. Designed in the form of a compact Greek Cross, the Spring House has rusticated walls identical to the base of the tower on the Bottling Plant. On the roof is a round dome. Located at the intersection of the four gable ends, the dome is made entirely of copper. Its base has oval windows alternating with scroll-shaped brackets.

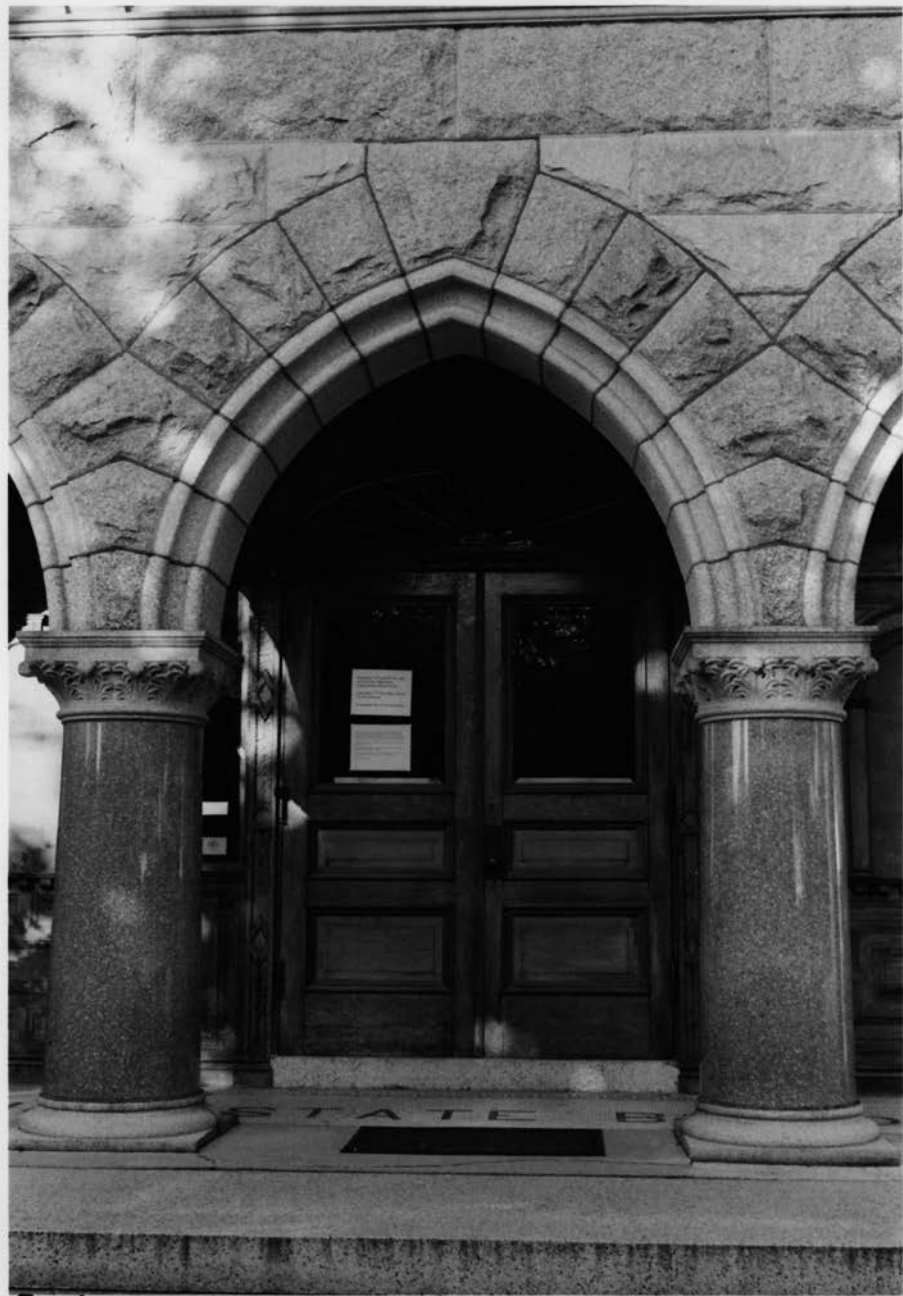
POLAND SPRING H.D.; ANDROSCOGGIN CO., ME 11 of 38

11. **Maine State Building, 1893.** Southeast corner of Preservation Way and Robbins Way. Contributing building
Charles S. Frost, Chicago, Architect
*Listed in the National Register in 1973.
Built in Chicago in 1893 and relocated to the Poland Spring Resort Grounds in 1895.
(Photos # 10, 11, 13)*

in the Queen Anne style. It has a gray granite foundation and first story which are executed in rough stone. Like the other materials in the structure, the granite is native to Maine. It came from several quarries and was treated in different ways to exhibit how it could be dressed. The first story façade is approached by a short, broad, finished-granite stairway. Across the front is a series of three pointed arches supported by two freestanding columns in the center and a semi-detached column at either side. The columns have heavy granite bases, polished pink granite shafts, and ornamentally carved gray granite capitals. Beyond the arched colonnade is an open loggia. The wall behind the loggia is divided into five bays, all of which display richly paneled wood. The central bay has a double entrance door with sidelights. On either side is an arched plaque relating the building's history and at either end is a window framed in paneling.

The third story is contained within the large slate-covered octagonal roof. A dormer window is found on the front, side, and rear sections of the roof, while the corner sections contain large glass skylights. At the peak of the roof is a small wooden octagonal tower supported by brackets and open on all sides. Its slate-covered octagonal roof ends in a peak with a flagpole.
