National Register of Historic Places Registration Form

historic name Tucson Veterans Administration Hospital Historic District

other names/site number Southern Arizona Veterans Affairs Health Care System, Tucson, Arizona / 128

street & number 3601 South Sixth Avenue

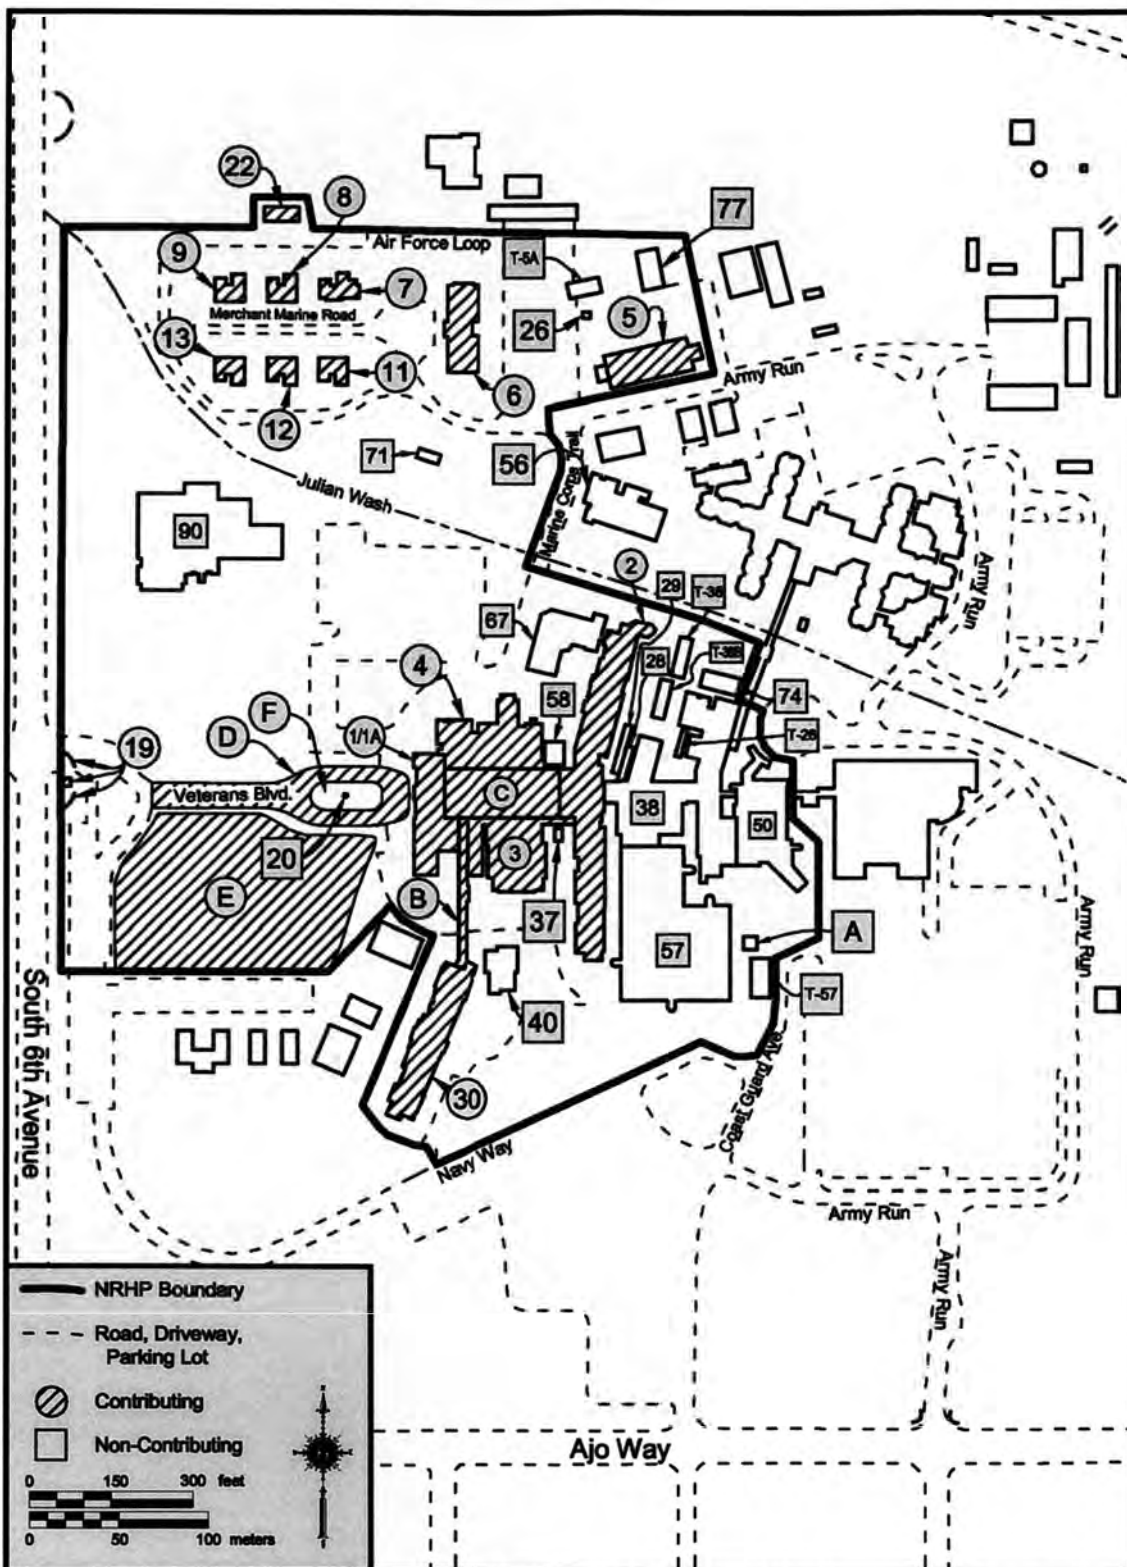
Sketch map indicating National Register boundary, contributing and noncontributing resources.

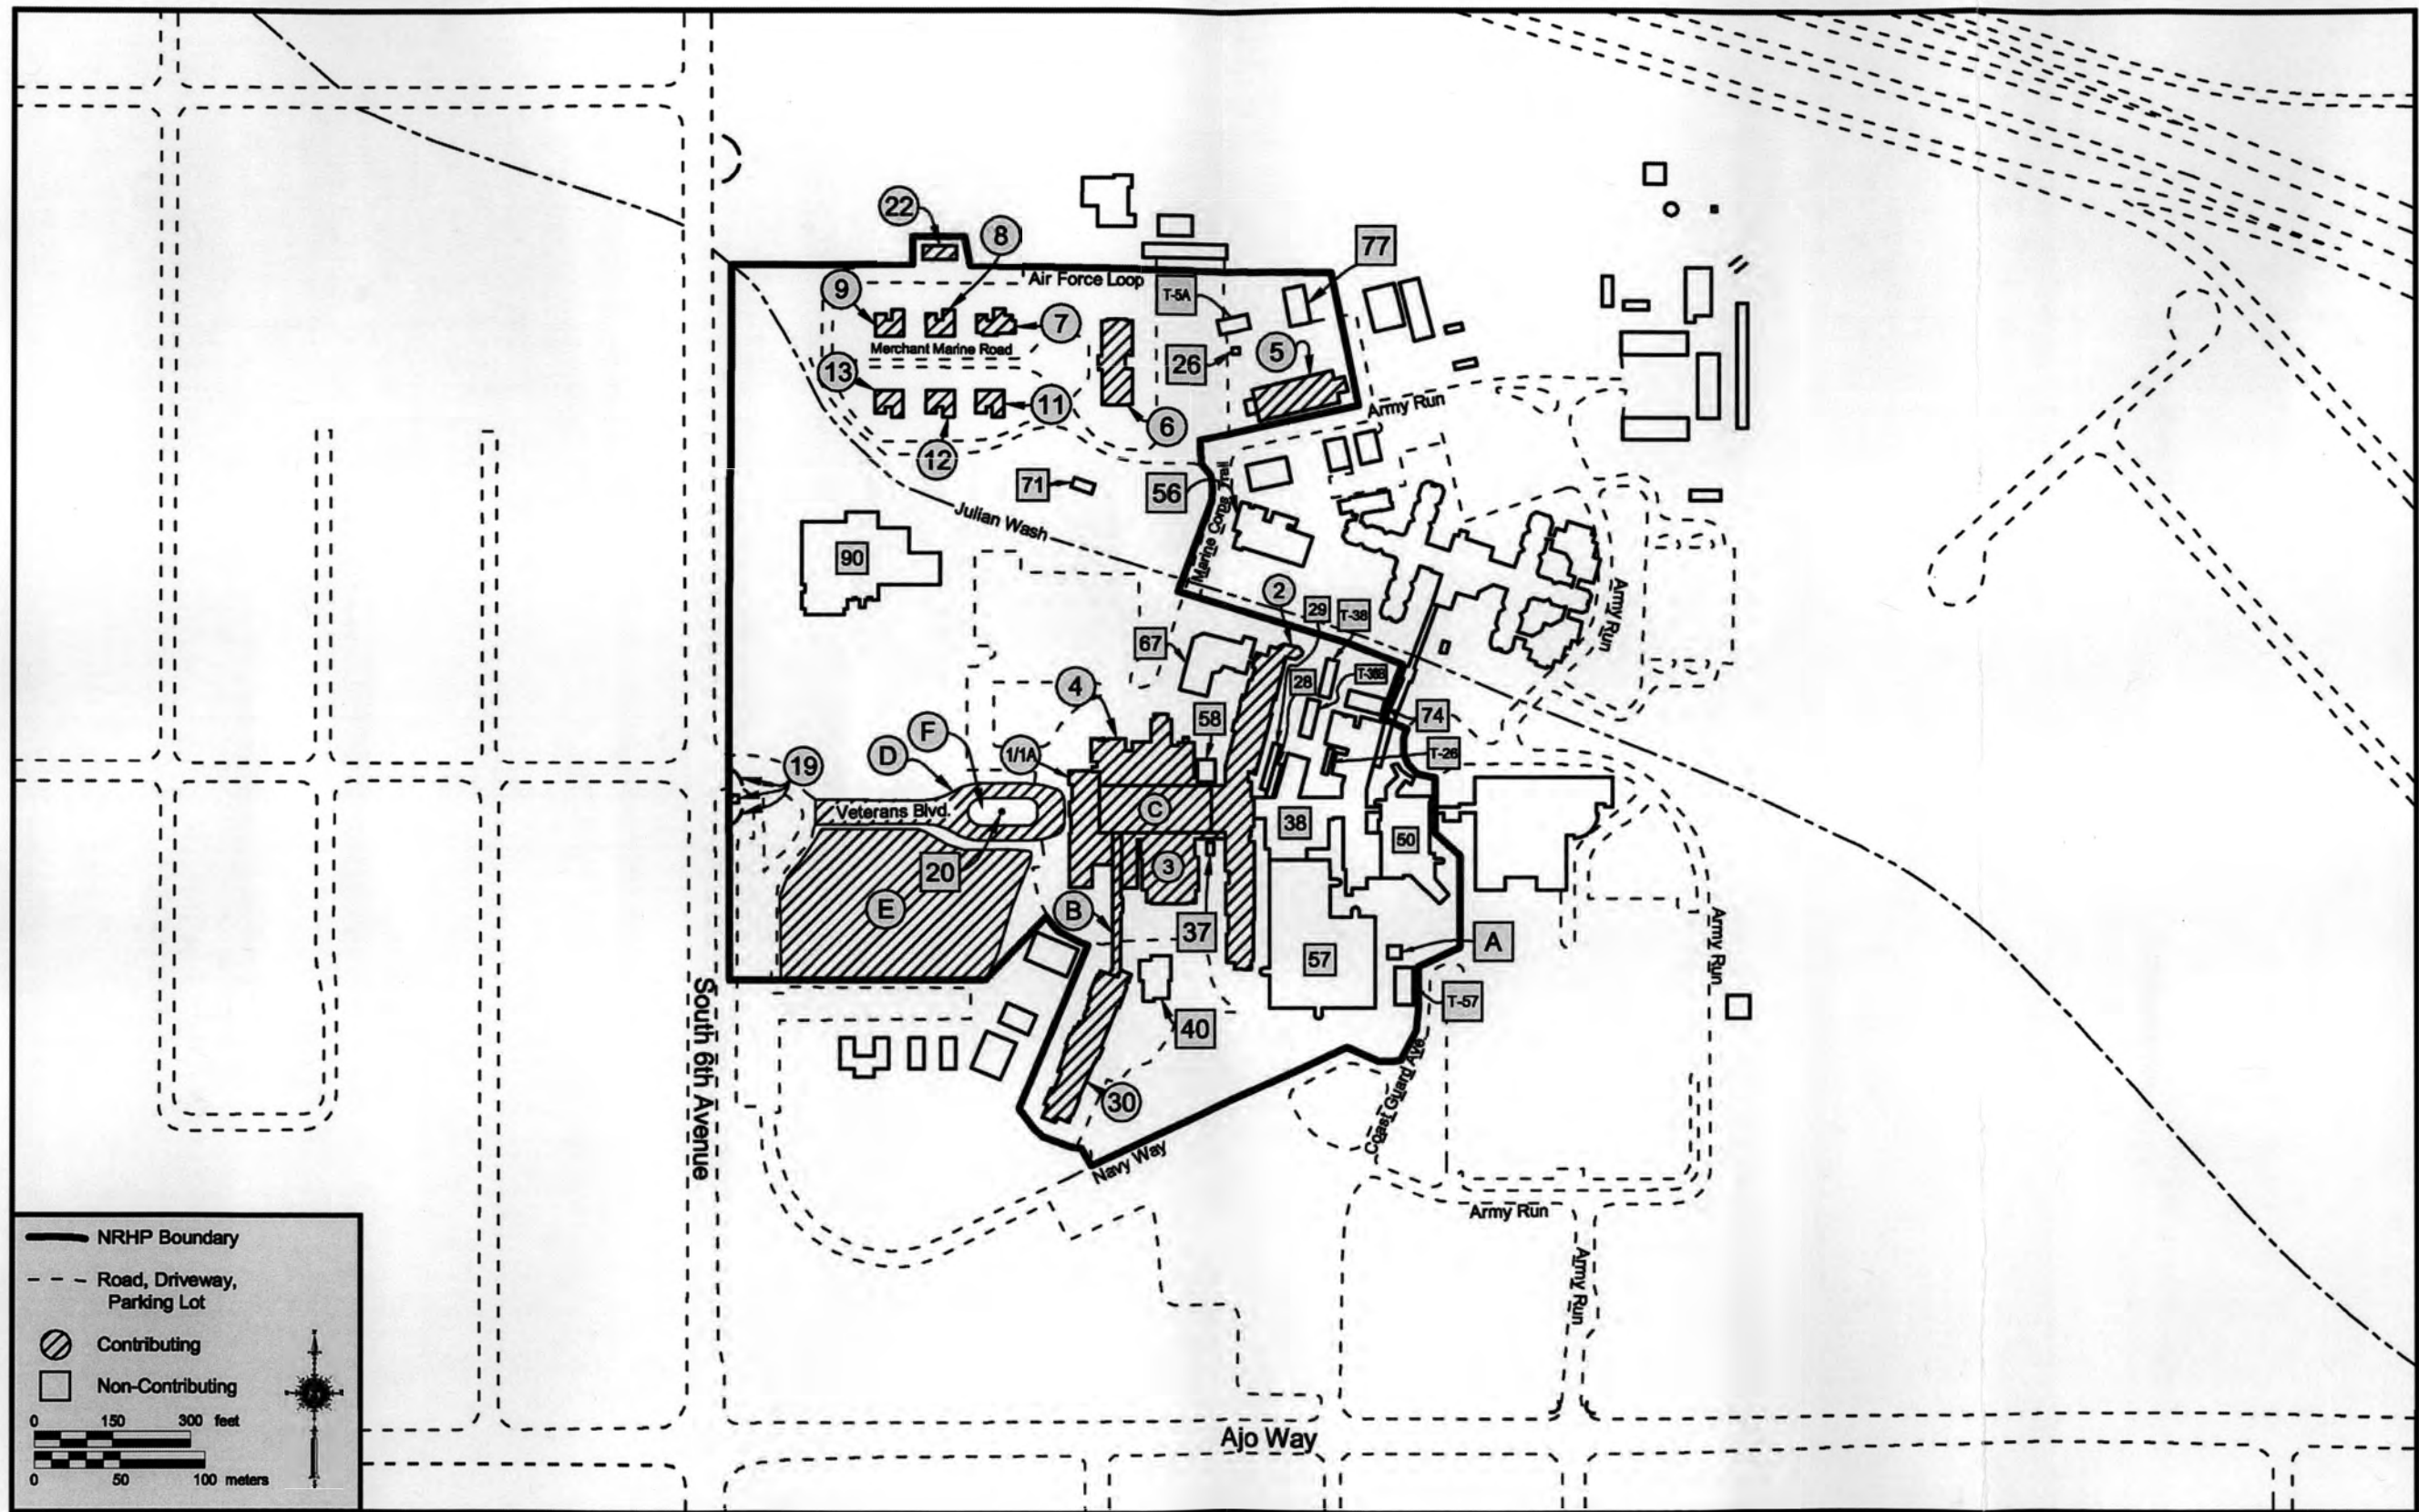
Sketch map indicating National Register boundary, contributing and noncontributing resources (oversize).
