# KENTUCKY HISTORIC RESOURCES Individual Inventory Form

Resource SHELBY	ŧ	SH	247
	_		County

SH 247

Continuation Sheet SH 247
S.D. Glass house

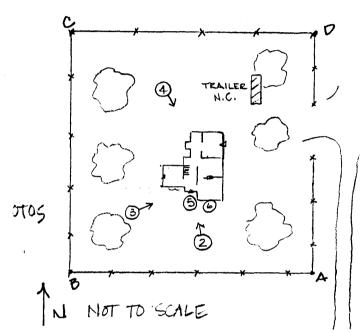
44. Site Plan (and boundary description and justification for N.R. sites):

THE PROPERTY BEING NOMINATED CONTAINS LESS THAN ONE ACRE AND IS THE YARD AREA IMMEDIATELY SURROUNDING THE FARM THERE ARE THREE BARNS, A RESIDENCE. SILO AND SEVERAL OTHER OUTBUILDINGS ASSOCIATED WITH THE FARM TO THE NORTH-EAST BUT THEY ARE NOT INCLUDED WITHIN THE BOUNDARIES BECAUSE OF LOSS OF IN-TEGRITY OR RECENT CONSTRUCTION DATES. THE DIMENSIONS OF THE PROPERTY MEASURE ROUGHLY 200' FEET SQUARE, CENTERED ON THE HOUSE AND DELINEATED ON THE SOUTH AND WEST BY A BOARD FENCE. A MOBILE HOME LOCATED WITHIN THE YARD AREA IS CONSIDERED IMPERMANENT AND THEREFORE, NOT COUNTED IN THE PROPERTY.

The southeast corner, point A, is located 75' SE of the SE corner of the house, and 100' south of the drive.
