KENTUCKY HISTORIC RESOURCES
Individual Inventory Form

Resource # 64
Shelby County

1. Name of Resource:
White House

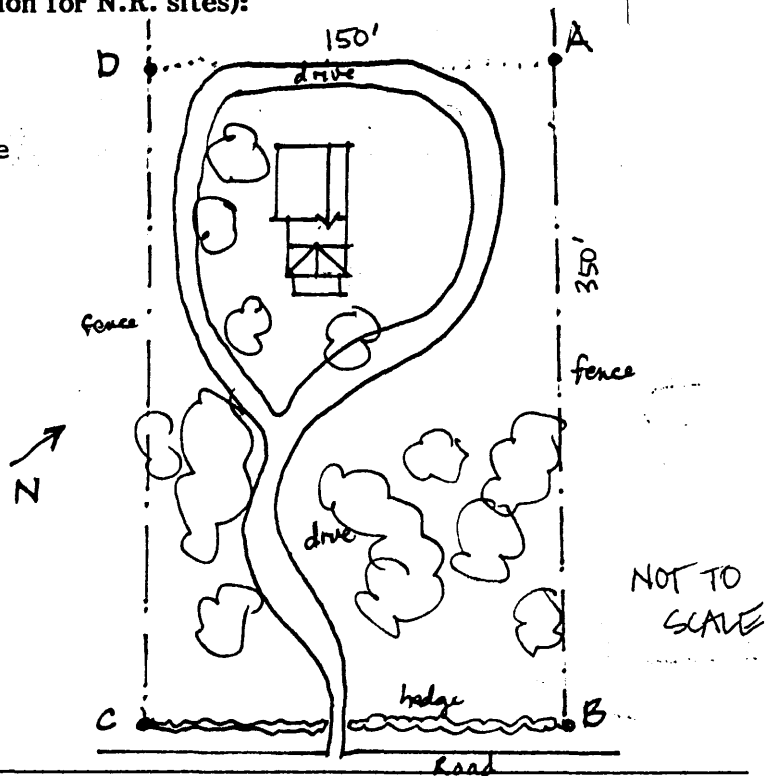
44. Site Plan (and boundary description and justification for N.R. sites):

Beginning at A, at the fence, E along the fence 350' to B, S 150' along a hedgerow bordering the Cropper Rd. to C, W 350' along a fence to D, N 150' in a line along the drive and continuing to point of origin. The boundaries were chosen to encompass the house and domestic space enclosed by fences, shrubbery and the drive, with fields to the N, W and S.

Point A is 82 feet north of the northern corner of the house.

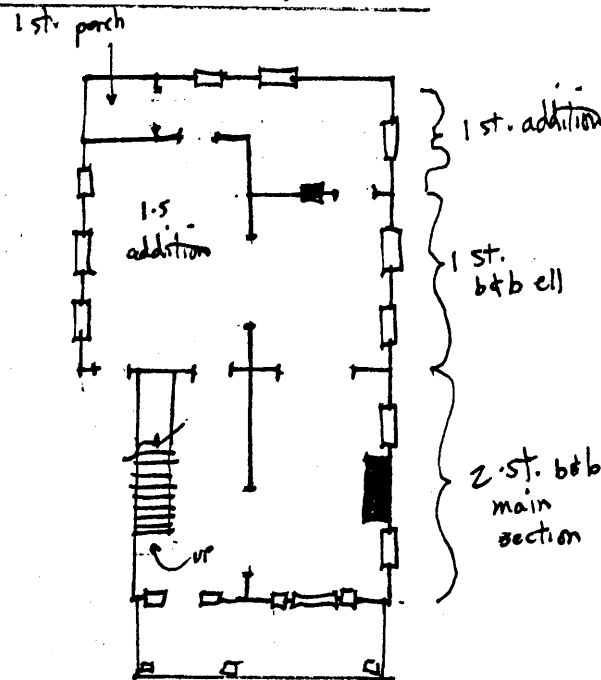
45. Description and House Plan:

1 1/2-story, 2-bay side-passage plan house of frame construction with brick nogging and clad in board and batten siding on the front and sides and in weatherboard on the rear and ell addition enclosed porch on west side of ell cross-gable roof with overhanging eaves, and bargeboards molded corners with consoles over windows on board and batten portions, 1-story, flat-roofed porch has bargeboard, corner with consoles over door, sidelights and transom, window altered on first floor front, coursed stone foundation under original portion, one-room one-story ell with addition on rear, interior brick end chimney.

Side-passage plan with stairs along west wall, most earred woodwork intact, mantel removed in ell, replaced in parlor, archway from ell into parlor and parlor into passage later with no trim.
