Louisiana State Capitol, 1849-1932, Baton Rouge, Louisiana

NATIONAL REGISTER OF HISTORIC PLACES
PROPERTY PHOTOGRAPH FORM

1. NAME COMMON		AND/OR HISTORIC	NUMERIC CODE (Assigned by NPS)
Old Louisiana State Capitol		State House	JAN 12 1973
2. LOCATION STATE		COUNTY	TOWN
Louisiana		East Baton Rouge	Baton Rouge
STREET AND NUMBER			
North Boulevard and St. Philip Street			
3. PHOTO REFERENCE PHOTO CREDIT		DATE	NEGATIVE FILED AT
Grady Smart		Unknown	La. Historical Preservation and Cultural Commission, Baton Rouge
4. IDENTIFICATION DESCRIBE VIEW, DIRECTION, ETC.

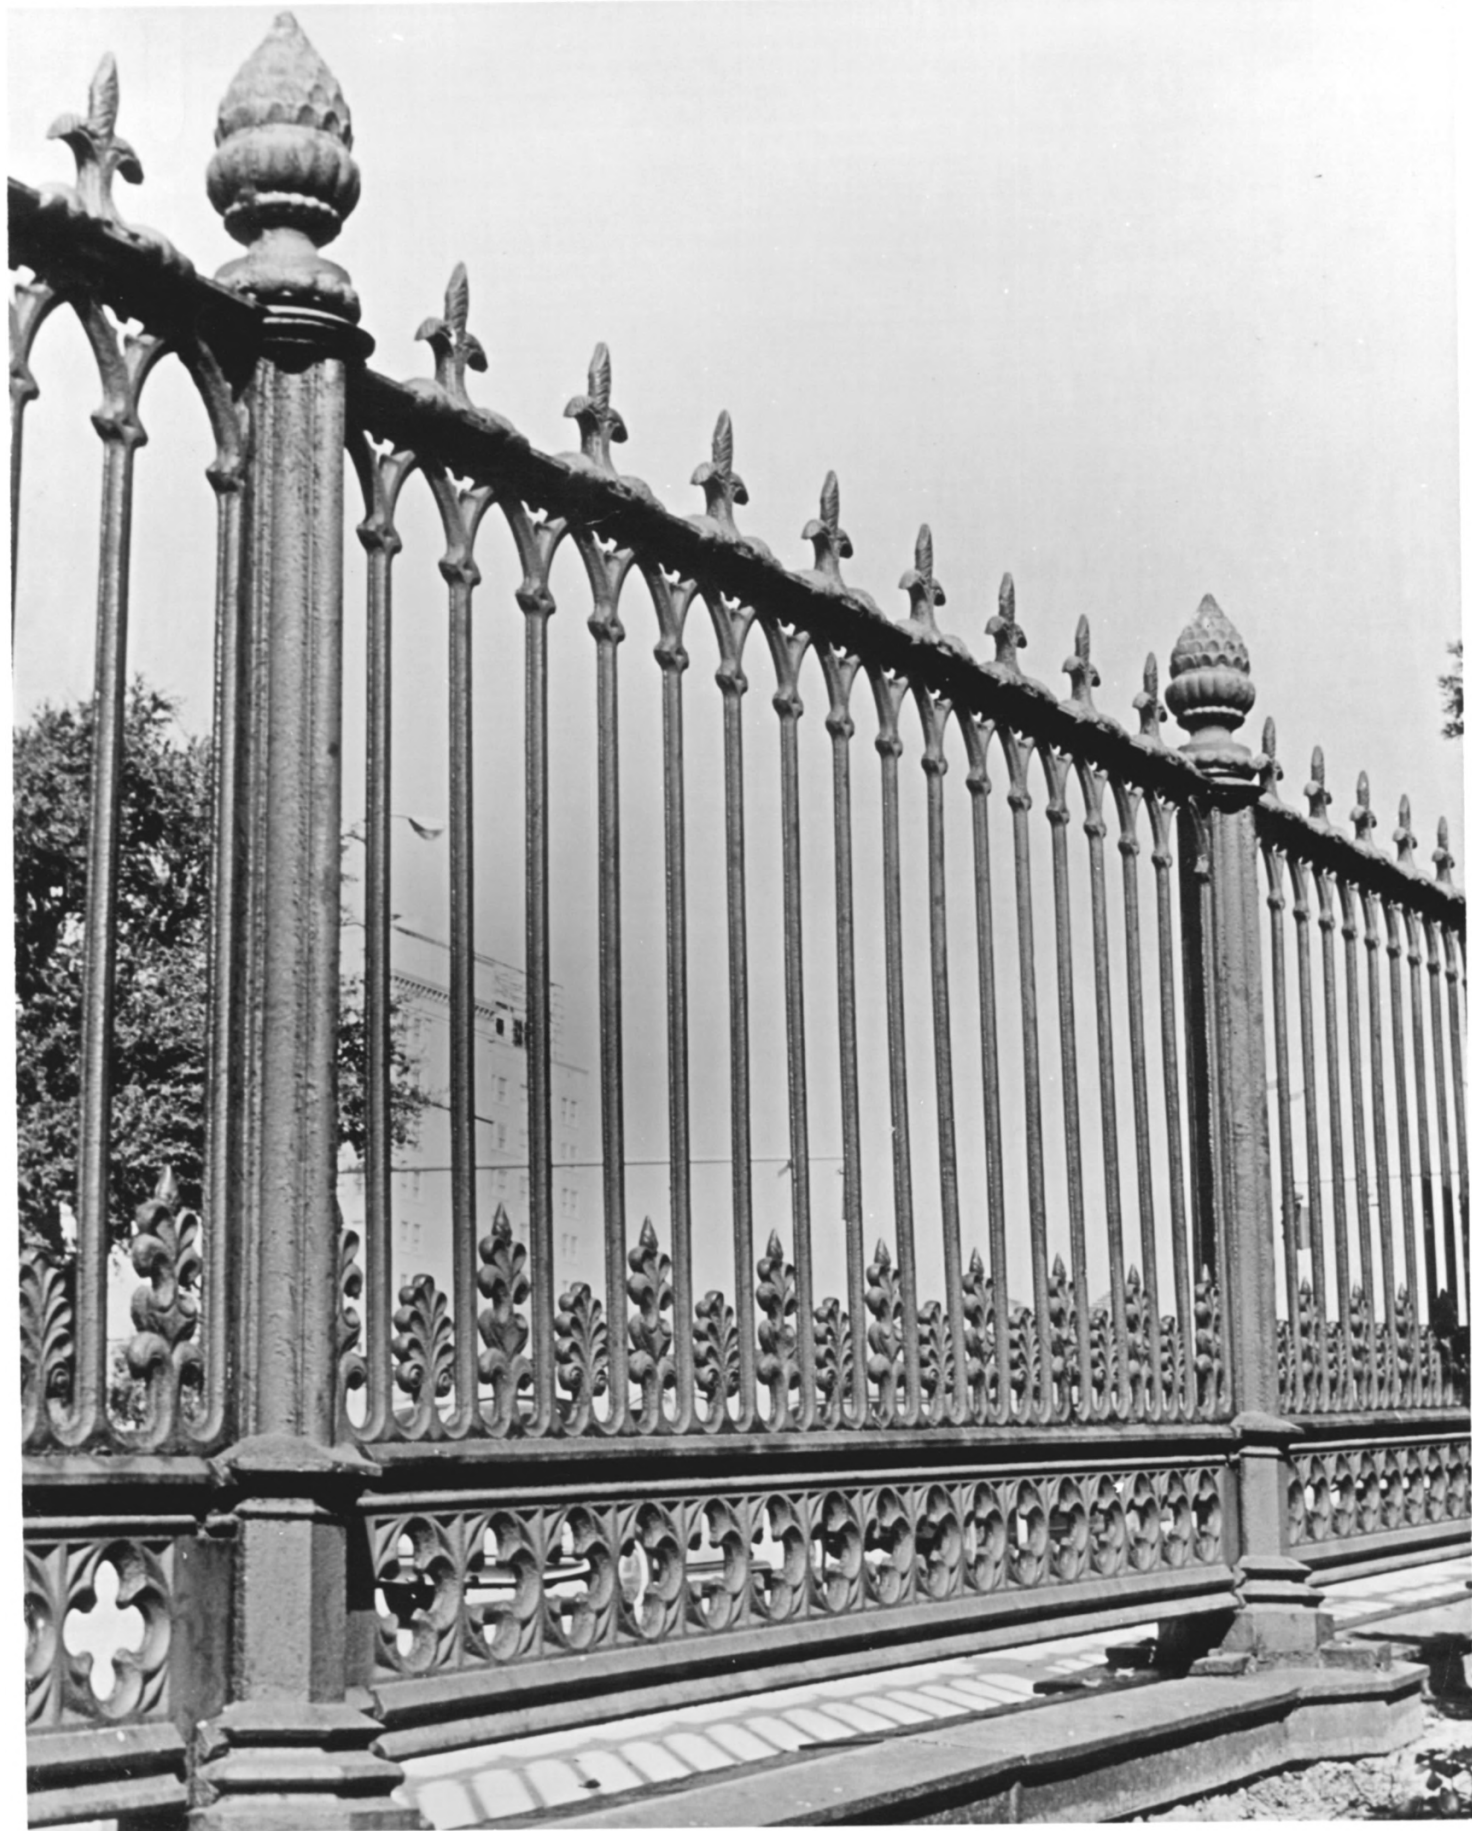
View of the 1849 cast iron fence taken from inside the fence facing northeast. The fence is so constructed that the only bolts in the fence are those holding the fence to its concrete base--it "jigsaws" together.

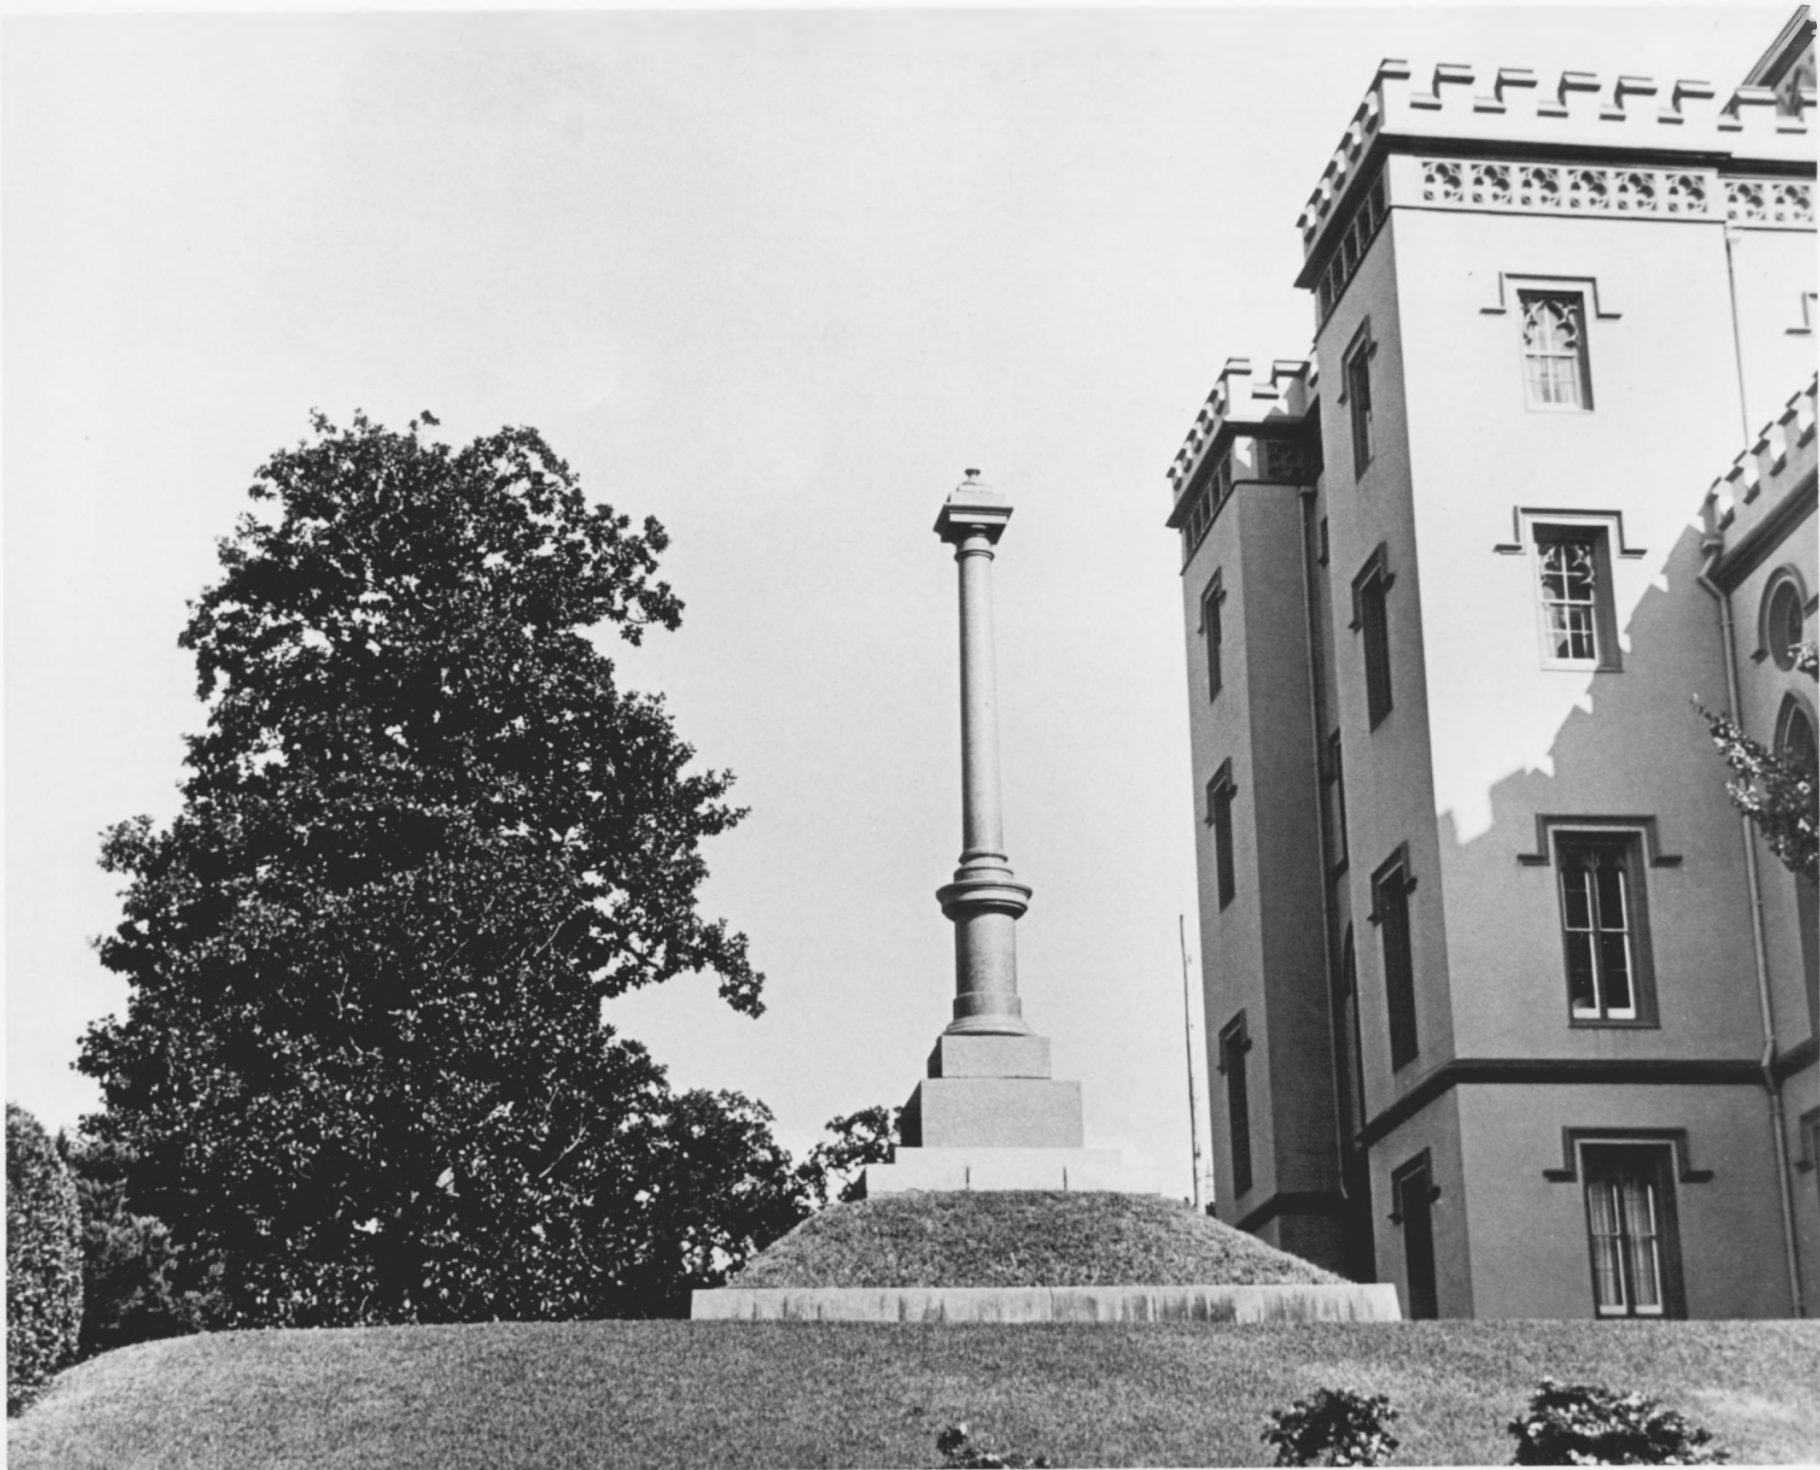
View taken from the west of the Gov. Henry Watkins Allen Monument and grave. The Monument is made of pink Vermont marble. There is carving on the base of the Monument giving facts and quotes about Allen. The northern facade of the Old State Capitol is on the right.

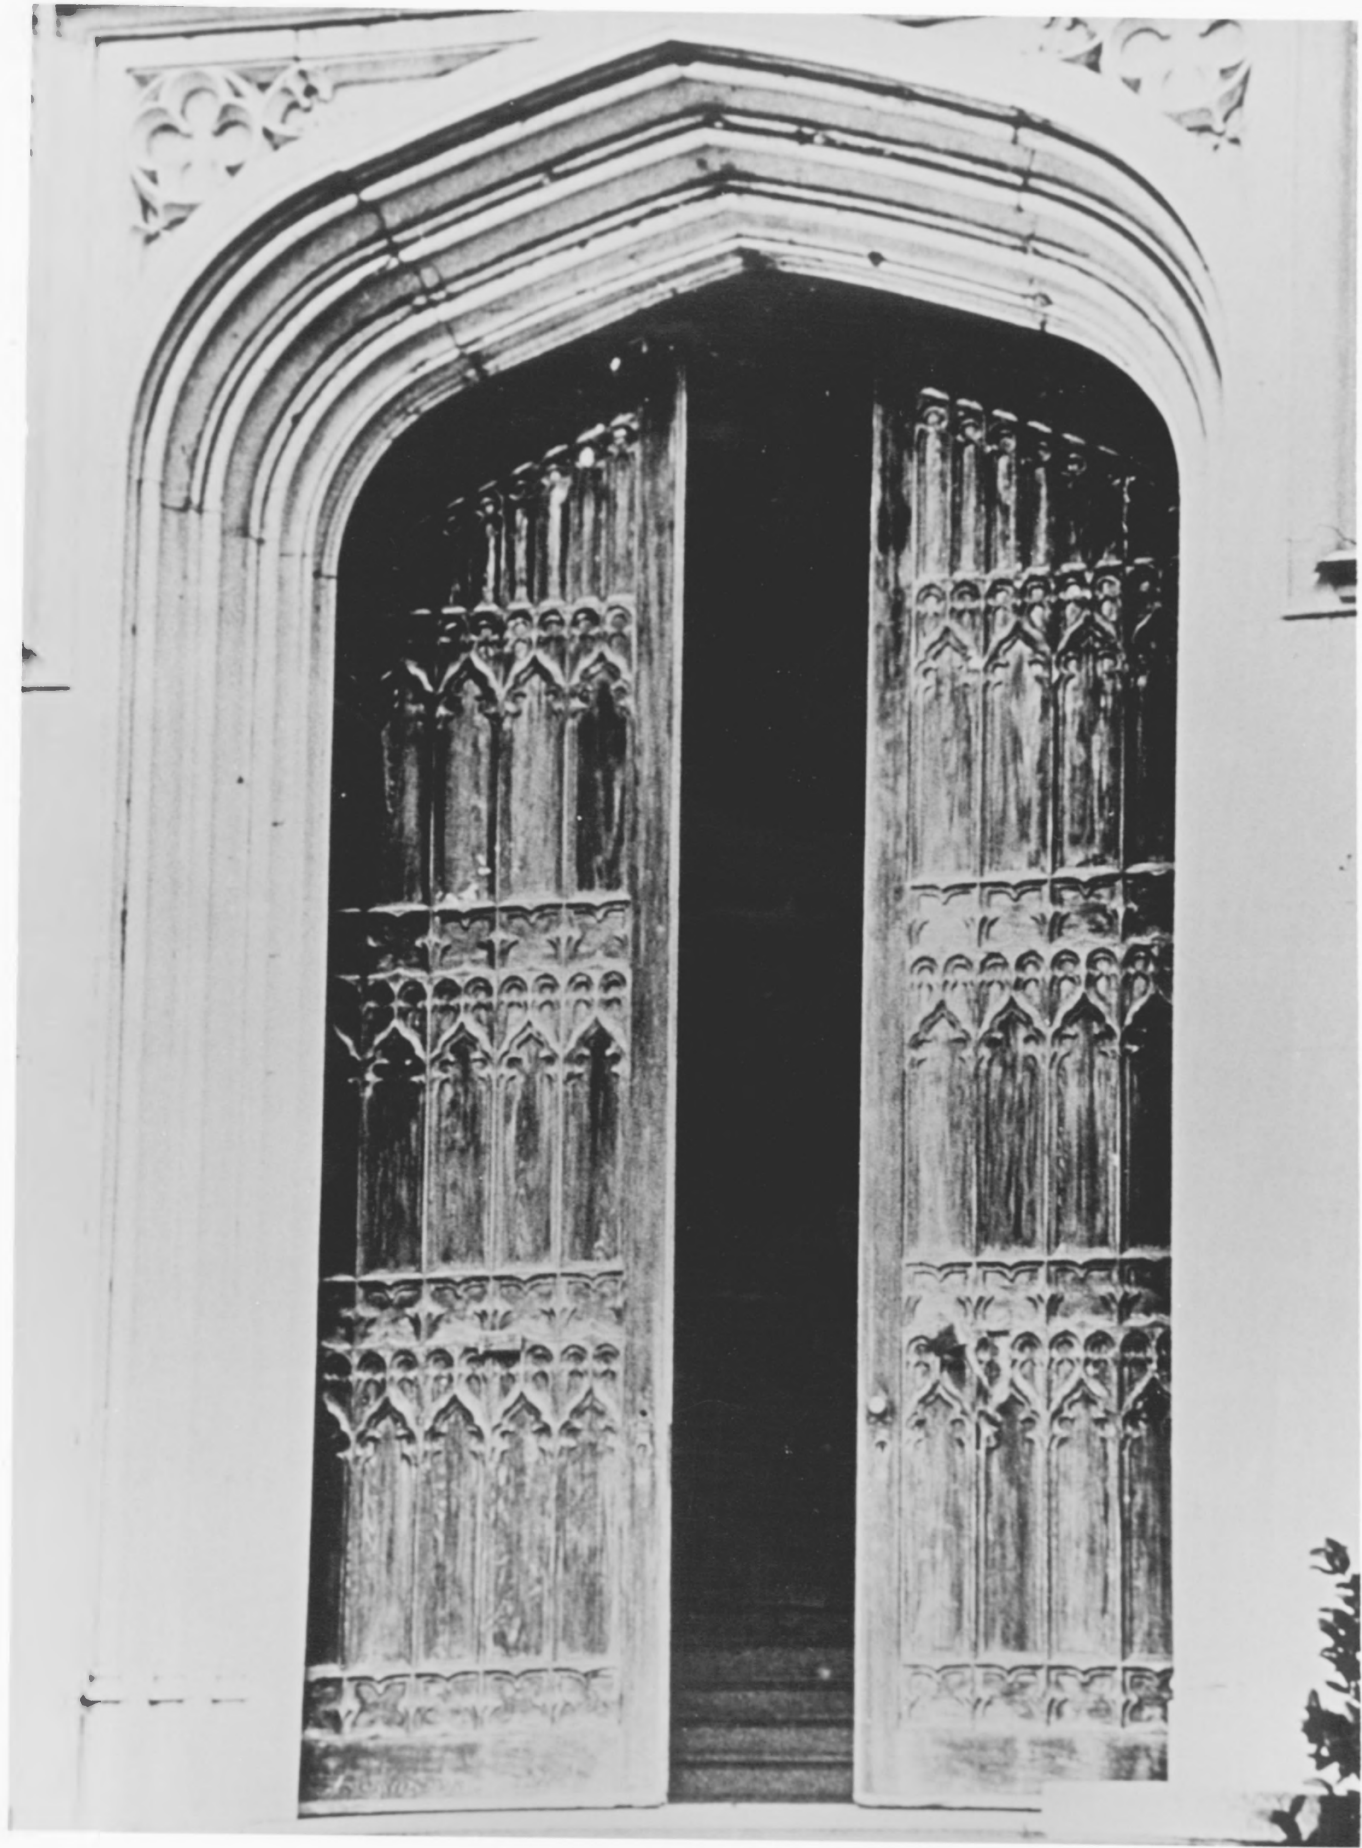
View of the wooden double doors on the western side of the building. Note the carving on the doors and the fact that they slide into the wall to open. This picture was taken prior to sandblasting and painting of the doors.

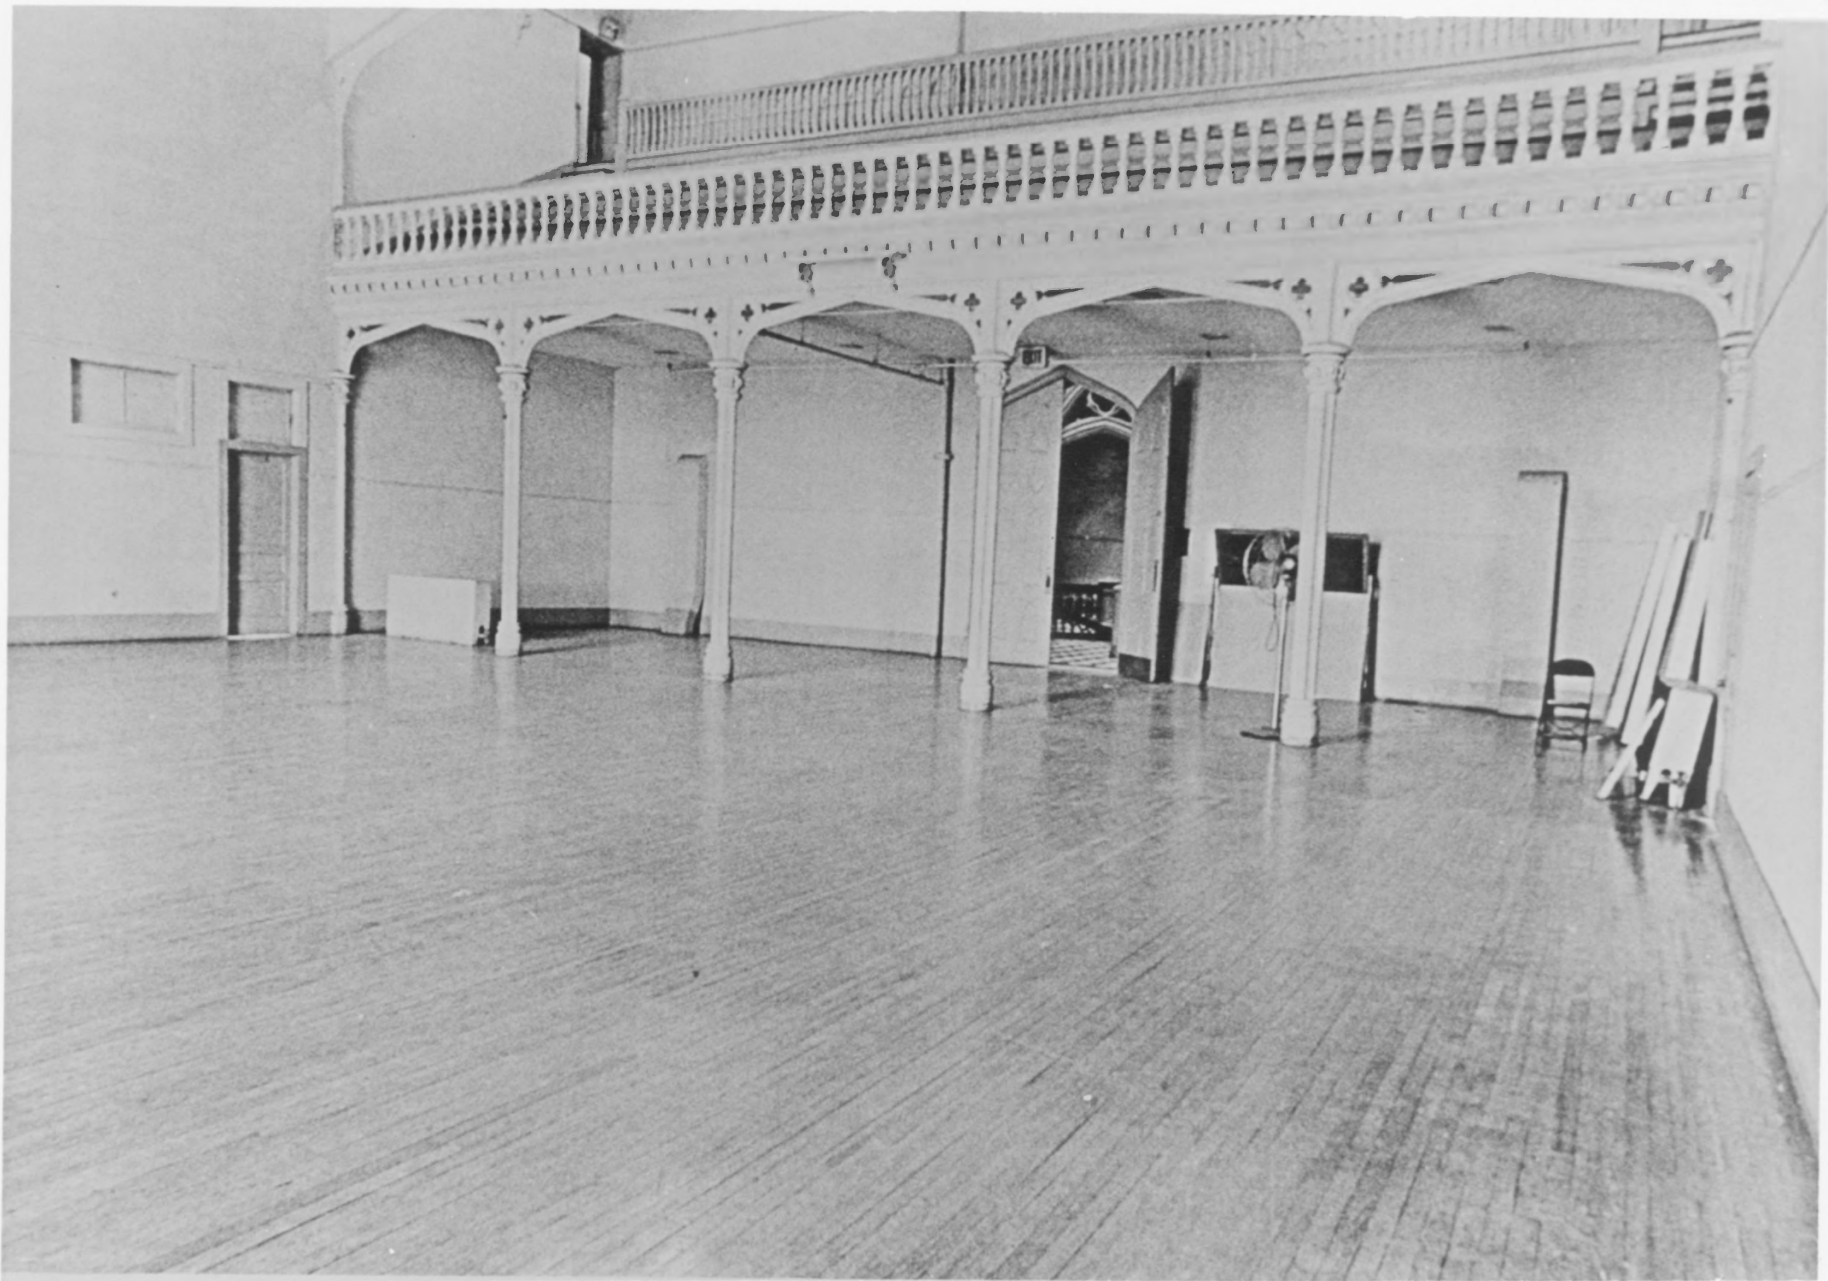
View of the gallery in the House of Representatives Chamber taken facing east. The walls on the extreme right and left of the picture were removed in the 1968 restoration. The doorway leads to the rotunda area.

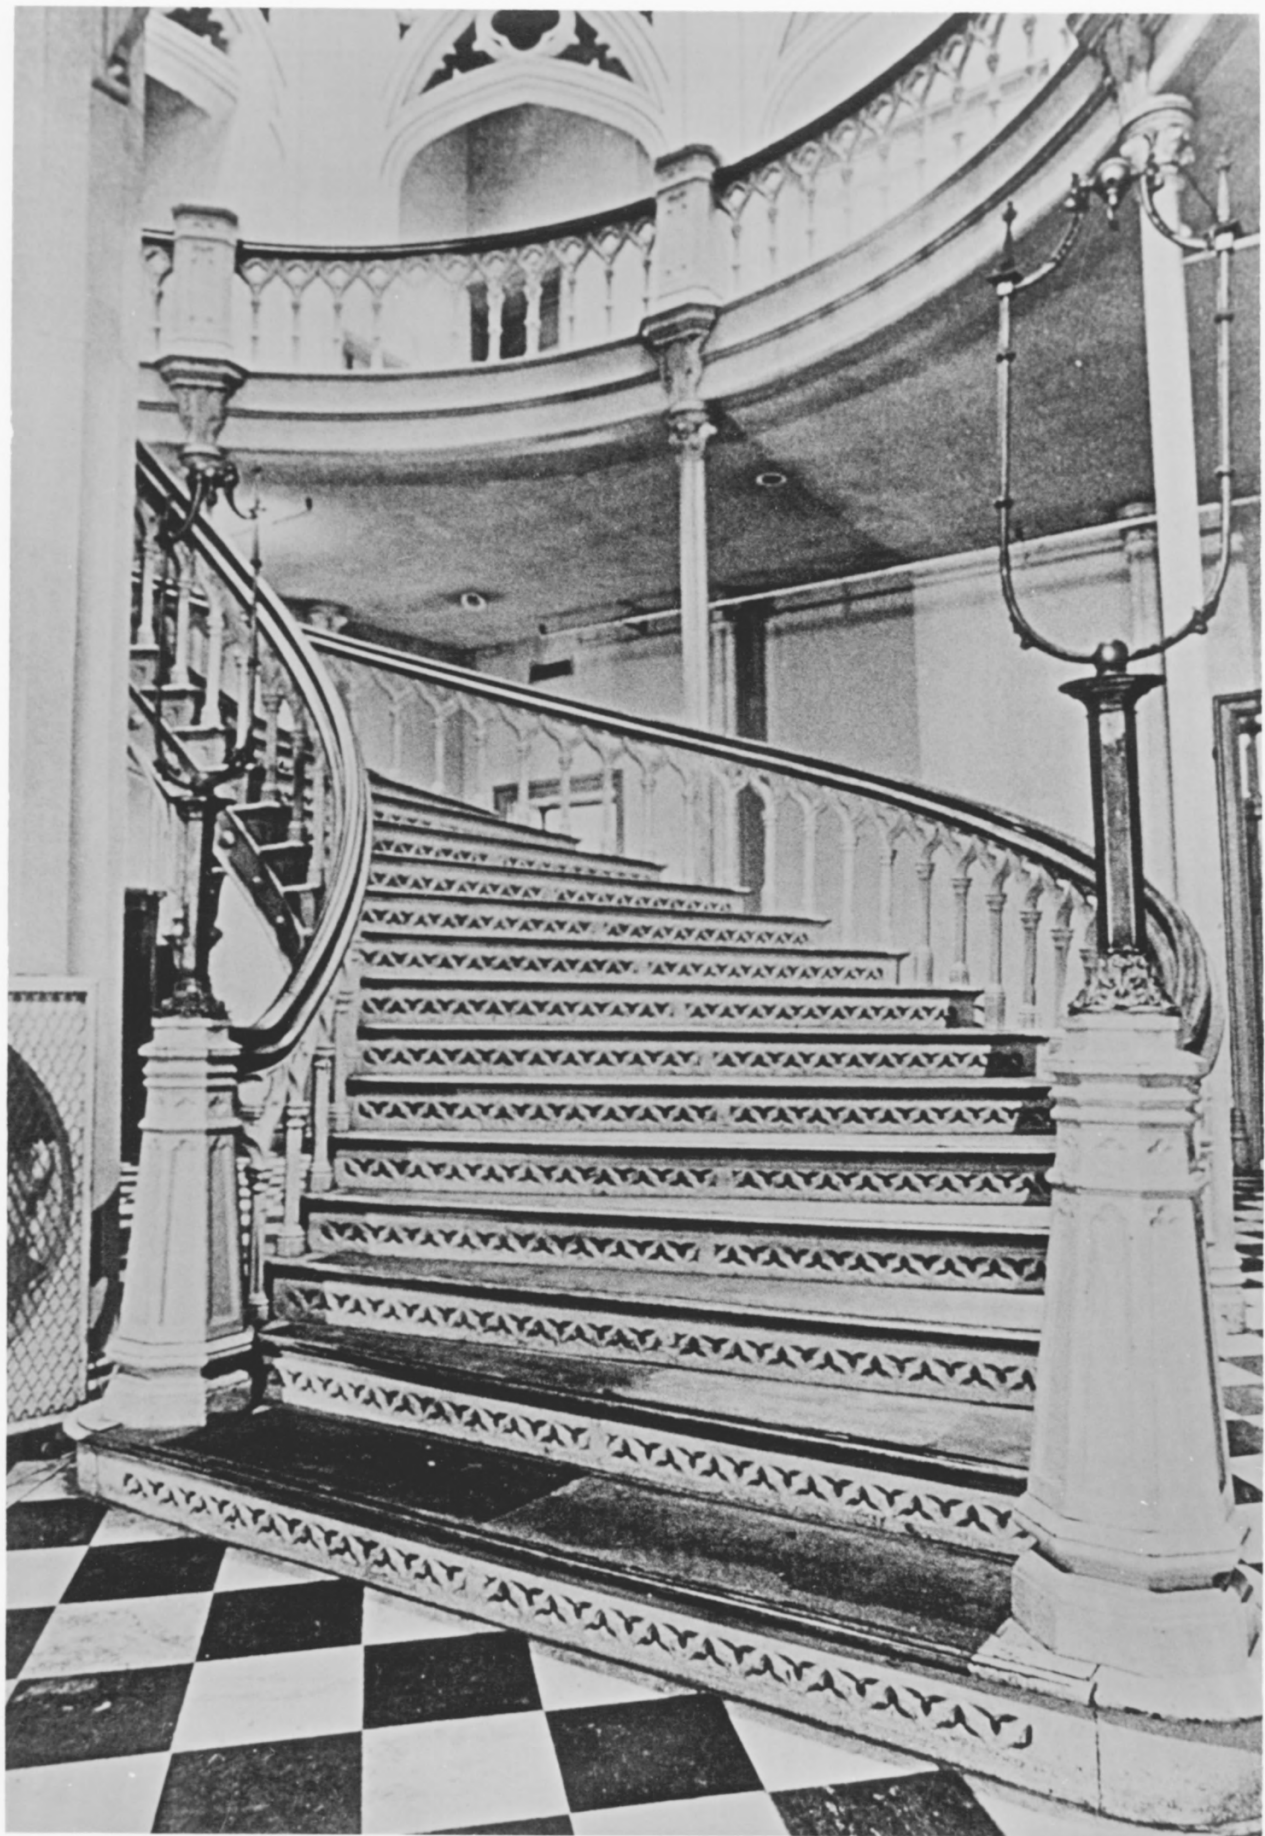
View of the cast iron stairs taken from the first floor. The brackets on the newels posts held elaborate gas lamps.

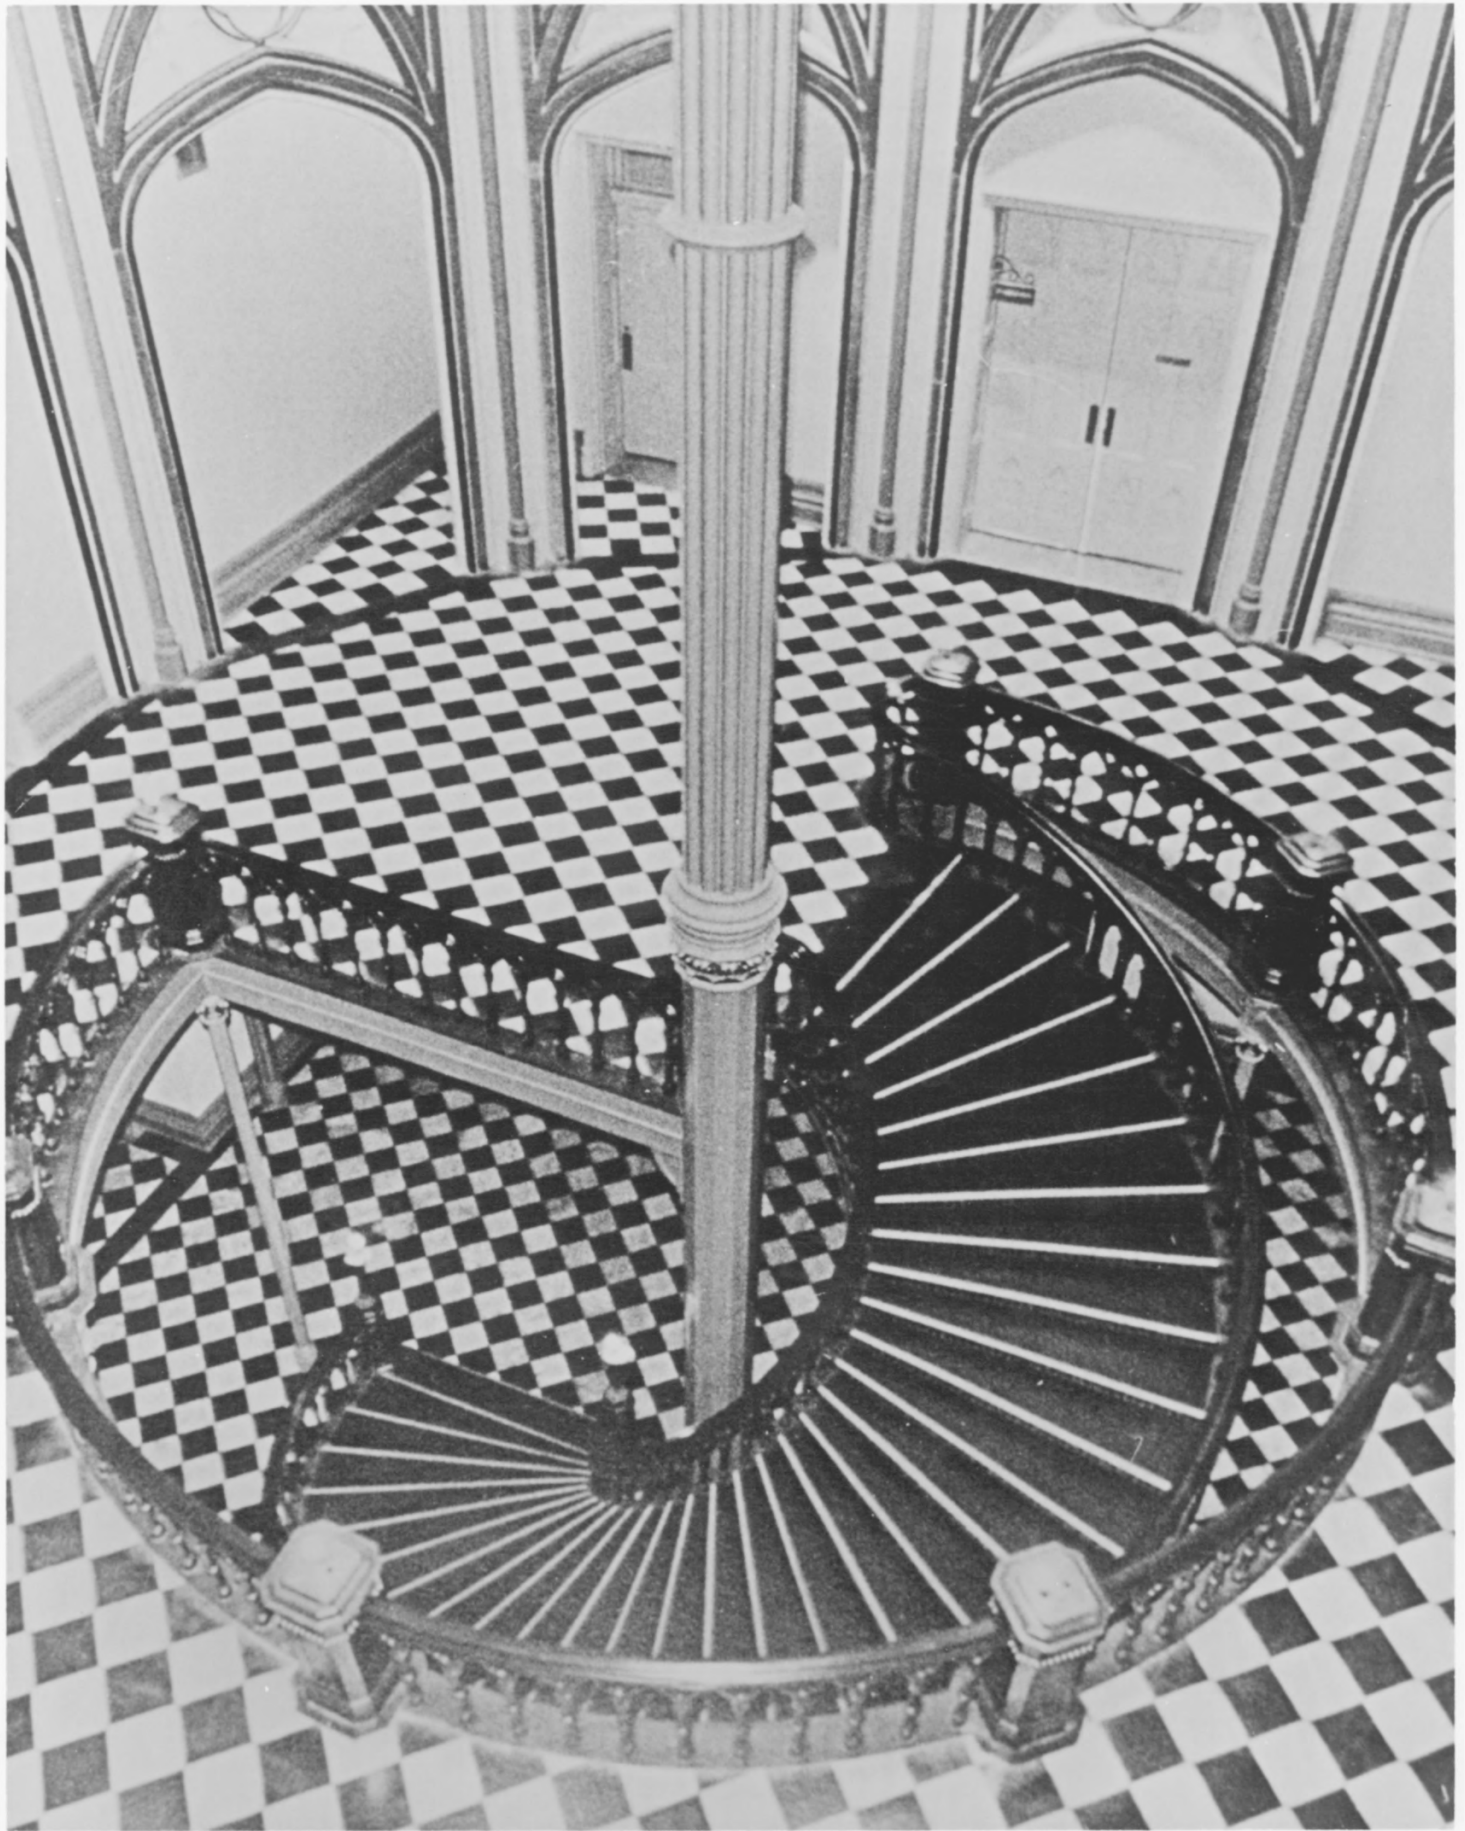
View of the spiral cast iron staircase taken from the fourth floor gallery by the elevator door (facing northwest). Note the poyntell floor and massive cast iron column that rises from the basement to support the stained glass rotunda.

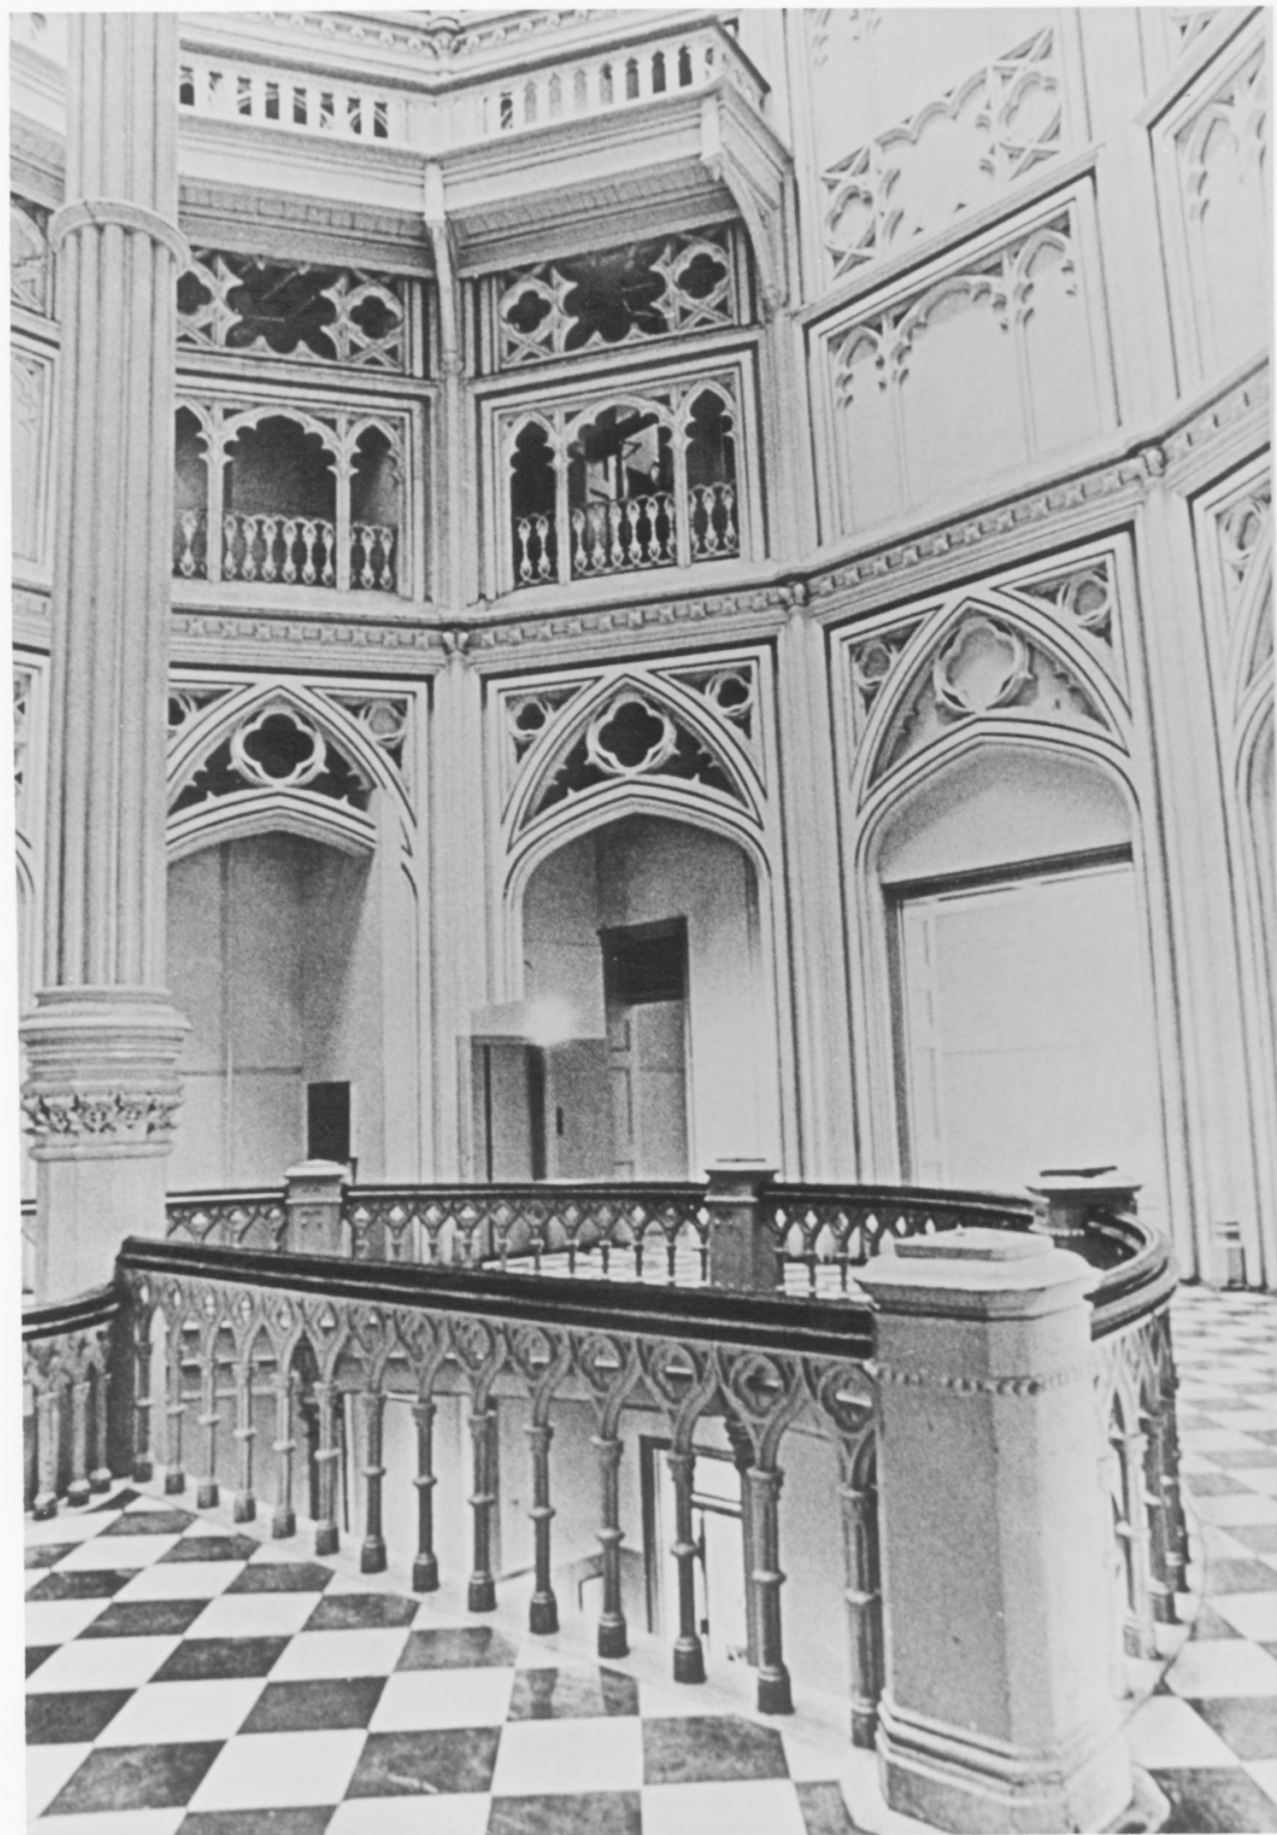
View of the rotunda area taken from the second floor facing southeast. The second floor elevator door is in the center of the picture. The fourth floor gallery can be seen at the top.

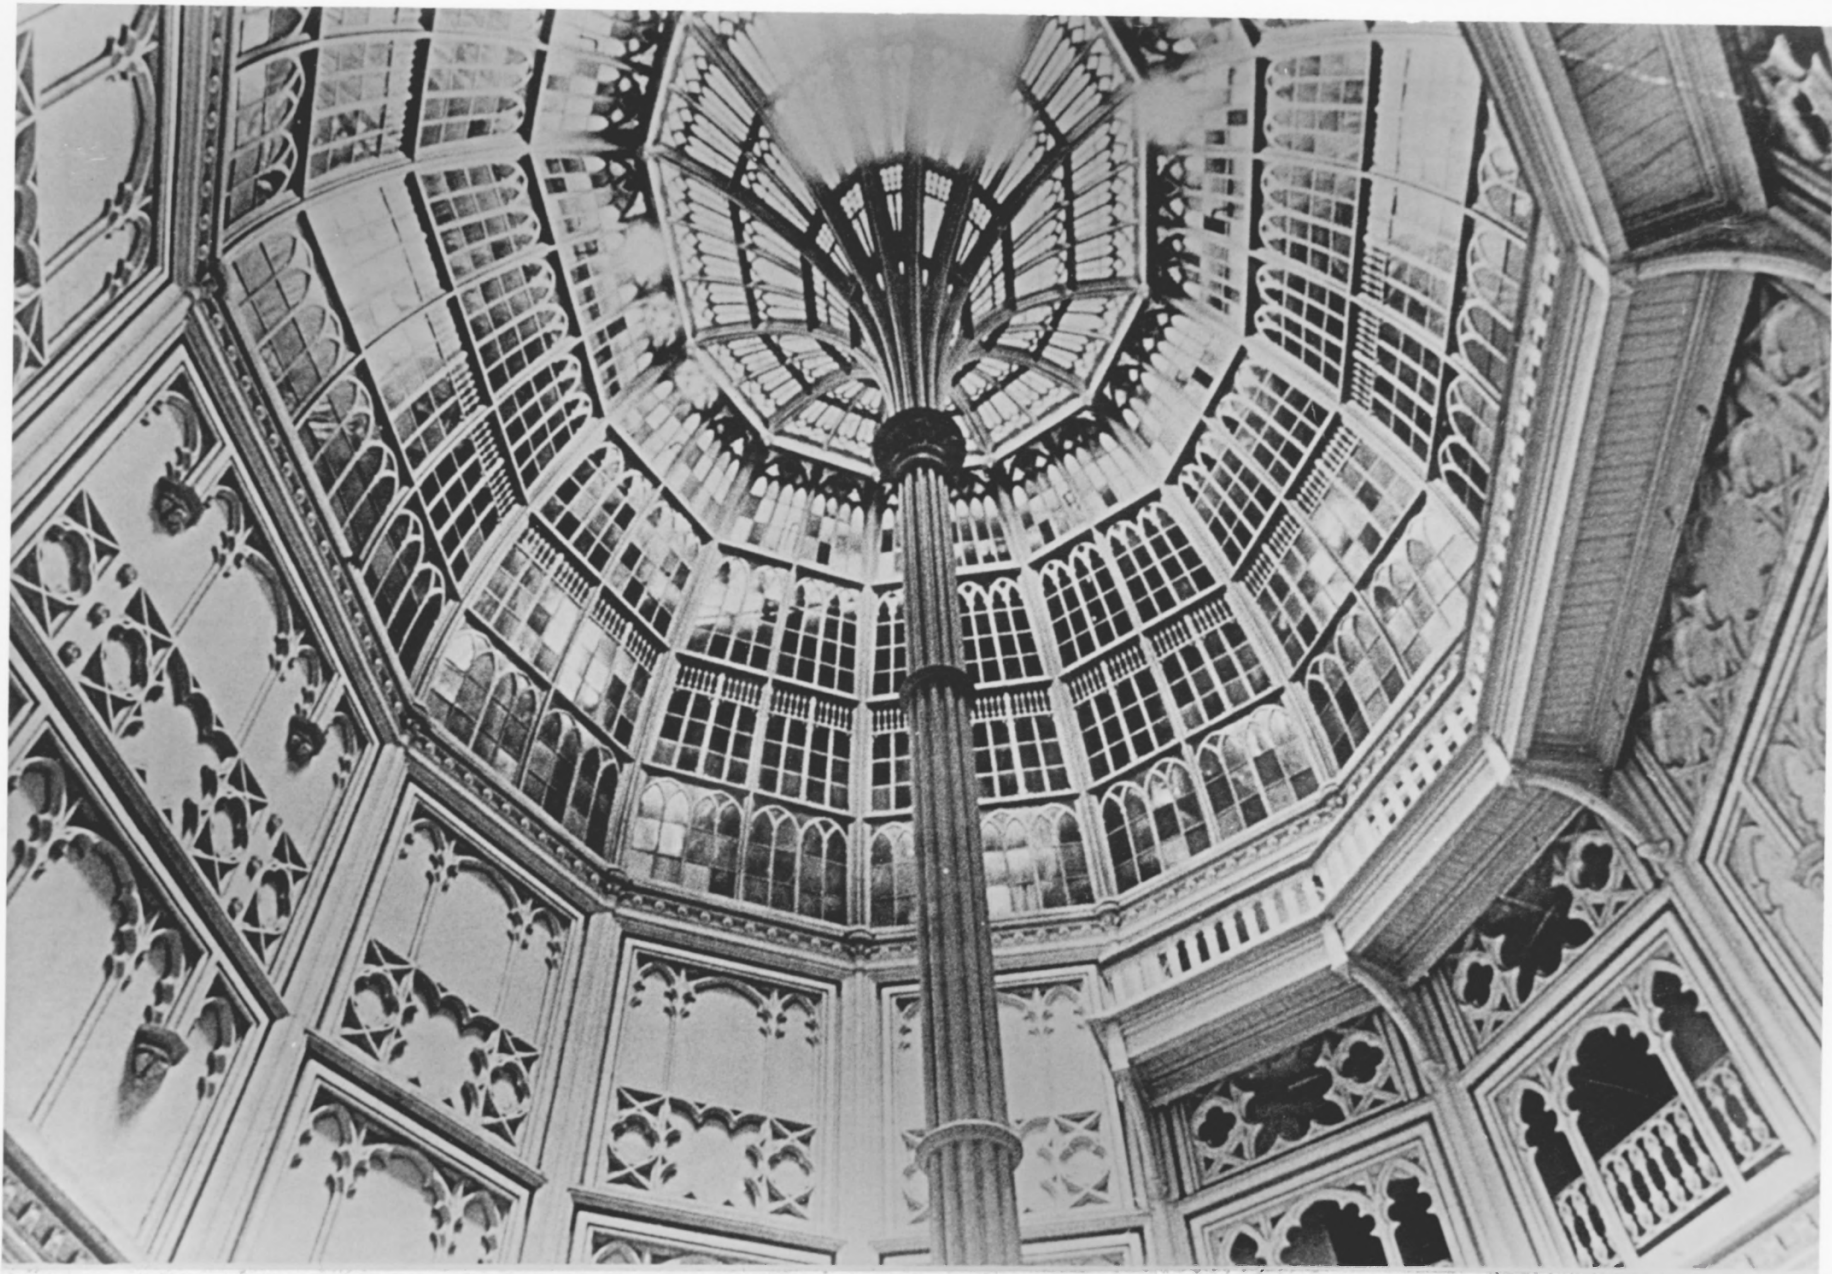
View of the stained glass rotunda taken facing north. Note the fourth floor gallery in the right side of the picture. The cast iron column supporting the rotunda rises from the basement floor.
