National Register of Historic Places Registration Form

historic name Northampton Veterans Administration Hospital Historic District
other names/site number Northampton Veterans Affairs Medical Center; Veterans Affairs Central Western
Massachusetts Healthcare System / NTH.M

street & number 421 North Main Street
city or town Northampton
state Massachusetts code MA county Hampshire code 015 zip code 01053

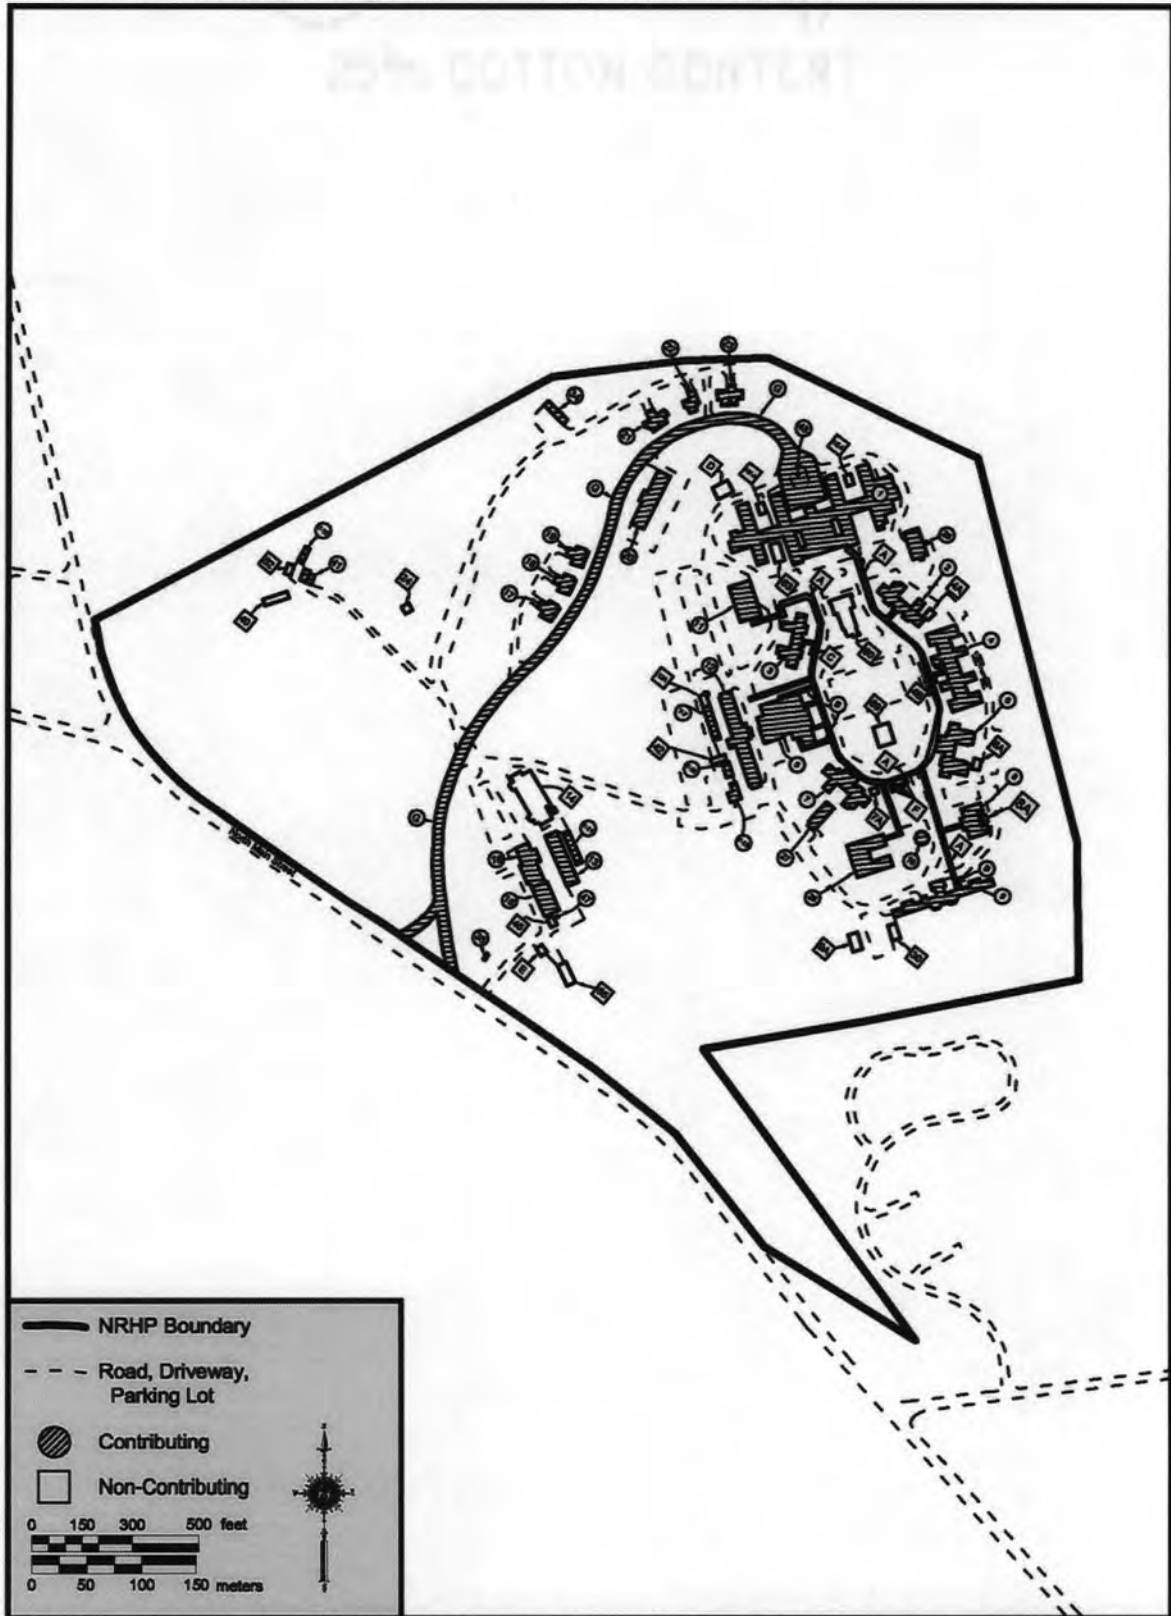
Sketch map indicating National Register boundary, contributing and noncontributing resources.

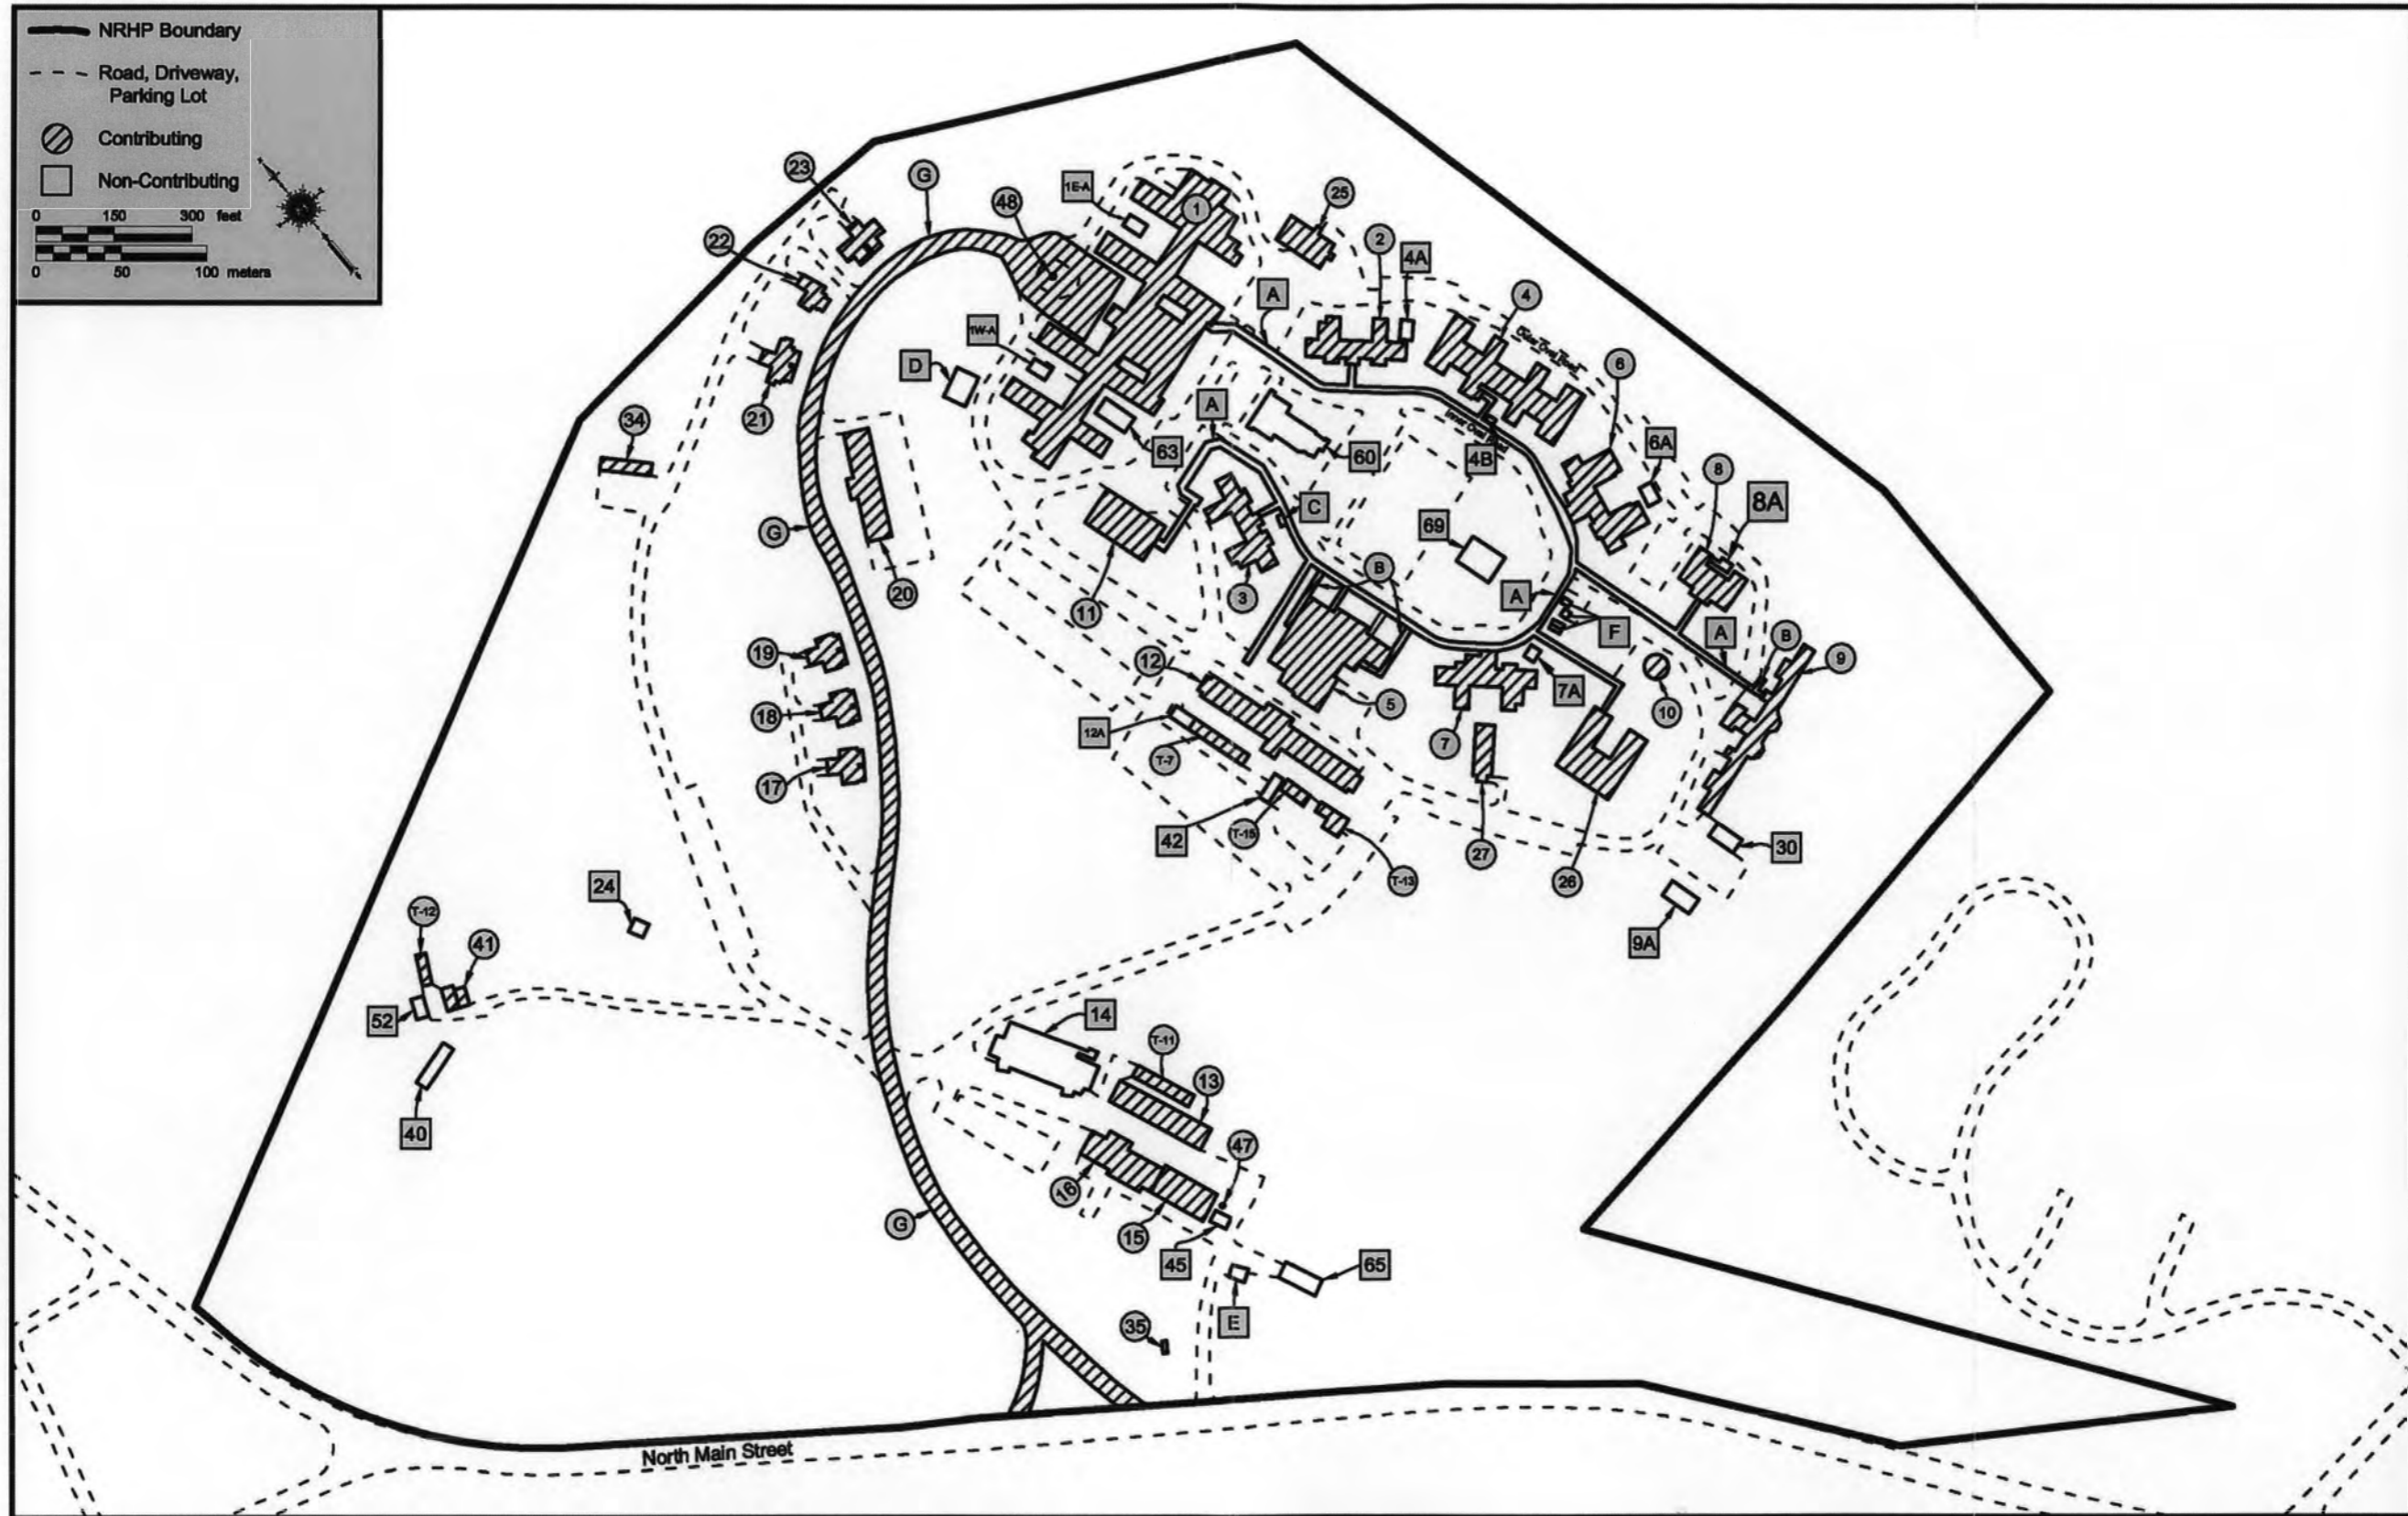
Sketch map indicating National Register boundary, contributing and noncontributing resources (oversize).

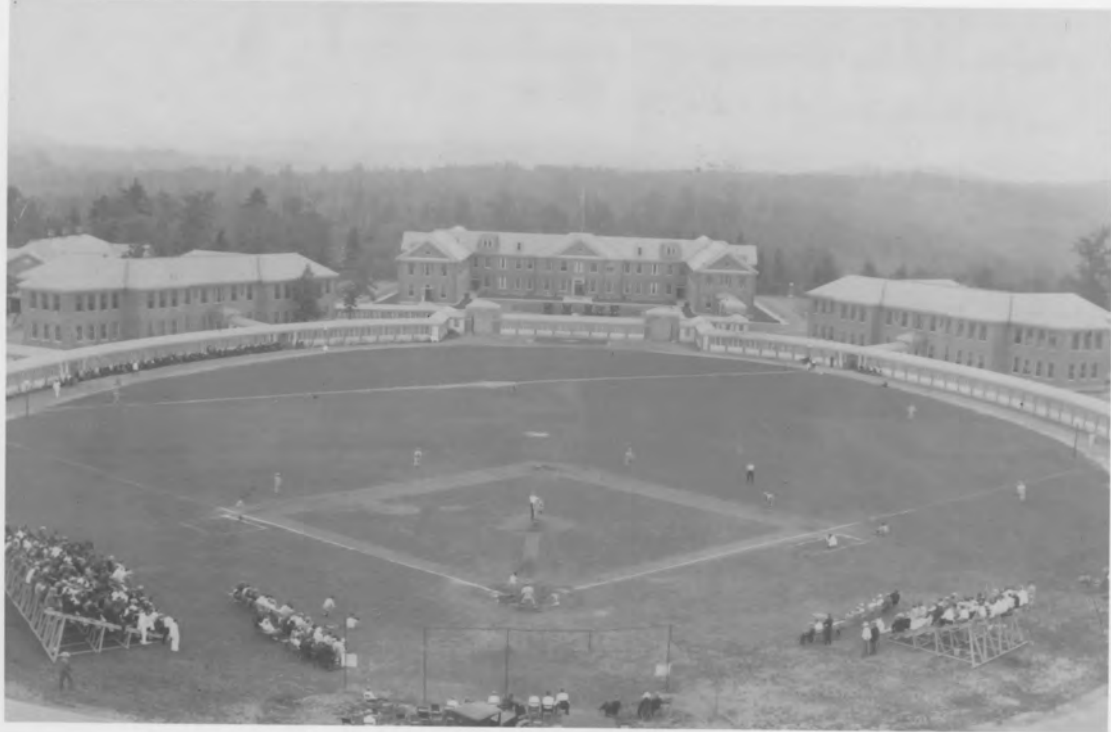
MA - Hampshire County - 2nd Generation Veterans Hospitals MPS -
Northampton VA Hospital - 0025

25. Circa 1928 photograph from the water tower looking to the northwest at the courtyard, original corridor, and Resources 3, 1, and 2. Photograph located in the files of the library of the Veterans Affairs Medical Center, Northampton, Massachusetts.

This Continued Treatment Building (Resource 2, 1923) is a two-story, nineteen-bay, hip-roof, brick building in simplified Colonial Revival style (see Photographs 7, 9, 25, and 26). It is located at the northeast side of the oval and currently houses information resource management offices. The building, oriented to the southwest, rests on a raised poured concrete foundation and exhibits rectangular slate shingles covering the roof. Cast stone sills, a cast stone water table, wide eaves, and a wood cornice add embellishment to the building. Two hip-roof sections aligned with the rear return wings project slightly from the facade elevation. A two-story, flat-roof egress addition is located in the center of the facade over the original entrance to the building. The addition, extending slightly above the cornice of the main block, displays brick soldier coursing and aluminum framed glass. The first story of this addition, which projects toward the connecting corridor, is slightly open and recessed with brick piers and brick knee walls. The facade addition of the Continued Treatment Building is attached to the connecting corridor system (Resource A, circa 1980s).

The Re-educational Building (Resource 3, 1923) is a two-story, hip-roof, nineteen-bay, brick building with minimal Colonial Revival style elements (see Photographs 8 and 25). It is oriented to the southeast and is located north of the Mess and Kitchen Building (Resource 5, 1923). This building currently houses engineering and personnel offices. The Re-educational Building is nearly identical to the Continued Treatment Building (Resource 2, 1923). The building rests on a raised poured concrete foundation and has a hipped roof sheathed in rectangular slate shingles. A cast stone water table, cast stone sills, wooden cornice, and extended eaves add embellishment. The center of the facade elevation displays a large two-story, single-bay, brick egress addition with a flat roof and metal coping. The addition, extending slightly farther from the facade wall plane than the flanking projections, connects to the exterior connecting corridor (Resource A, circa 1980s). The single-leaf facade entry is filled with a replacement metal door. The rear return wings retain original two-story sections, each with an arched window. A modern pent-roof awning addition over an open porch is located on the northeast elevation of the northeast rear return wing.

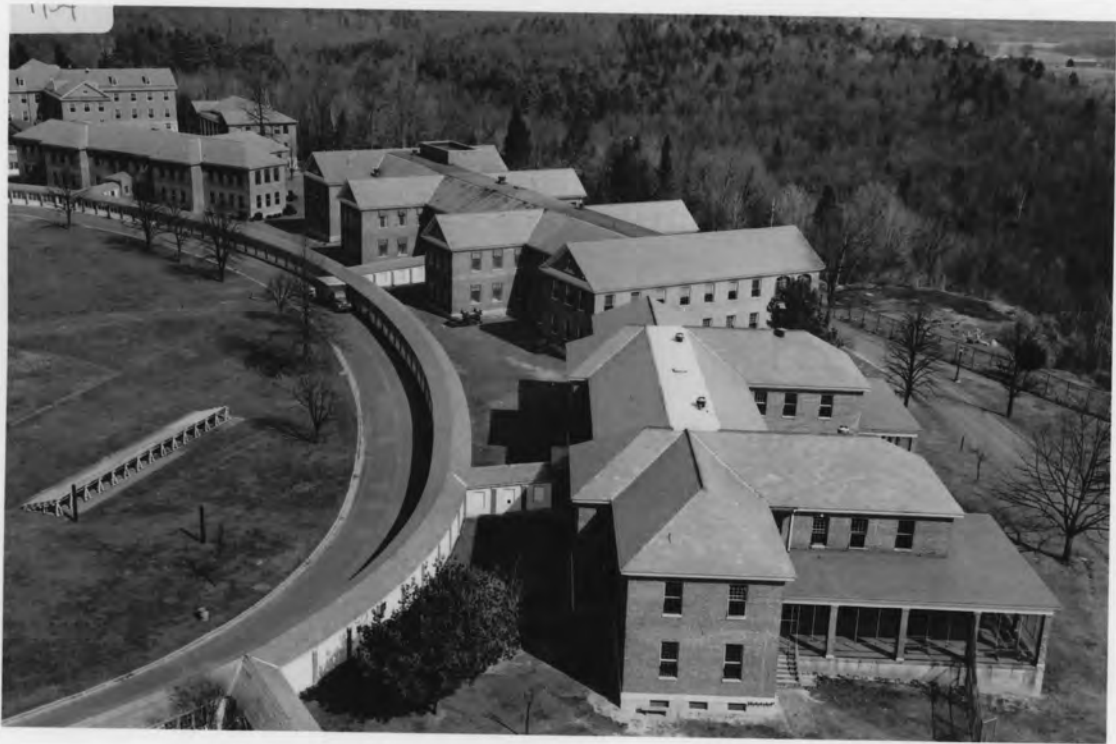
MA- Hampshire County- 2nd Generation Veterans Hospitals mps-
Northampton VA Hospital- 0026

26. Circa 1954 photograph looking to the northeast to the original corridor and Resources 1, 2, 25, 4, and 6. Photograph located in the files of the library of the Veterans Affairs Medical Center, Northampton, Massachusetts.

The Disturbed Patients Building (Resource 4, 1923) is a two-story, twenty-seven-bay, hip-roof, brick building with minimal Colonial Revival style decorative elements (see Photographs 9, 18, and 26). It is located at the east side of the oval and is currently housing substance abuse facilities. The building, oriented to the west, rests on a raised poured concrete foundation and has a dominant side-gable roof with rectangular slate shingles. Originally an H-shape building, two side wings added in 1938 give the building its present footprint, which is similar to that of the Main Building (Resource 1, 1923), though much smaller in scale. Four return wings extend from the facade elevation. The two interior wings exhibit oval-shaped tracery windows within the pediment, while two outer wings feature vented lunettes with keystones. A one-bay, hip-roof entry on the facade elevation has been enclosed and connects to the exterior connecting corridor (Resource A, circa 1980s). Cast stone sills, a cast stone water table, wide eaves, and a wooden cornice embellish the building. Double-hung one-over-one replacement windows are found throughout the building. A two-story, red brick, shed-roof egress addition probably housing stairs is located on the south side of the facade return wing located north of the hip-roof main entry. The egress addition has a metal roof.
