Belleview Post Office

Burlington (Belleview), KY 41005

### KENTUCKY HISTORIC RESOURCES Individual Inventory Form

Resource # Be-8b

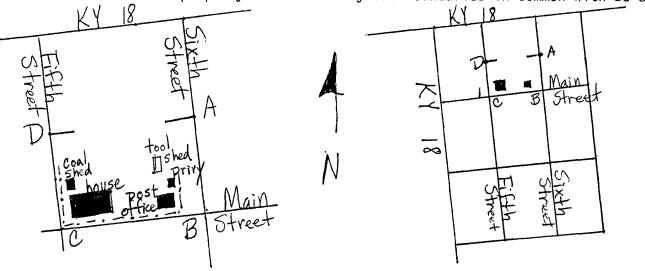
## 45. Description and House Plan:

The  $1\frac{1}{2}$ -story, 1-room plan, frame building has a 2-bay front (south) and rear (north), and an interior end chimney in the east gable. The upper half-story is lighted by a 6-pane casement window in the west gable, while the windows on the 1st floor have 6/6 lights. The building is sheathed with weatherboarding, and the foundation is covered with currogated metal. The sole exterior ornamentation is the decorative bargeboards. The front entry has a shed stoop roof and concrete steps, while the rear door has concrete steps only.

The interior features tongue-in-groove paneling and an enclosed corner staircase.

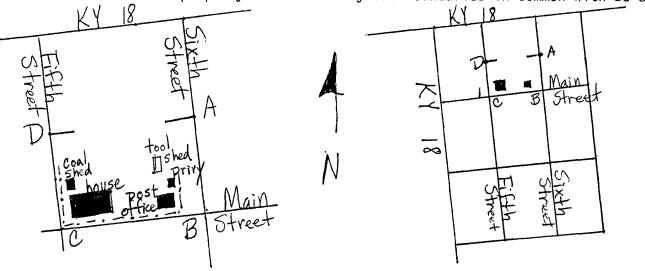
## 45. Description and House Plan:

The  $1\frac{1}{2}$ -story, 1-room plan, frame building has a 2-bay front (south) and rear (north), and an interior end chimney in the east gable. The upper half-story is lighted by a 6-pane casement window in the west gable, while the windows on the 1st floor have 6/6 lights. The building is sheathed with weatherboarding, and the foundation is covered with currogated metal. The sole exterior ornamentation is the decorative bargeboards. The front entry has a shed stoop roof and concrete steps, while the rear door has concrete steps only.

The interior features tongue-in-groove paneling and an enclosed corner staircase.
