# National Register of Historic Places Registration Form

Historic Name: St. Joseph's Church and Cemetery  
Other Names/Site Number: 5CN.816  
Name of related multiple property listing: n/a

Street & Number: 19895 County Road 8  
City or town: Capulin State: CO County: Conejos  
Not for Publication:  Vicinity:

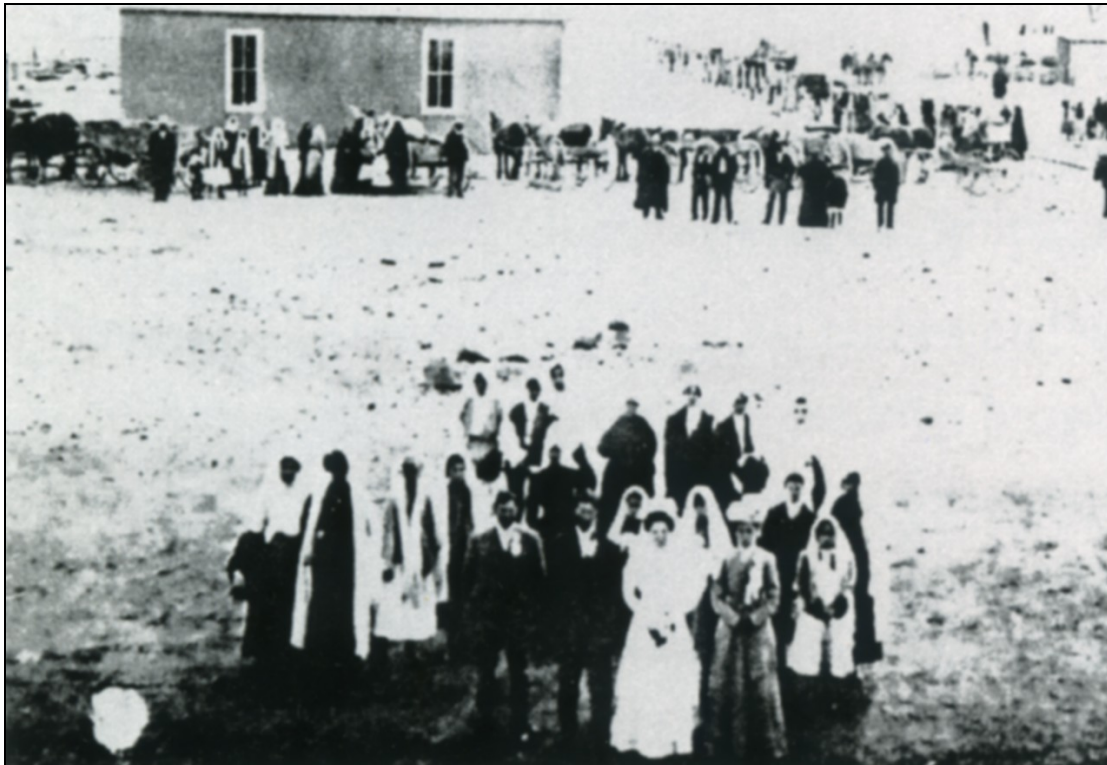
Figure 2. This ca. 1912 photograph of a wedding party shows the 1878 adobe church at Capulin in the background with the current church under construction at the upper right. Courtesy of *100 Year, 1912-2012 Anniversary Jubilee* (2012), 2.

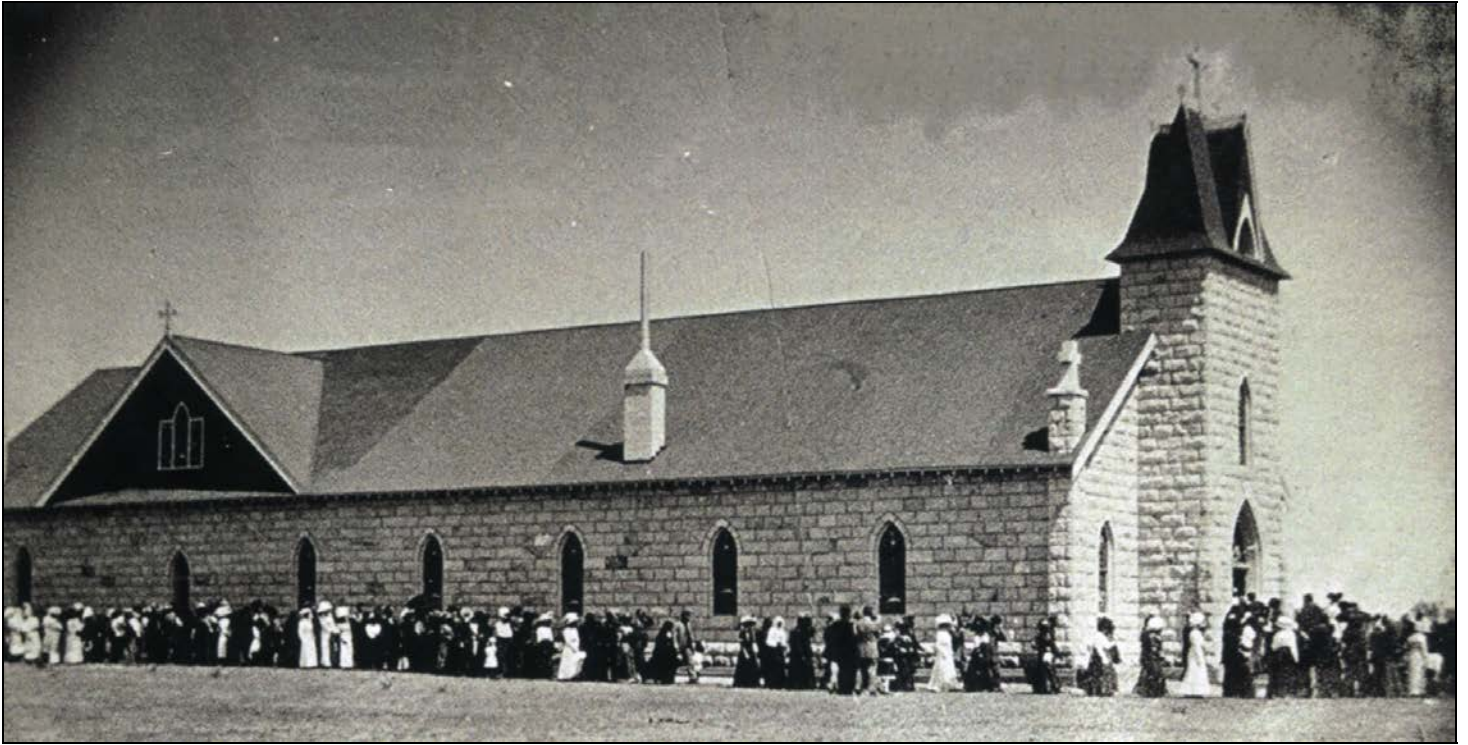
Figure 3. Bishop Nicholas Matz of the Diocese of Denver blessed the church on 3 July 1913 (view north-northwest). Note that the tower featured a different top at that time. Courtesy of *100 Year, 1912-2012 Anniversary Jubilee* (2012), 5.

Bishop Nicholas C. Matz of the Denver Diocese dedicated St. Joseph's Church on 3 July 1913 while on a visit to the San Luis Valley (see Figures 3 and 4). The *Denver Catholic Register* reported the church cost \$20,000 and observed: "The Spanish people of Capulin are to be congratulated on their beautiful church. It is built of white stone, is 40 by 40 feet [sic], and finished in the most approved style. Fully 2,000 people were at the dedication, and the confirmation class was the second largest in the valley."<sup>37</sup> The dimensions of the church were actually about 130' x 40'; the photographs of the dedication show the current full east-west length of the church. A 1934 history of the parish reported the church could seat nine hundred persons and placed the total cost at \$35,000.<sup>38</sup>

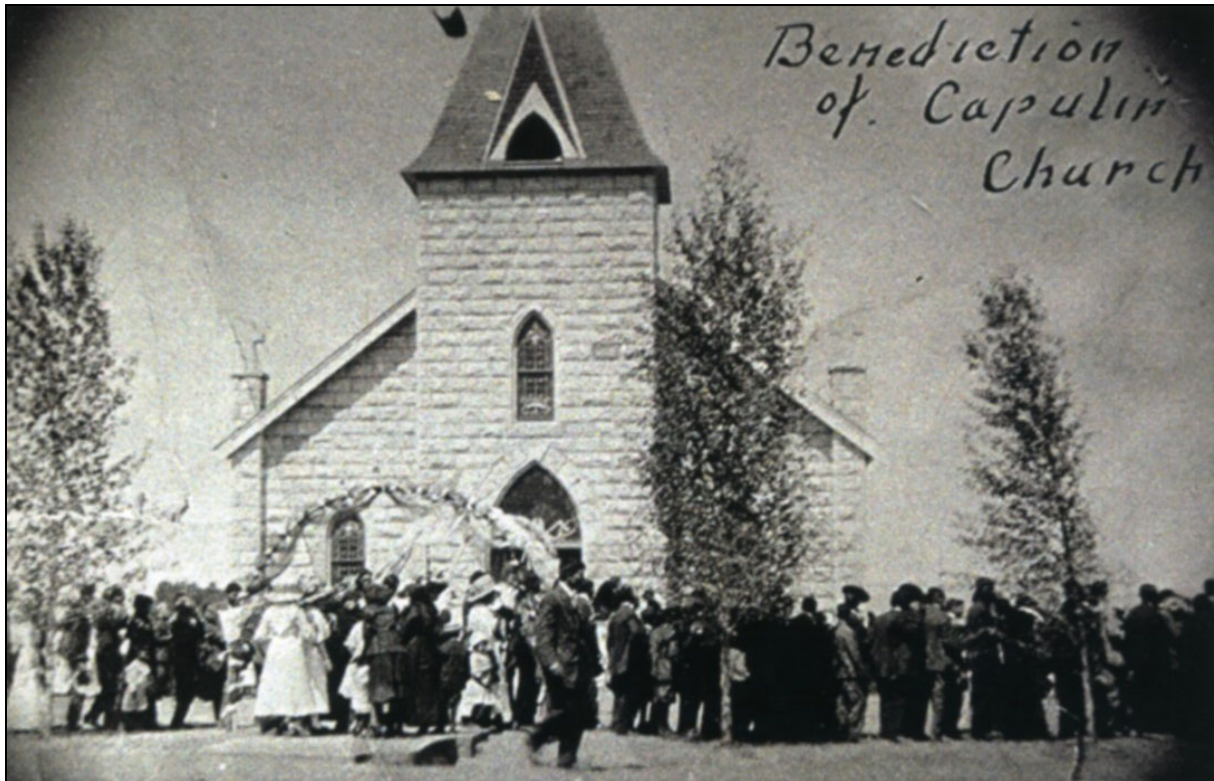
Figure 4. This view west shows the front (east wall) of the church at the 3 July 1913 blessing. Note the different tower design, presence of stained glass, and the absence of the one-story stone section to the north (right). Courtesy of *100 Year, 1912-2012 Anniversary Jubilee* (2012), 5.

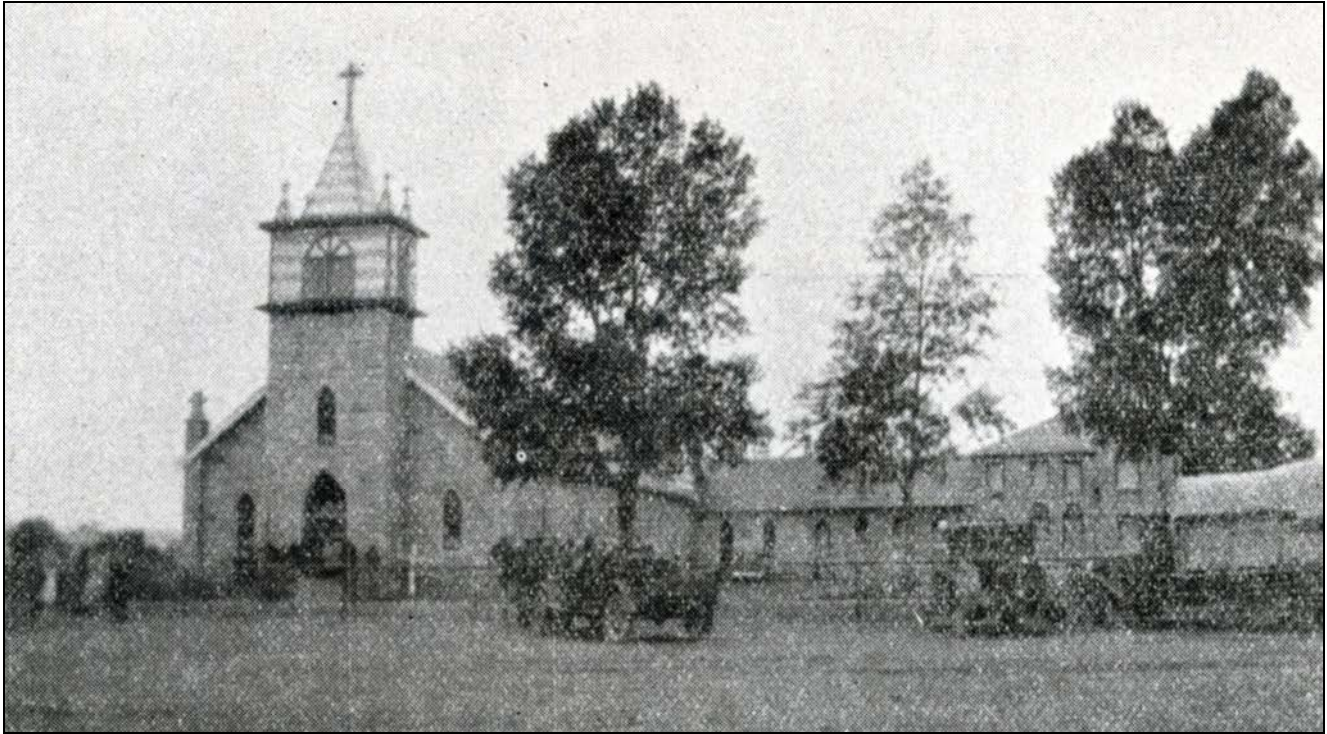
Figure 5. By 1934 the church displayed its current tower (1928), as well as north additions: the one-story stone chapel (ca. 1913-17) and the ornamental concrete block chapel expansion (one-story) and rectory (two-story) (both 1933-34). The view in the photograph is to the west-southwest. Courtesy of *El Reino de Dios a La Parroquia de Conejos en Sus Bodas de Diamante* (1934), 22.

ALTERATIONS. The church tower and steeple were rebuilt in 1928 after a windstorm blew the original one off. All of the additions to the original church occurred within the period of significance, with the possible exception of a small shed-roof garage on the rear, which is not shown on a 1960 fire insurance map. Doors in the original church were replaced, as well as the front concrete stoop and railings, by 2012. Windows and doors in the two-story rectory to the north and the two-story convent to the south are nonhistoric replacements (installed by 2012). In some instances the windows used are shorter than the original ones and the remaining portions of the window openings, including Gothic-arch transoms, have been filled in with stucco; this occurred in the recent past when the vinyl replacement windows were installed. A brick chimney on the south slope of the original roof church is
