National Register of Historic Places
Inventory—Nomination Form

historic Daufuskie Island Historic District

ARCHAEOLOGICAL ADDENDUM FOR THE DAUFUSKIE ISLAND HISTORIC DISTRICT

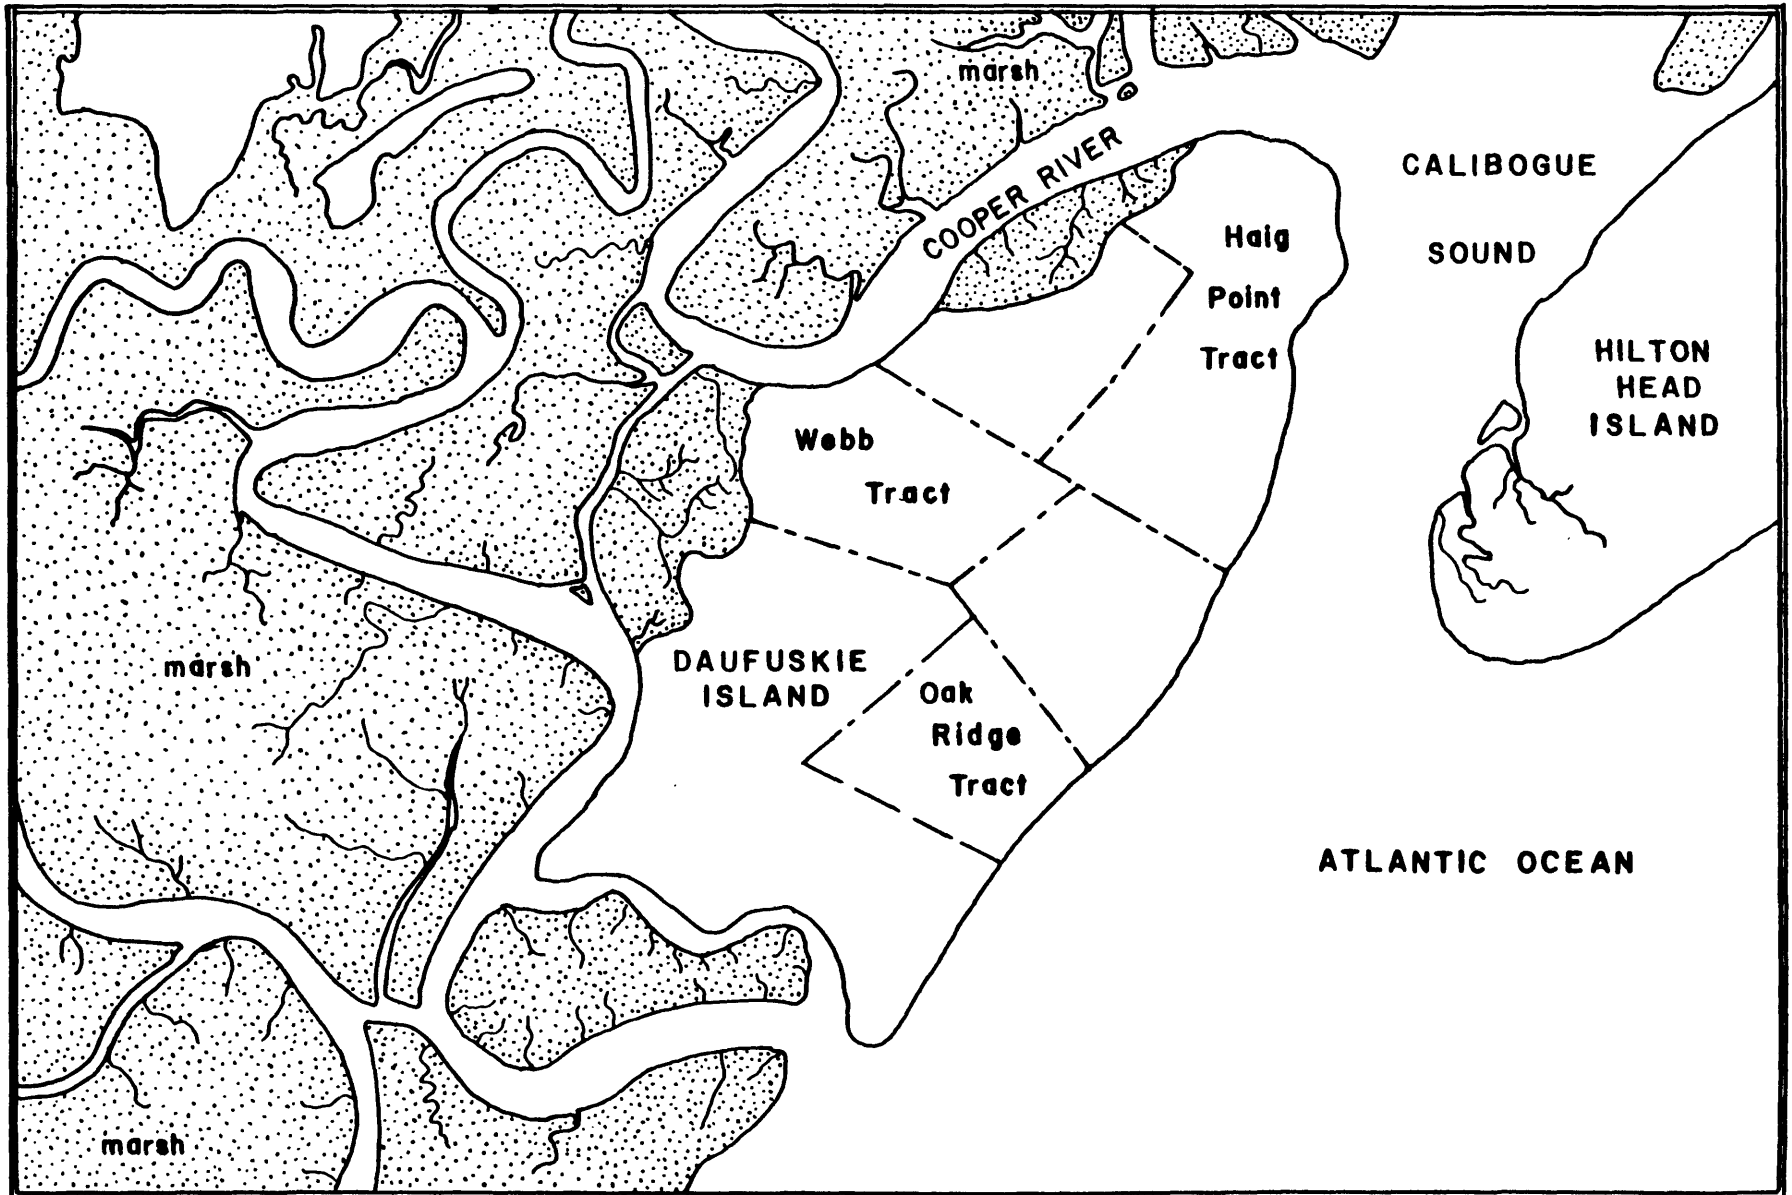
Figure 1. Daufuskie Island and surrounding landforms.

The reconnaissance survey that was conducted on the island emphasized the Haig Point, Webb, and Oak Ridge tracts of land (see Figure 1), but the survey frequently went outside of these areas to substantiate settlement patterns that were being monitored. In doing so, we were able to corroborate the patterns.
