National Register of Historic Places Registration Form

Historic name Northern State Hospital
Other names/site number Sedro-Wooley Insane Farm, Western State Hospital, North Cascades Gateway Center

Property ID & Resource Status Map

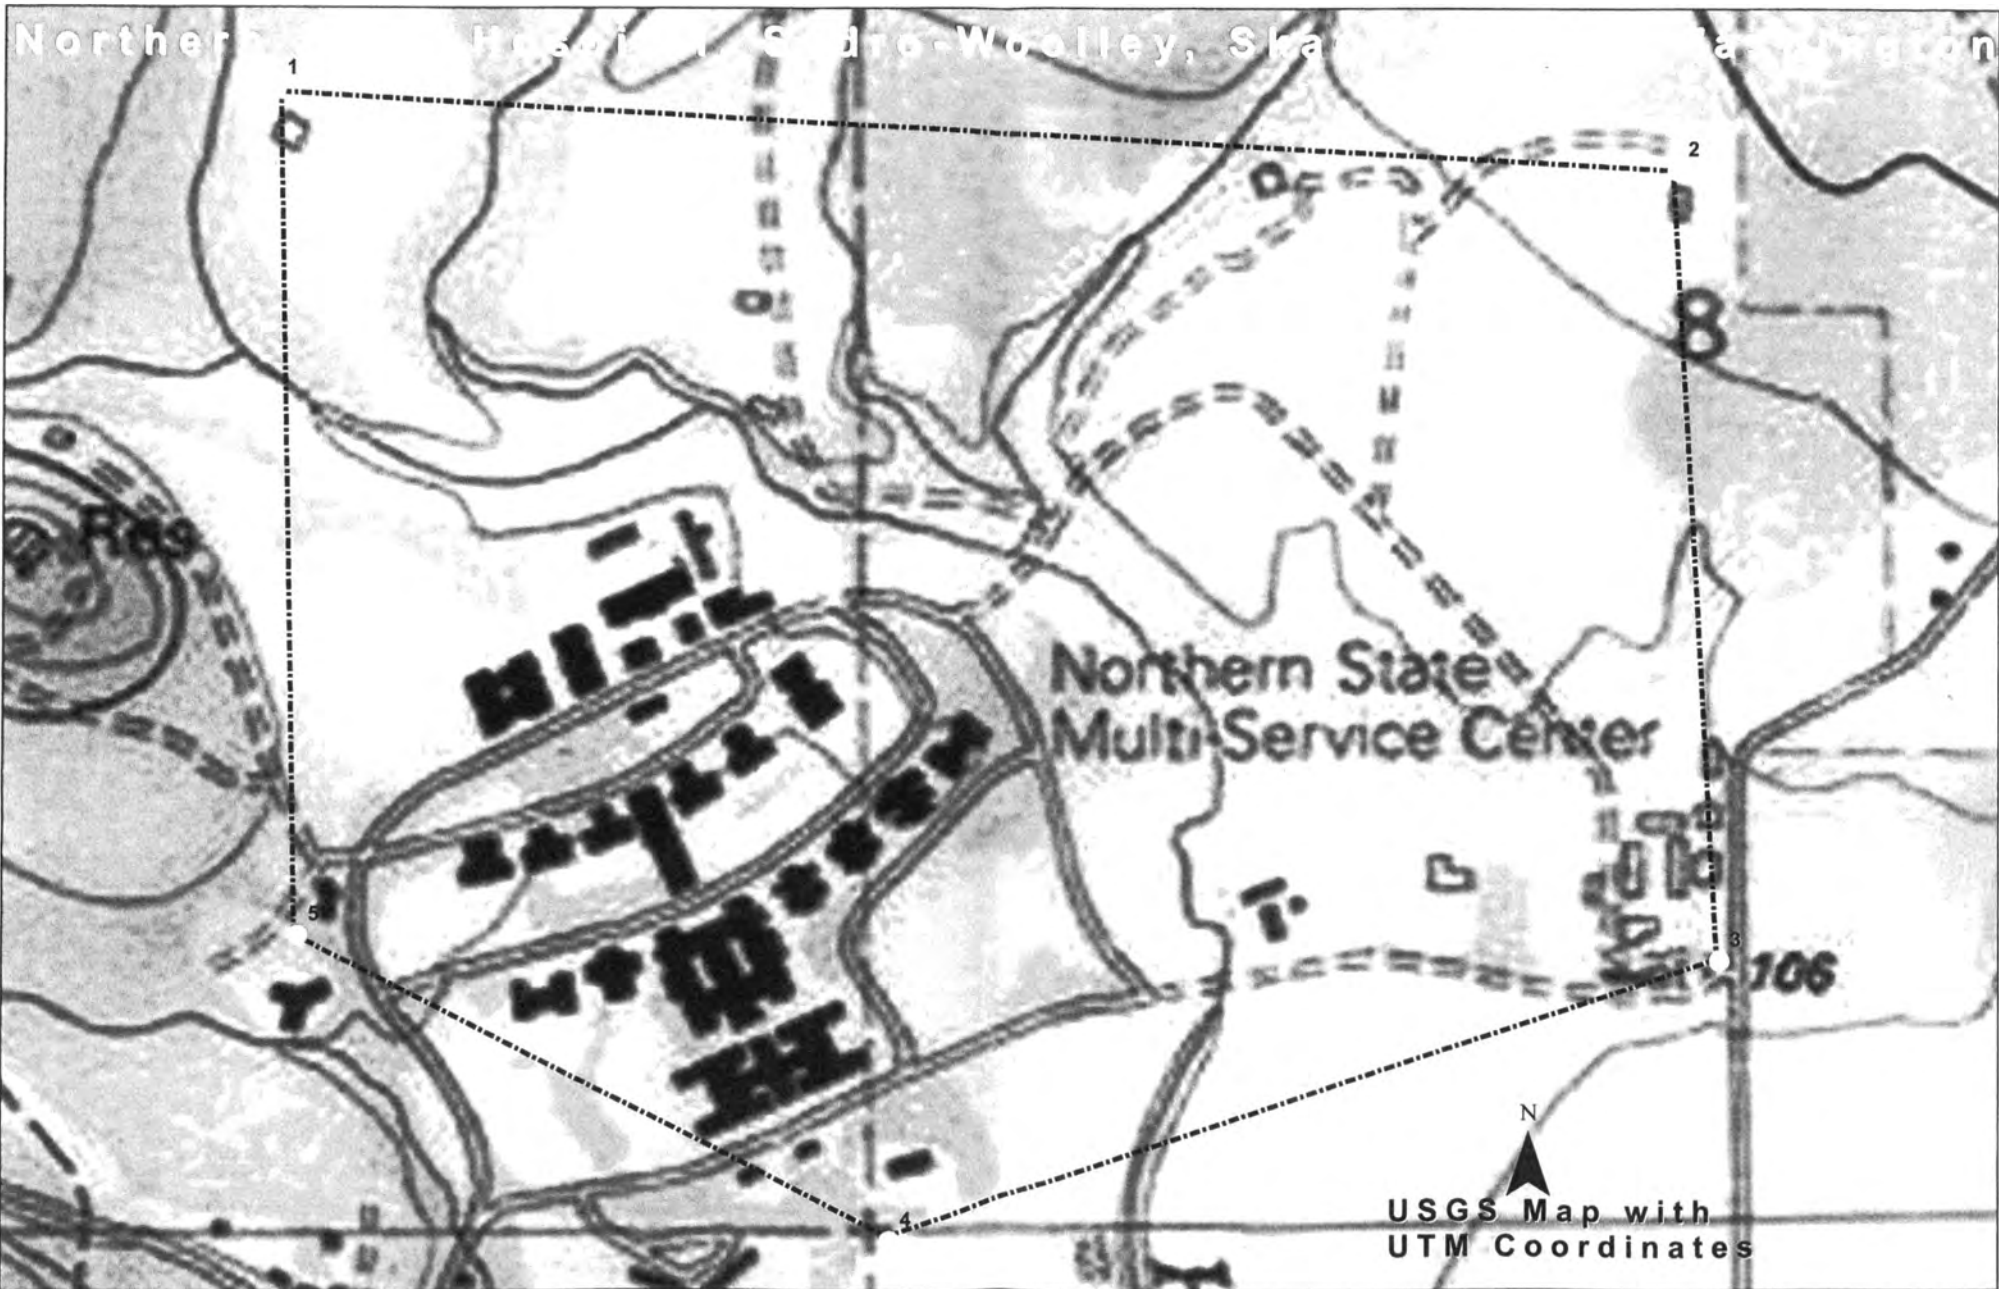
Northern State Hospital
Sedro-Woolley, Skagit County WA
NRHP District

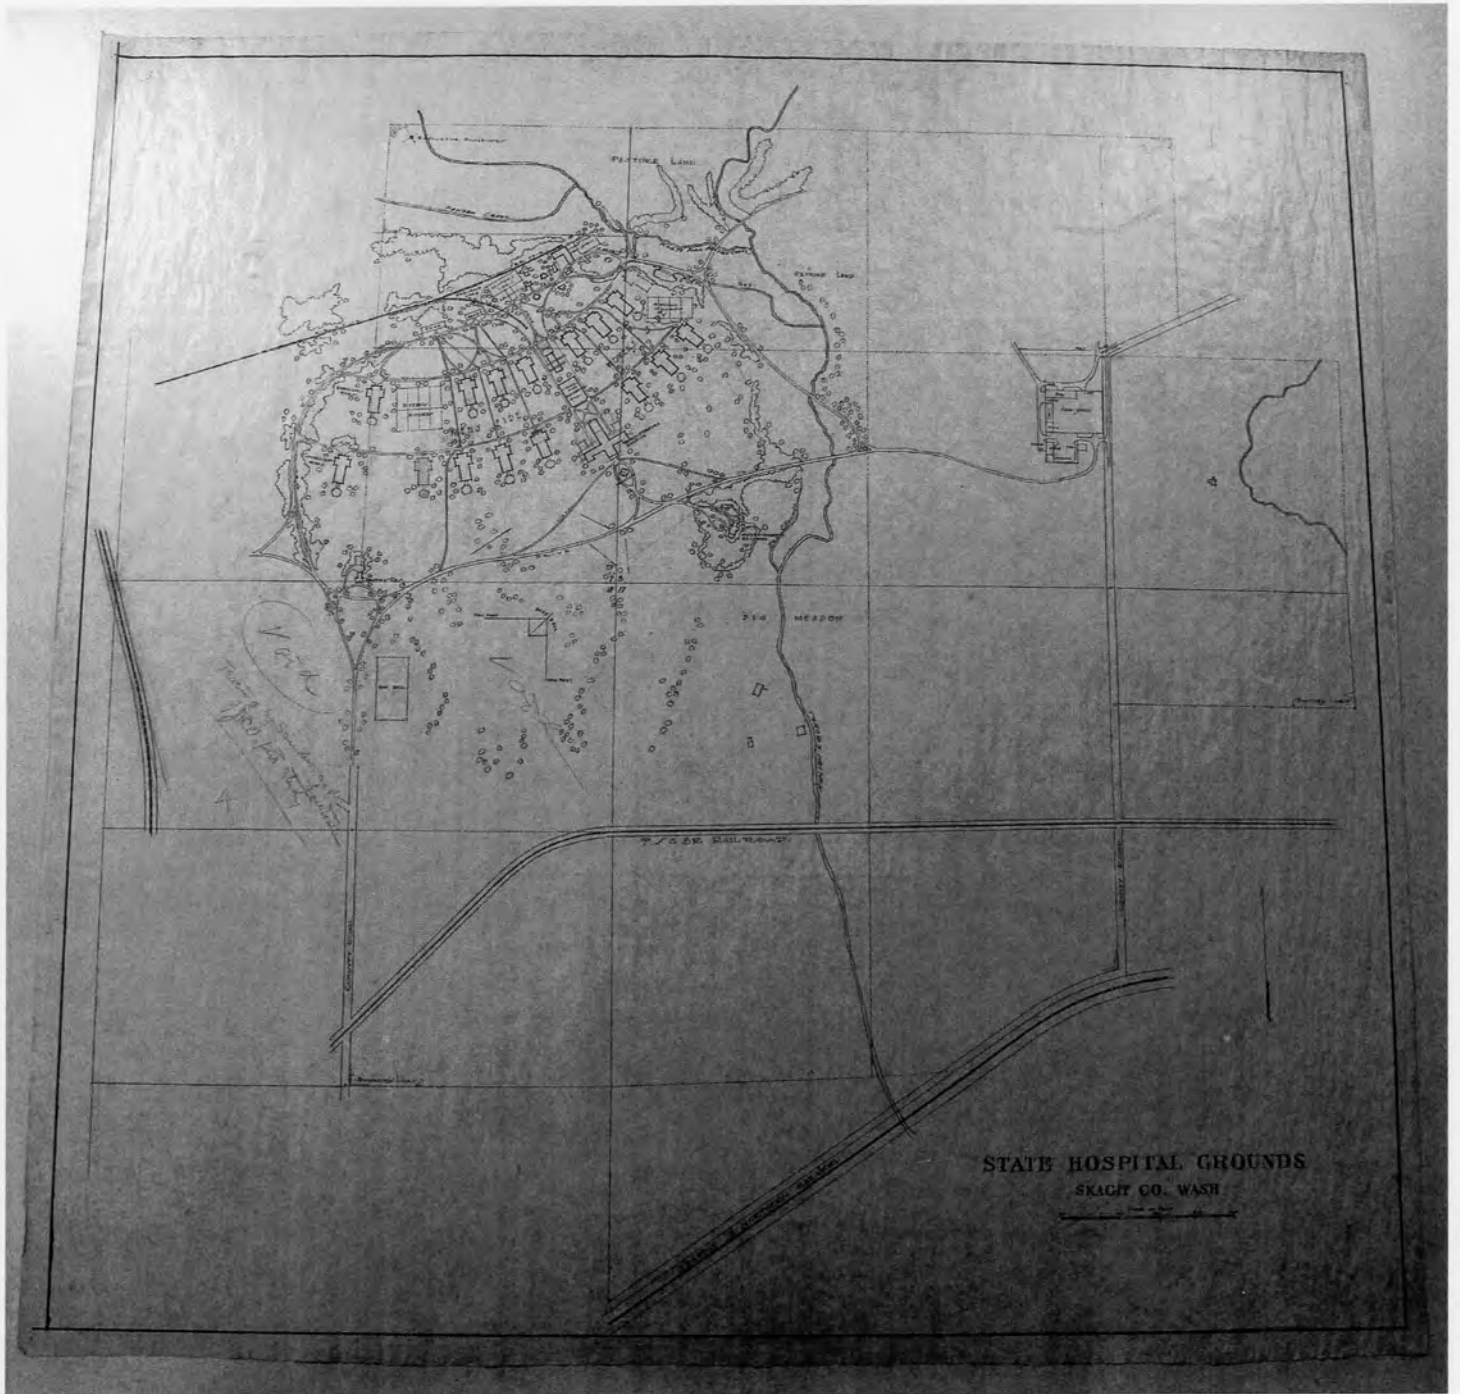
Undated, plan no. 4 prepared by the Olmsted Brothers for NSH. Source: Courtesy of the Olmsted National Historic Site, Brookline, MA.

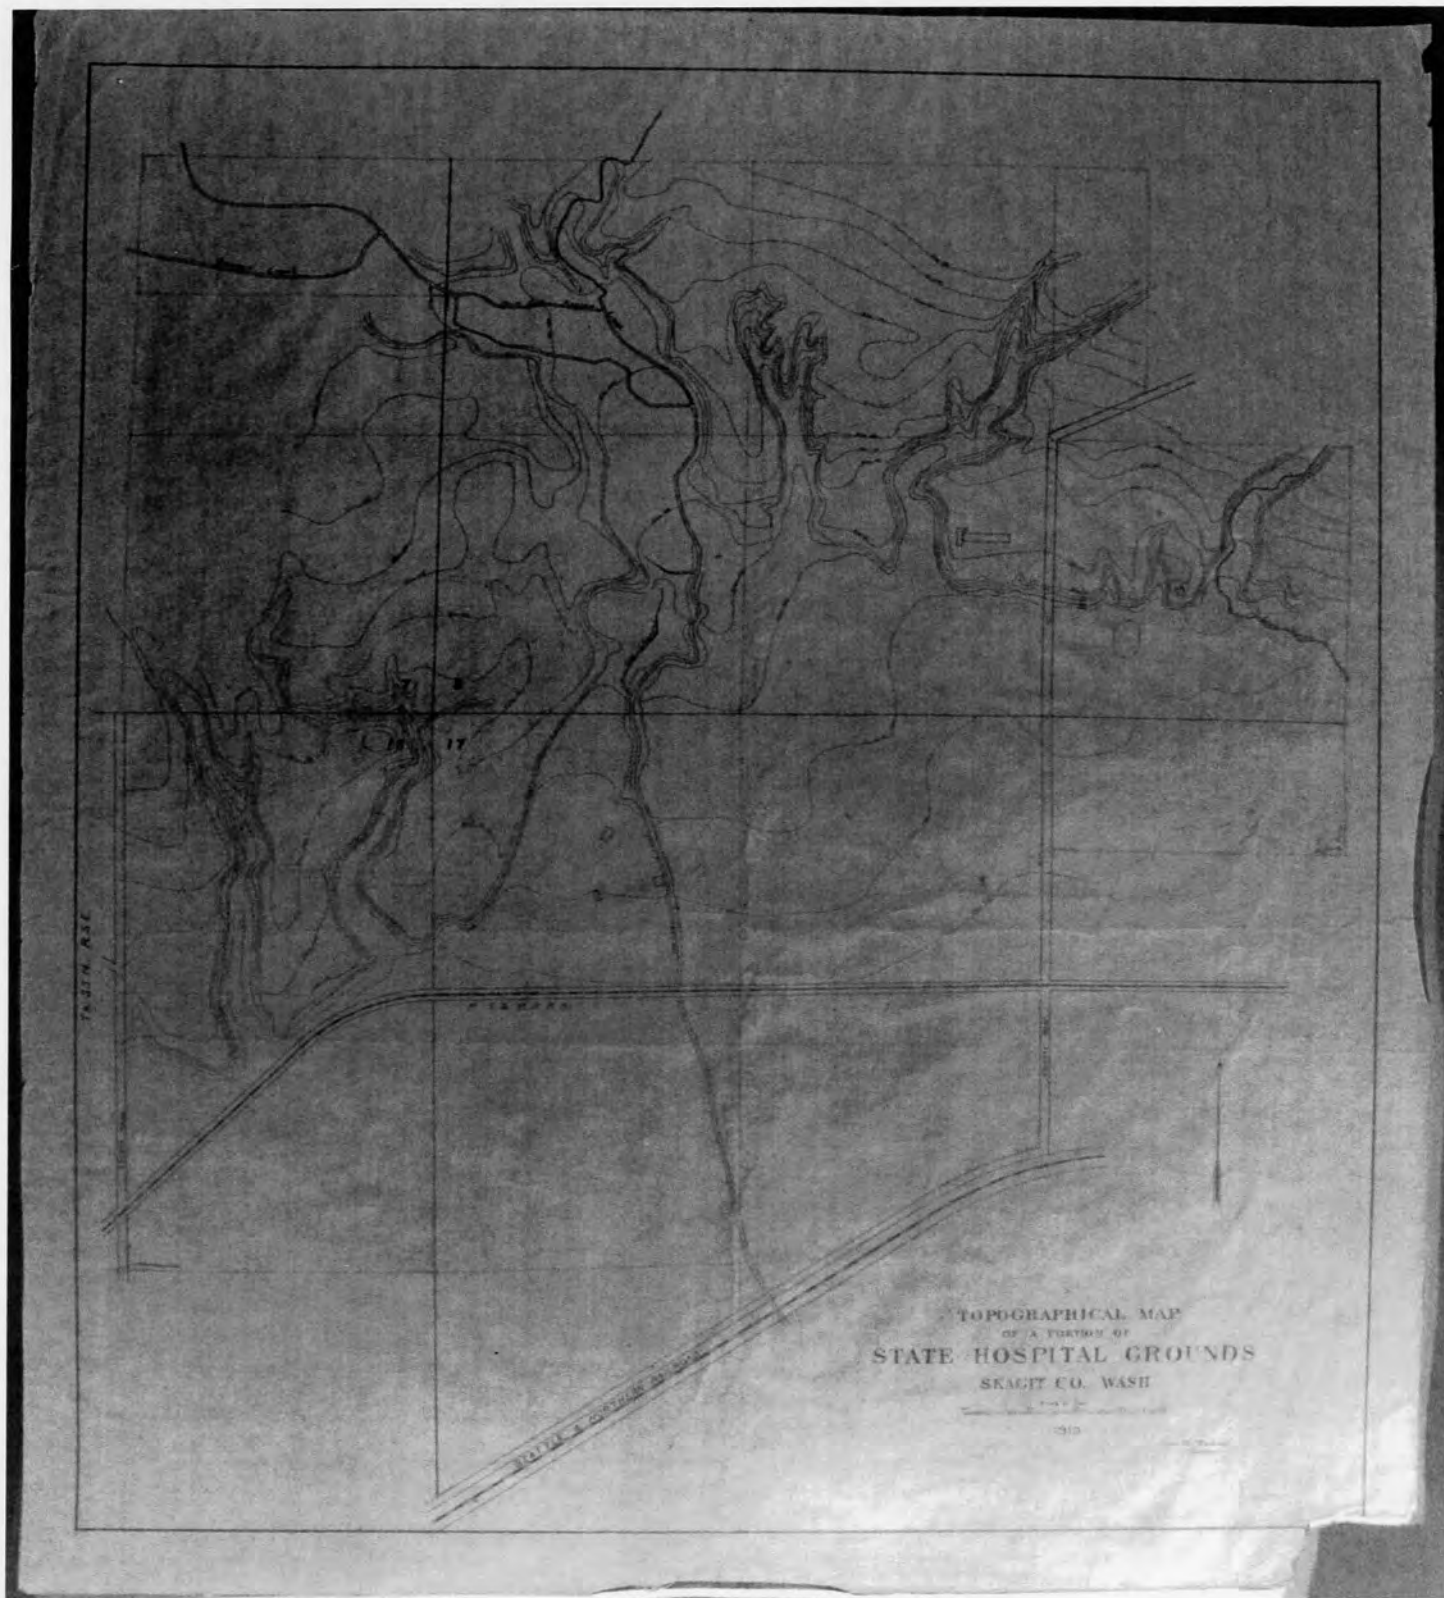
Plan no. 7, Topographical Map of a Portion of State Hospital Grounds, dated 1910 prepared by John W. Meehan, surveyor. Source: Courtesy of the Olmsted National Historic Site, Brookline, MA.

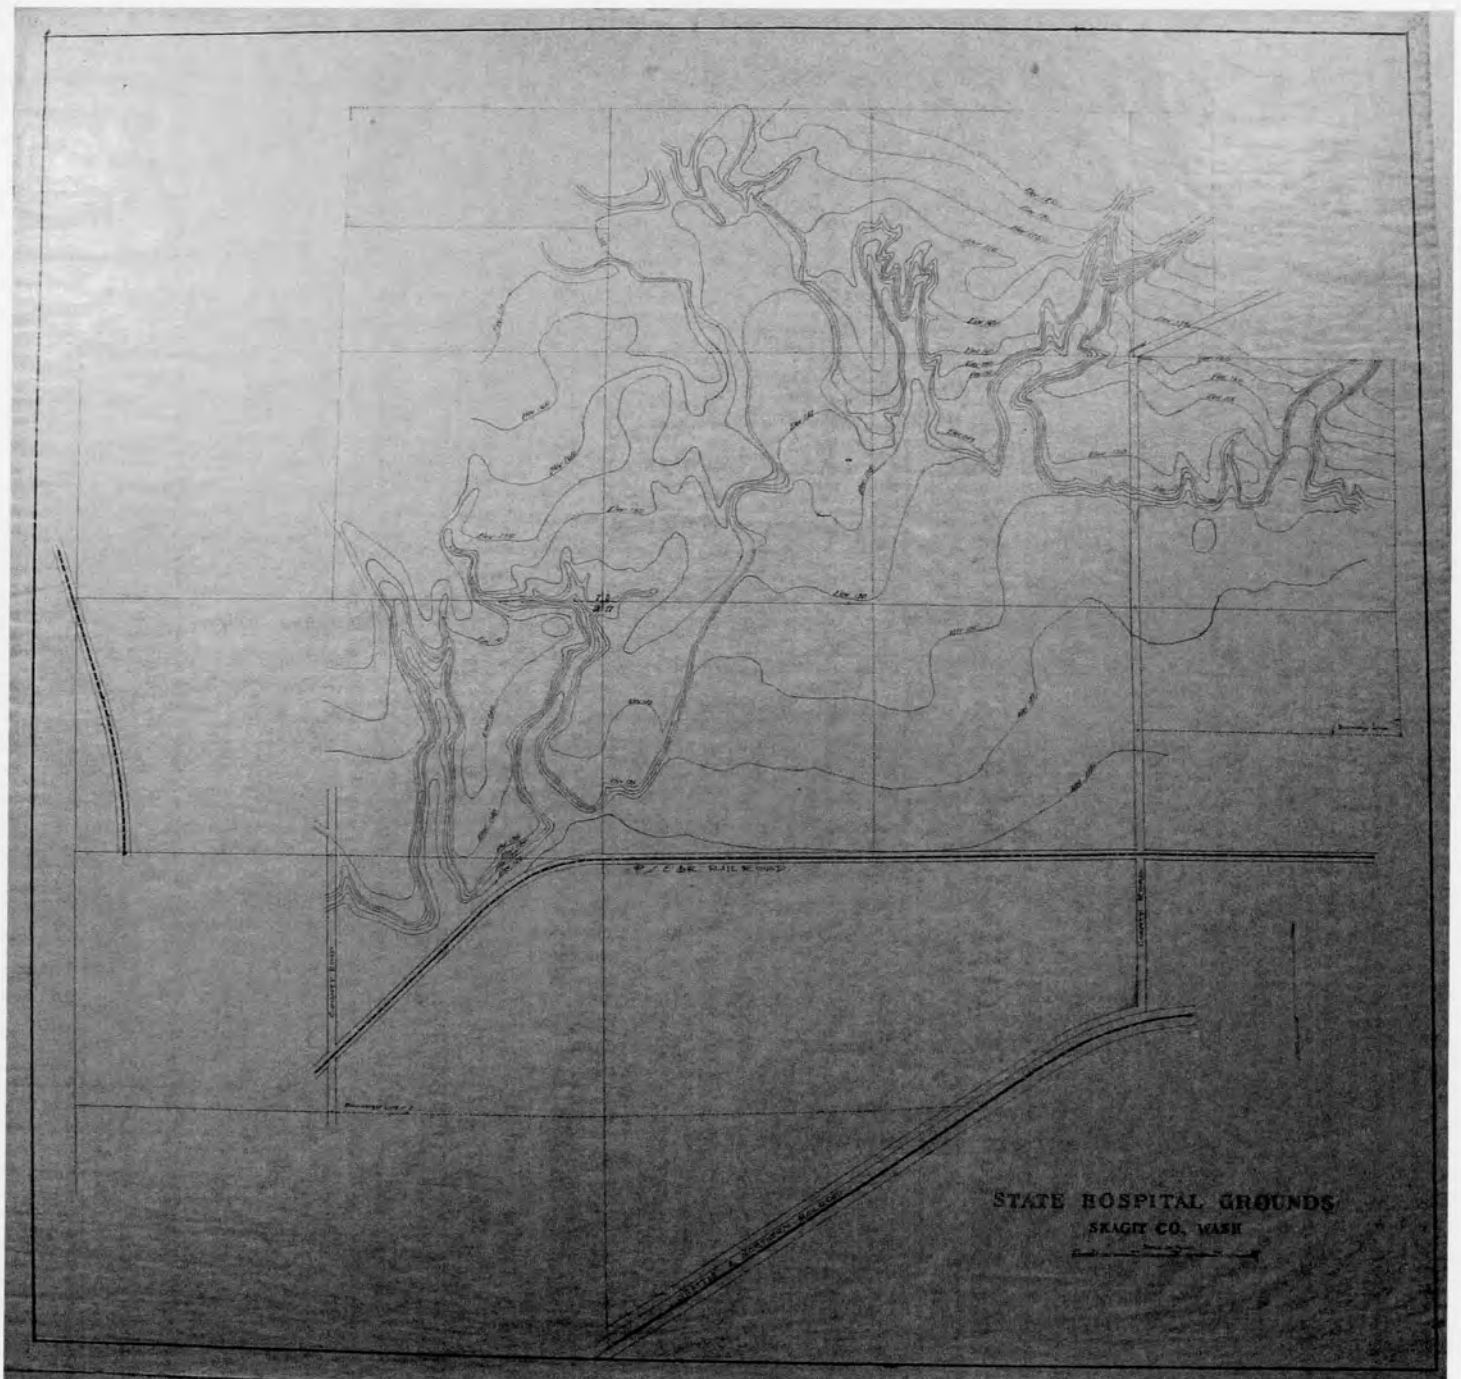
Undated, plan no. 11 prepared by the Olmsted Brothers for NSH. Source: Courtesy of the Olmsted National Historic Site, Brookline, MA.

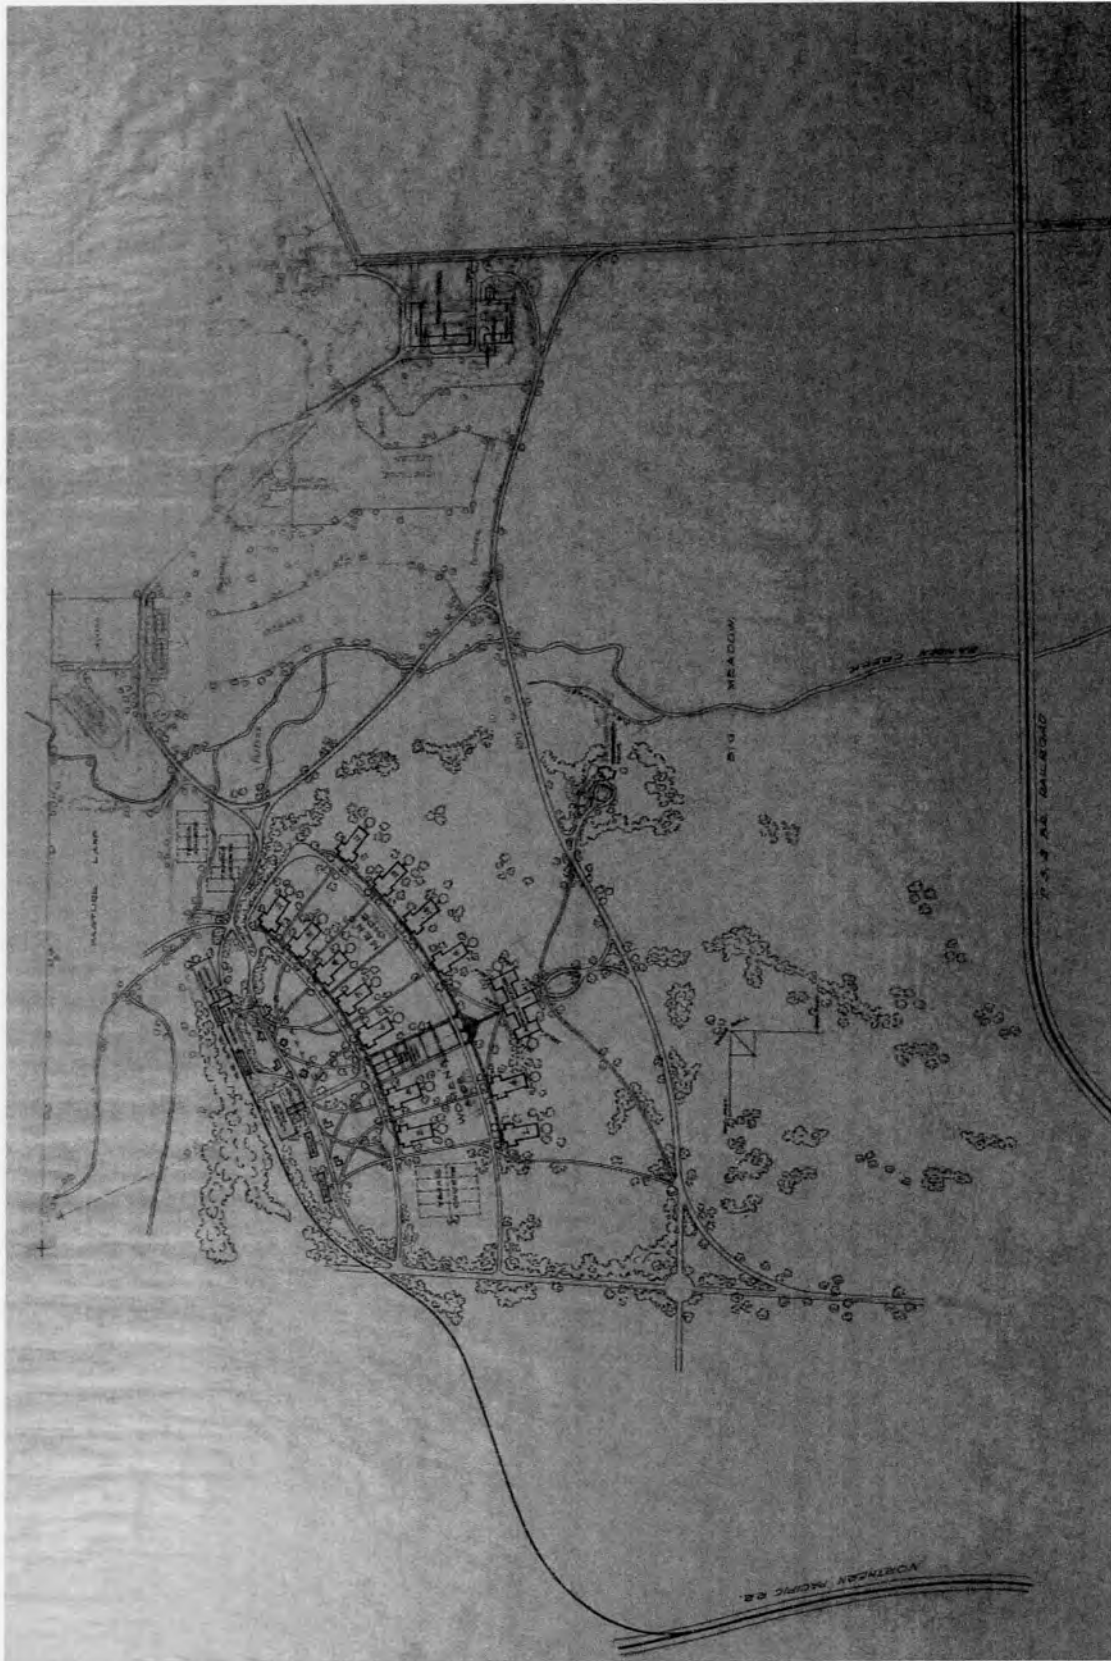
Undated, plan no. 12 prepared by the Olmsted Brothers for NSH. Source: Courtesy of the Olmsted National Historic Site, Brookline, MA.

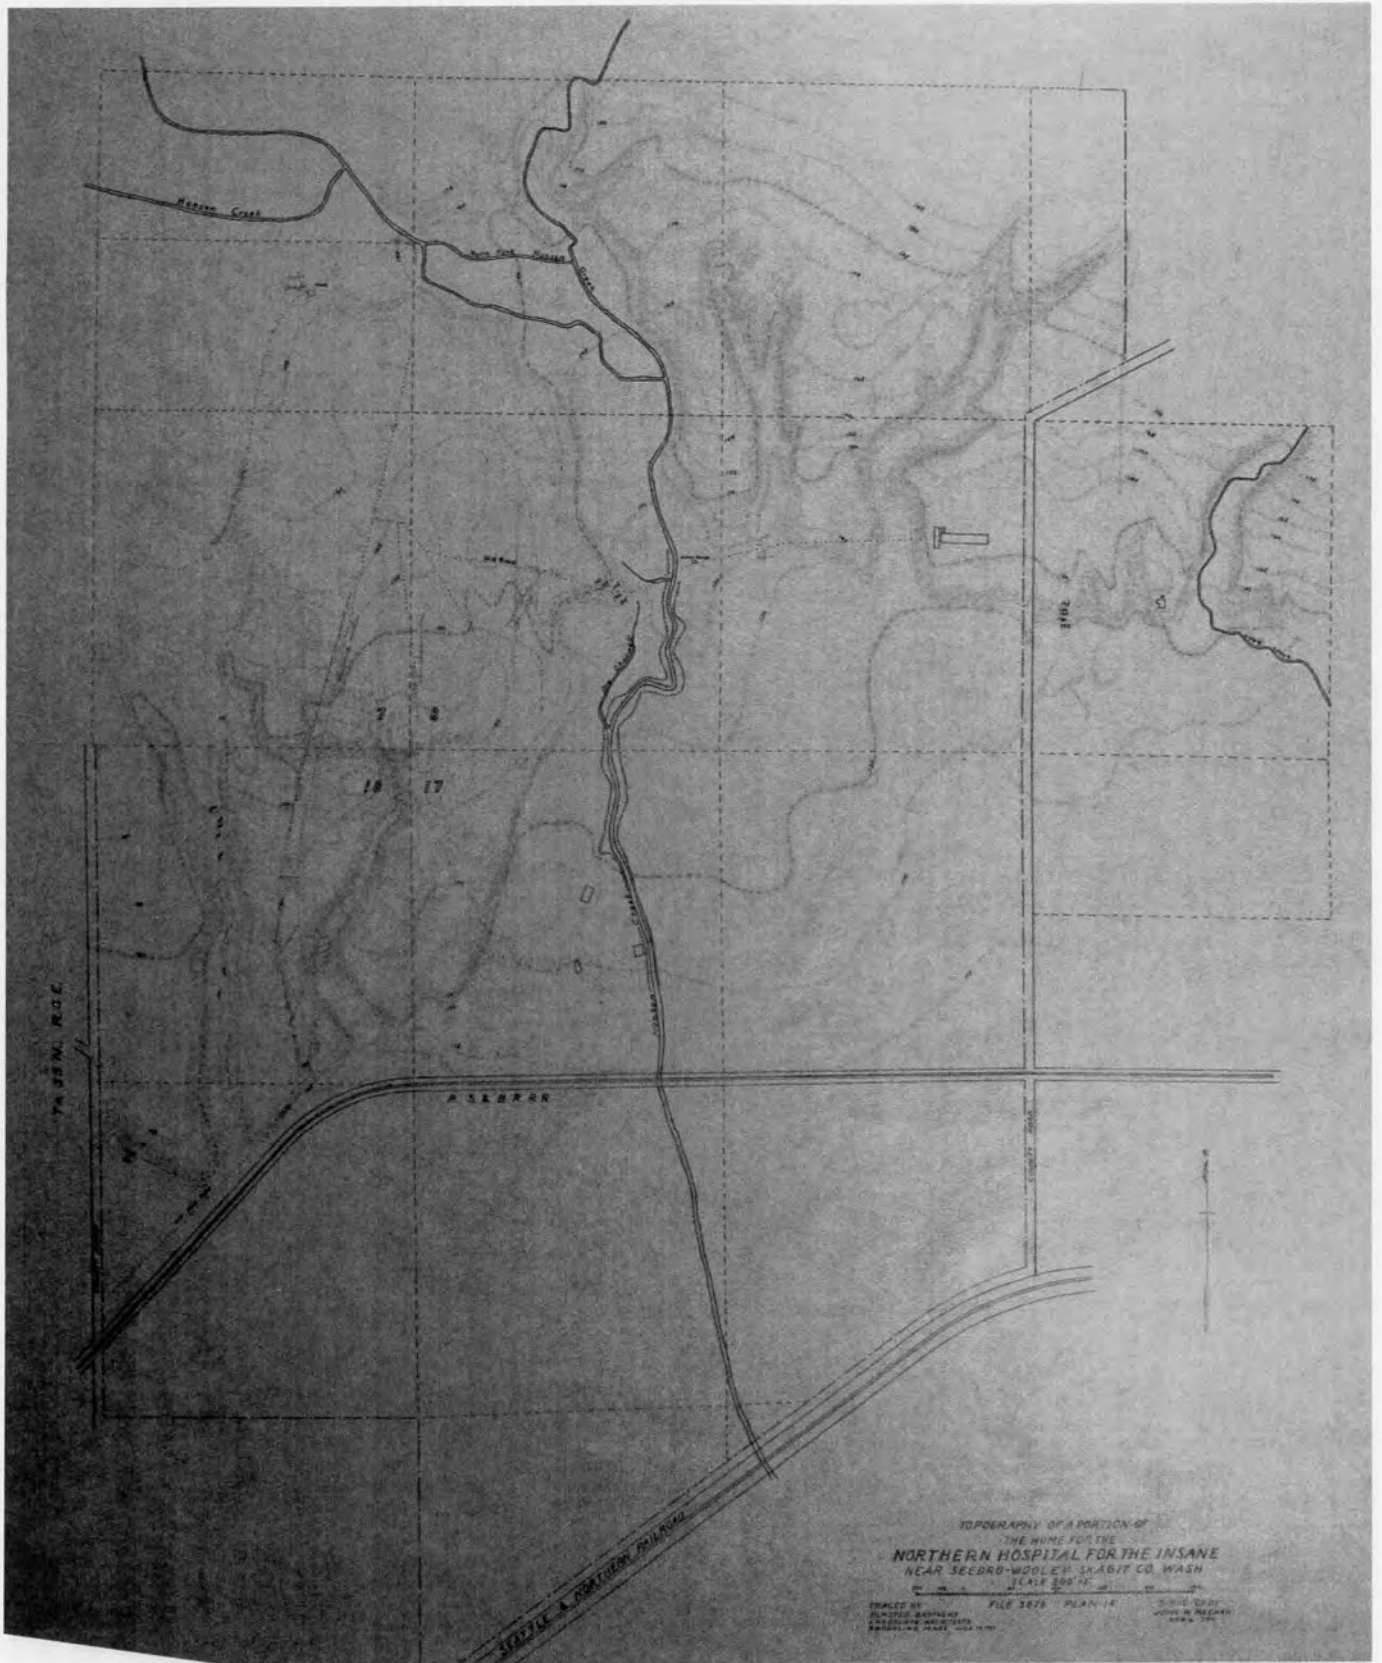
Plan no. 14. Meehan completed the survey work for the drawing in April of 1911. The Olmsted Brothers traced Meehan's topographical data on July 19, 1911. Source: Courtesy of the Olmsted National Historic Site, Brookline, MA.

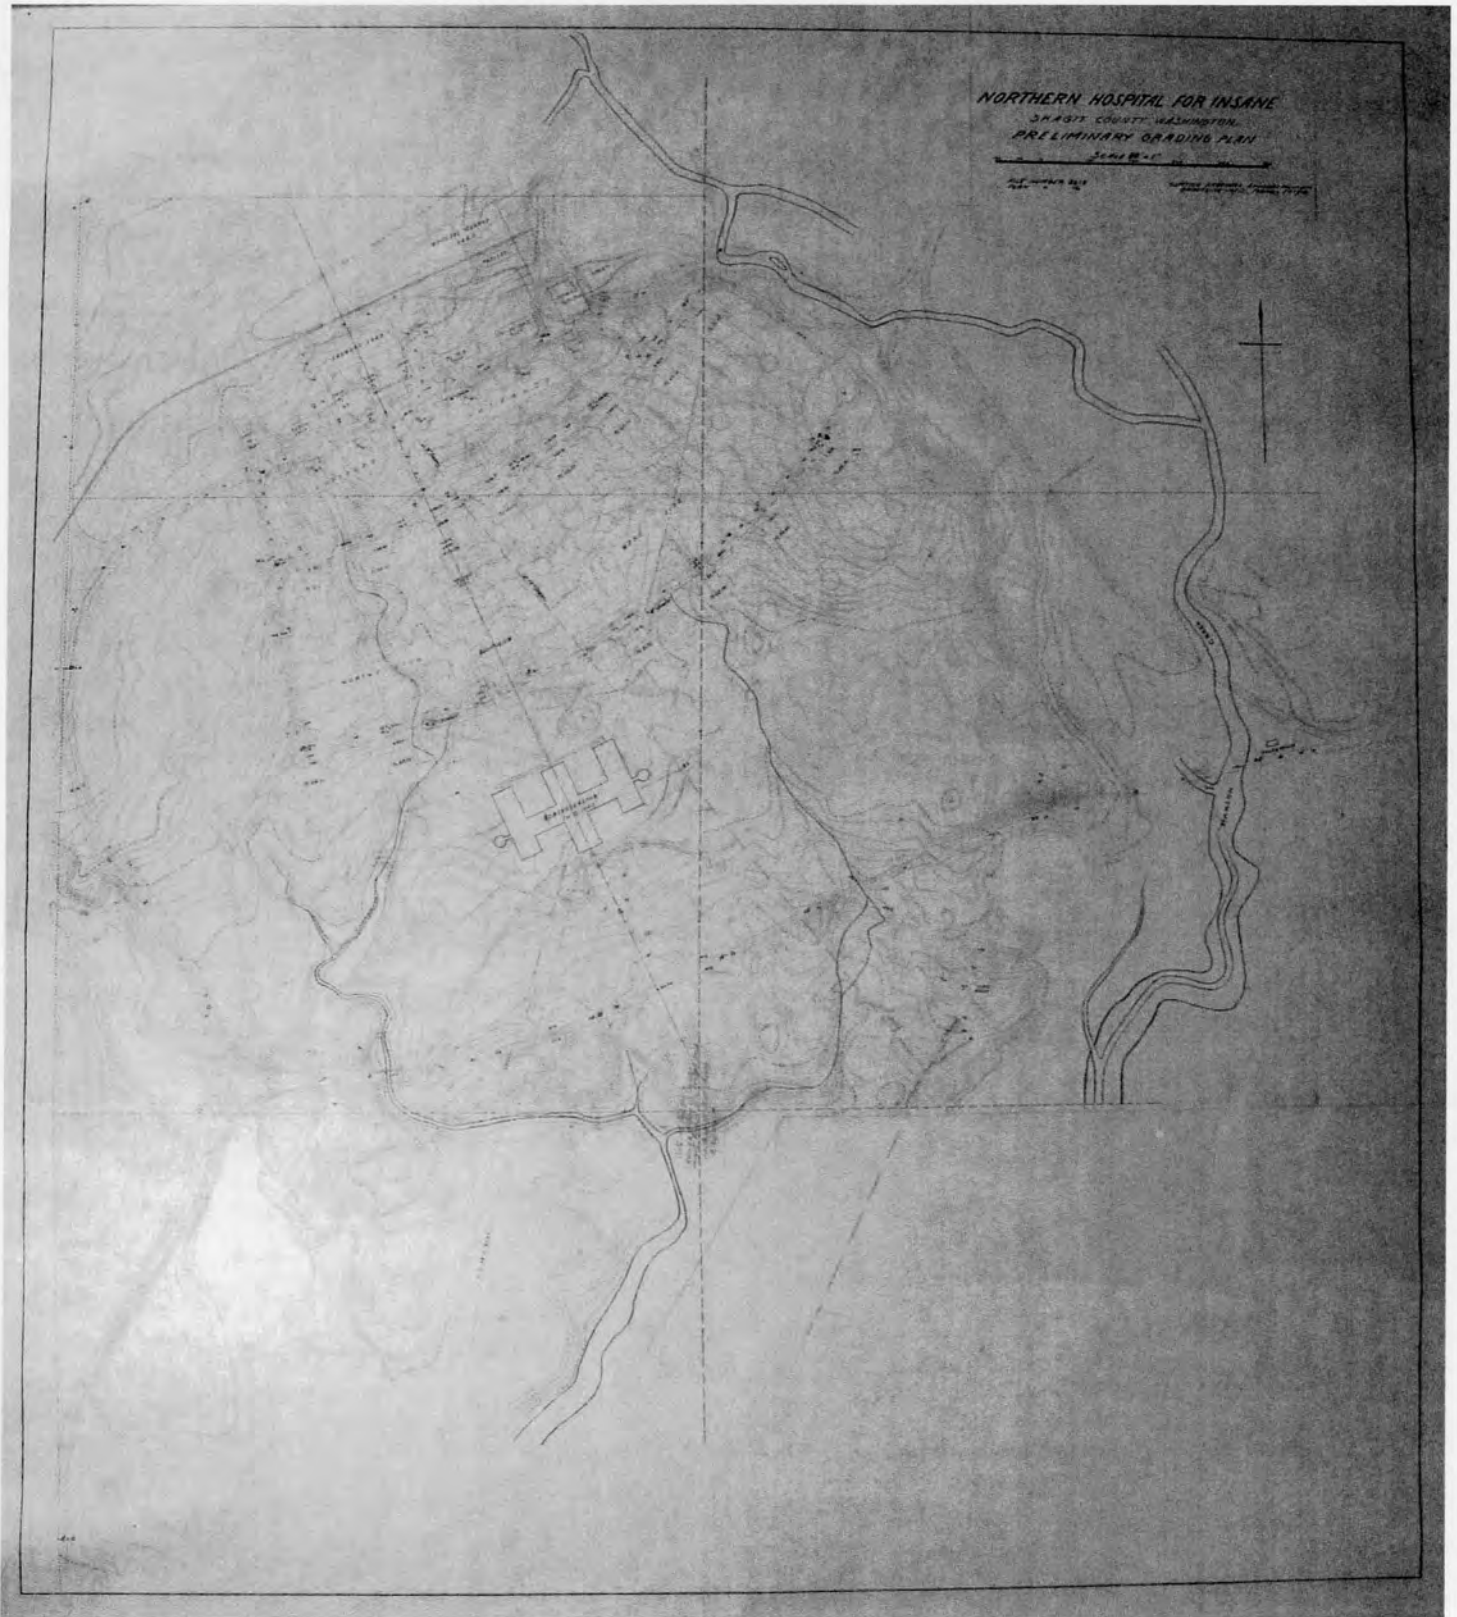
Plan no. 16, sheet 1 the Preliminary Grading Plan dated February, 1912. Source: Courtesy of the Olmsted National Historic Site, Brookline, MA.

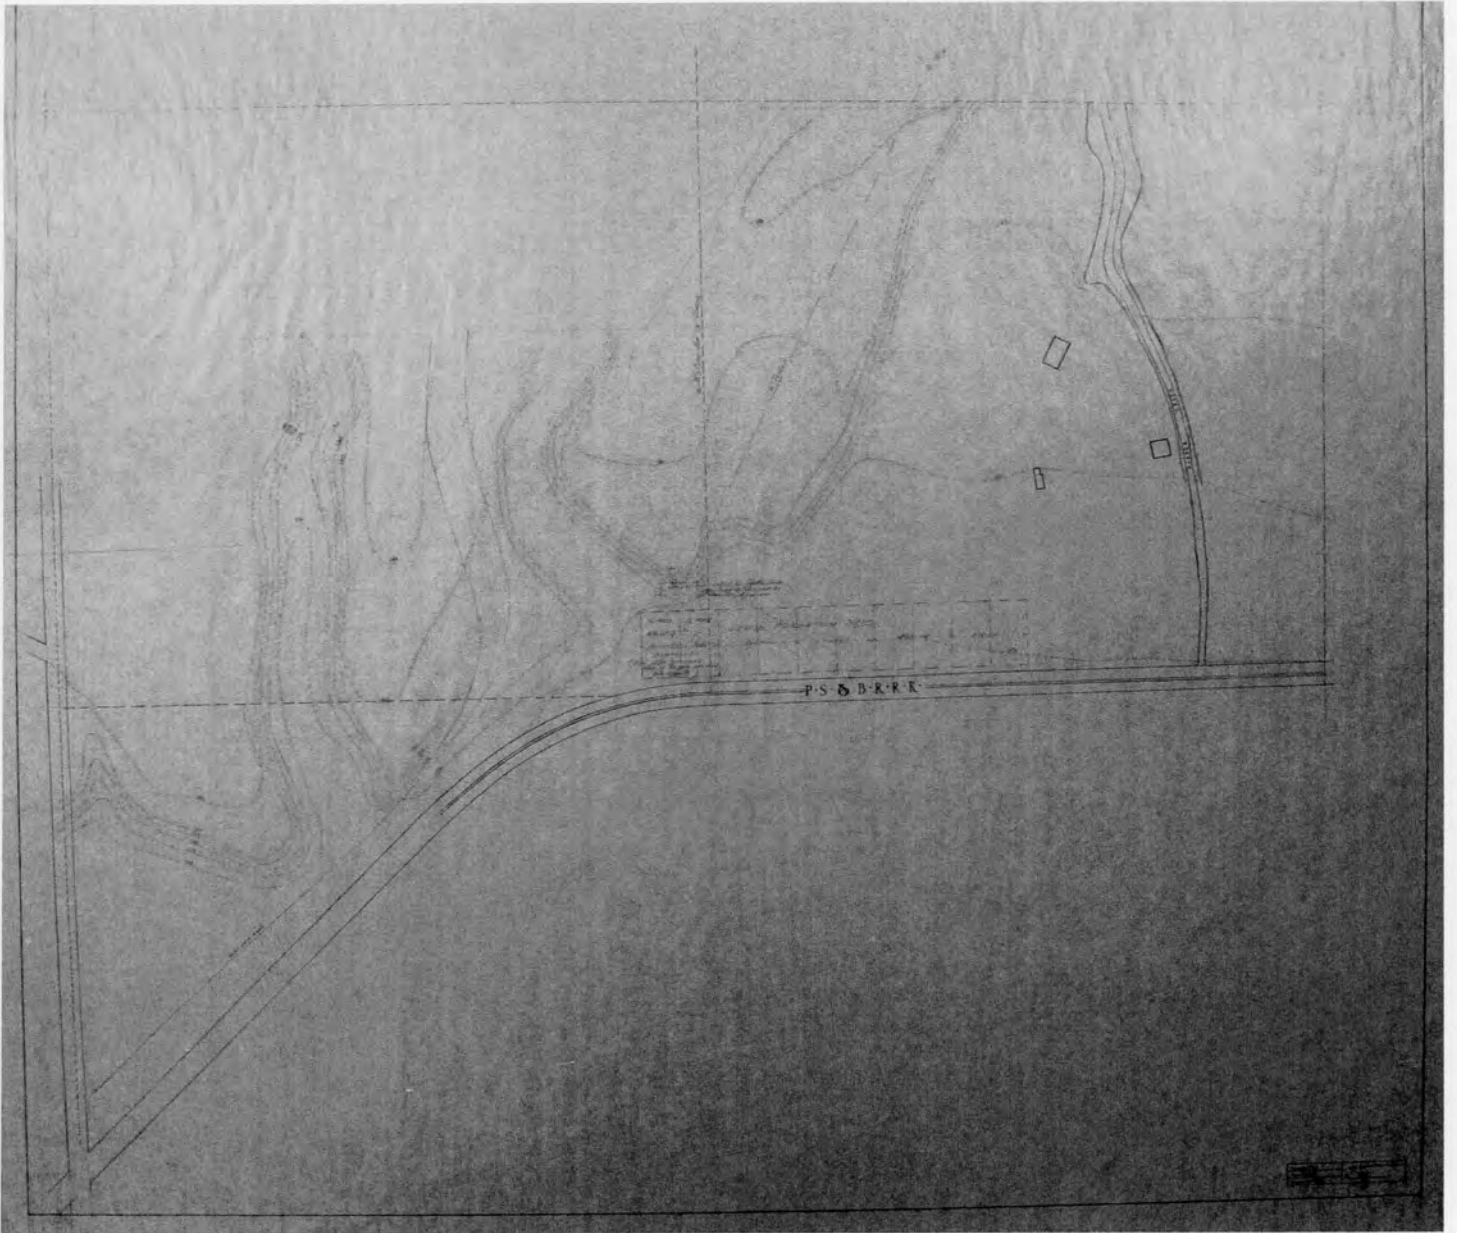
Plan no. 16, sheet 2 of the Preliminary Grading Plan. Source: Courtesy of the Olmsted National Historic Site, Brookline, MA.

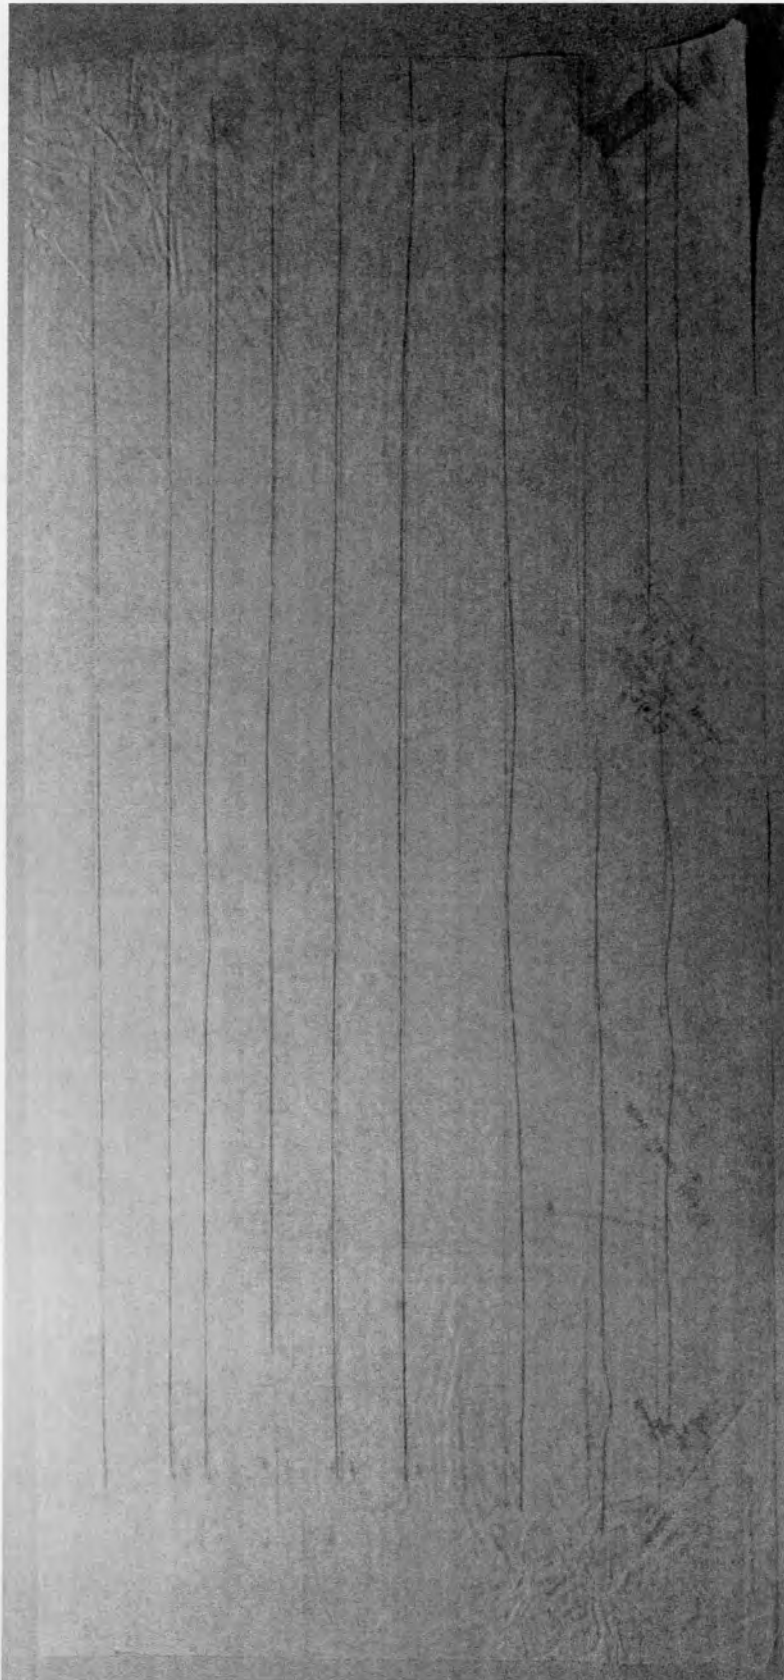
Plan no. 22 prepared by the Olmsted Brothers for NSH showing section data for grading. Source: Courtesy of the Olmsted National Historic Site, Brookline, MA.

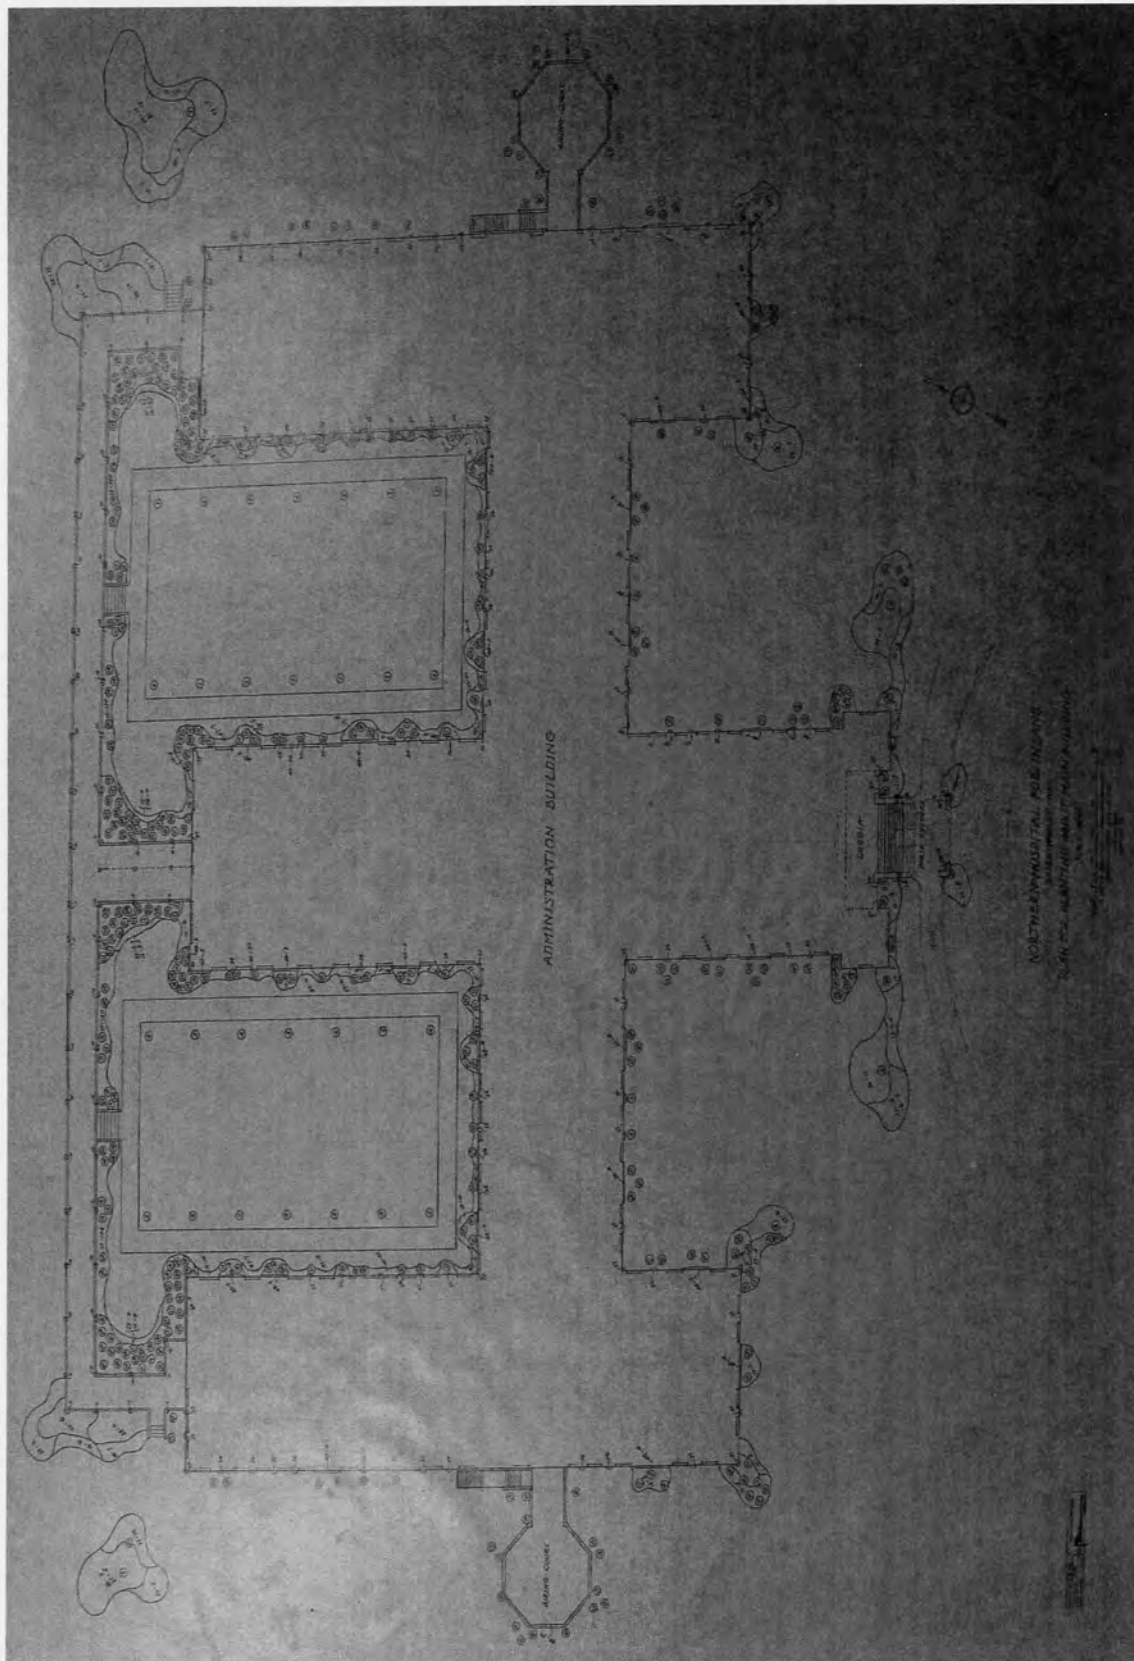
Plan no. 26 prepared by the Olmsted Brothers for NSH showing the planting plan around the Administration Building. Source: Courtesy of the Olmsted National Historic Site, Brookline, MA.

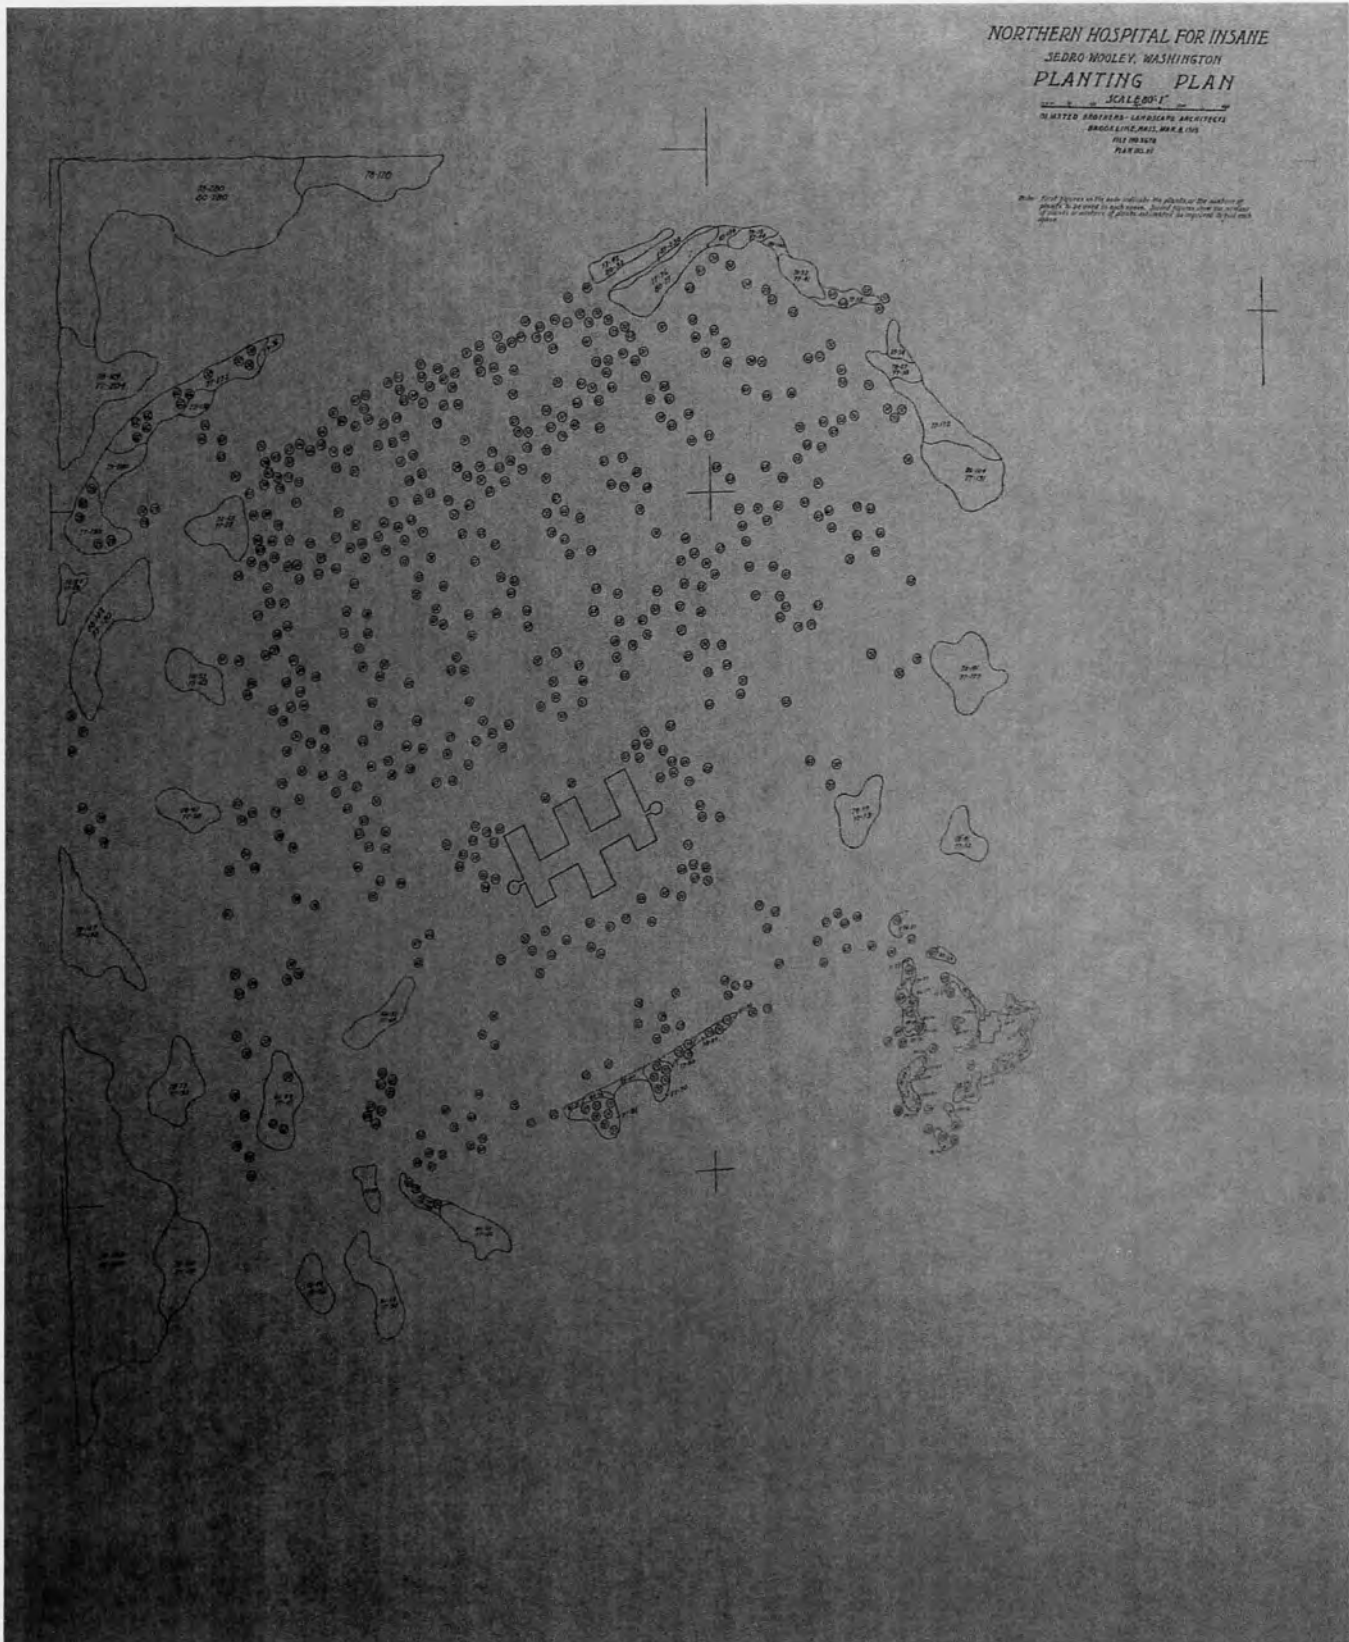
Plan no. 27 prepared by the Olmsted Brothers for NSH showing planting plan. Source: Courtesy of the Olmsted National Historic Site, Brookline, MA.
