National Register of Historic Places Registration Form

Historic name Northern State Hospital
Other names/site number Sedro-Wooley Insane Farm, Western State Hospital, North Cascades Gateway Center

Property ID & Resource Status Map

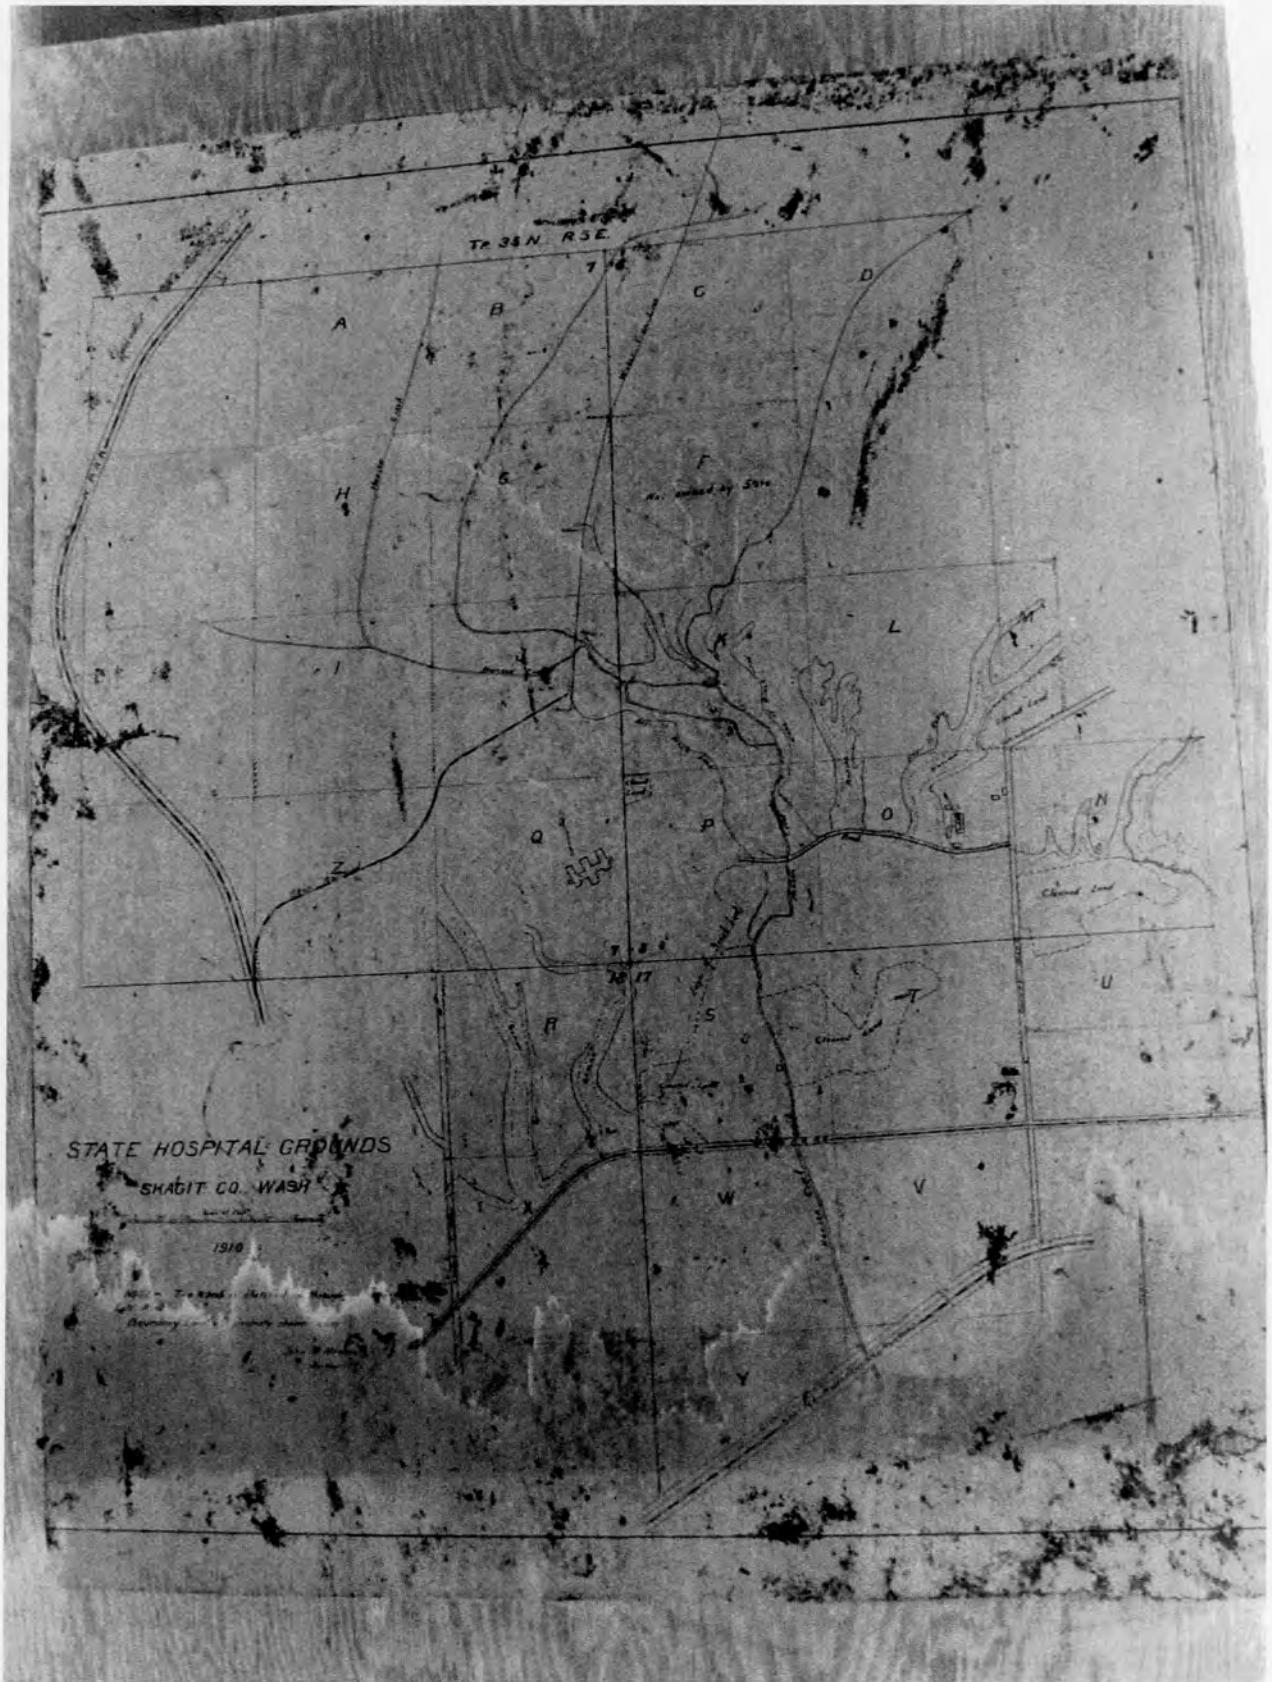
1910 survey of the State Hospital Grounds prepared by John W. Meehan, Surveyor. Source: North Cascades Gateway Center.

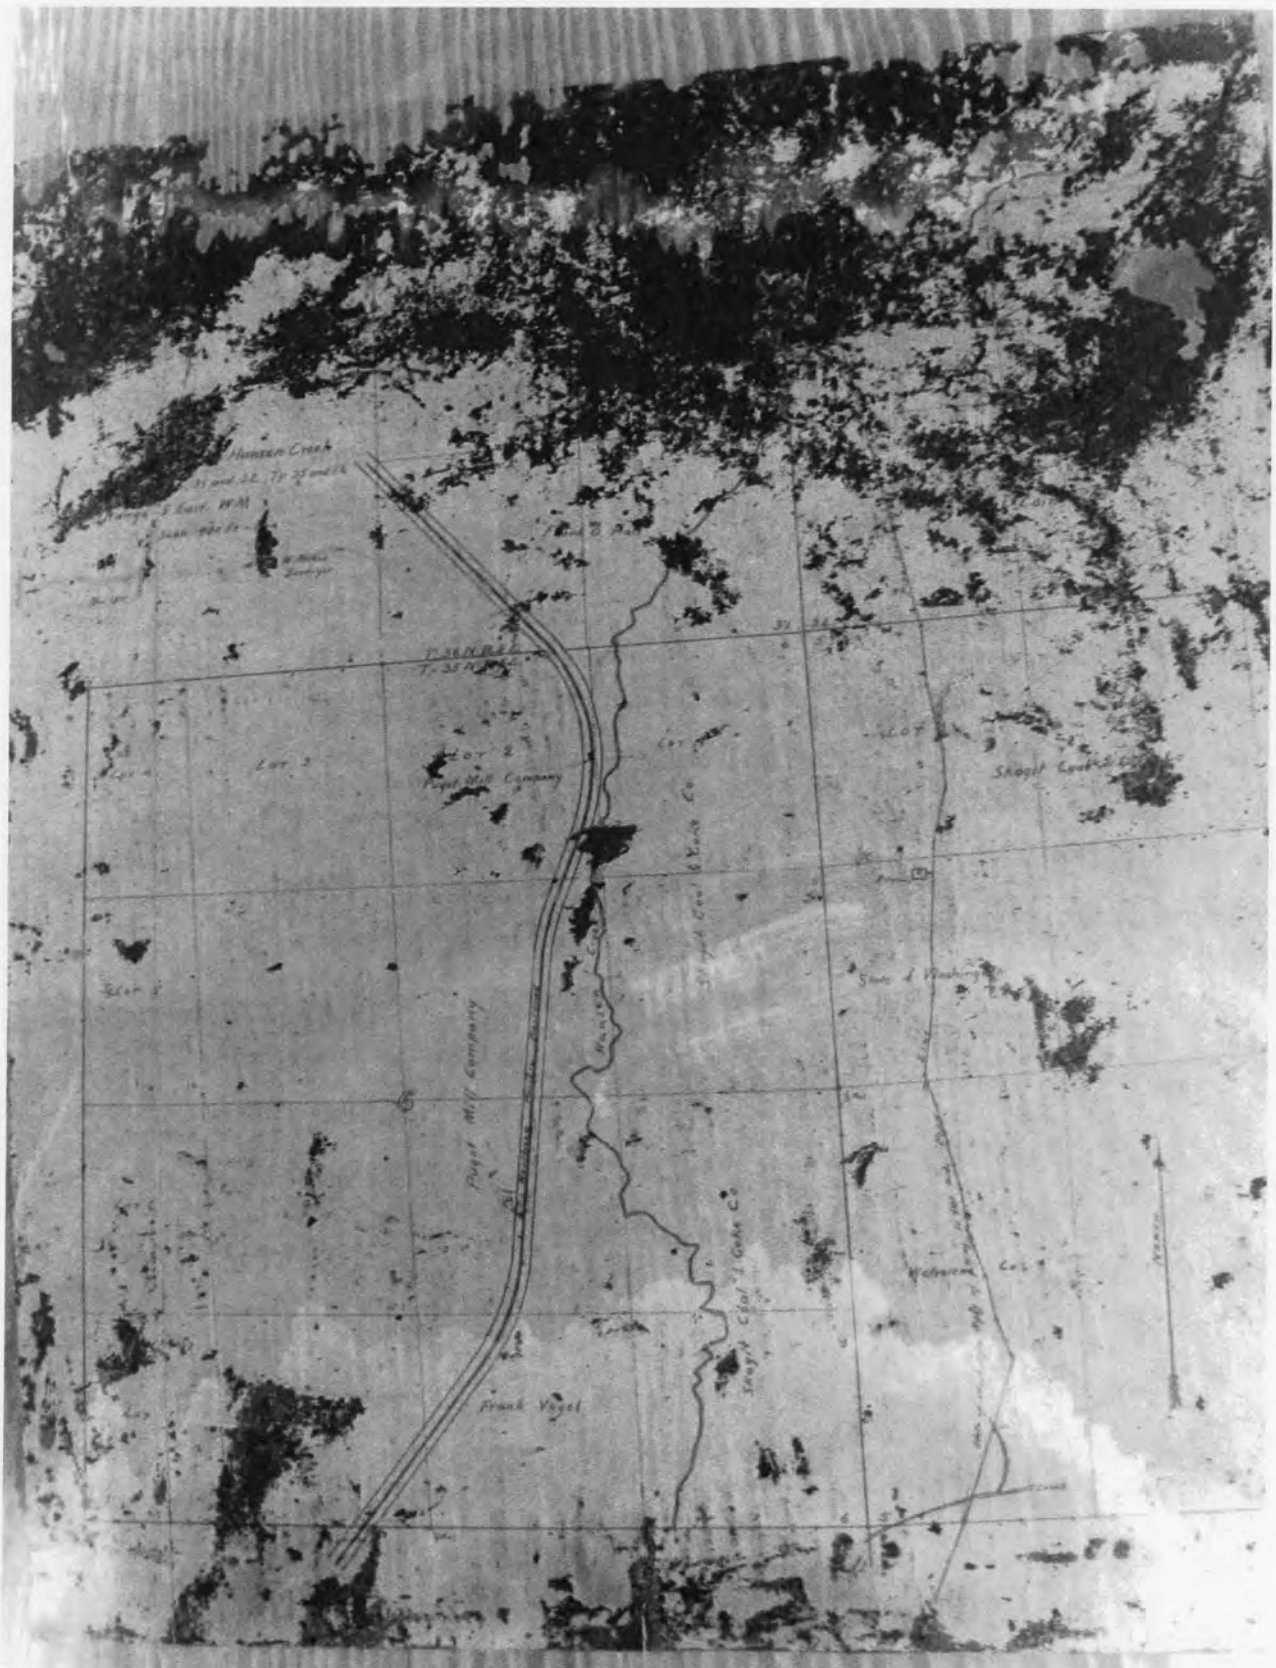
1910 survey of the land north of the State Hospital Grounds prepared by John W. Meehan, Surveyor. Source: North Cascades Gateway Center.

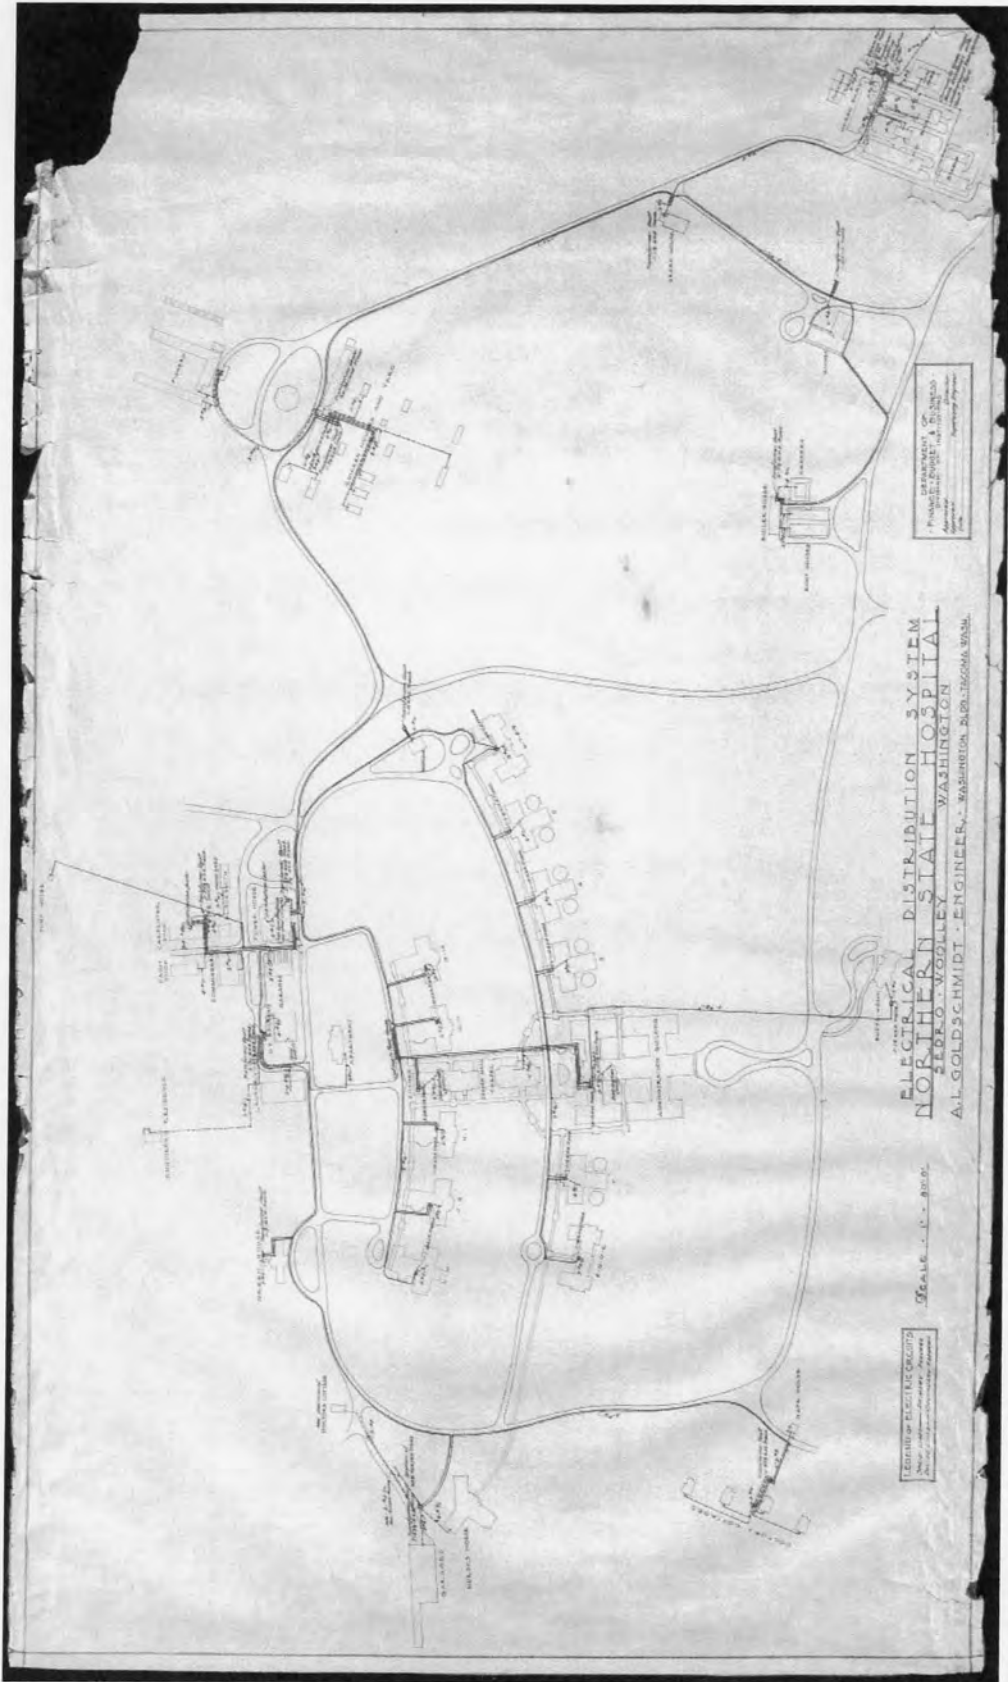
ca. 1940 Electrical Distribution Plan prepared by A. L. Goldschmidt, Engineer. Source: Washington State Archives.

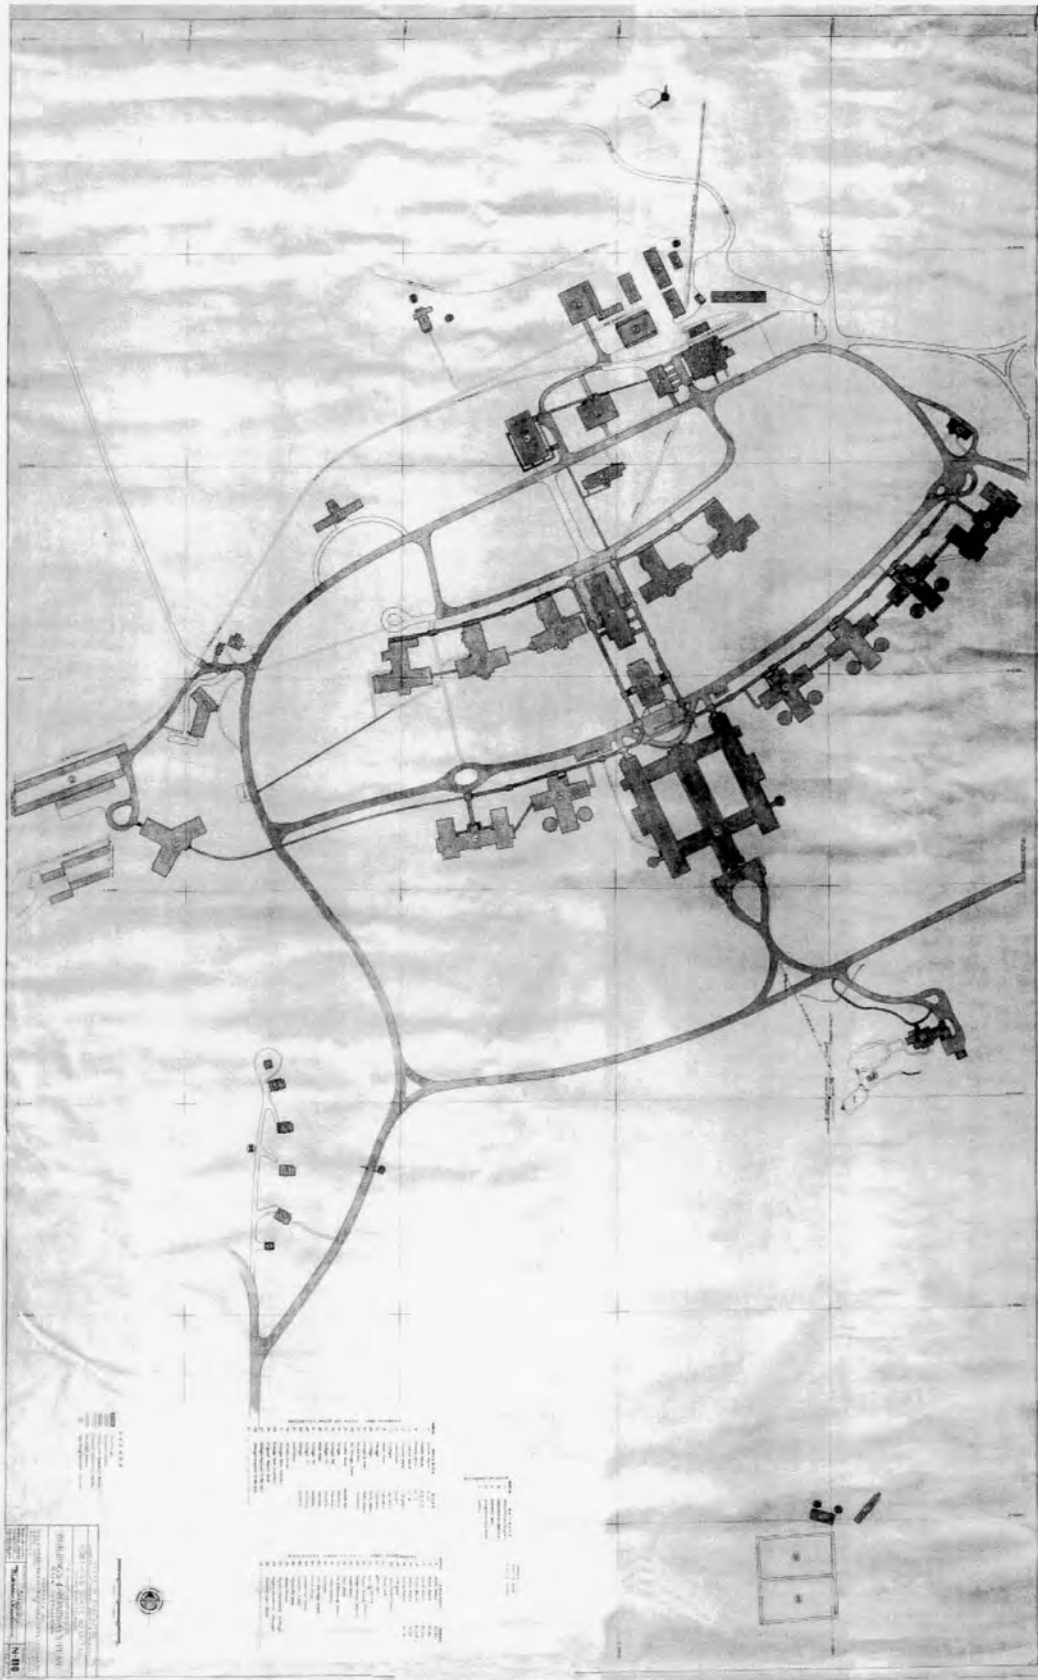
1944 Buildings & Roadways Plan prepared by architects Narramore, Brady, Bain, Grainger, Johanson for NSH. Source: Washington State Archives.

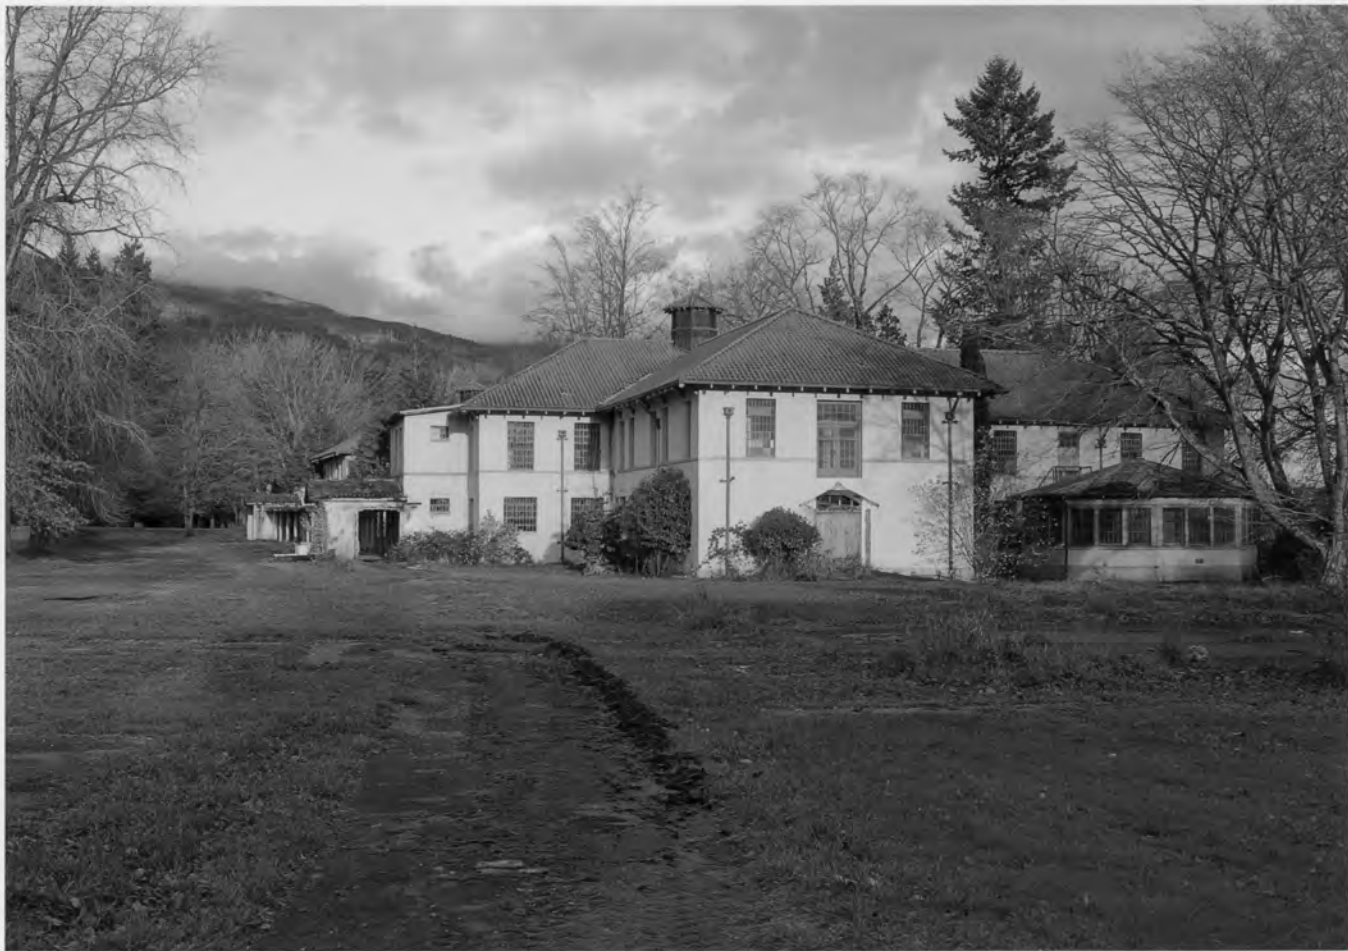
6 of 57

Ward #4, Northern State Hospital
Skagit County, Washington
Mary McGoffin
November 11, 2009
West elevation of building

Description: These wards are two story buildings on a T-shaped footprint with octagonal sunrooms. Foundations are poured concrete, walls are stucco and roof is clay tile except for sunrooms, which have seam metal. Windows are steel casement with many broken panes. Metal gutters have corroded and water is entering the buildings undermining the foundations. Where the roof ridgelines intersect, copper-covered cupolas sit. Inside, the entry vestibules are in poor condition with plaster missing from the walls and next ceramic tiles missing from the floor. Corridor doors have transom lites. The maple flooring is buckling in areas. The roof framing is constructed using steel angles to create trusses, and steel "C" sections for the roof purlins and ceiling joists, from which the metal lath and plaster ceiling are hung. The roof decking is 2 x 6 inch tongue and groove boards.

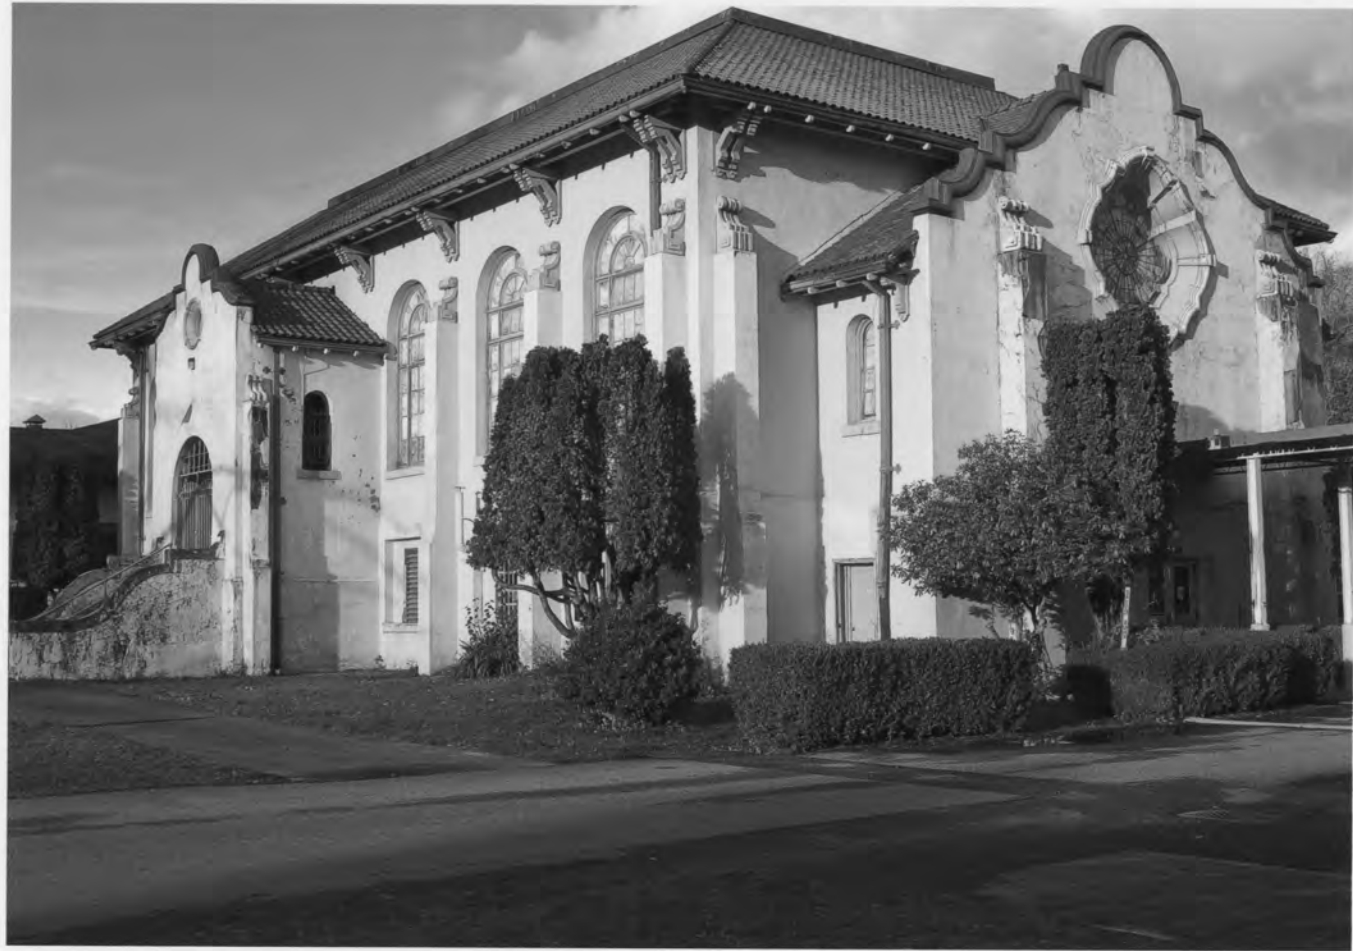
#18 of 57

Assembly Hall, Northern State Hospital
Skagit County, Washington
Mary McGoffin
November 11, 2009
Southwest elevation

Description: This 12,092 square foot two-story building is a typical concrete frame, hollow clay tile infill, stucco finish with numerous decorative details. The stained glass windows, including two large rosettes on the north and south ends are largely intact. The stucco finish has spalled off in several places exposing the clay tile. A covered entry and walkway have been added on the east end. The second story interior is an exposed open truss structure with paneled ceilings. Light fixtures are original. Maple flooring is in good condition. The face of both stages is quarter-sawn oak. The window stools, frames and casing are oak; a few are decaying. Large radiators located along the exterior walls operate in the winter to protect the building's interior. The projector booth retains some of its original equipment. The first floor exterior doors have been replaced with aluminum ones. The floor tile has been removed except in the bathrooms. Concrete support beams, columns and walls are plastered. Concrete stairs lead from the first floor to the stage above. This building stands as the centerpiece of the campus.

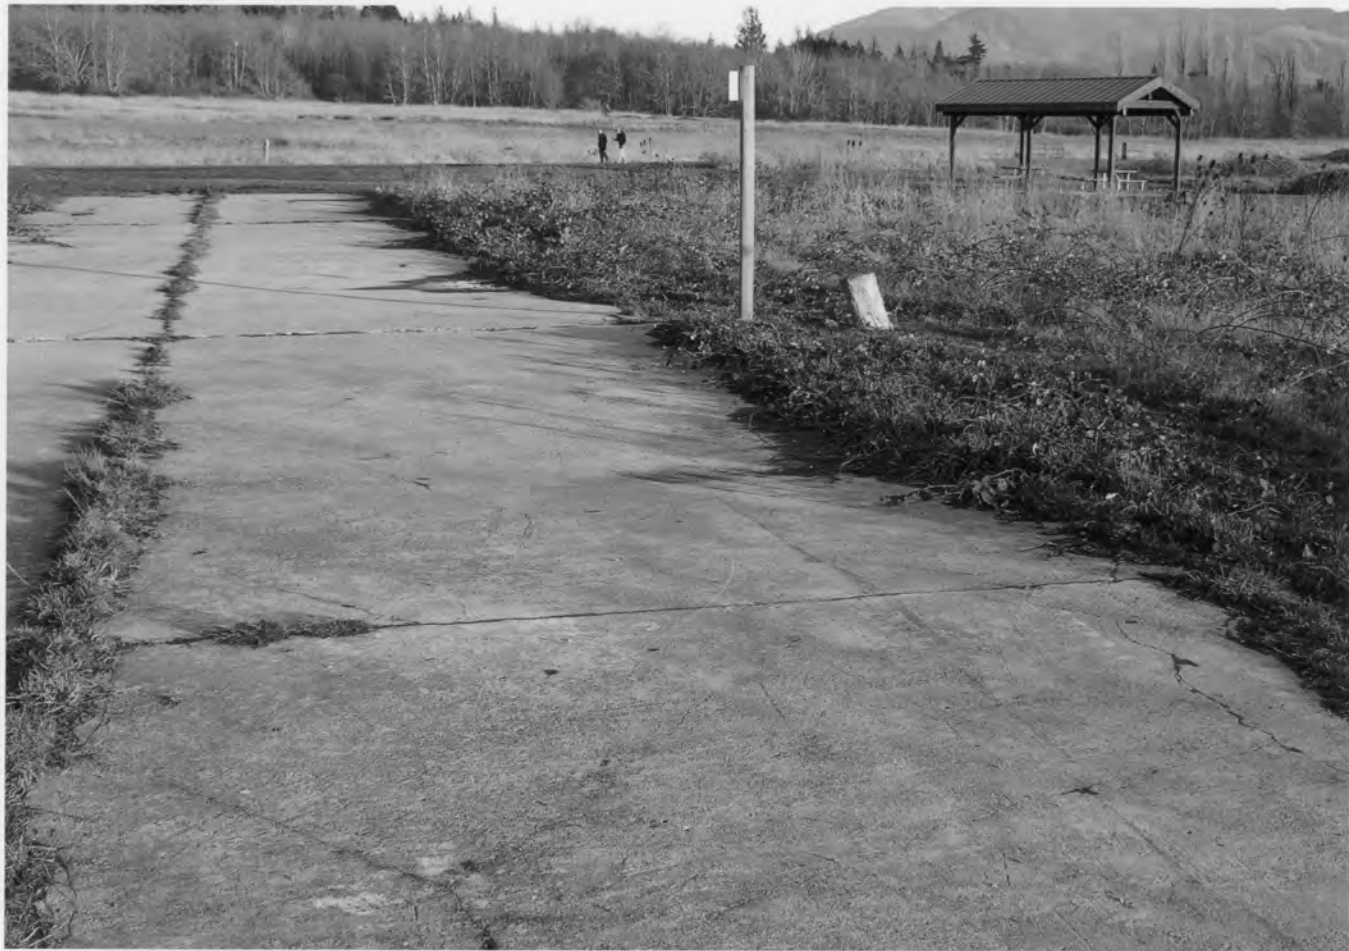
#31 of 57

Poultry Building Foundation, Northern State Hospital
Skagit County, Washington
