**National Register of Historic Places
Inventory—Nomination Form**

Property Title: Tonsfeldt Round Barn
Site Number: 113

Location: Plymouth County Fairgrounds
LeMars, Plymouth County

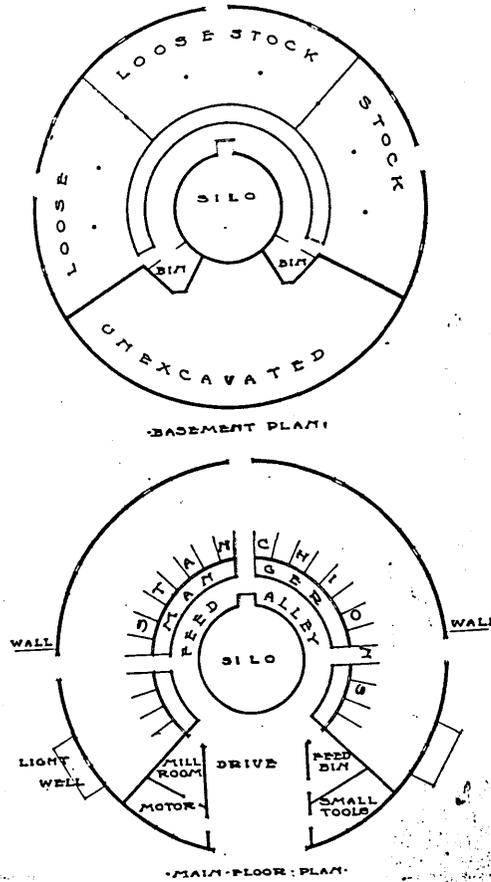
Fig. 26. Plan of round barn

Floor plan

Laminated dome roof. Circular interior around central cement/wood stave. silo. Silo - 18' diameter. Barn - 70' diameter, wood shingles. Granary on level Litter track, Oats elevator. Milk pipeline originally. 3 levels.

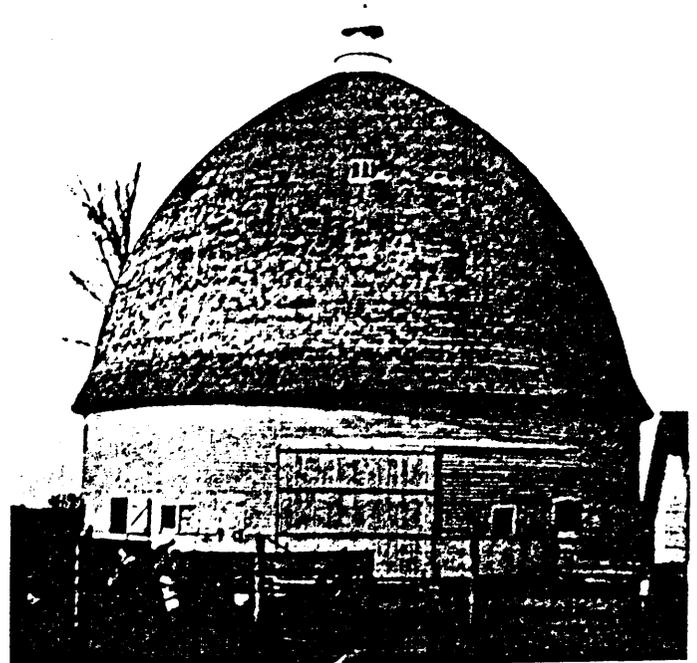
Fig. 25. Round barn

Original Appearance

The spectacular self-supporting gothic arch dome roof of this true-round barn is the only one of its kind known to have been built on an Iowa farm. In 1981, in a successful effort to preserve this unique barn, the Tonsfeldt Round Barn was moved from its original location on the former Tonsfeldt farm west of Le Mars, Iowa to the Plymouth County Fair grounds in Le Mars. It is now used during the days of the Plymouth County Fair for crafts, antiques, art, and horticultural exhibits. The barn was originally built to house Mr. Tonsfeldt's purebred Polled Herefords and Tonsfeldt's prized bull, Ito's Perfection. While most true-round barns have conical or gambrel roofs, this dome roofed barn is an example of the diversity and variation found within the theme of Iowa Round Barns. Built during the peak years for construction of round barns, 1910-1920.

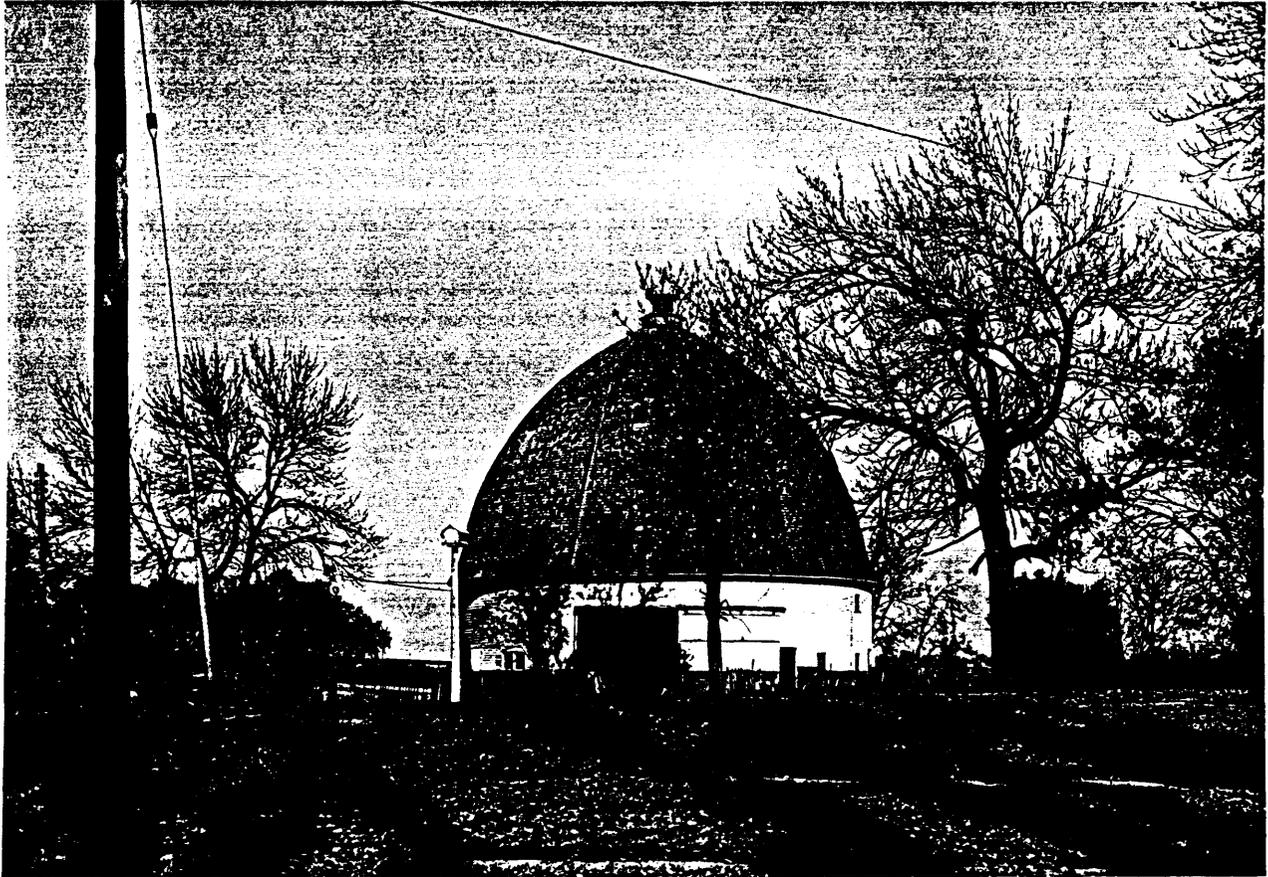
Original setting, 1978

This property was at first not accepted by the Review Committee because it had been moved from its original site. I consulted by phone with our NPS Reviewer, Ms. Beth Grosvenor and SHPO was advised as follows: The Thematic nomination did not attempt to take into account the farmsteads themselves, only the barns were evaluated. The loss of association with the farmstead therefore was not a direct issue. The nomination is a historical one, the integrity test being the state of preservation of original barn fabric. This barn is not only externally intact but the rare wood silo which gives it its significance within this nomination typology, was carefully preserved in the move. Lastly because of the rareness of the domed roof profile in the state, it was felt by staff that the preservation of the resource outweighed the loss of site/setting integrity inflicted by the move. The Review Committee agreed at a second review.
