National Register of Historic Places Registration Form

historic name Camp Naco Historic District
other names/site number Fort Naco, CCC Camp 3839, Newell's Camp

Camp Naco Historic District
 Name of Property

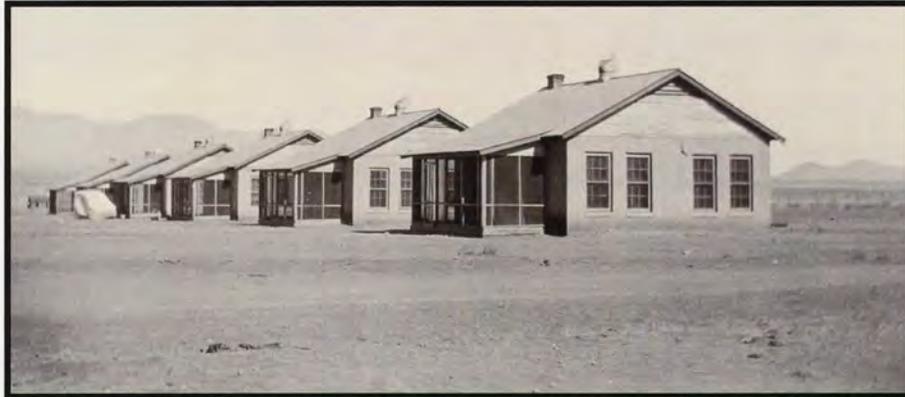
Photograph 3. Historical photograph showing non-commissioned officer's quarters, circa 1919. Image courtesy of Bisbee Mining and Historical Museum, Bisbee.

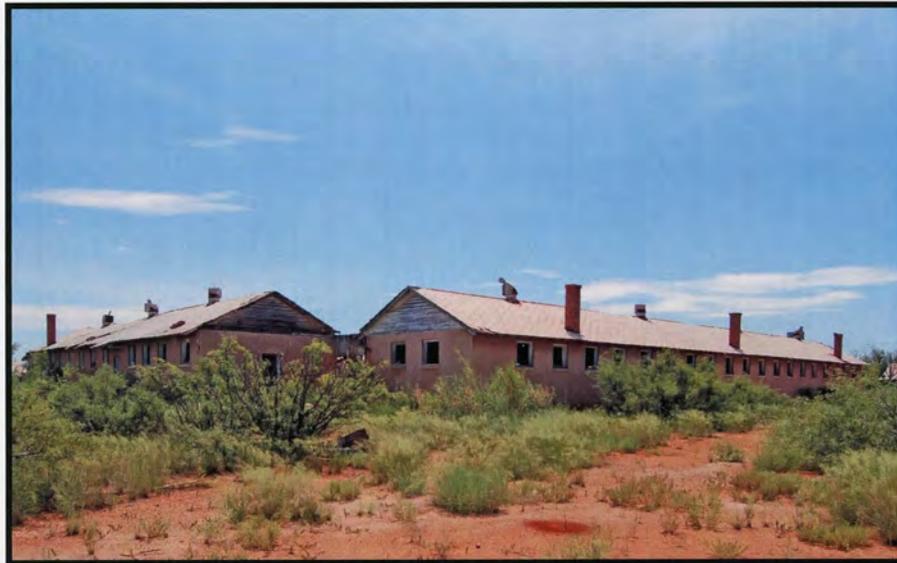
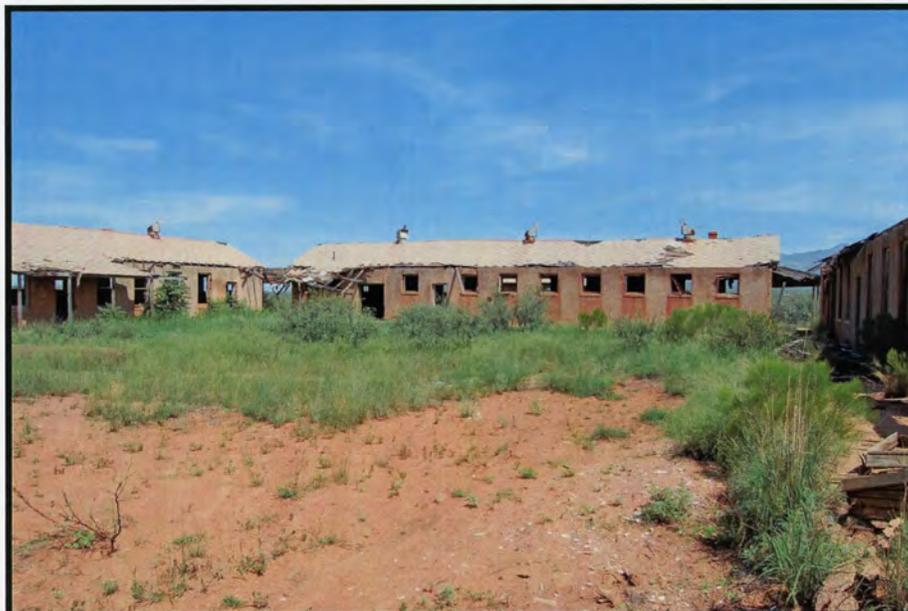
Photographs 5 and 6. Recent (2010) images of eastern quadrangle (detail of A-7 and A-8). *Top*: Exterior view facing Southeast. *Bottom*: Courtyard view facing north-northwest. Images courtesy of Desert Archaeology, Inc., Tucson.

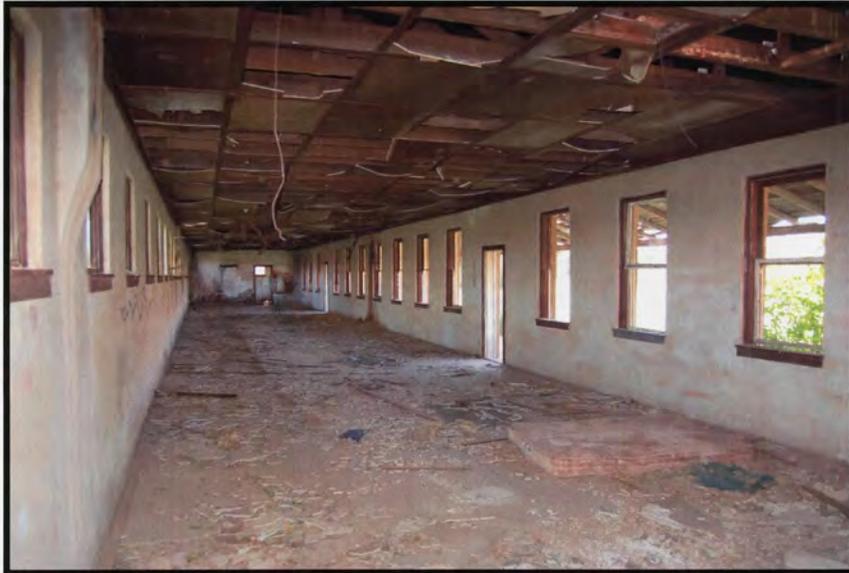
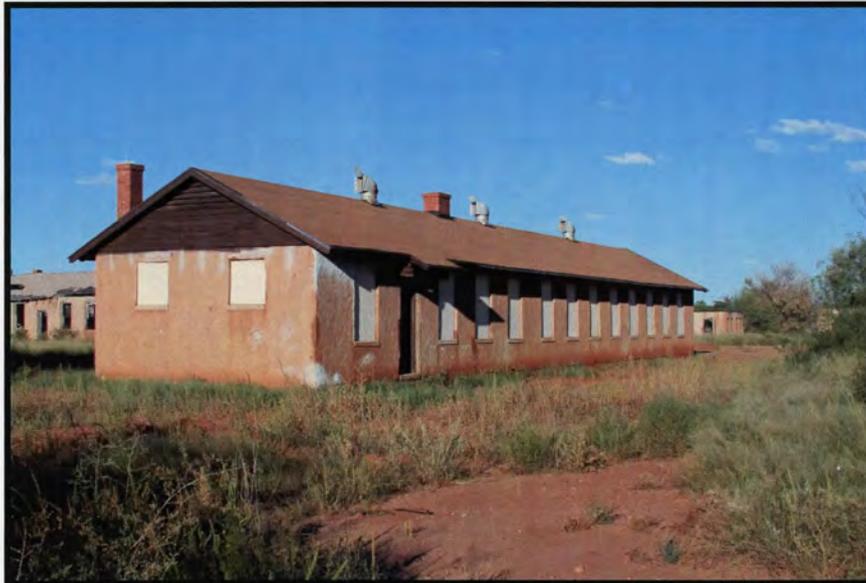
Photographs 7 and 8. Recent (2010) images of the Building A-2 within the western quadrangle and former recreation building (A-5) within the eastern quadrangle. *Top*: Interior of Building A-2. *Bottom*: Exterior of recreation building (A-5) after stabilization work and roof repair, view facing northeast. Images courtesy of Desert Archaeology, Inc., Tucson.

There are eight rectangular buildings, set in two quadrangles, each grouped around a common courtyard. Each quadrangle had two barracks housing about 50 soldiers. The northern barrack buildings served as mess halls, while the southern buildings served as either a hospital ([A-1] western quadrangle) or recreation facility ([A-5] eastern quadrangle). Each barrack building has stuccoed, mud adobe walls and exhibits medium-pitched gable roofs sheathed with diagonal-slatted asbestos shingles and supported by trussed rafters. Below the roofline are wood-sided gable ends and exposed eaves and integrated porches flank the courtyard-facing elevations (with the exception of the southernmost buildings, A-1 and A-5). The Recreation Building (A-5), the southern building in the eastern quadrangle, also contains a brick fireplace. Windows and door frames are constructed of wood with concrete sills and courtyard-facing entryways contain double wood doors capped by transom windows. Entryways are accessible via a raised concrete patio. In addition, the floors were constructed of poured concrete.

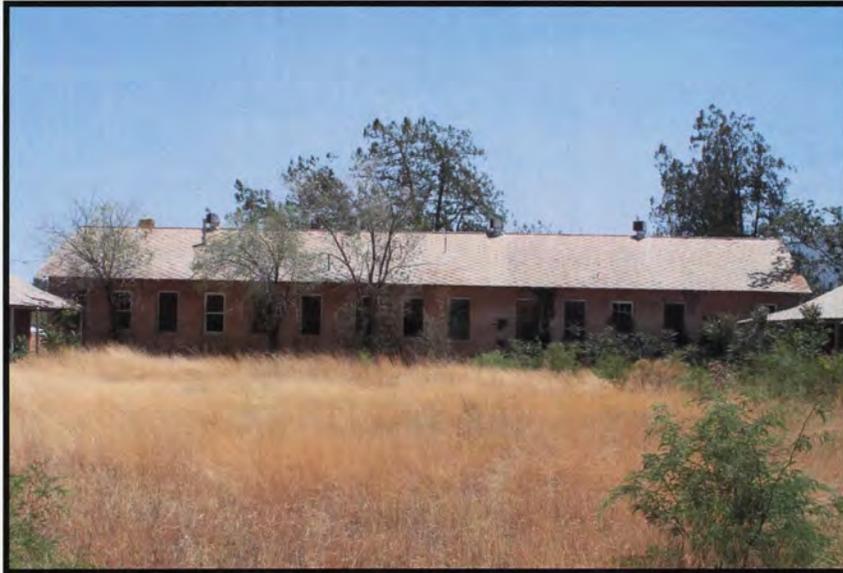
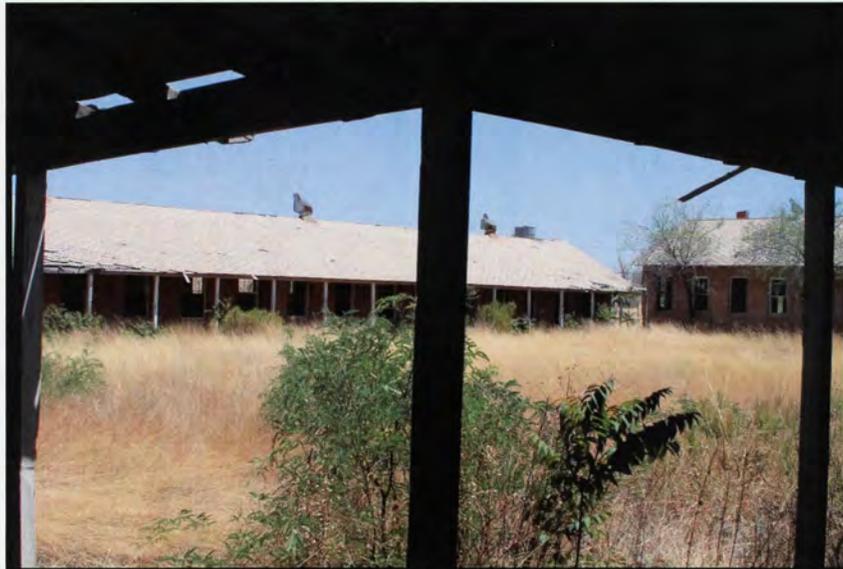
Photographs 9 and 10. Recent (2010) images of the western quadrangle. *Top*: Courtyard view facing south towards former hospital (A-1). *Bottom*: Courtyard view under porch facing southeast (A-1 and A-2). Images courtesy of Demion Clinco, Tucson.

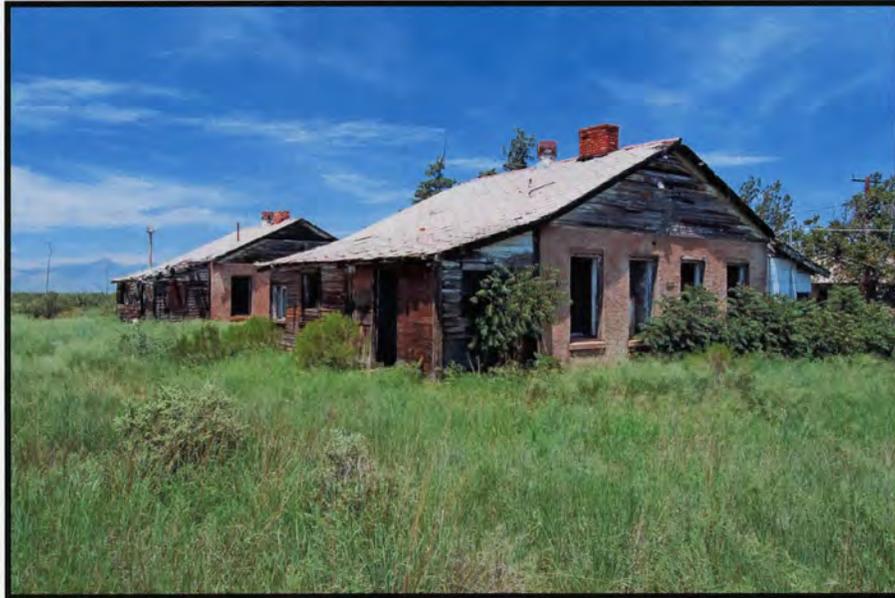
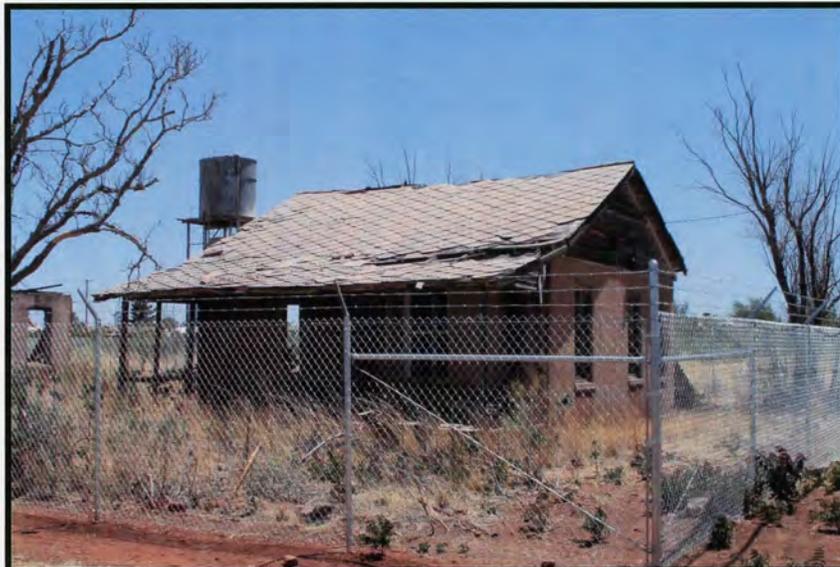
Photographs 11 and 12. Recent (2010) images of the former officer's quarters. *Top*: Westernmost officer's quarters (c-1 and C-2), view facing northwest elevation. *Bottom*: Easternmost officer quarter (Building C-3; Building C-4 in left-hand corner), view facing north elevation. Images courtesy of Desert Archaeology, Inc. and Demion Clinco, Tucson

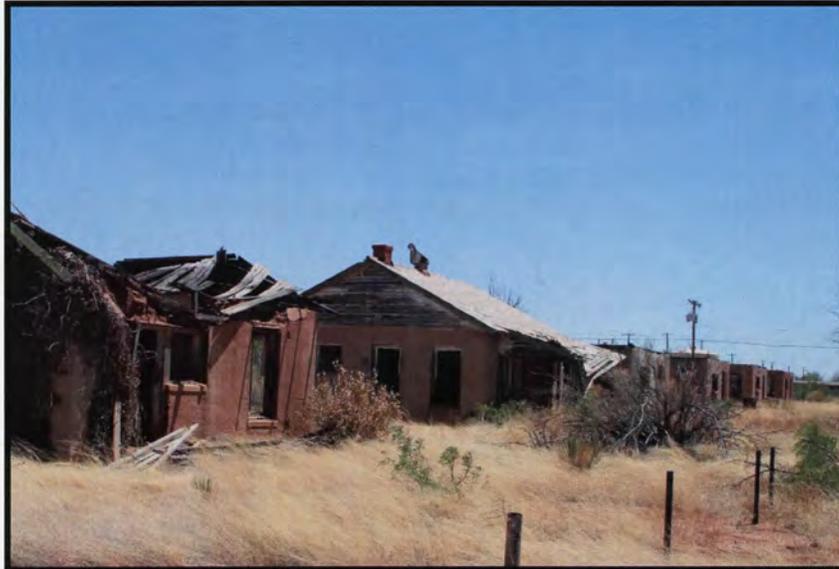
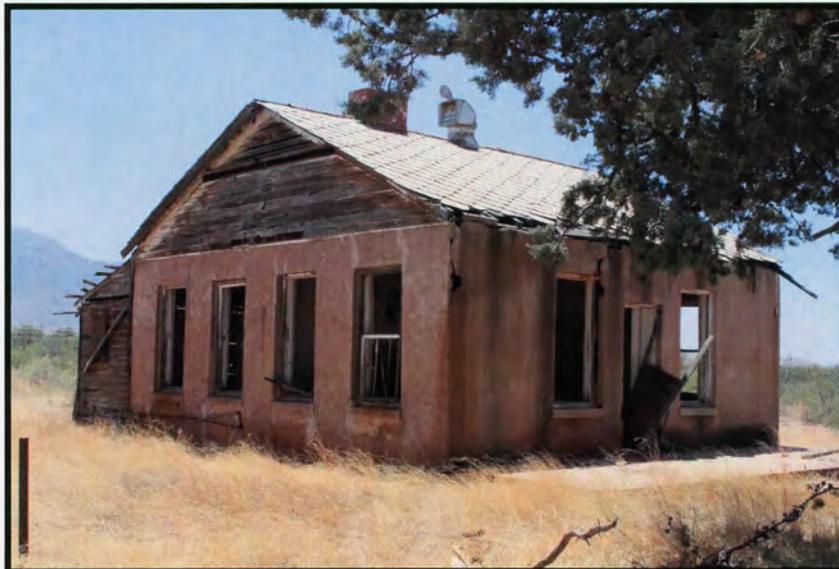
Photographs 13 and 14. Recent (2010) images of the former non-commissioned officer's quarters and Officer's quarter. *Top*: Row of non-commissioned officer's quarters (B-1 through B-6), view facing southeast. *Bottom*: Officer's Quarter, C-1, view facing southwest. Images courtesy of Demion Clinco, Tucson.

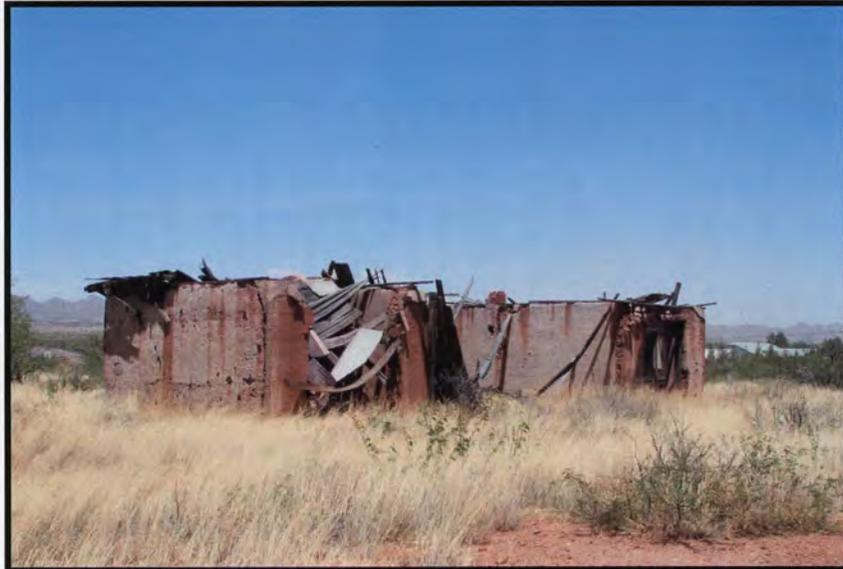
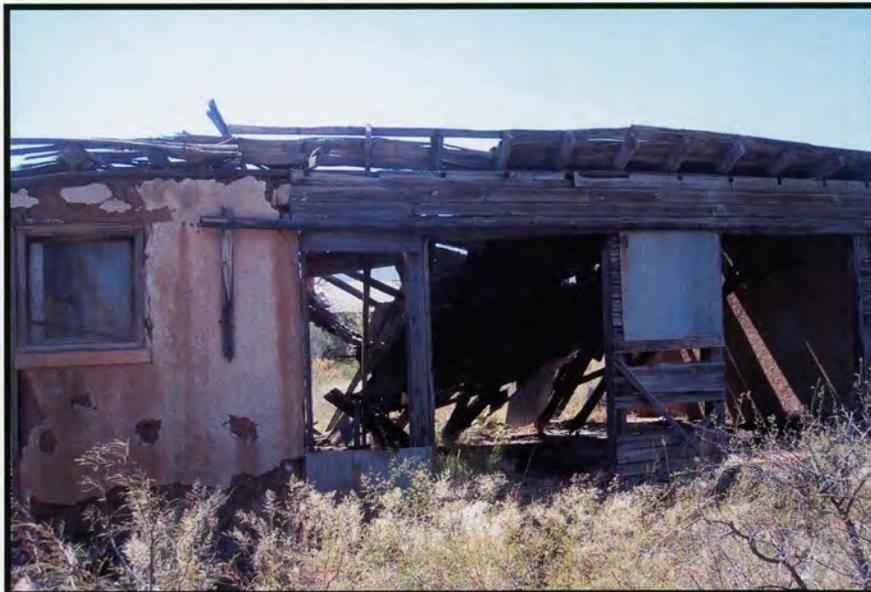
At Camp Naco, the stables, associated blacksmith shop and stable guard buildings are represented by the partial remains of four adobe-walled structures and three concrete foundations. It is not entirely clear which of these remains reflect which portion of the stables, but based on historical photographs, Camp Naco's stable system encompassed two u-shaped stable areas that housed blacksmith shops and guard buildings located within the southern-most structures, while horses were stalled in the eastern and western "arms" of the stable. The two stable groupings are situated immediately north of

the barracks and bath houses. The portion of the stables which housed the cavalry horses is no longer standing (likely because it contained building materials that were salvaged after the fort was abandoned). The remaining portions of the stables are in poor condition and exhibit partially collapsed adobe walls and wood trusses and roofing surrounded by dense vegetation. Because these structures exhibit poor integrity and no longer convey their historical use, they are considered non-contributing resources.

Photographs 15 and 16. Recent (2009-2010) images of the former stables and associated blacksmith/stable guard building. *Top*: Remains of stables (D-2 and D-3), north of barracks, view facing northeast. *Bottom*: Remains of stable and blacksmith/stable guard building (D-4 and D-5), view facing north. Images courtesy of R. Brooks Jeffery, University of Arizona, and Demion Clinco, Tucson.

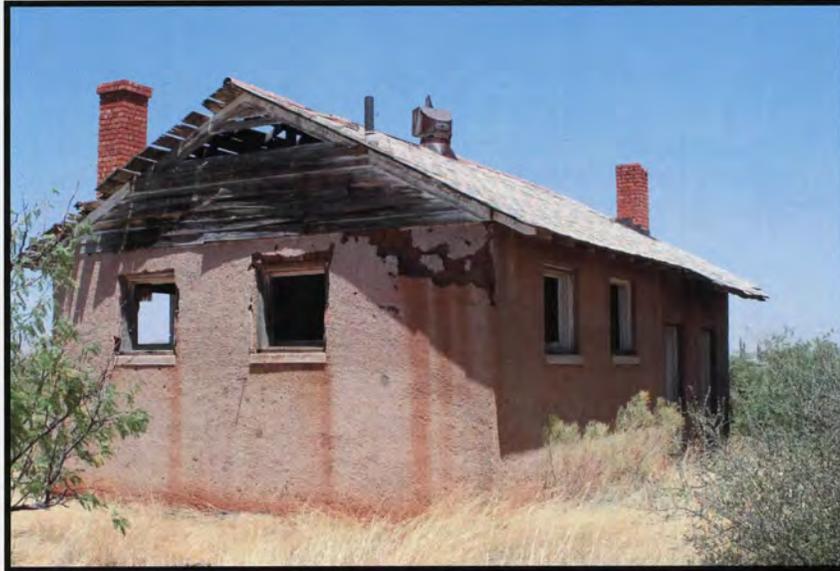
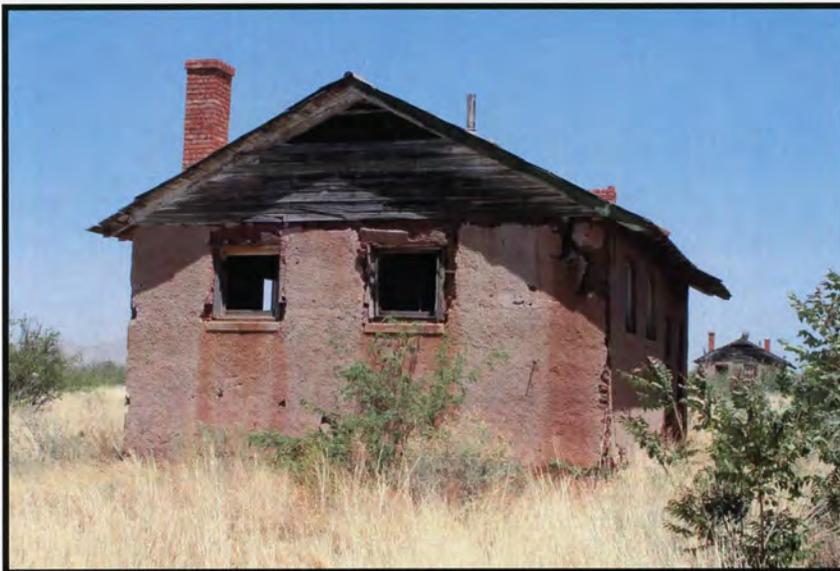
There are two bath houses immediately north of the barracks. These are small rectangular buildings with concrete foundations, gable roofs, diagonal-slatted asbestos shingles, wood gable ends, and open eaves. The roofs are supported by wood trusses and adobe walls sheathed in a smooth stucco finish. The buildings also feature red-brick chimneys, wood-framed pivoting or hopper windows, south-facing entryways, as well as showers, toilets, and a boiler unit for hot water.

Photographs 17 and 18. Recent (2010) images of former bath houses located behind the barracks. *Top*: Bath house (A-9) north of eastern quadrangle, view facing northeast. *Bottom*: Bath house (A-10) north of western quadrangle, with eastern bath house in background, view facing northeast. Images courtesy of Demion Clinco, Tucson.

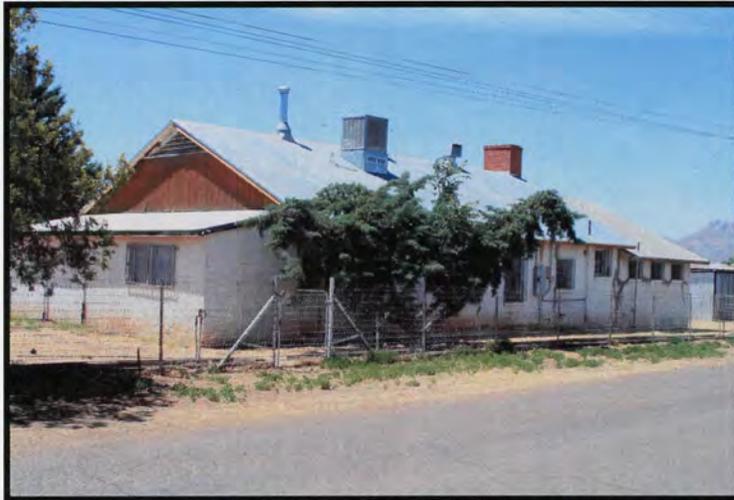
Photograph 19. Recent (2010) image of former bakery building (E-1), now under private ownership, located on the west side of Willson Road. Image courtesy of Demion Clinco, Tucson.

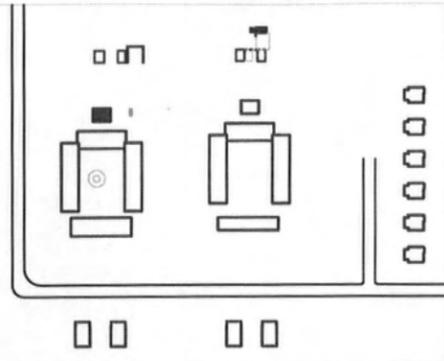
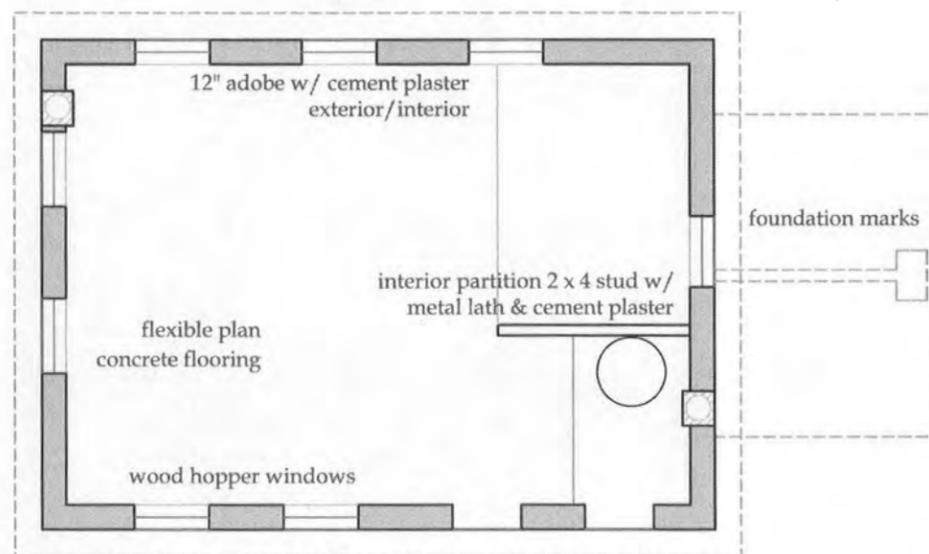
Building A-10: Bathhouse

concrete foundation
