National Register of Historic Places Registration Form

Historic Name: Reinbolt Hall at St. Mary's University  
Other name/site number: St. Louis College  
Name of related multiple property listing: NA

Street & number: 1 Camino Santa Maria  
City or town: San Antonio State: Texas County: Bexar  
Not for publication:  Vicinity:

**Architectural Classification:** Late Victorian: Romanesque Revival

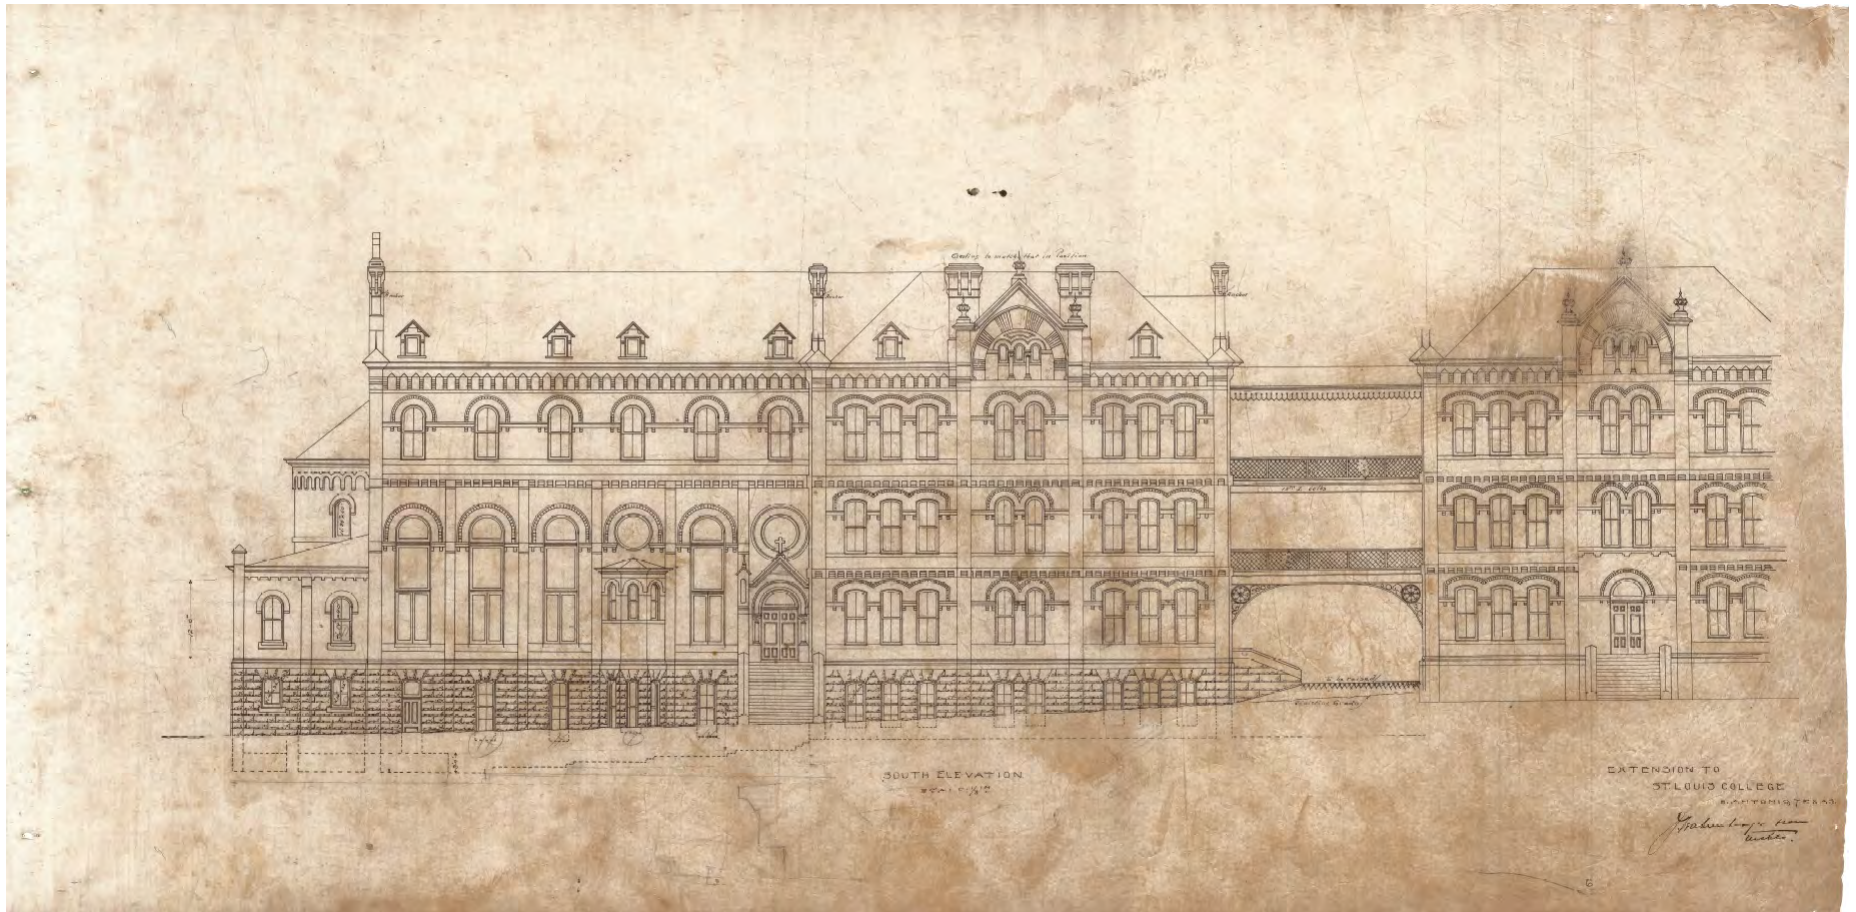
**Figure 8:** James Wahrenberger, Reinbolt Hall Construction Drawings, South Elevation, 1908  
Source: St. Mary's University Archives

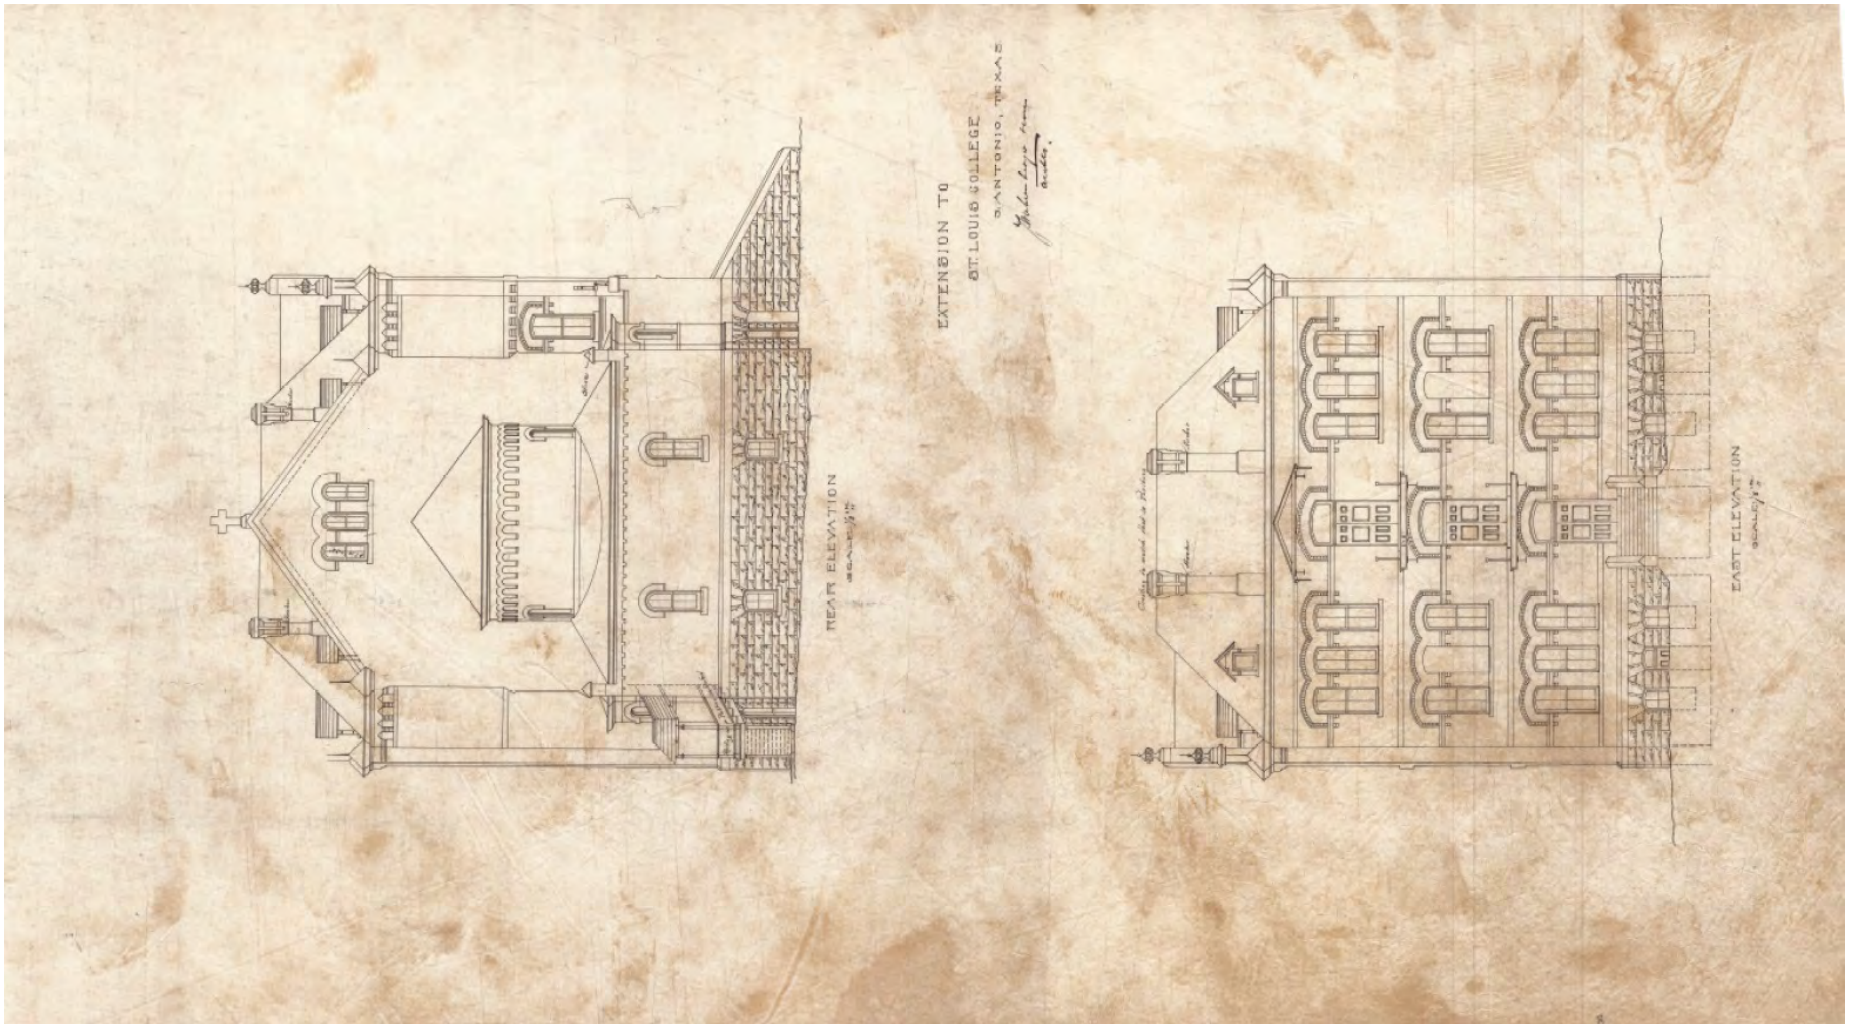
**Figure 9:** James Wahrenberger, Reinbolt Hall Construction Drawings, East & West Elevations, 1908  
Source: St. Mary's University Archives

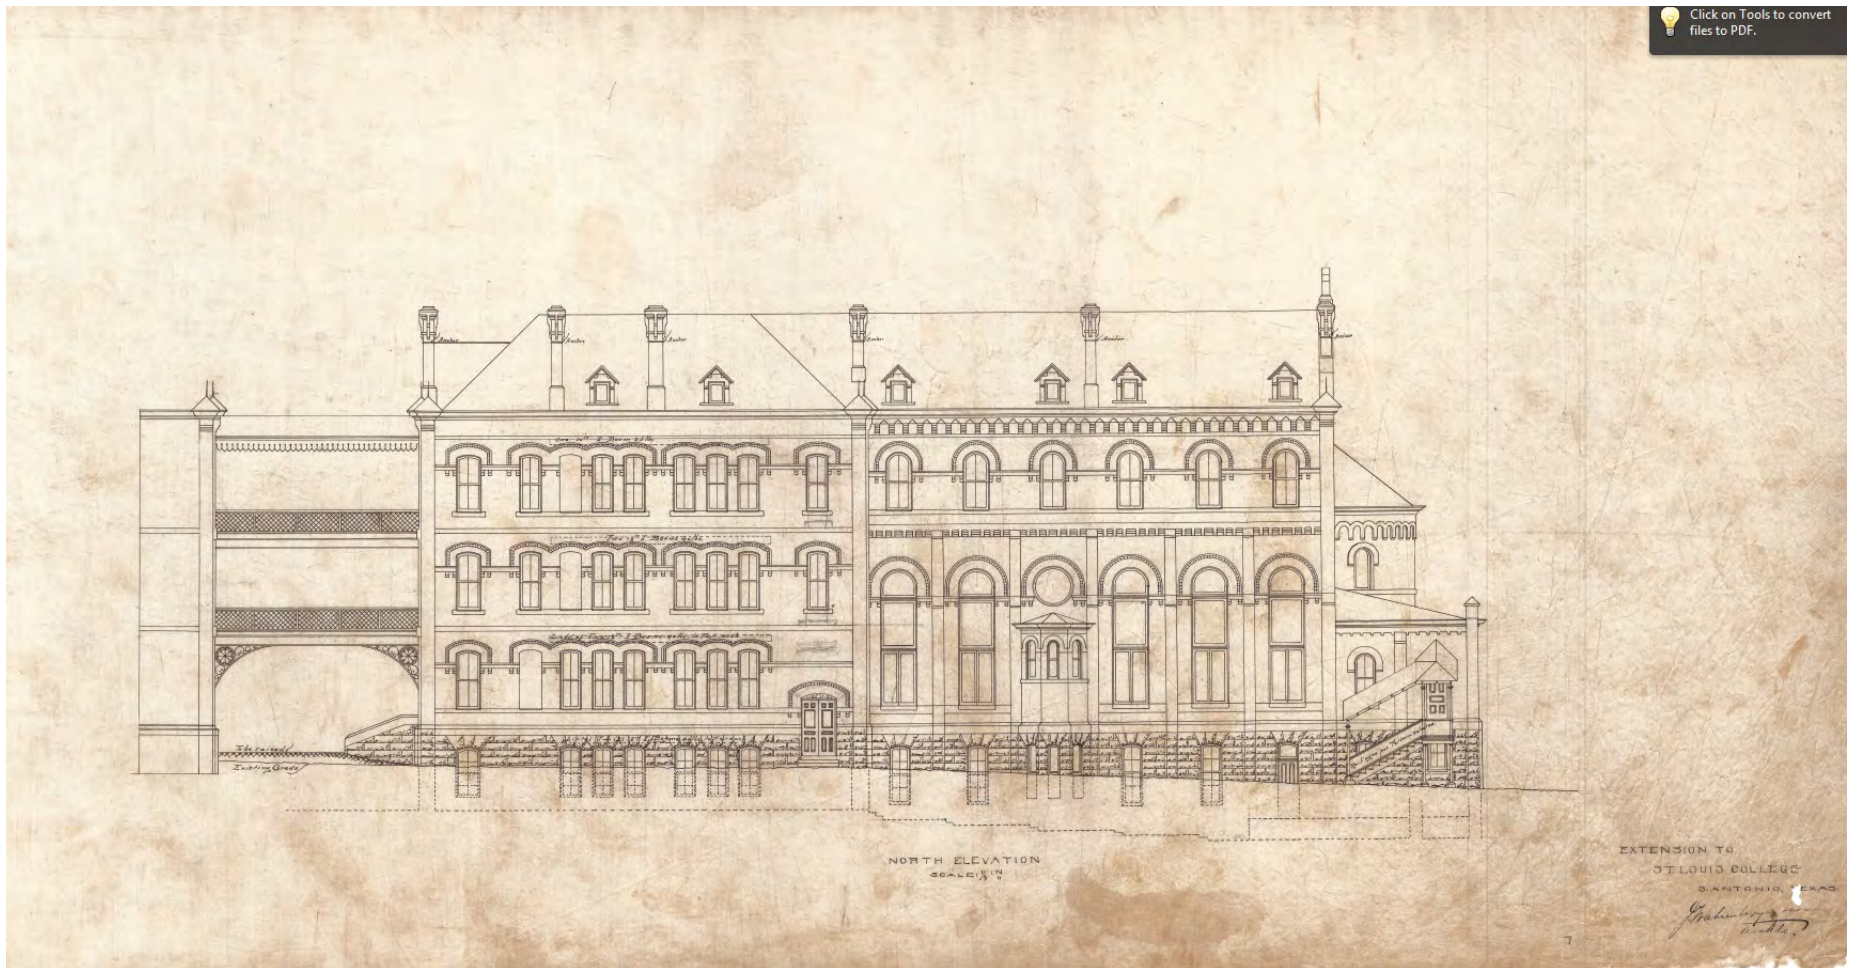
**Figure 10:** James Wahrenberger, Reinbolt Hall Construction Drawings, North Elevation, 1908  
Source: St. Mary's University Archives

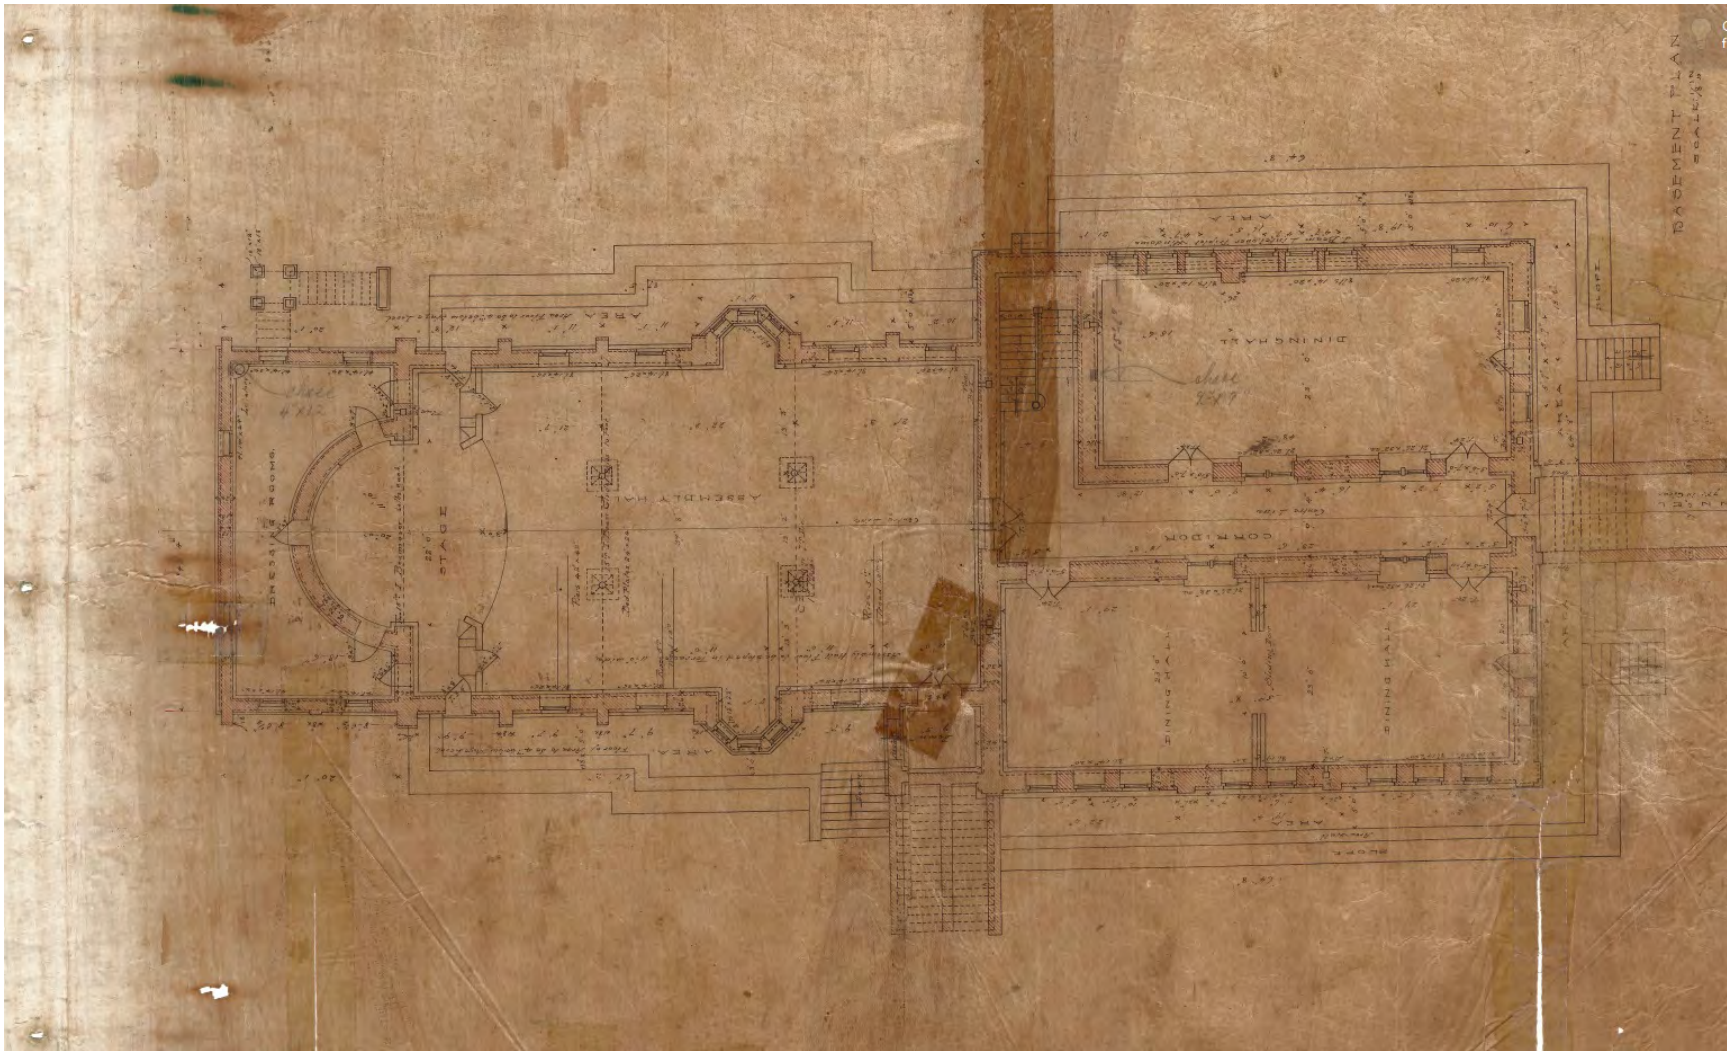
**Figure 11:** James Wahrenberger, Reinbolt Hall Construction Drawings, Basement Floorplan, 1908  
Source: St. Mary's University Archives

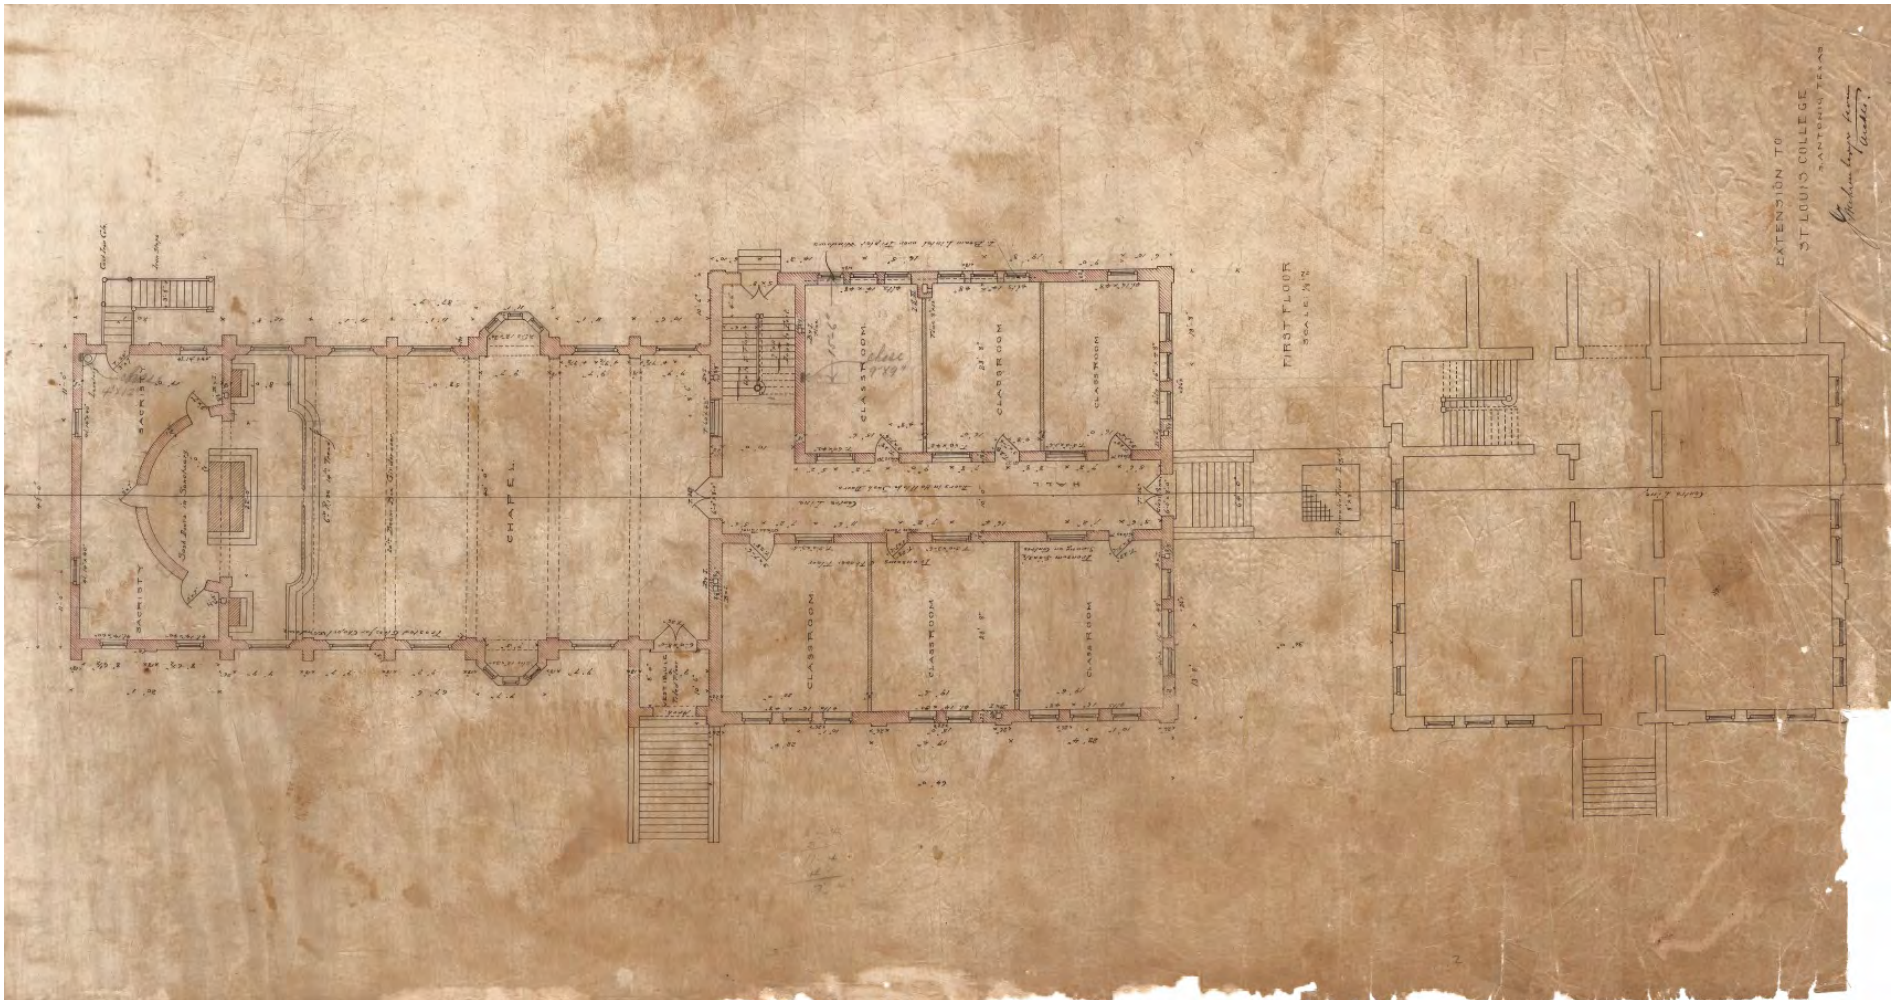
**Figure 12:** James Wahrenberger, Reinbolt Hall Construction Drawings, First Floor Floorplan, 1908  
Source: St. Mary's University Archives

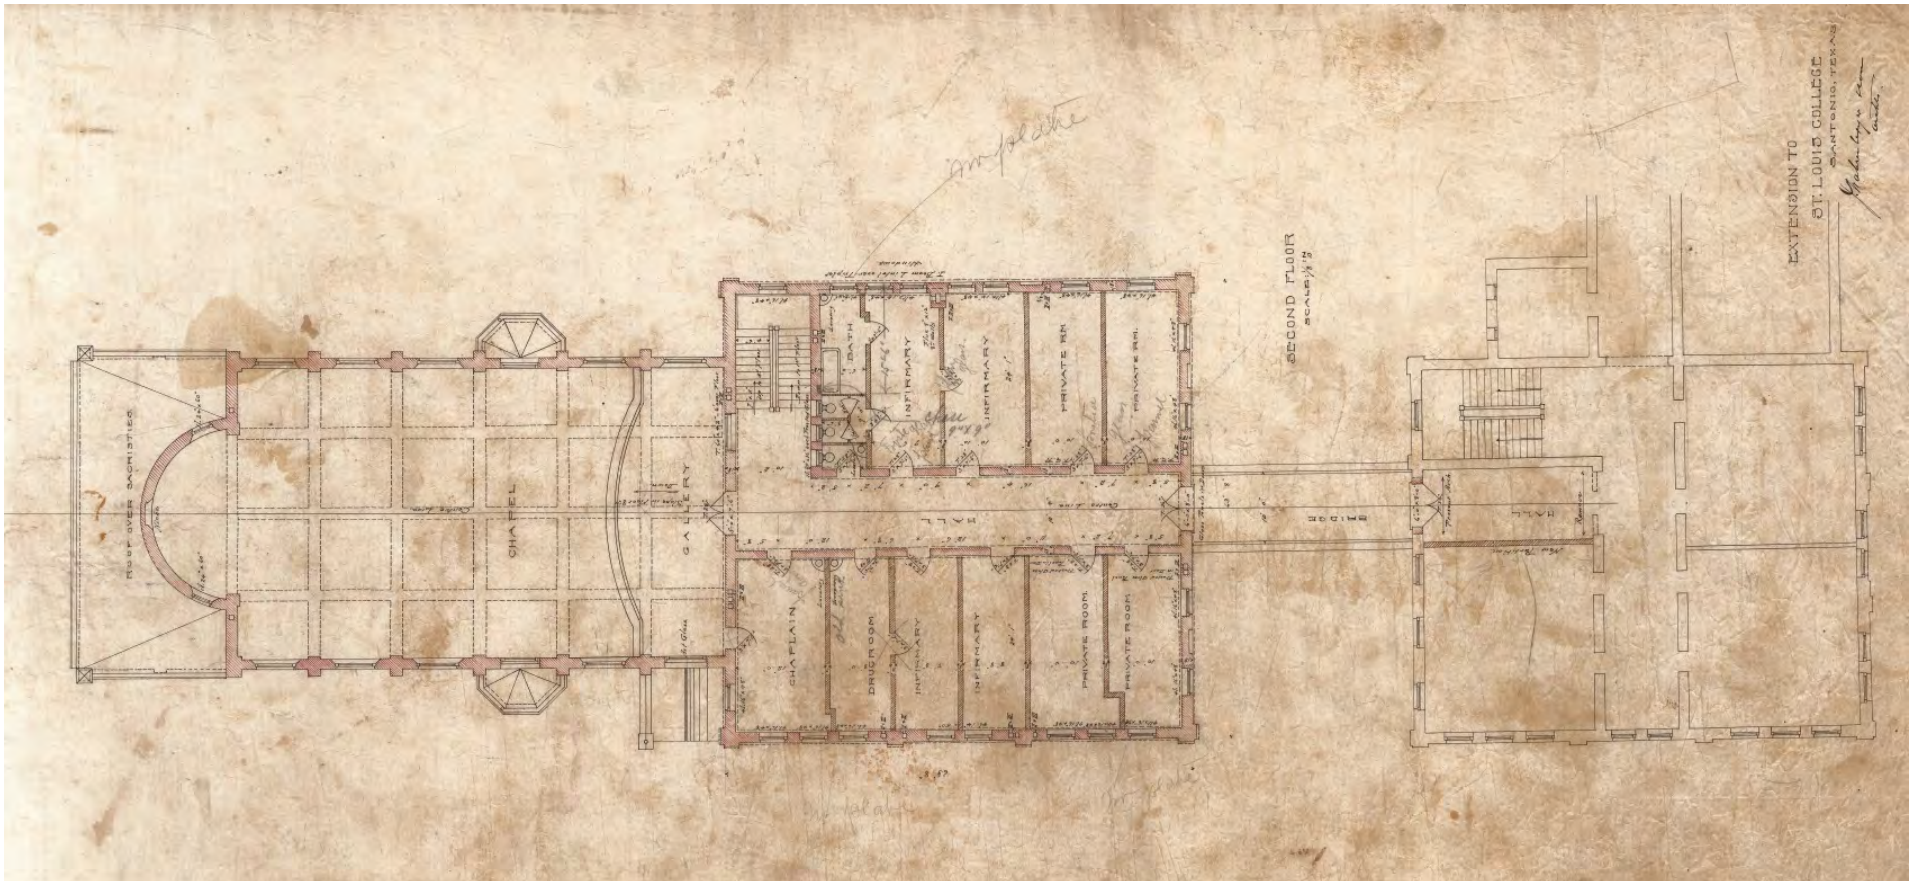
**Figure 13:** James Wahrenberger, Reinbolt Hall Construction Drawings, Second Floor Floorplan, 1908  
Source: St. Mary's University Archives

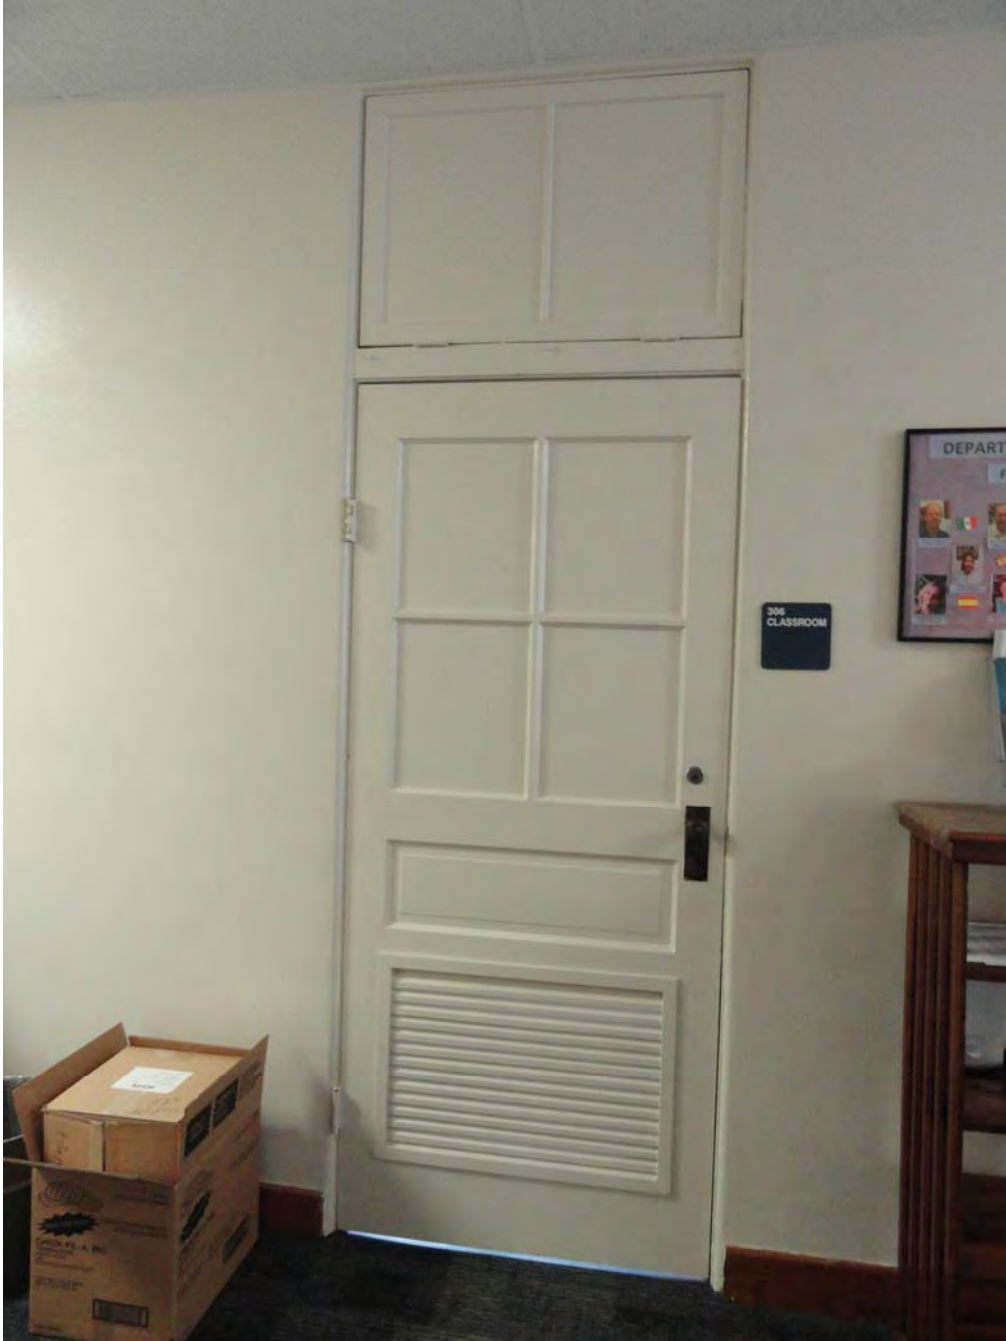
**Photo 17:** door to hallway with original transom and louvered ventilation panel  
Photographed by Maria Pfeiffer, May 2015

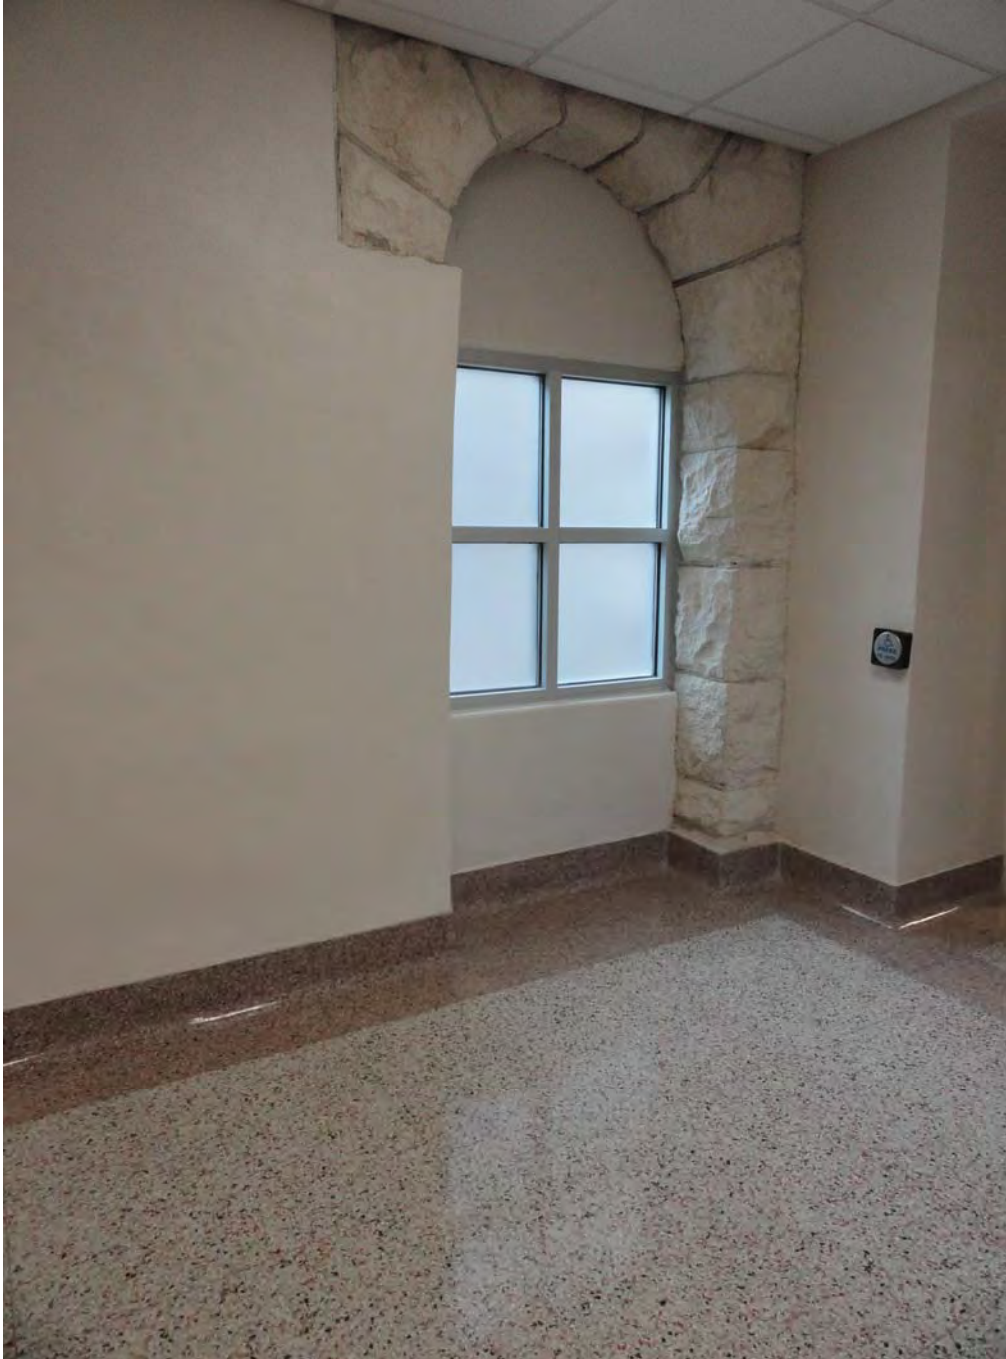
**Photo 18:** basement, original stone arch  
Photographed by Maria Pfeiffer, May 2015

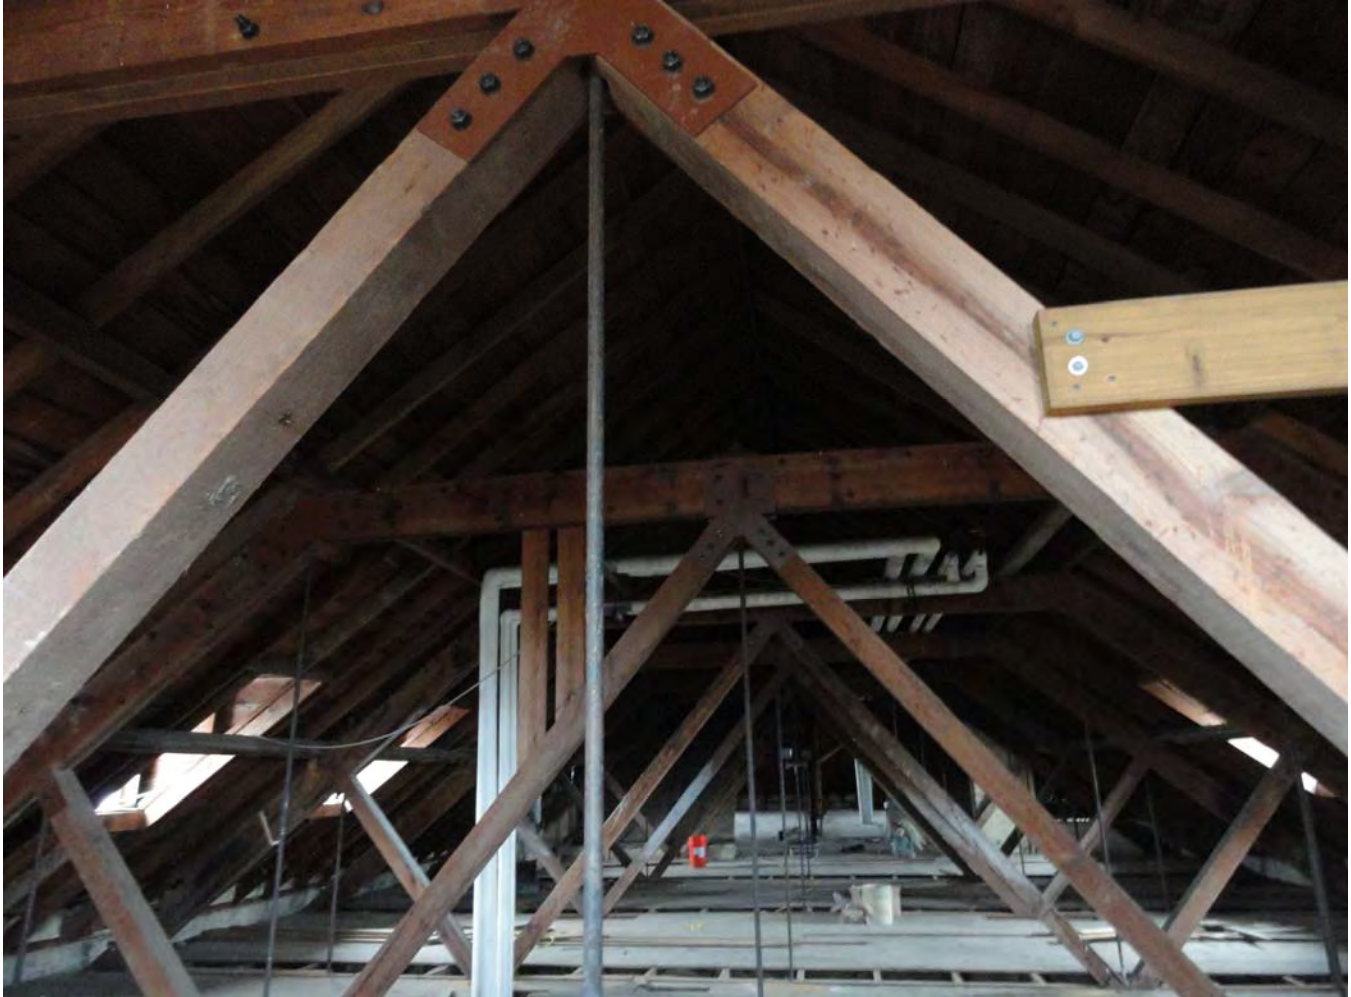
**Photo 22:** attic wooden trusswork  
Photographed by Maria Pfeiffer, May 2015
