KENTUCKY HISTORIC RESOURCES  
Individual Inventory Form

Resource # 63  
Shelby County

1. Name of Resource: Snook House

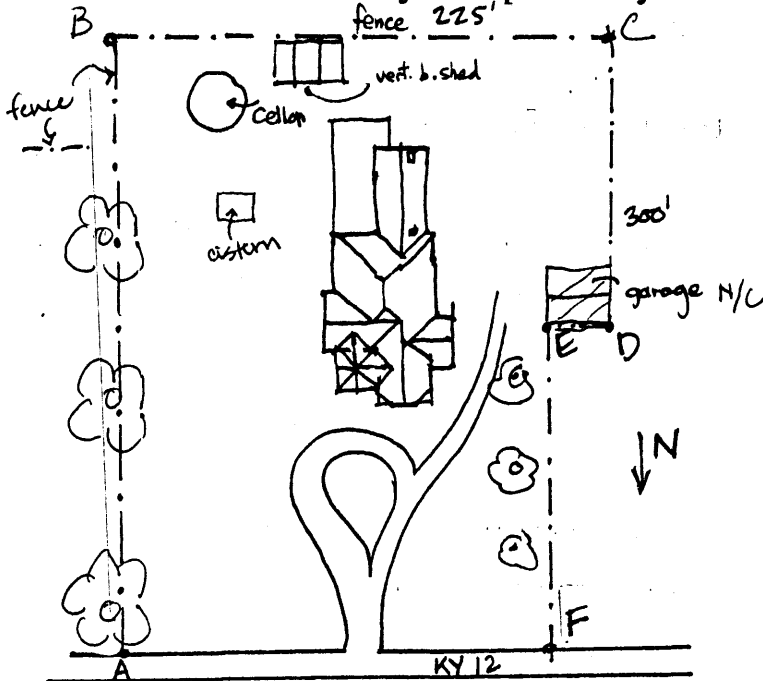
44. Site Plan (and boundary description and justification for N.R. sites):

Beginning at a point on the southern edge of KY 12 that is 71 ft. west of the western edge of the drive (A), 300 ft. southward along a tree line and fence to intersection with another fence (B); 225 ft. eastward along rear yard fence to intersection with another fence (C); 150 ft. northward along fence to northwestern corner of garage (D); 30 ft. east along northern side of garage to its northeastern corner (E); 150 ft. northward along fence to edge of KY 12 (F); 225 ft. westward along southern edge of KY 12 to point of origin.

The boundaries were selected to enclose the house and domestic-related area and are defined by fences on the west and south, a tree line and fence on the west, and KY 12 on the north. In addition to the house, the area includes three outbuildings--a shed (C), cellar (C), and garage (NC)--as well as one structure (cistern-C).
