National Register of Historic Places  
Registration Form

historic name St. John's Danish Evangelical Lutheran Church Historic District  
other names/site number St. John's Lutheran Congregation (L.C.A)

street & number 1207 Indigo Avenue [N/A] not for publication  
city or town Hampton [x] vicinity  
state Iowa code IA county Franklin code 069 zip code 50441-7559

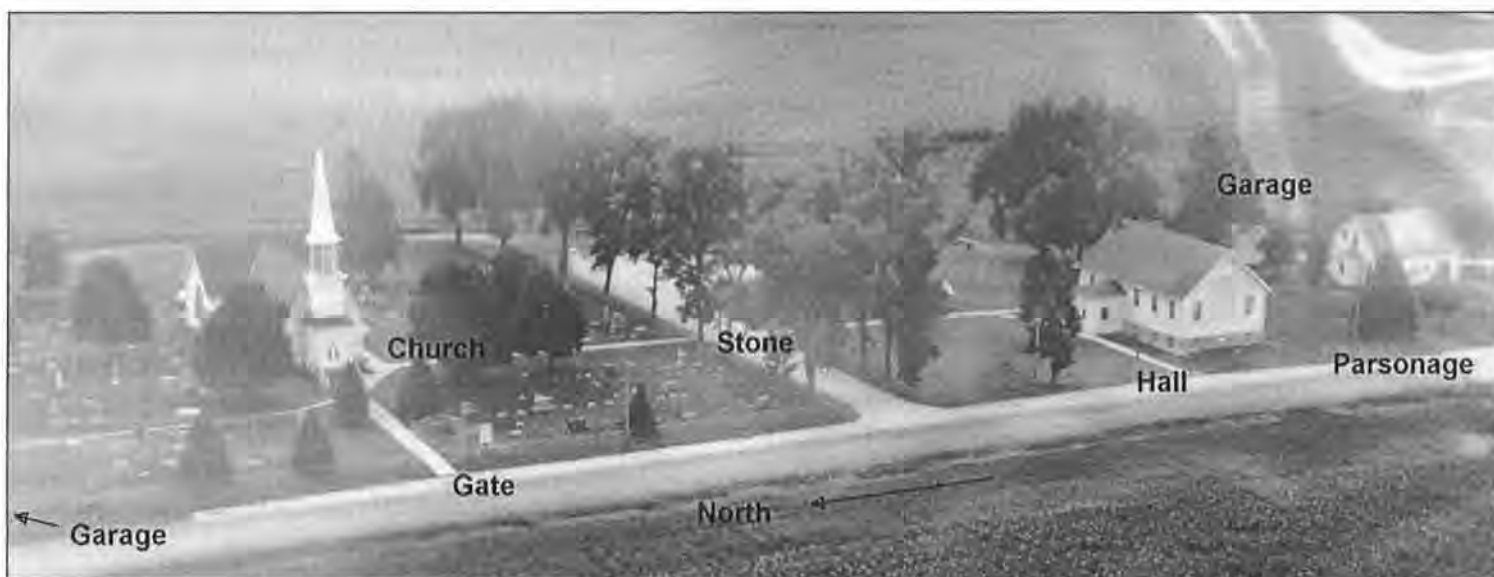
Figure 1a: aerial overview looking southeast with key resources labeled  
(framed image on site digitally copied)

The church complex consists of a 15-acre rectangular parcel that presents its longer dimension to and on the east side of Indigo Avenue. The church complex proper accounts for one third of the total acreage while the rest is cropped with the proceeds that have historically supported the church. The farmed portion is along the east edge and at the south end of the parcel (Figure #22). The pavement on that street ends abruptly at the south end of the complex, one measure of its importance to the county. The site makeup consists of a north-end windbreak; the church proper surrounded by a circular road and its associated cemetery, the church hall placed in close proximity to the road, and finally on the south end the parsonage and its garage. The lost custodian's residence occupied the northwest corner of the present cemetery and its associated garage still stands to the north of that site near the windbreak.

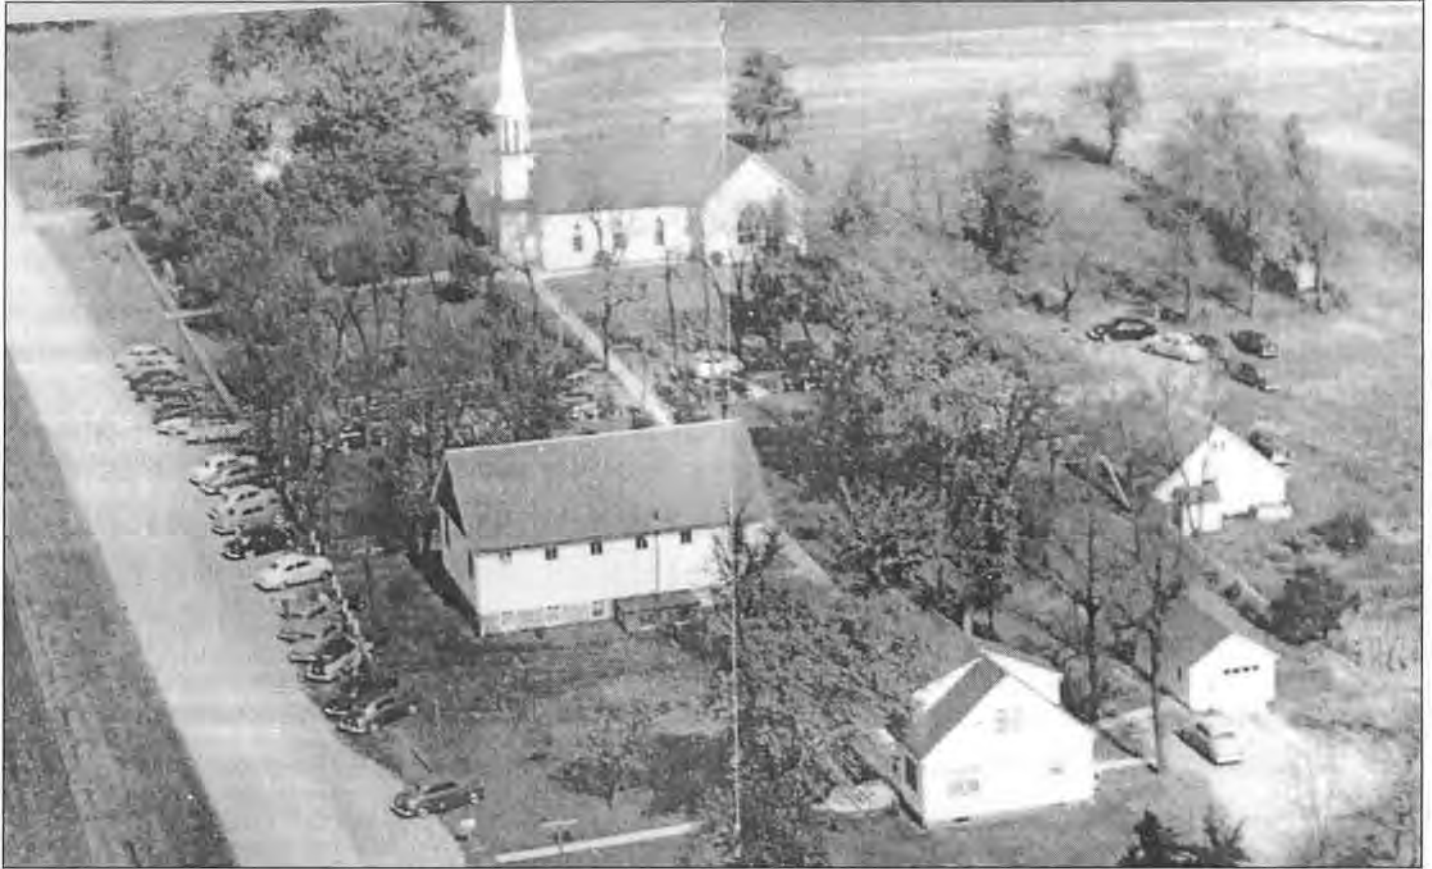
Figure 2: Ca.1953 aerial view looking north  
(75<sup>th</sup> Anniversary Booklet)

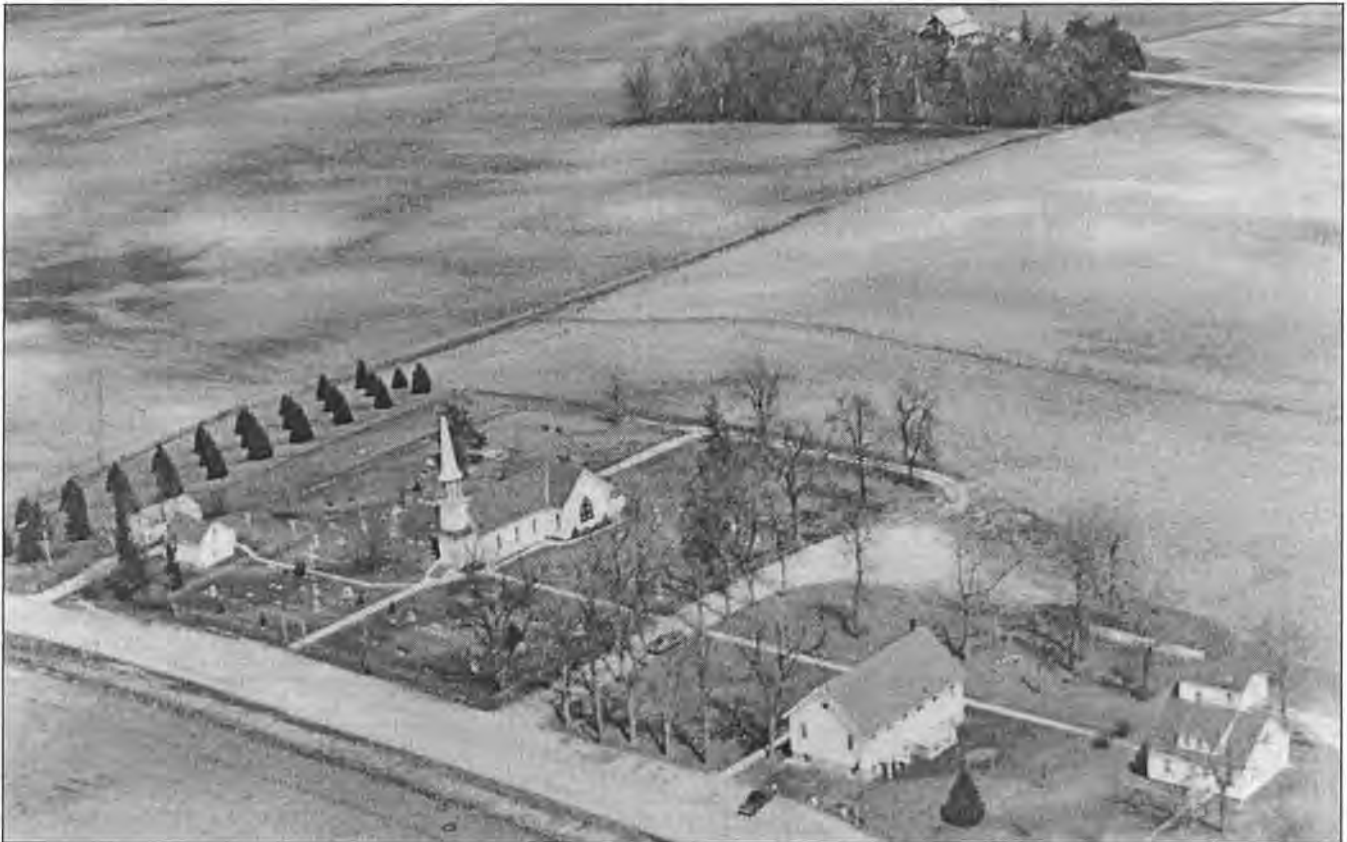
Figure 3: 1953 aerial view looking northeast  
(100<sup>th</sup> Anniversary Booklet)

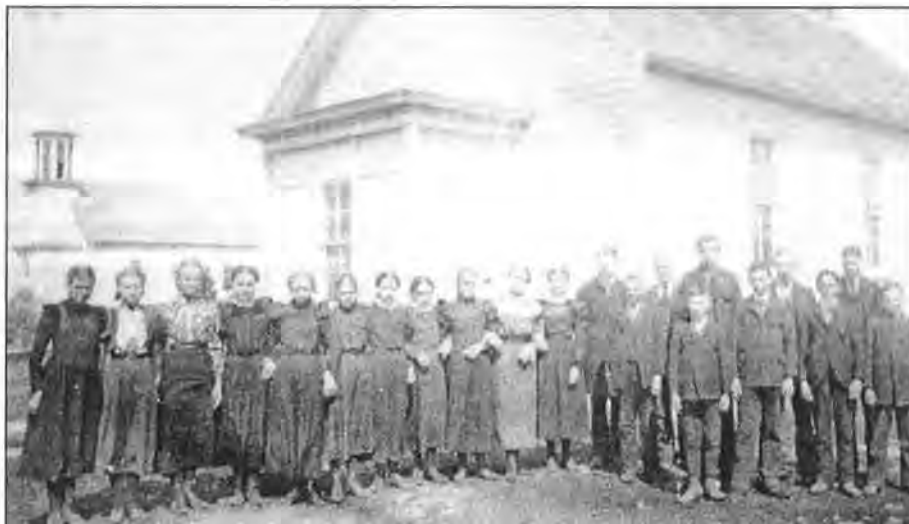
Figure 6: Pre-1899 photo showing language school, first hall and original church, view northeast (75<sup>th</sup> Anniversary Booklet)

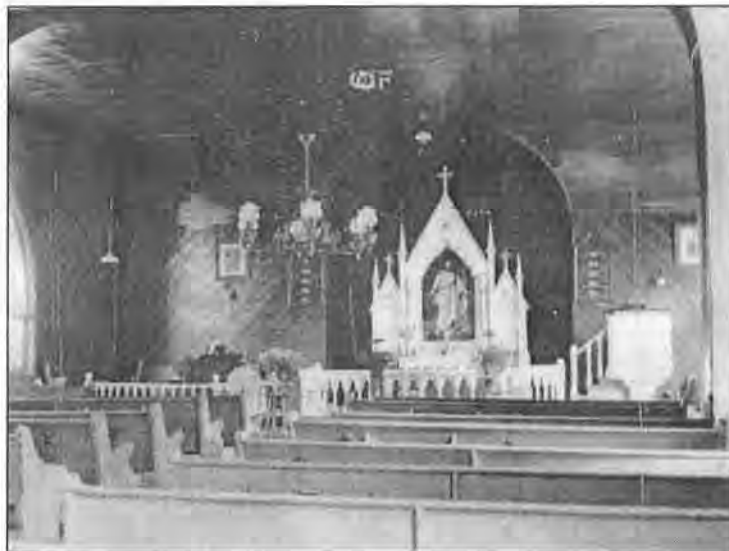
Figure 76: Interior view of enlarged church showing paneled/wainscot interior cladding, view southeast (note existing altarpiece, altar rail and pulpit) (75<sup>th</sup> Anniversary Booklet)

The major church alterations were its main addition (1899), the replacement of its very unusual wainscot interior (survives in hall), the front bathroom addition and its residing. The main hall addition is its added bathroom; otherwise it is very well preserved. The parsonage is likely altered internally and it has been resided but does retain its original siding underneath the covering.

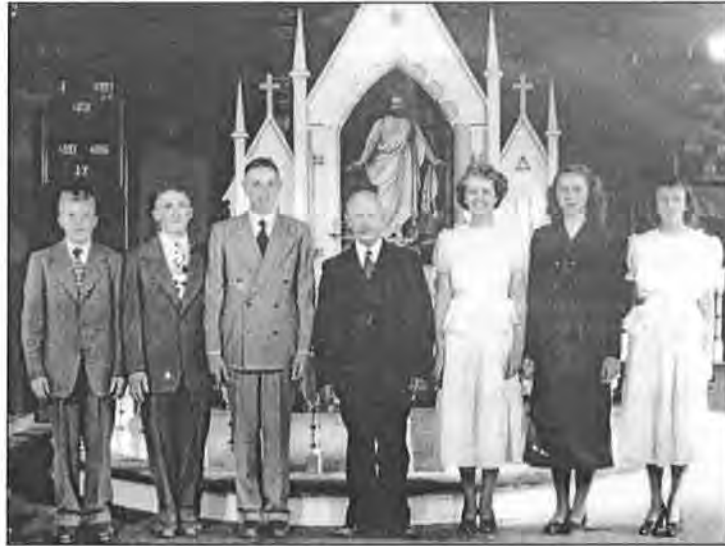
Figure 11: Confirmation class, October 17, 1948 (this image documents the retention of the paneled interior as of this date, also the altarpiece and altar rail), view west (100<sup>th</sup> Anniversary Booklet)

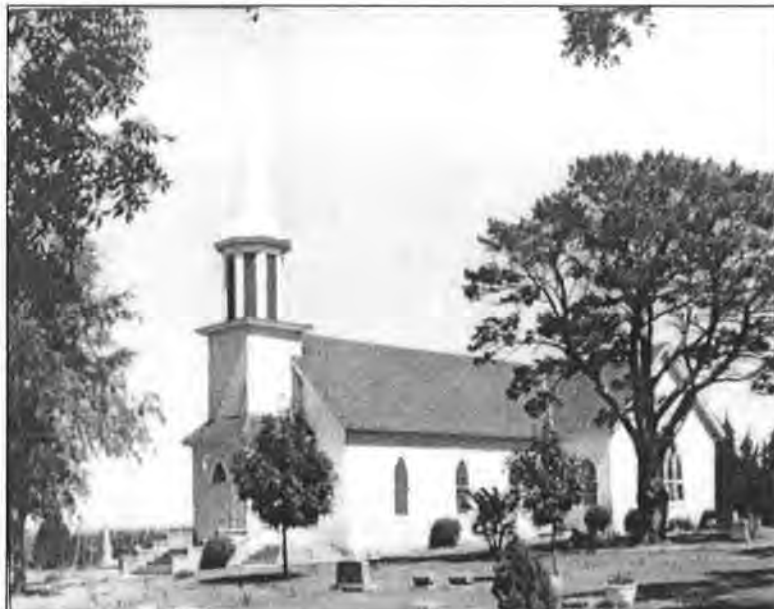
Figure 12: 1951 church and cemetery photo, view northeast  
(the large tree south of the church was removed during the winter of 1951-52)  
(75<sup>th</sup> Anniversary Booklet)

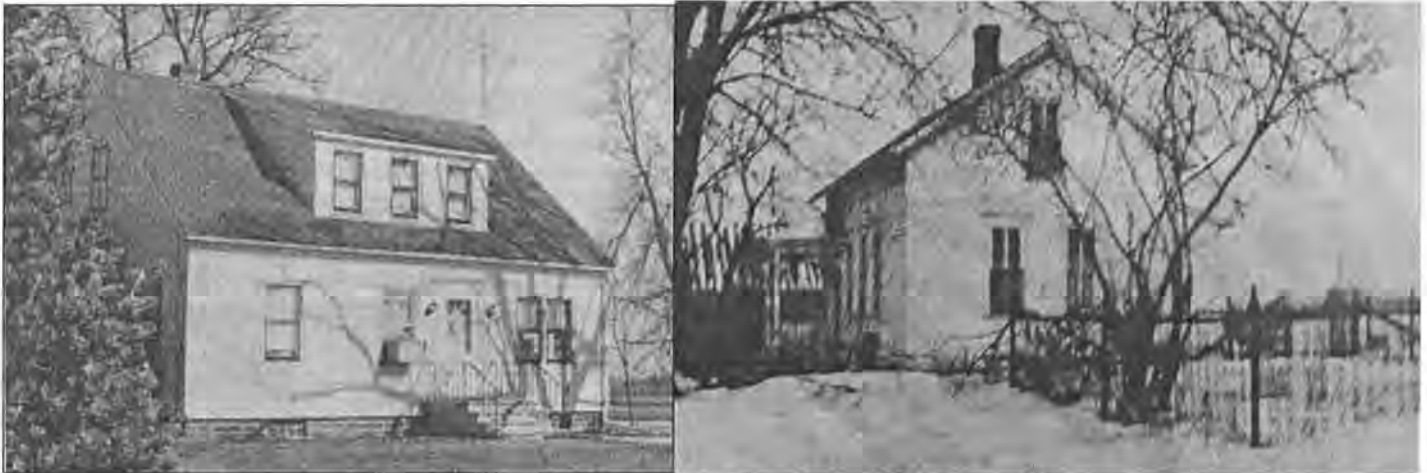
Figures 13, 14: new parsonage, view southeast, 1953 (left) and Custodian's house, view north (right) (100<sup>th</sup> Anniversary Booklet)

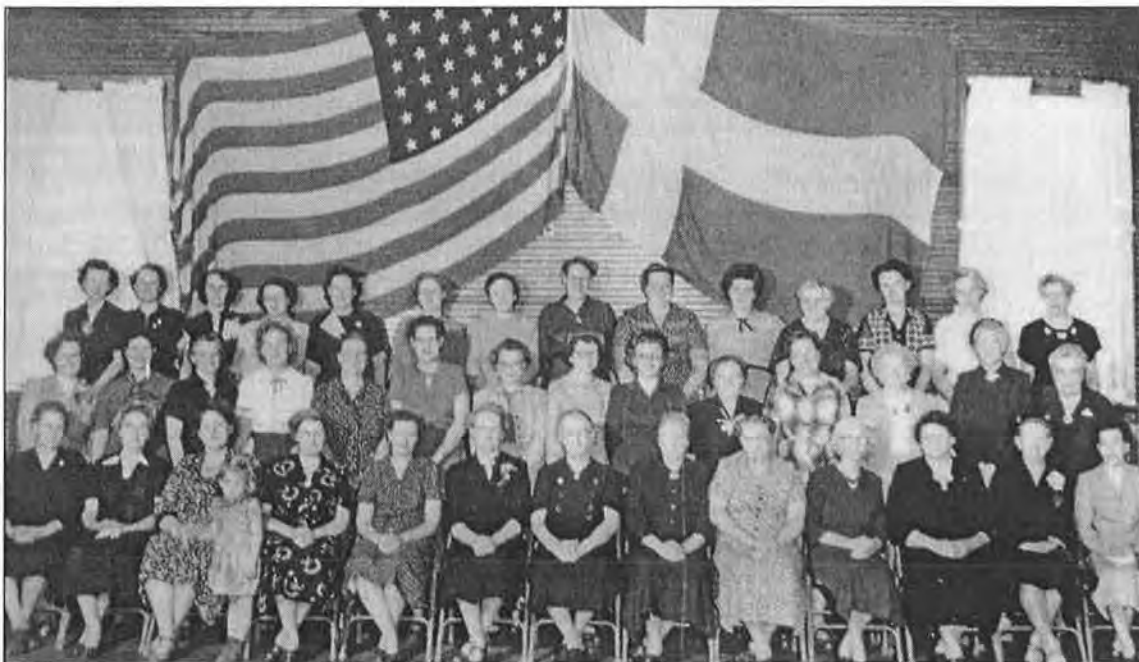
Figure 16: Ladies Aid in the church hall, 1953 (note wainscot, white curtains cover two windows) (75<sup>th</sup> Anniversary Booklet)

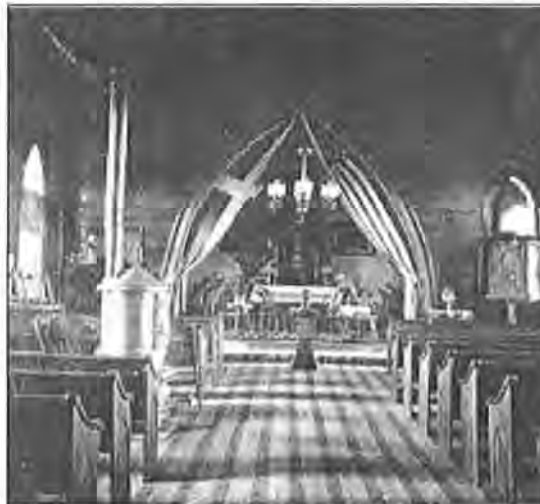
Figure 19: Comparable interior view, Fredsville, Iowa church  
(here the altar area was raised and largely separated from the congregation) (non-extant)  
(<http://www.fredsvillelutheran.org/who-we-are/ourhistory/1871-1900>)
