United States Department of the Interior National Park Service
NATIONAL REGISTER OF HISTORIC PLACES REGISTRATION
FORM

historic name: Camp Mad Anthony Wayne

street & number: 2125 Spring Valley Drive

city/town: Huntington

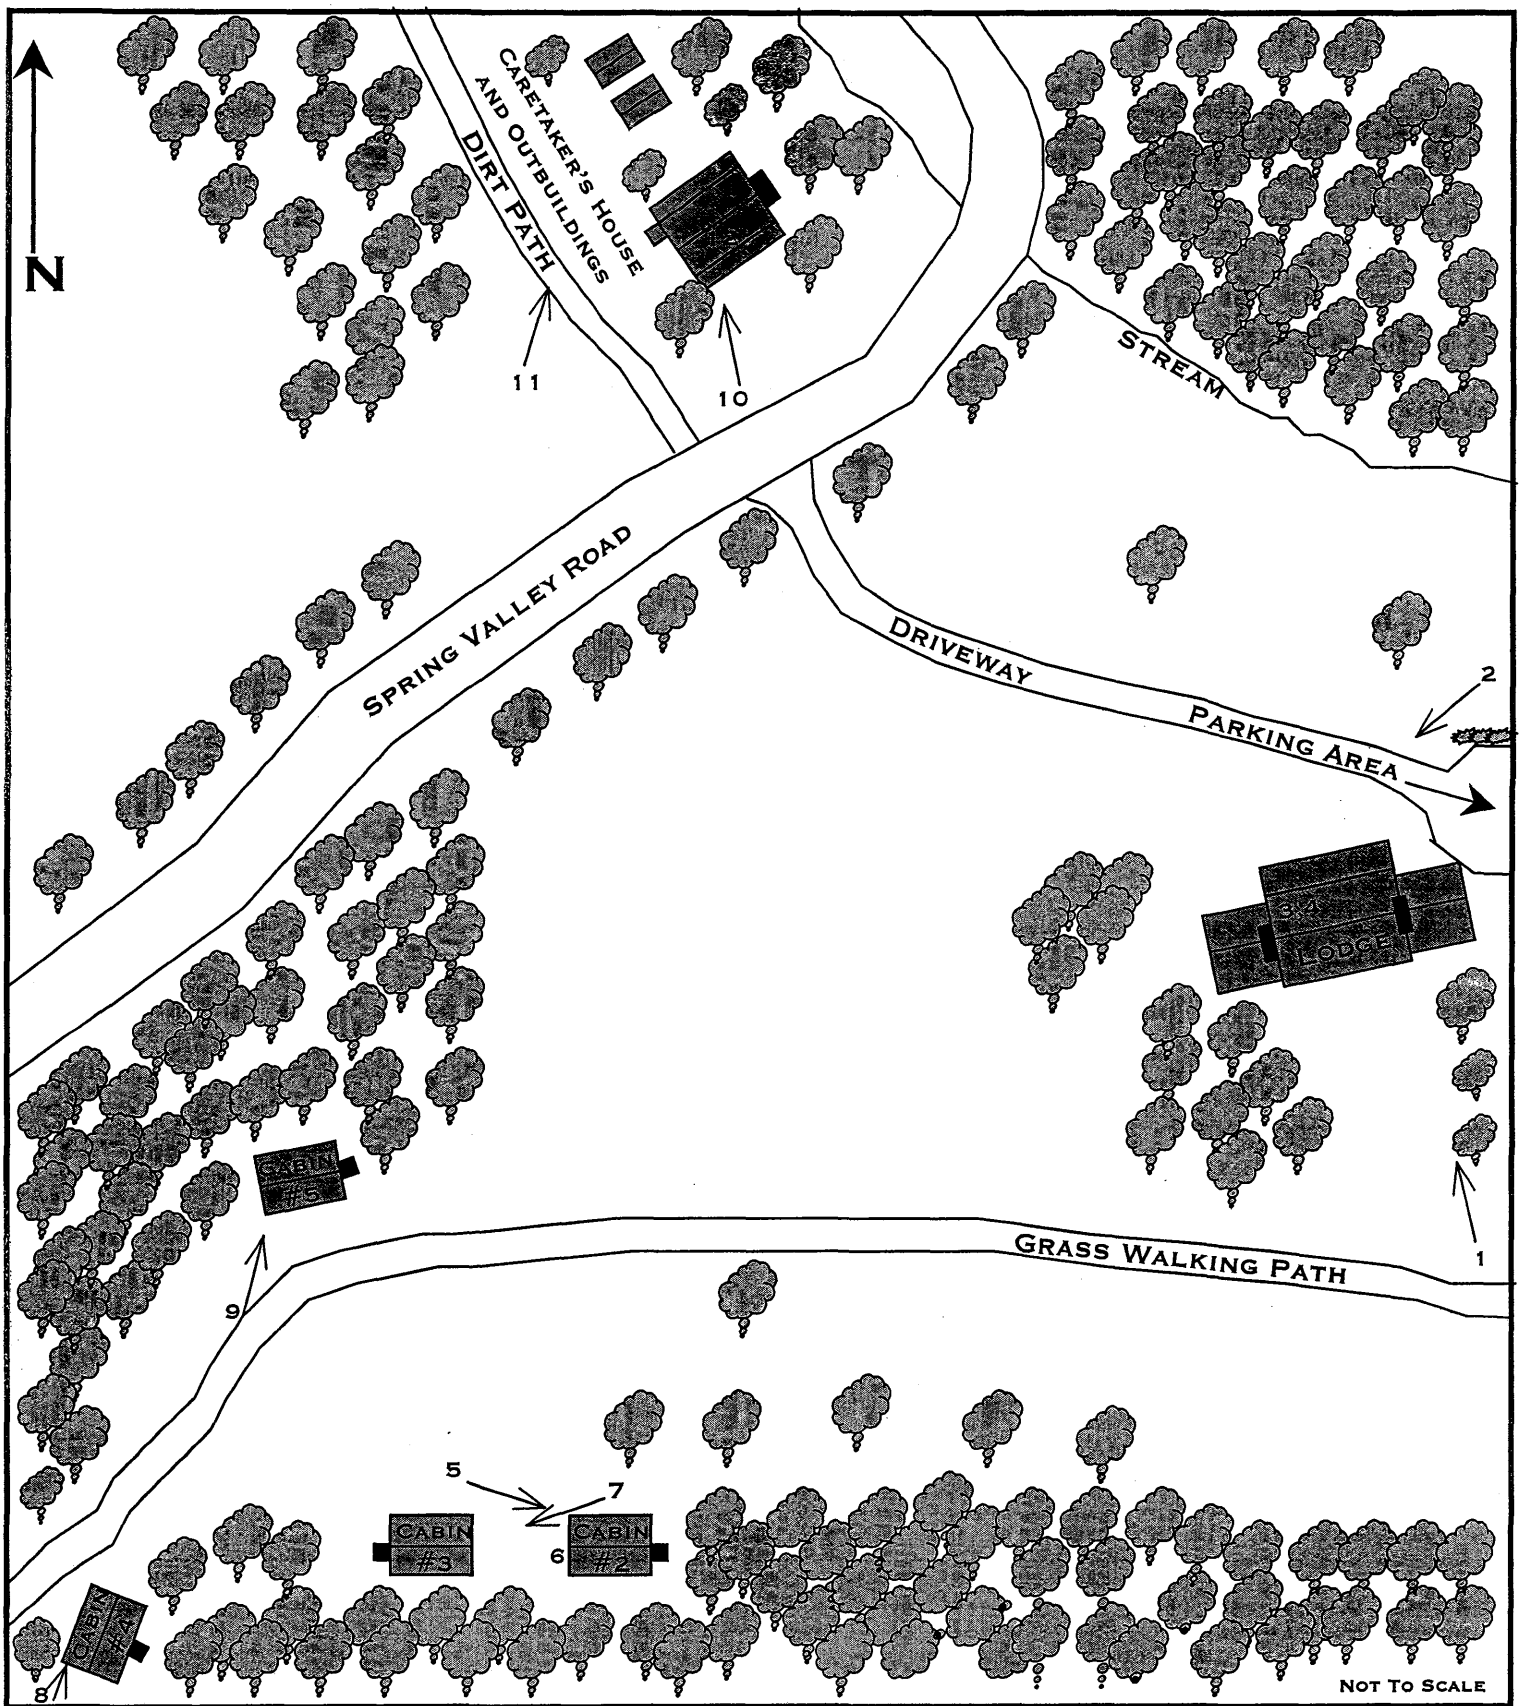
- Photo 1/8 Camp Lodge Building. Camera facing northwest
- Photo 2/8 Camp Lodge Building. Camera facing West-southwest
- Photo 3/8 Camp Cottage No. 2. Camera facing southeast
- Photo 4/8 Camp Cottage No. 3. Camera facing southwest
- Photo 5/8 Camp Cottage No. 4. Camera facing north
- Photo 6/8 Camp Cottage No. 5. Camera facing north
- Photo 7/8 Caretaker's Cottage. Camera facing north
- Photo 8/8 Caretaker's Cottage Outbuildings: Garage on Left and Storage Building on Right. Camera facing northeast

KEY

1 → PHOTO NUMBER AND DIRECTION
