National Register of Historic Places Registration Form

Historic name Vickers Petroleum Service Station
Other names/site number Vickers Building; KHRI #173-12988
Name of related Multiple Property Listing Roadside Kansas

Street & number 140 N Main Street N/A not for publication
City or town Haysville N/A vicinity
State Kansas Code KS County Sedgwick Code 173 Zip code 67060

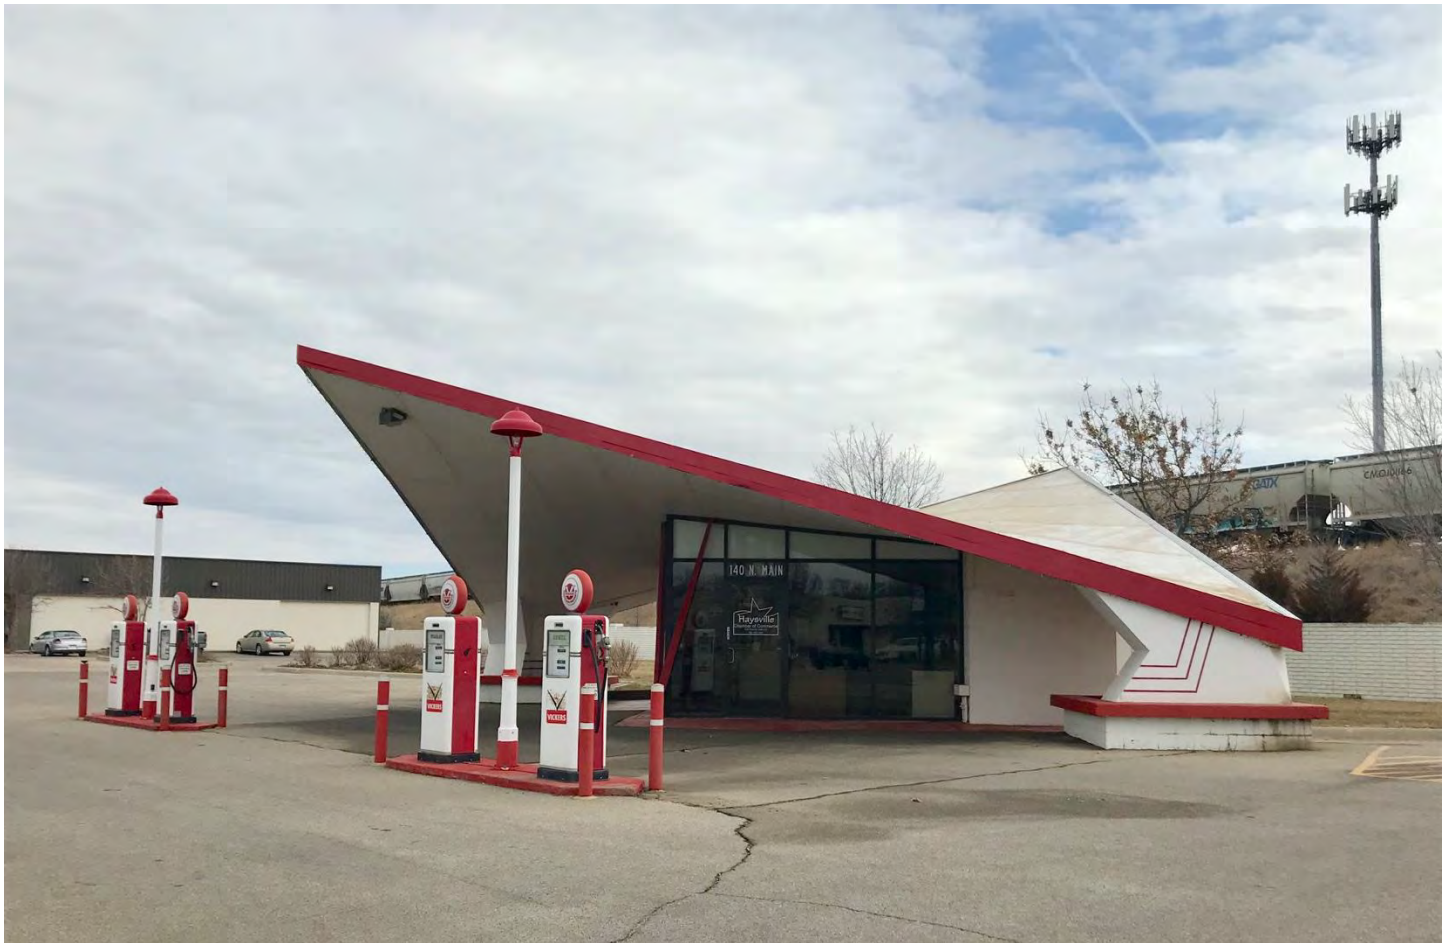
Photo: The two axes of the building can be observed. The batwings open to the east and west.

The geometrically complex form is created by a convex axis and concave axis that intersect to create the hyperbolic paraboloid. The convex form of the paraboloid runs along the N-S axis, and the concave form runs along the E-W axis, creating the “batwing” that opens to the east and the west (see photo below). Each point of the concave form terminates at a geometric concrete column with two V-shaped angular wings that have a large 48”x48” white-painted cinder block planter as a base on the inner facing side.

There is a column at the north end of the structure and one at the south. The planters have a six-inch tall by one-foot deep concrete lip that overhangs the two cinder block courses by six inches. There is currently soil in the planter boxes, but no plants. The planters reside at the inner facing side of the concrete column, so that the planter itself is facing towards the building. Each column has two wings that form an “L” with a cant connecting the two wings on the interior of the structure. In the column’s vertical axis, the top and bottom edges both taper towards the center point of the column shaft, creating an offset, obtuse-angled “V”-shaped indentation into the side of each column wing, starting at the planter base and terminating at the underside of the roof shell (see photo below). At the interior and exterior of each of the column wings, three recessed grooves painted in red create patterns providing visual relief to the massive white columns. Where the roof terminates above each column, the column splays from a point near the corner of the planter base back towards the interior of the building, creating a triangular surface at each edge of the roof in the convex axis.

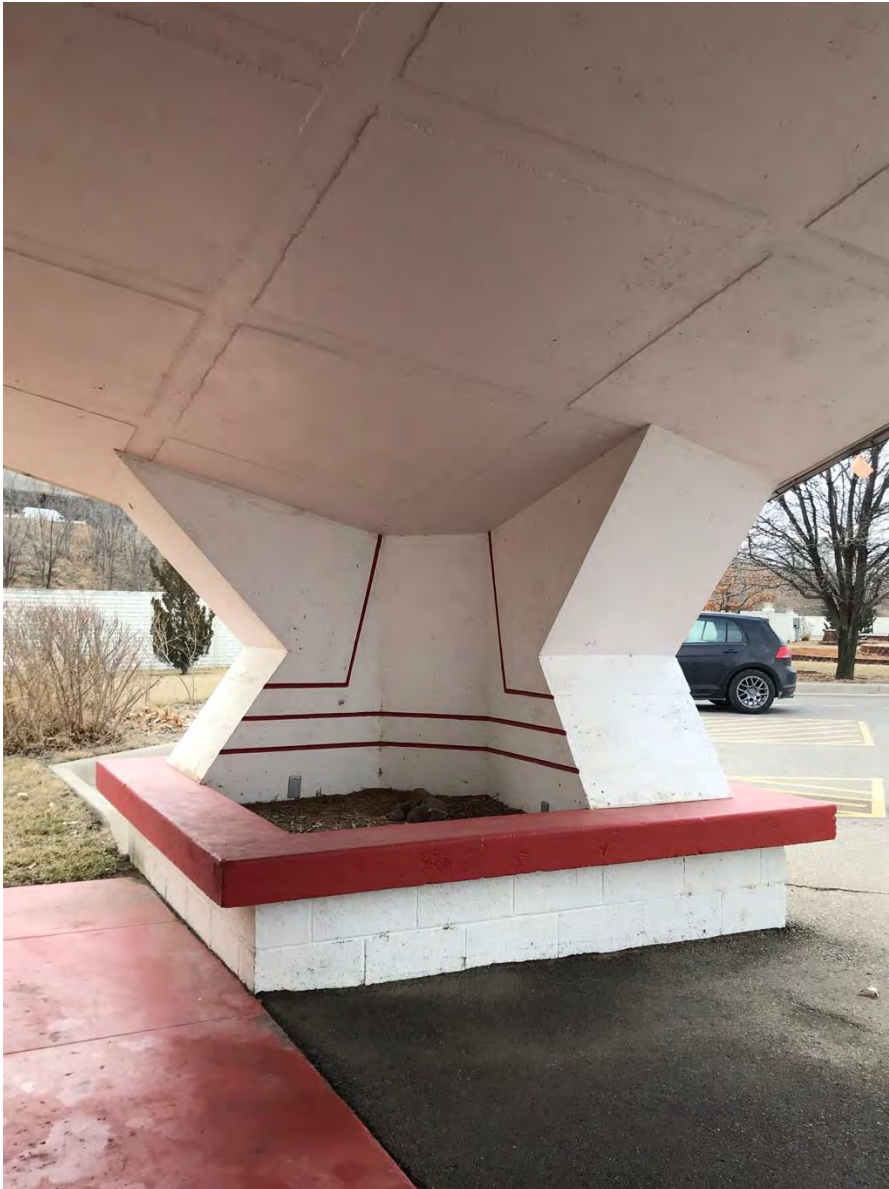
Photo: One of the two large column planters at which the roof shell terminates.

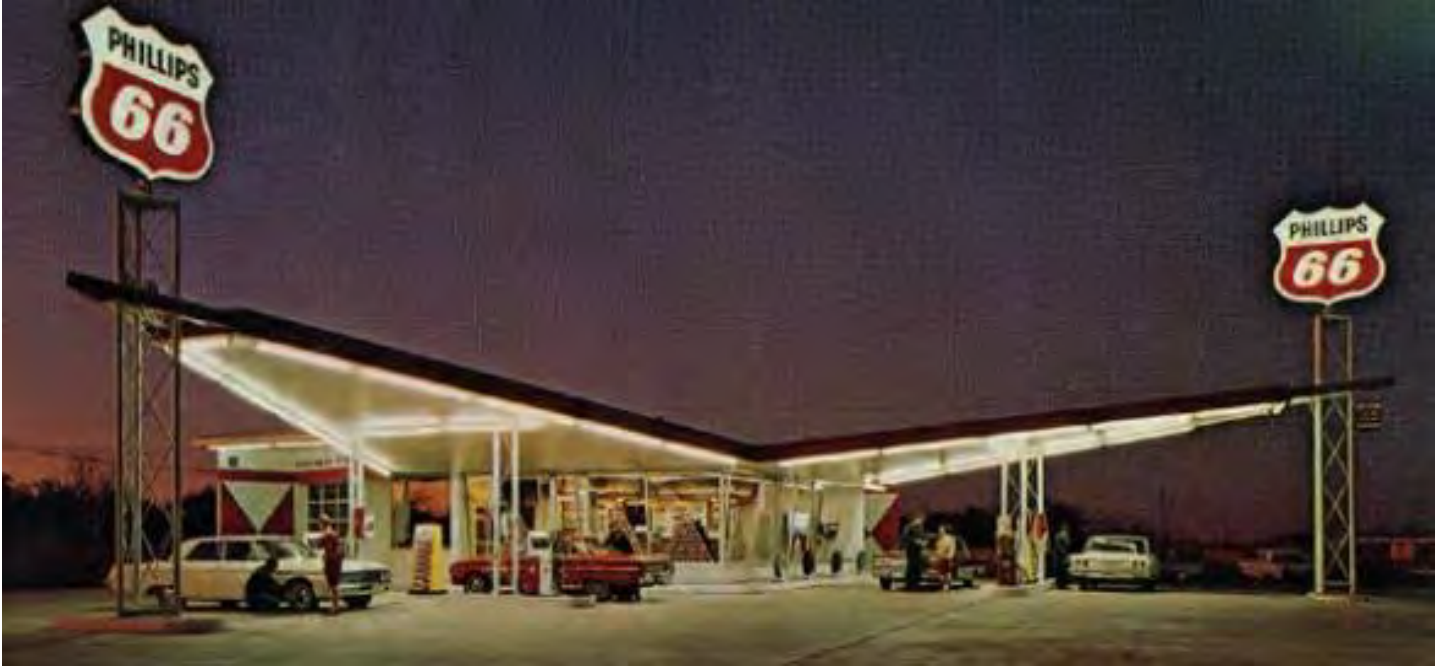
Figure 3: A Phillips 66 gas station with two “batwing” canopies. Taken from “A Field Guide to Gas Stations in Texas.”
Source: Allen, Roadside Picture, Flickr

Many other oil companies and service stations subsequently adopted the style including Phillips 66. It was not until 1960 that Phillips 66 architect Clarence Reinhardt introduced their iconic standard of design. This standard included the large triangular canopy that extended from the service station's office and out to a tall metal pier from which a Phillips 66 was usually hung.¹⁵ (See Figure 3).

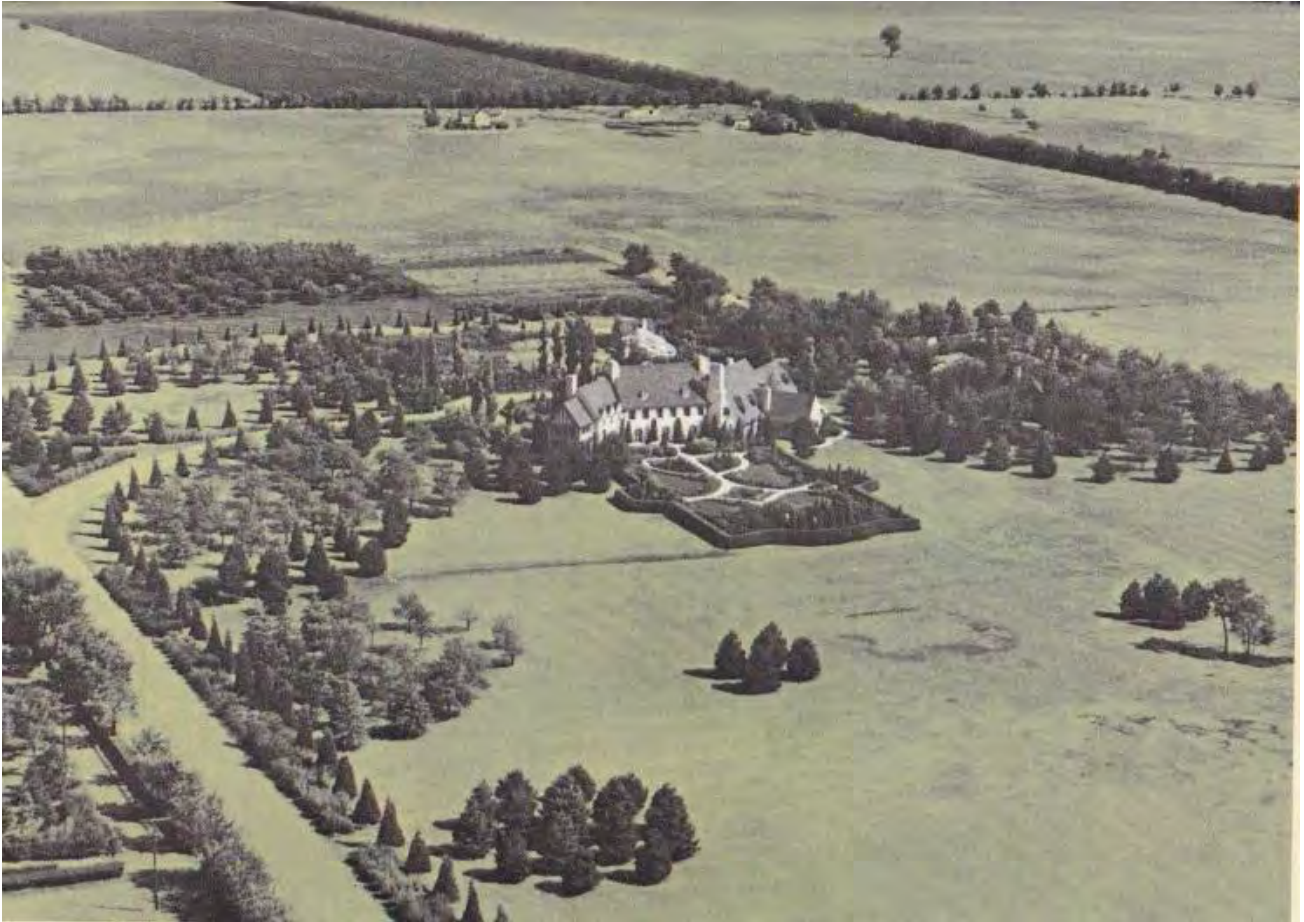
Figure 4: Aerial Photo of 'Vickridge' c. 1935 from "50th '1918...': page 10

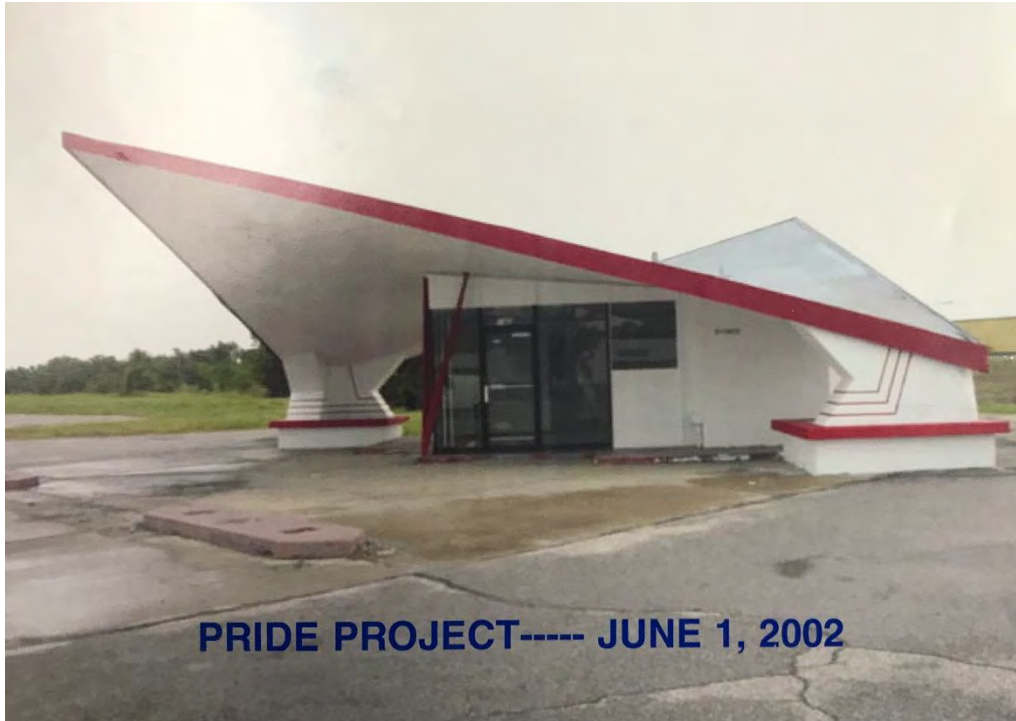
Figure 5: After the Pride Project in 2002. A first reconstruction was built in 1999 with a wood-framed bulkhead above the storefront. Volunteers painted the building as part of the Pride Project. Photo courtesy of Rosemarie Corby.

² A first reconstruction occurred in 1999 as part of the "Pride Project", a rebuilding effort in the area. The reconstruction was redone in 2007 and the storefront was re-designed from what appears in Figure 5.

time. (See Figure 5). In 2002, the Vickers Building was the recipient of community service as part of the "Pride Project." This project utilized volunteer help to re-paint the building once again. It was also adopted into Pride Park along with the parcel directly to the south and receives City protections today.¹⁶ In 2007, an interior space was re-constructed beneath the concrete structure that remained to better match what was originally built as the service station. This interior build-out now houses the Haysville Chamber of Commerce office. A storefront system was built at the front of the office that better match the storefront that originally was there. The mullions and glass now reach to the underside of the roof structure, rather than having a bulkhead above the storefront system and incorrect sash patterns. (See Figure 5). The original construction had storefront systems enclosing both the front and rear facades of the service station store. (See Figure 7).

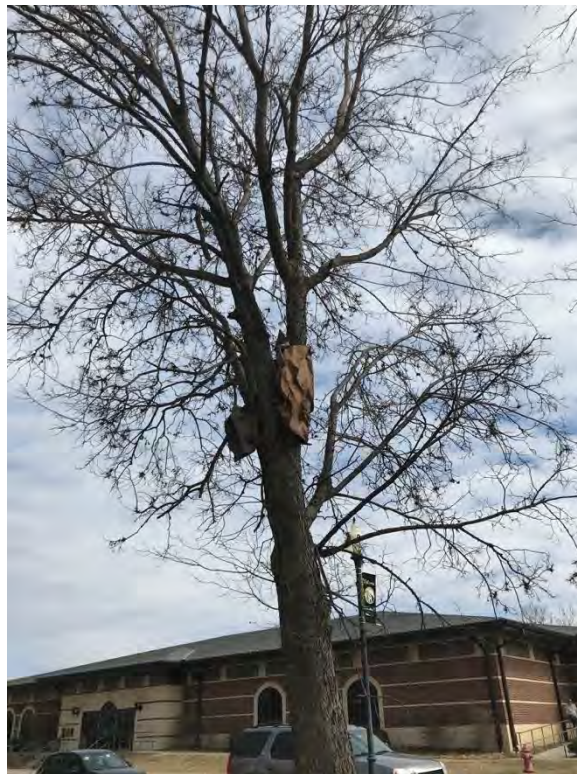
Figure 6: A tree in Historic Park with a large piece of metal lodged into its bark.

The restoration and reconstruction of the service station reflect the community's support and admiration of its history. This restoration was part of a larger project that involved the reconstruction of the historic Haysville State Bank around its original masonry vault, the only part of the bank that remained after the 1999 tornado. A historic blacksmith shop destroyed in the tornado was reconstructed next to the bank, and the Wire House was relocated to the Historic Park also. This house was one of the few that remained after the tornado. Trees in the park still contain debris from the tornado that was lodged into the bark during the storm. (See Figure 6).

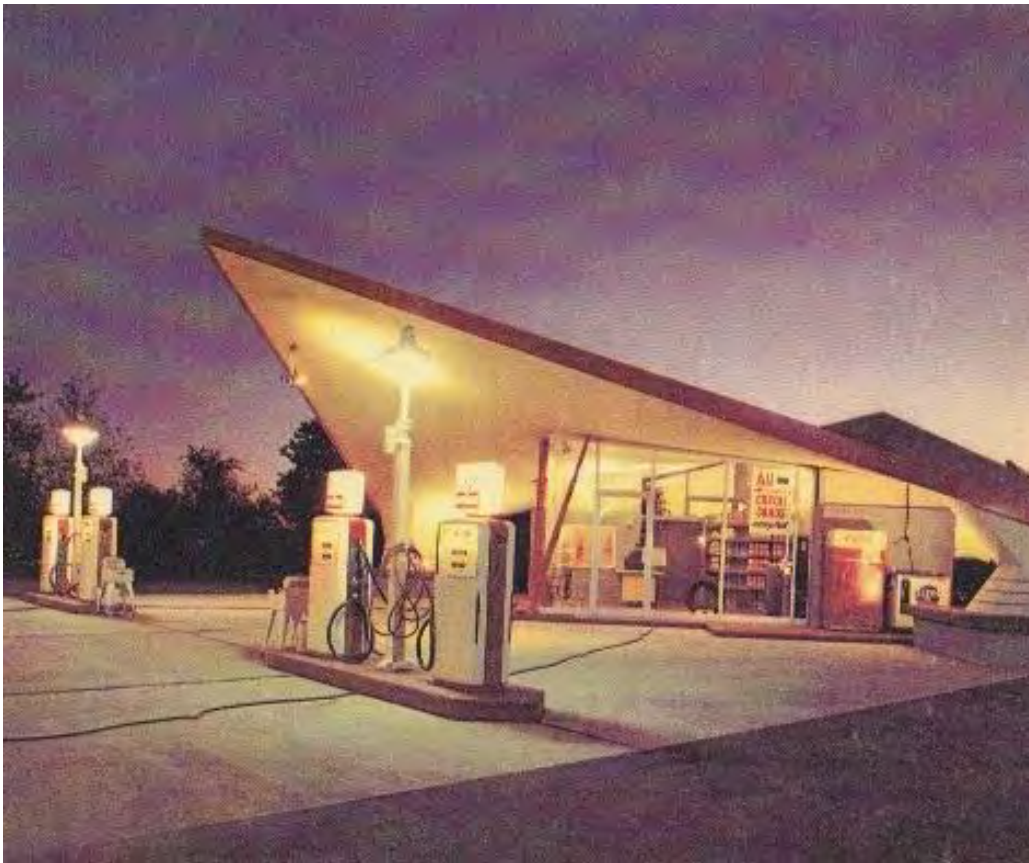
Figure 7: Vickers Petroleum Service Station in Hayesville shortly after it was constructed. This photo shows that there were storefront systems at both the front and rear facades of the interior store space. Photo from "50th '1918...": page 13.

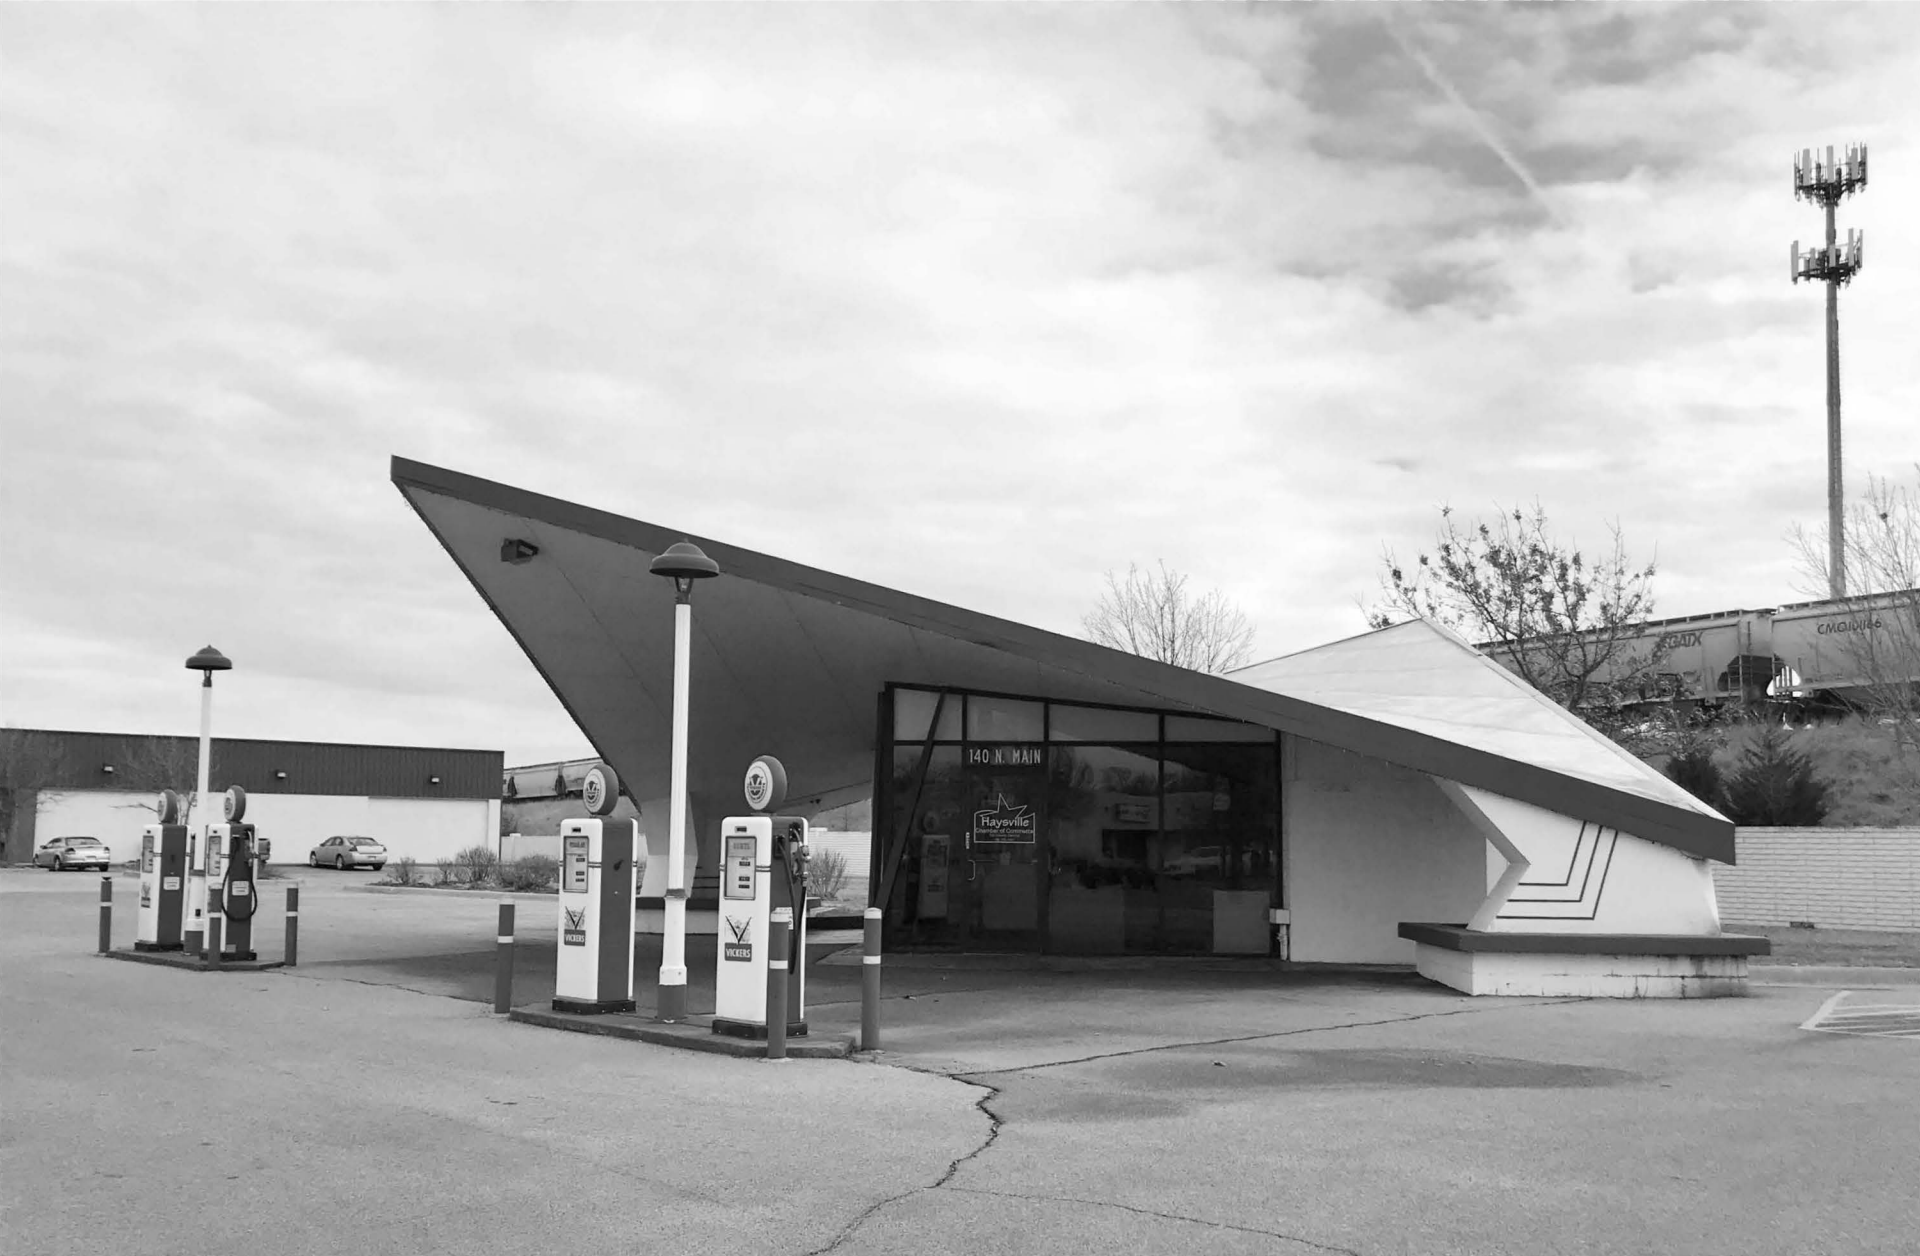
- 1 of 18: Looking northeast towards the service station. Roof shell and southwest storefront are visible. Non-original gas pumps in the foreground. "V"-shaped steel ornament is noted at the corner created by the storefront system.
