National Register of Historic Places  
Registration Form

historic name Hebron Church  
other names/site number Hebron Lutheran Church; Hebron Evangelical Lutheran Church

street & number 10851 Carper's Pike / CR 259  not for publication  
city or town Yellow Springs  vicinity  
state West Virginia code WV county Hampshire code 027 zip code 26865

MID-19<sup>th</sup> CENTURY: Greek Revival

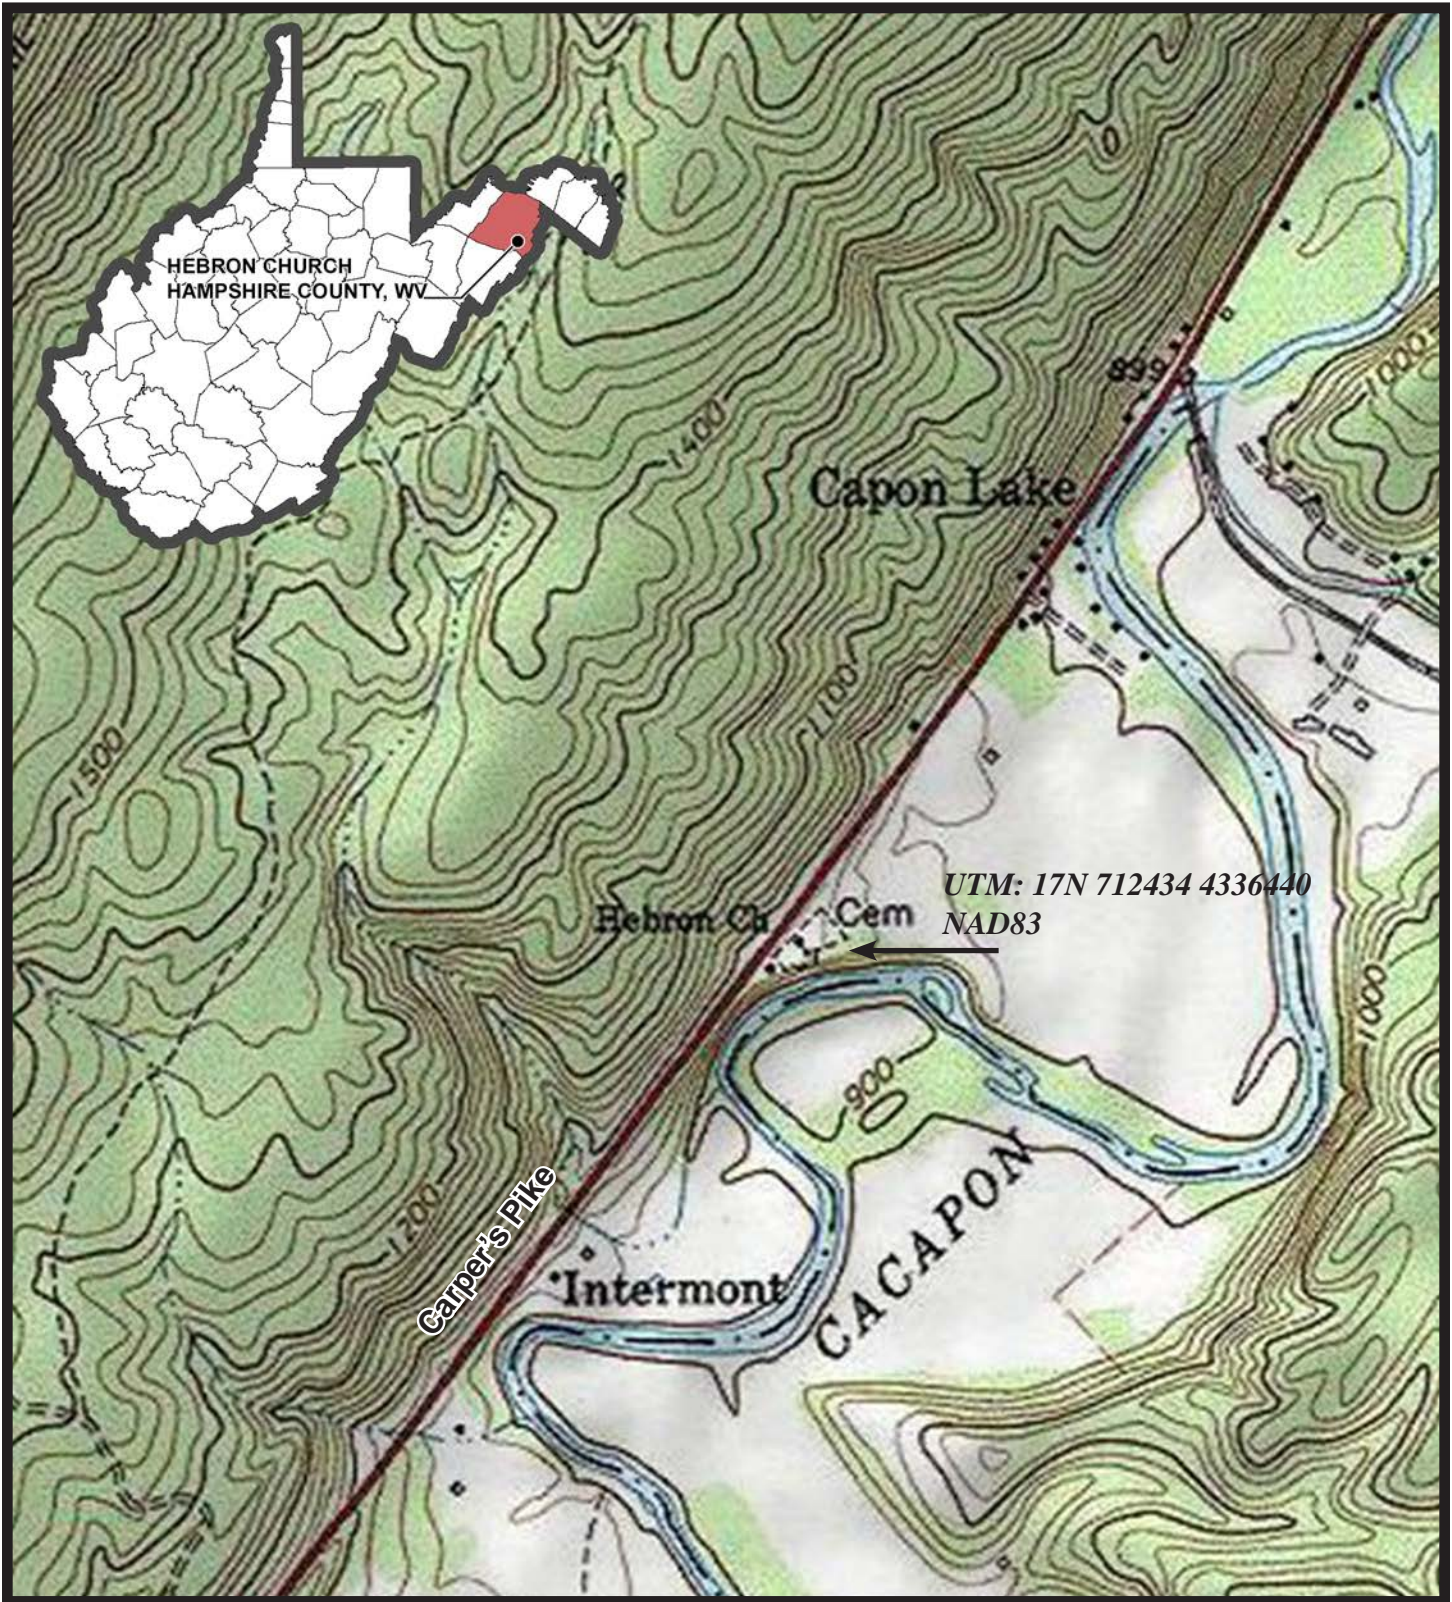
*Figure 1  
 Location Map  
 Hebron Church - Location  
 Yellow Spring, Hampshire County, West Virginia*

The National Register boundary for the Hebron Lutheran church includes the contributing historic brick church and cemetery as illustrated on the accompanying map (Figure 1). The modern community building is considered noncontributing.

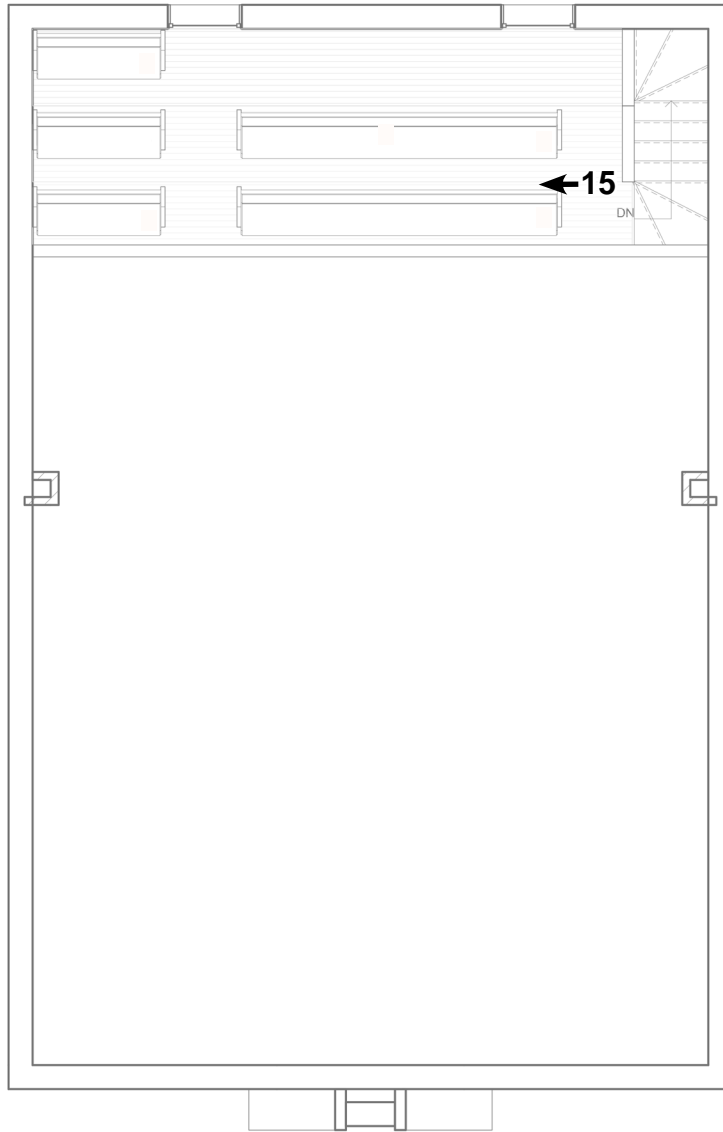
*Figure 2*  
*Photo Location Map 3 of 3*  
*Hebron Church - Level 2*  
*Yellow Spring, Hampshire County, West Virginia*

② Level 2 w/ Furniture  
1/4" = 1'-0"

Twelve wooden winder stairs access the gallery (Photo 14). It has an unfinished wood floor and four pews. The sides of the pews are painted white with the seat and rails unfinished wood (Photo 15). The ceiling height is approximately six feet, although the sloping floor causes the height of the ceiling to decrease to approximately five feet at the wall juncture. The two windows located on the west side of the building consist of stained glass, but are not operable.

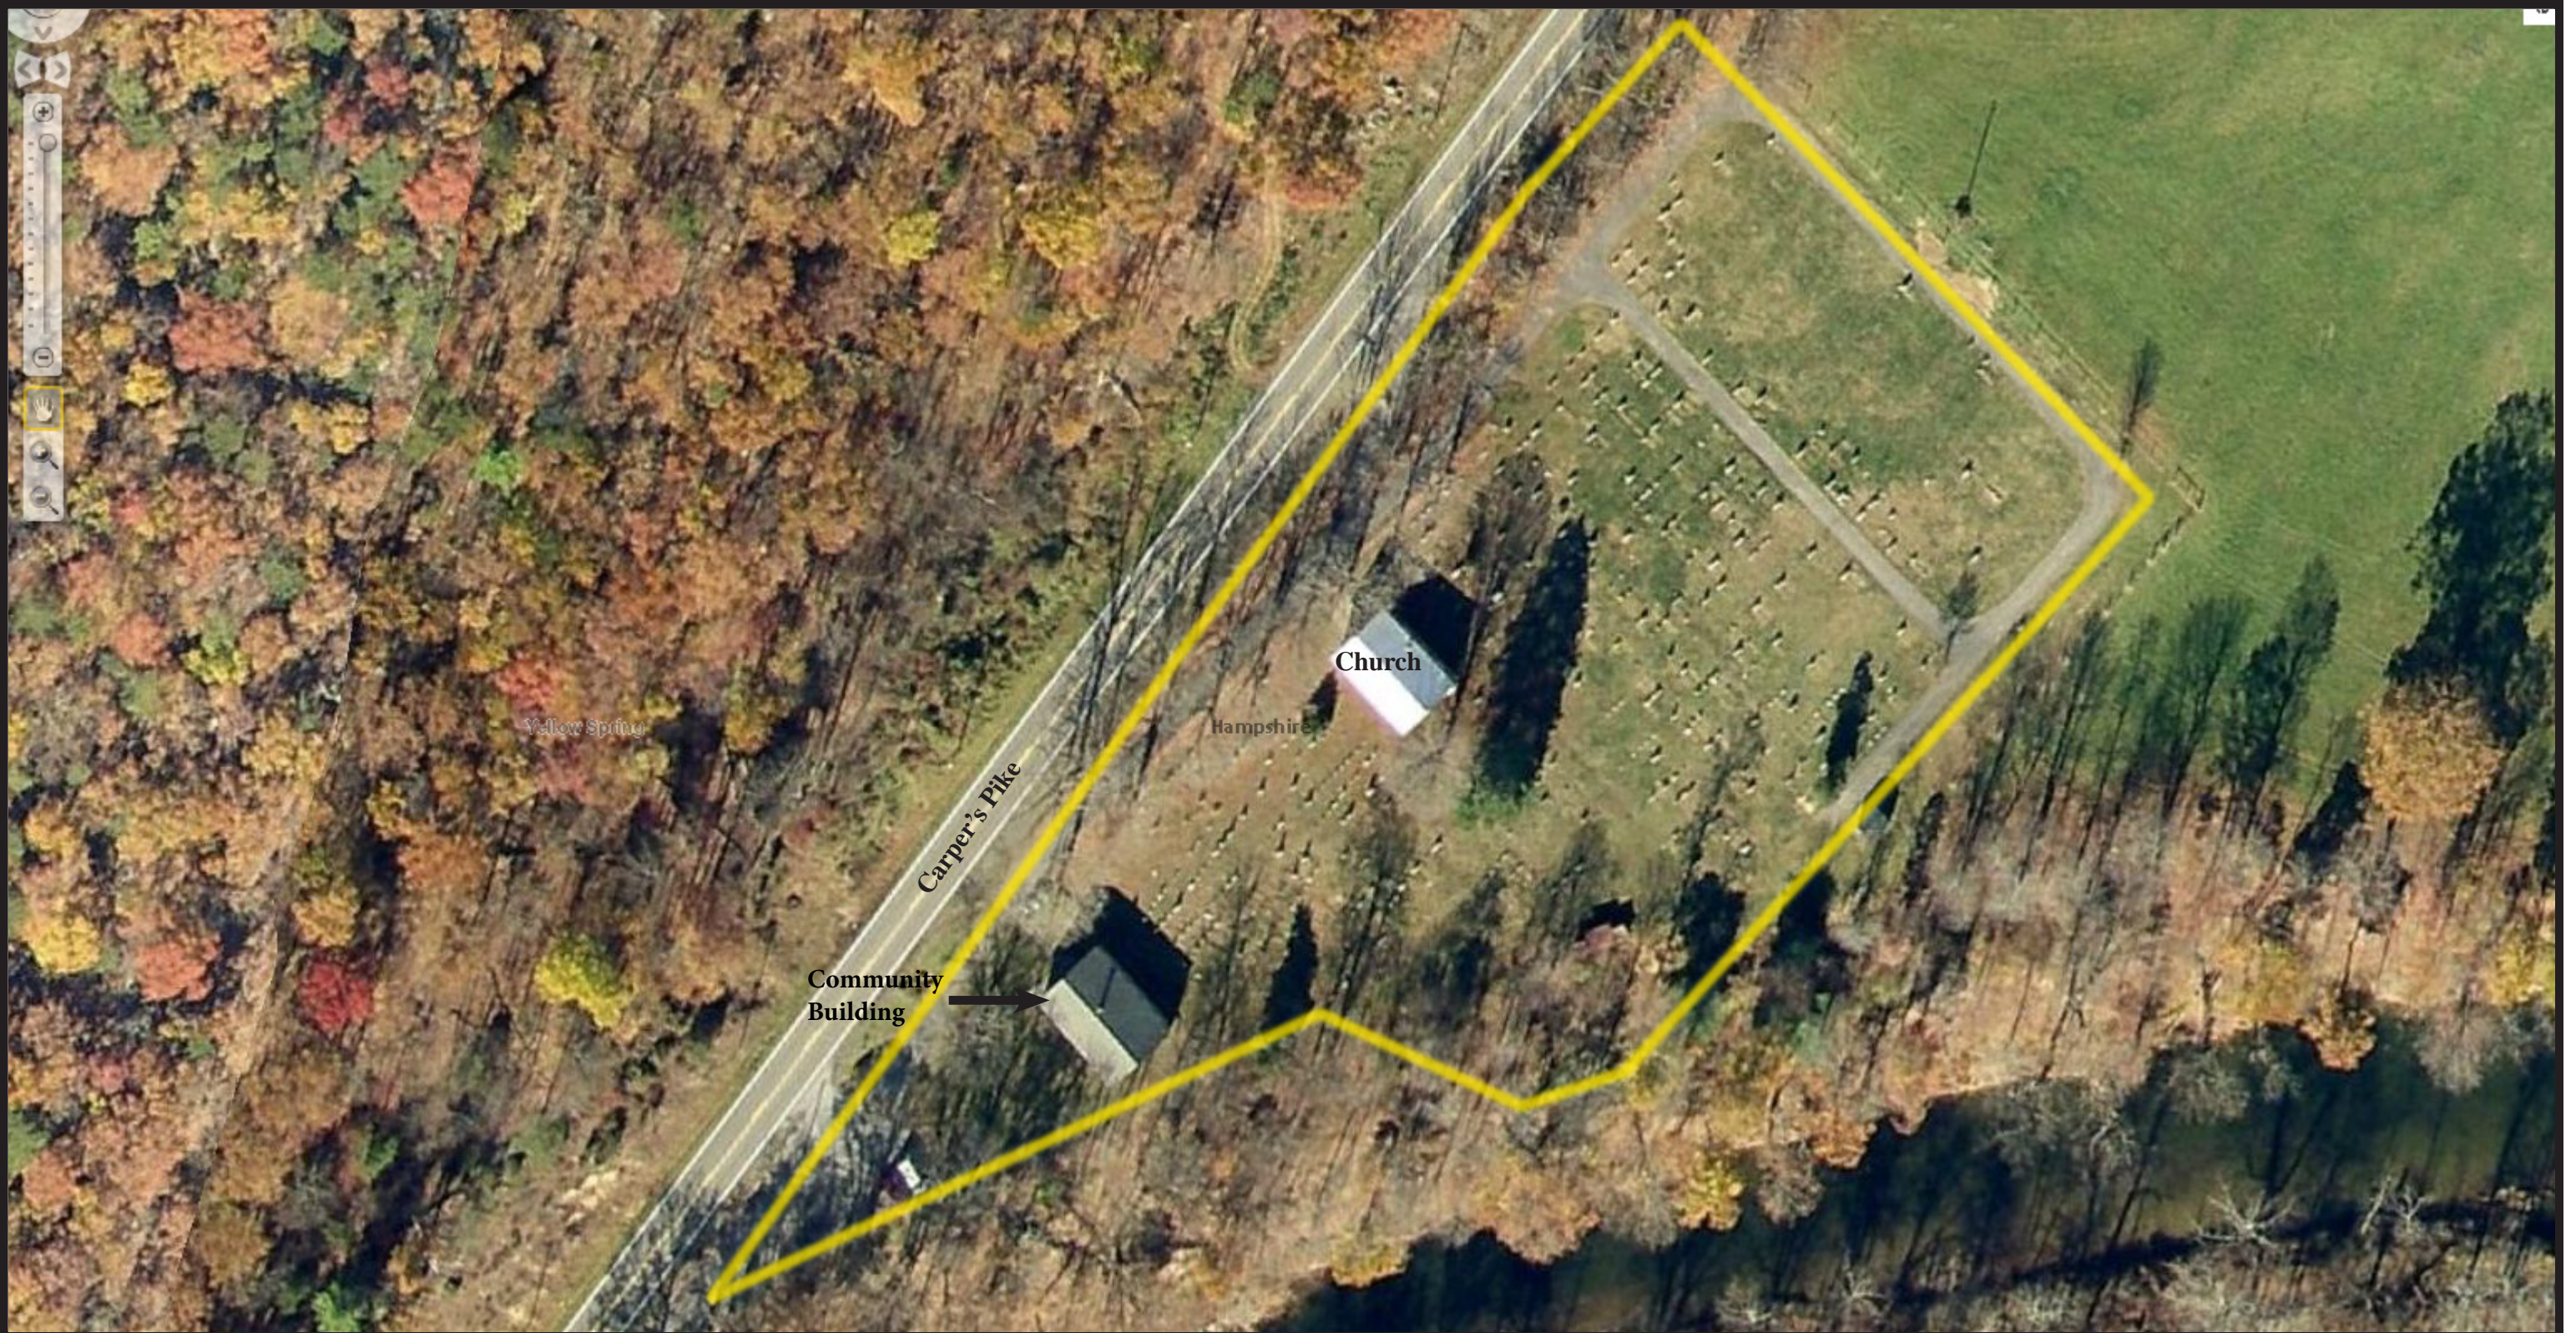
*Figure 3*  
*NRHP Boundary Map*  
*Hebron Church*  
*Yellow Spring, Hampshire County, West Virginia*

National Register Boundary

The recommended National Register boundary follows the current tax parcels which includes the land currently and historically owned by the Trustees of the Hebron Church.

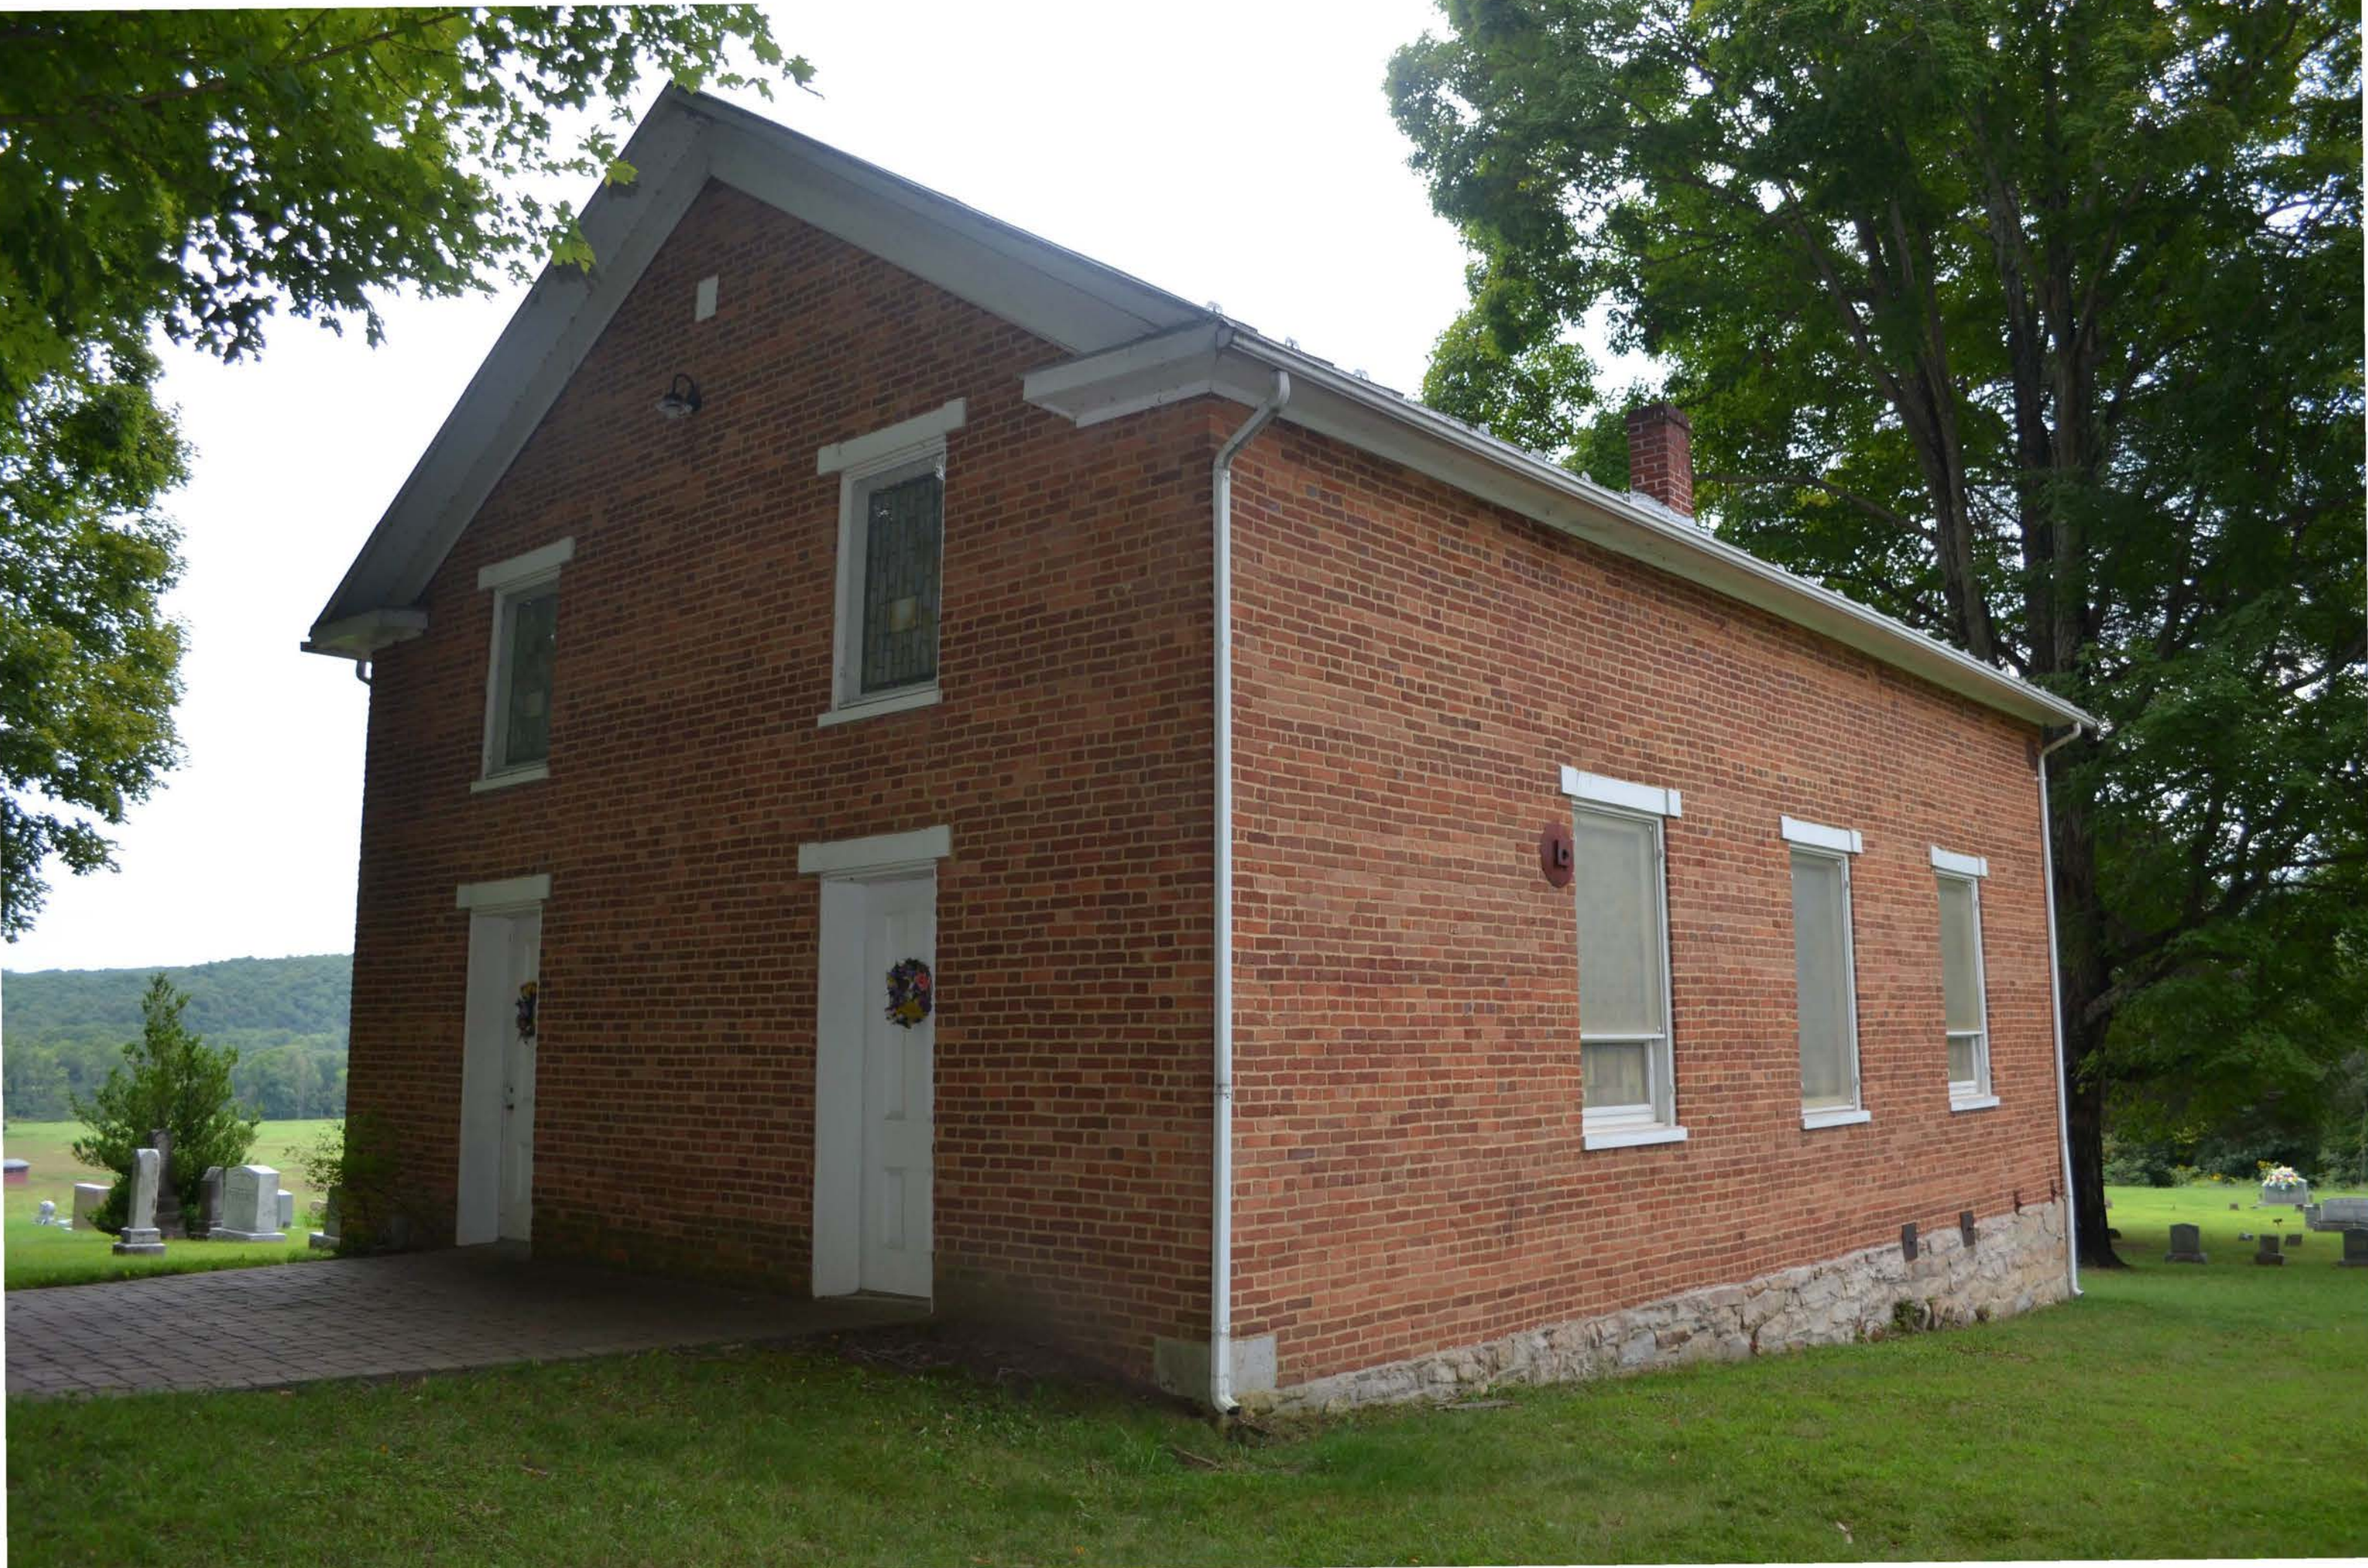
The Hebron Lutheran Church is located east of Route 259 (Carper's Pike) in the unincorporated community of Intermont in Hampshire County, north of the Hardy County line (Photo 1). The Cacapon River is located immediately southeast of the site. The setting of the church is rural with farmland interspersed with steep, wooded topography.

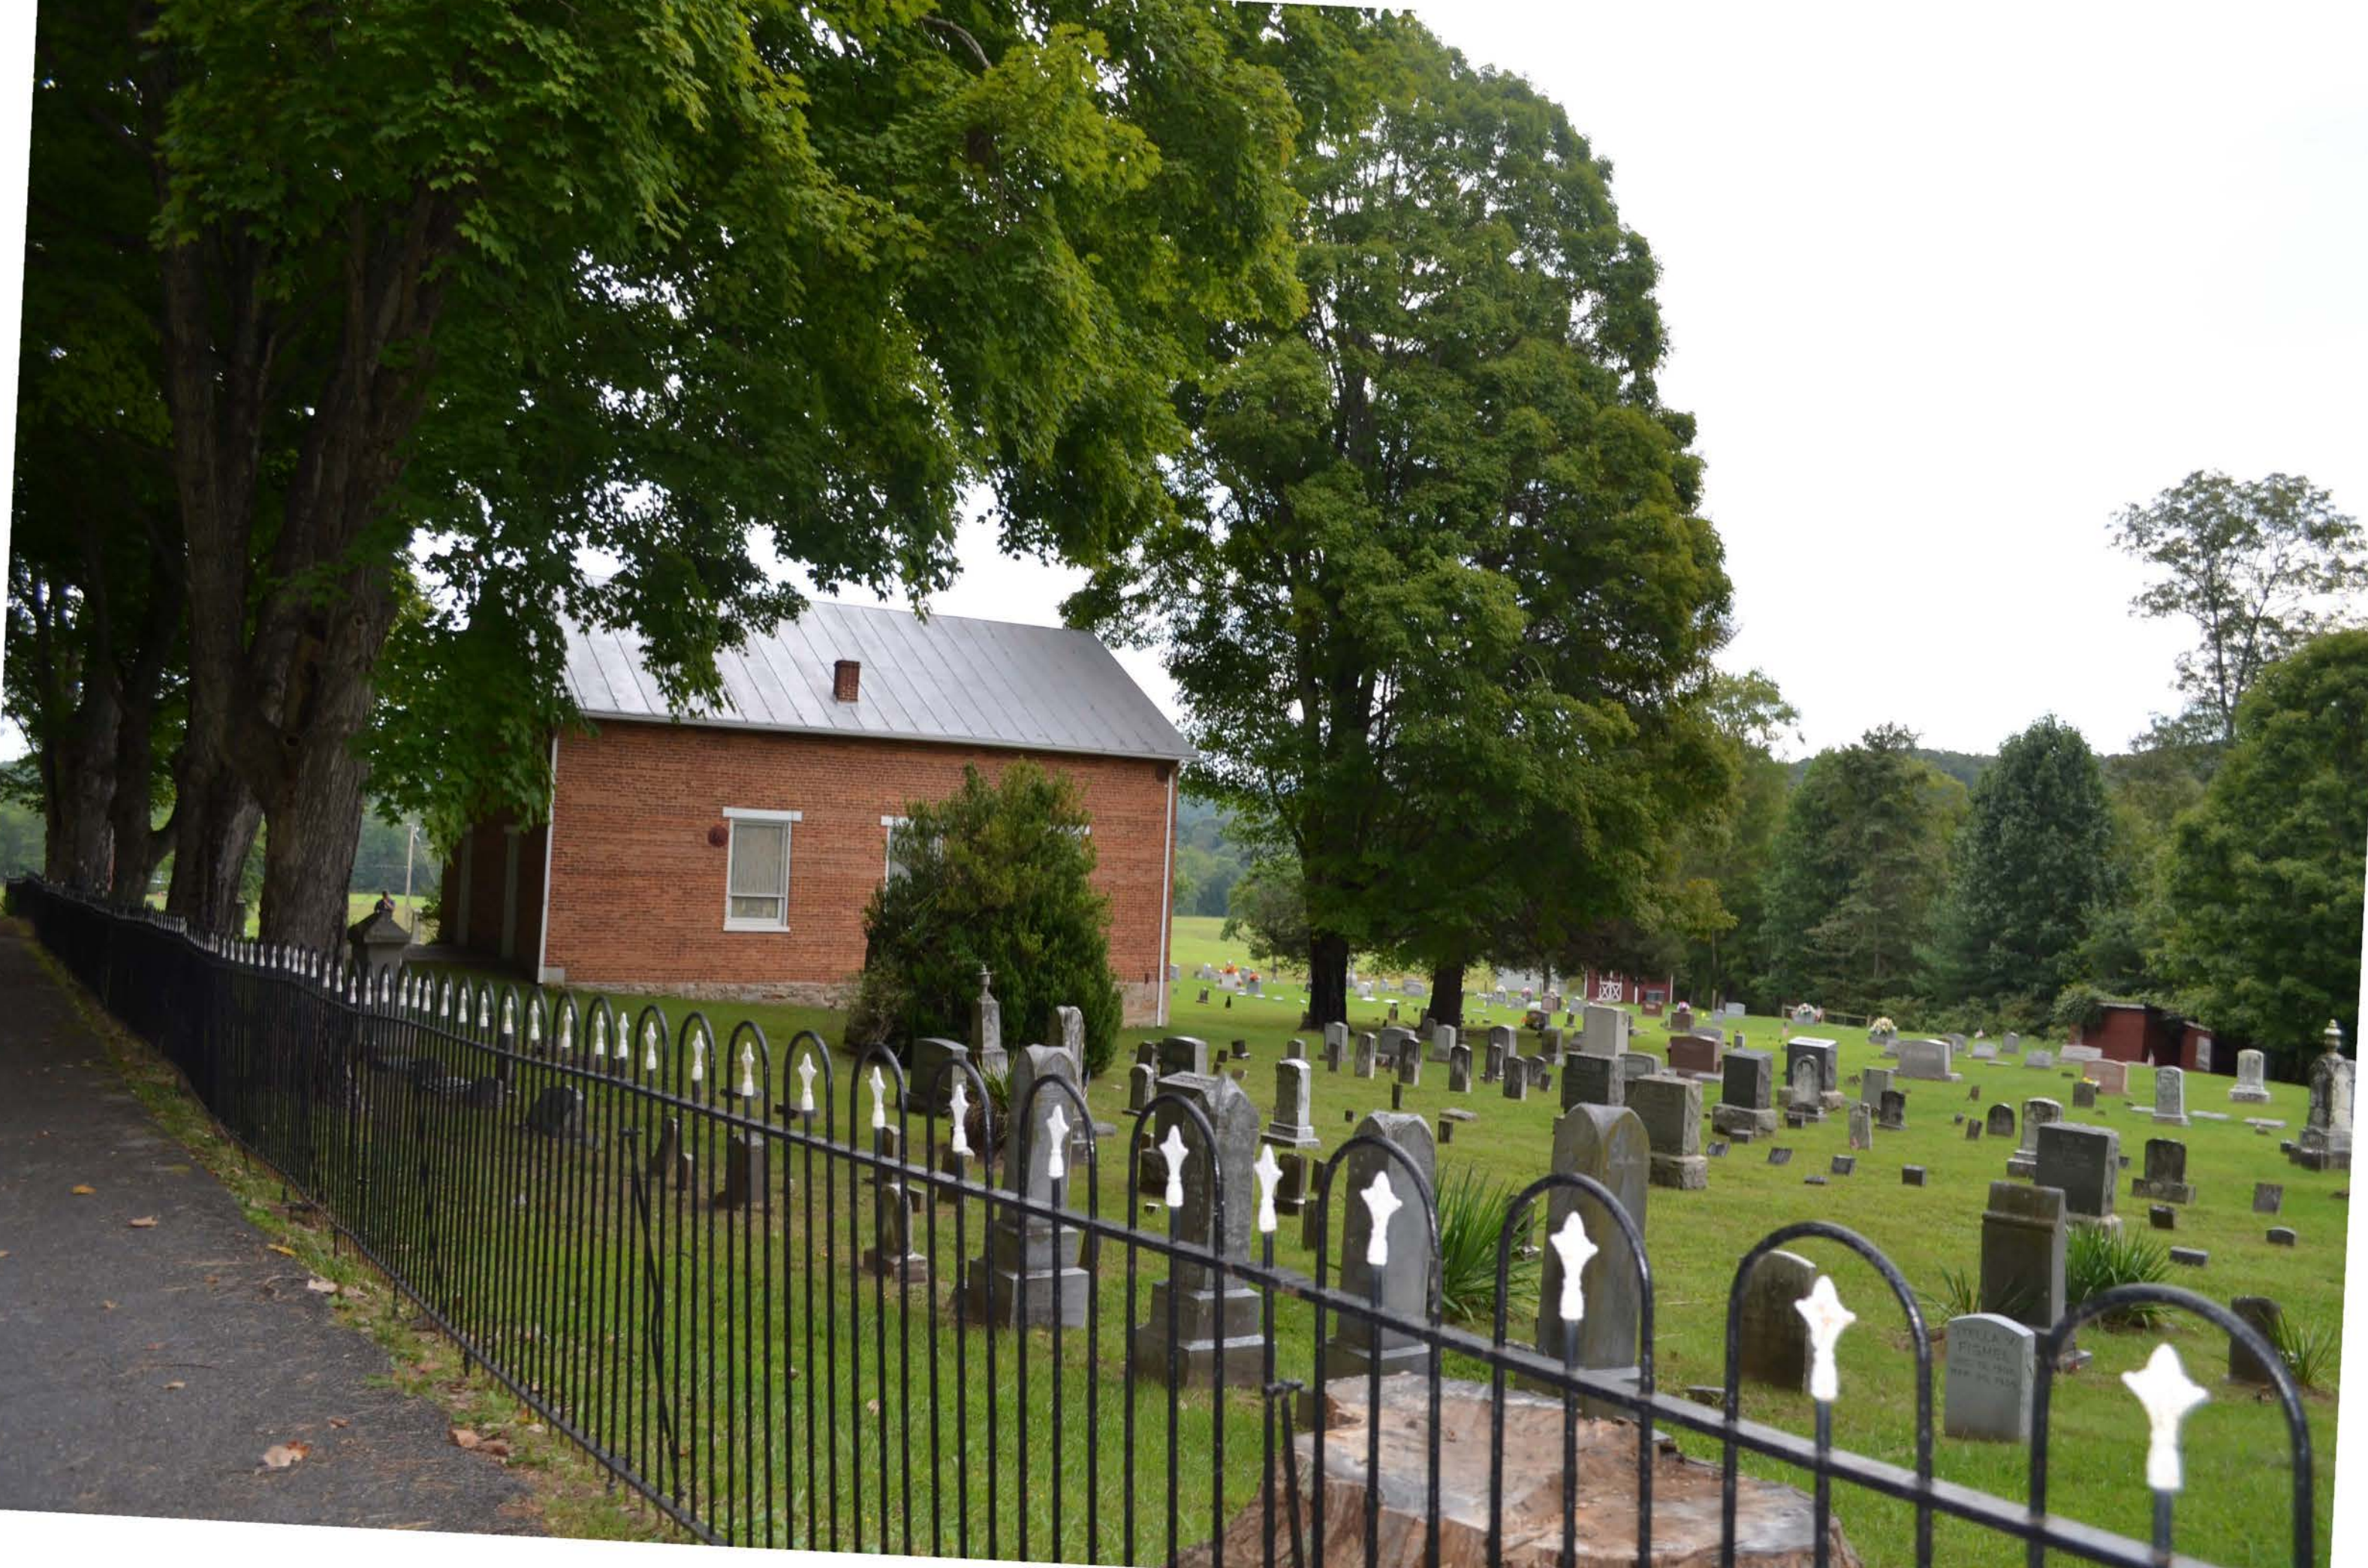
The small brick church building is located on a semi-circular asphalt drive which connects to Carper's Pike. A wrought iron fence runs along the western perimeter of the property and separates the church building and adjacent cemetery from the driveway (Photo 2). Large, old growth shade trees are located inside the fence line (Photo 3). The fence was installed in April 1895, replacing a wood picket fence.<sup>1</sup> A paved brick walkway extends from the fence to the façade of the church. The nearby Cacapon River is obscured from view by mature foliage east of the historic property.
