Property Name: Sistema de riego de las tres haciendas
(Waterworks in Puerto Rico, 1840-1898 MPS)

Historic name Sistema de riego de las tres haciendas
Other names/site number SI-53; SI0200031
Name of related multiple property listing Going with the Flow: Waterworks in Puerto Rico, 1840-1898.
(Enter "N/A" if property is not part of a multiple property listing)

Street & Number South of Highway PR-52, north and on PR-1, west and east of PR-153.
City or town Santa Isabel State Puerto Rico County Santa Isabel
Not for publication [N/A] Vicinity [X]

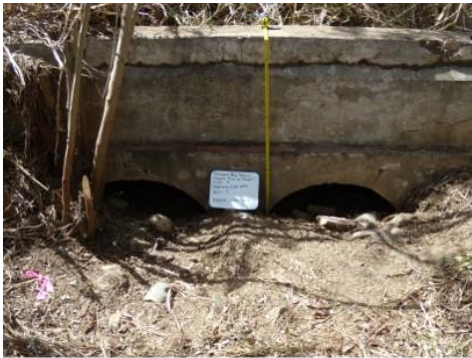
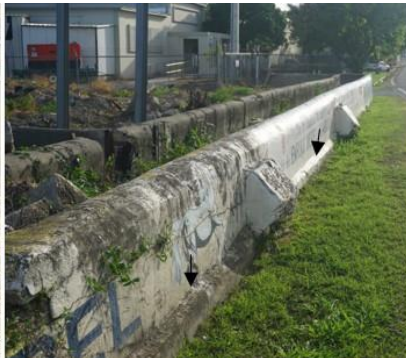
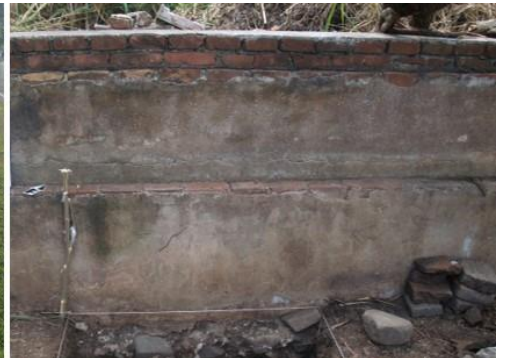
Left; Channel of the Hacienda Florida, raised on arches. Center; Channel of the Hacienda Florida, elevated on a base (note black arrows). Right; Channel of the Hacienda Florida, raised using a staggered base.

To maintain the constant flow of water through gravity, open channels were partly or fully buried, or elevated from the surrounding ground by means of bases, buttresses and arches. This network has no gates along its route, except for certain end sections located at the fields to be watered.

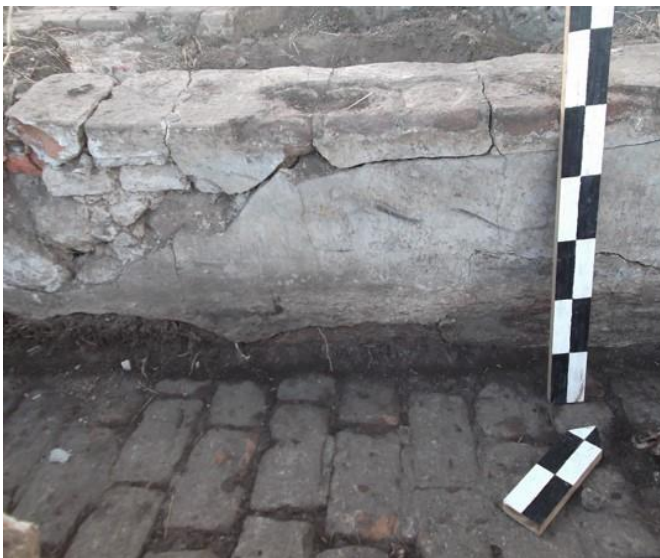
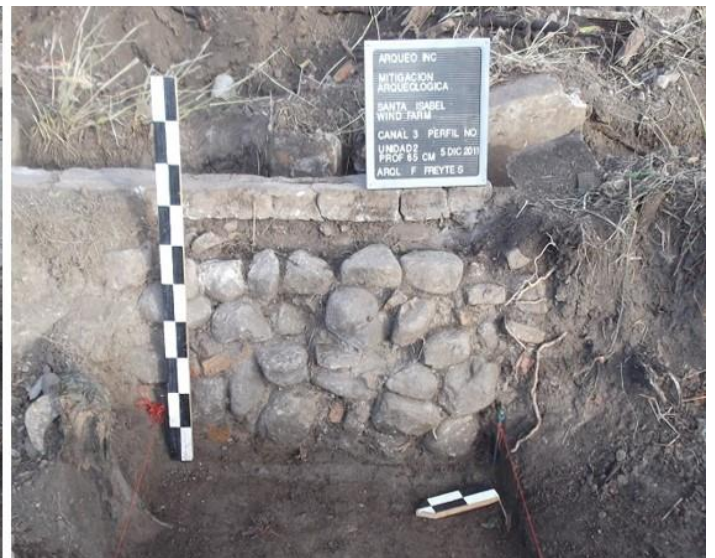
Detail of the makeup and construction method for the Hacienda El Destino Channel. Left, the inside of the west wall of the channel, covered with concrete, with some exposed bricks. Note that the floor has lost its concrete plastering. On the right, exterior view of the same wall segment.

The materials and method of construction for the components of the irrigation systems were thoroughly detailed in the Spanish legislation. For this reason, the entire construction of the *Tres Haciendas* Irrigation System is similar. The building materials that were used are ordinary brick, limestone or igneous river stones, masonry mortar composed of three parts sand and two parts lime for the foundations and walls, and concrete - made from hydraulic mortar with brick chippings or fine gravel in equal parts. The construction technique used for walls and floors consists of ordinary brick and stone masonry consolidated with lime mortar, and coated on the inside with concrete; and for the foundations, stone and well-compacted fragmented brick masonry, with or without mortar.

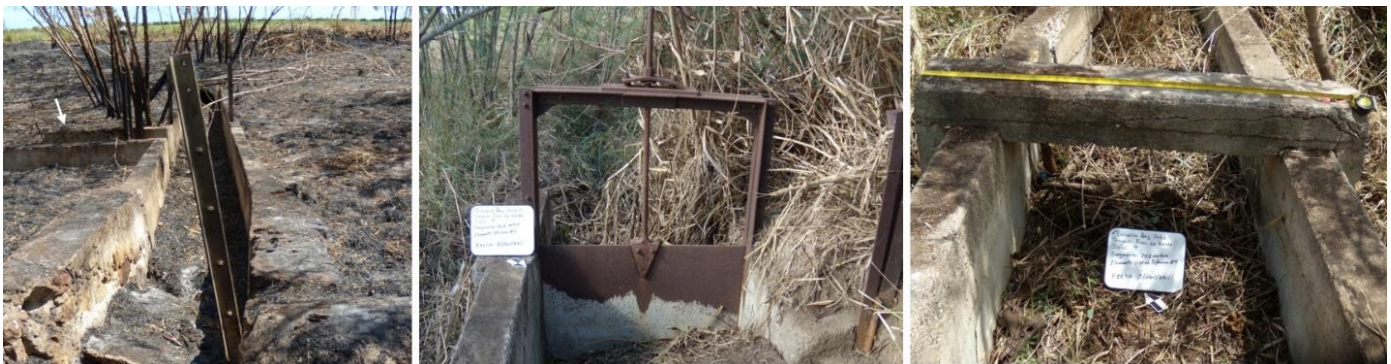
After its abandonment, the irrigation system has deteriorated. Some segments of the vaulted channel have collapsed, as have walls of the open channels affected by agricultural activities. In urbanized areas, open channels have been filled with earth or covered, using sheet metal on which a layer of concrete was poured (Photo 8). In rural areas, open channels are hidden by the vegetation, filled with soil, or buried under mounds of dirt and even rubble.

On the left, view of the *Hacienda Destino* channel, facing west. White arrow shows a channel that was added when it became part of the Irrigation District. In the center, detail of added sluice gate. Right; reinforcement beam added to the *Hacienda Florida* Channel.

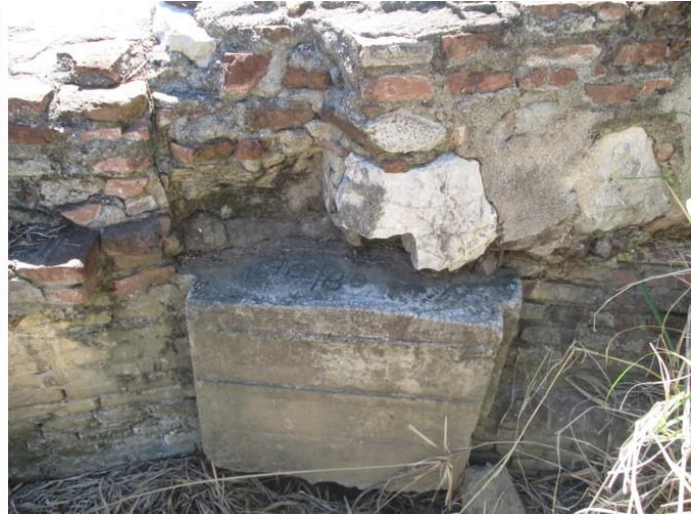
The *Tres Haciendas* Irrigation System was partially in use until the 1990s, when it was abandoned. For its full length, repairs that were performed throughout its period of usefulness can be found. Some repairs include inscriptions with the dates in which they were made, such as December 15, 1961 or December 16, 1980.

Repairs with date inscriptions. On the left, repair on the supply channel dated 1961 and to the right, repair to the low and torrential waters modules, dated 1980.

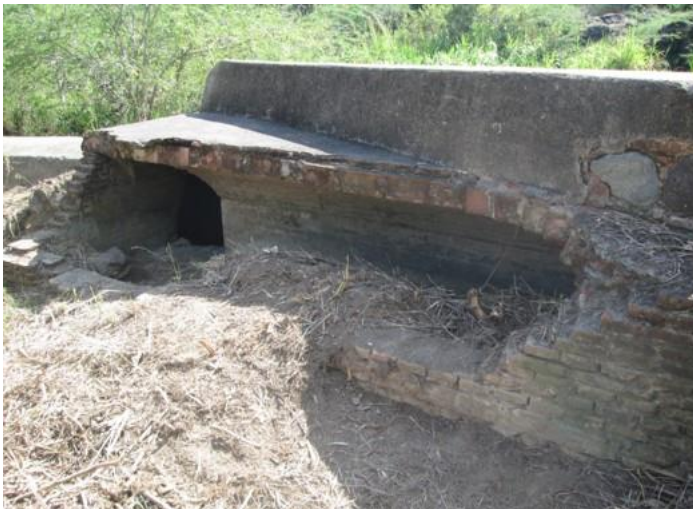
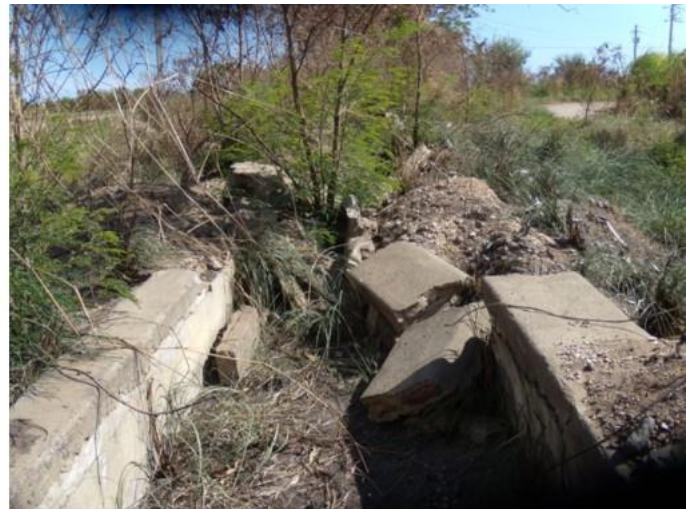
On the left, collapsed section of the torrential waters inlet channel, looking southwest. On the right segment of the supply channel with side impact caused by agricultural machinery.

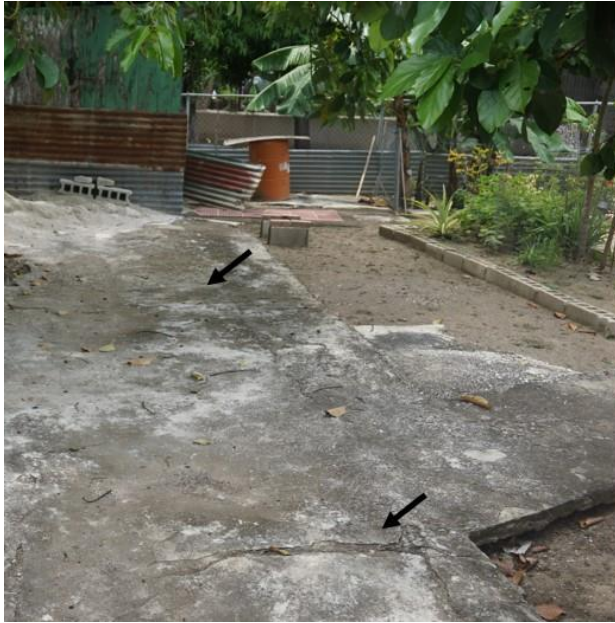
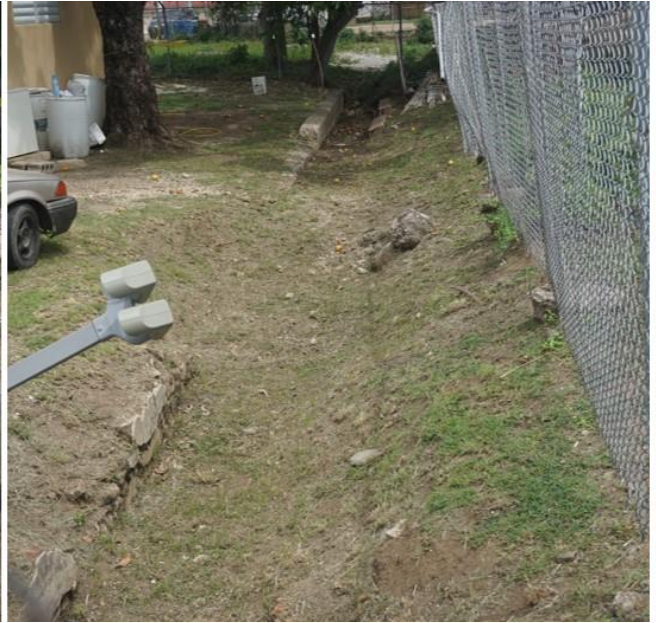
On the left, section of the supply channel covered with corrugated metal sheets and a slab of concrete. Arrows indicate the channel's route. To the right, supply channel in a backyard, filled with earth.

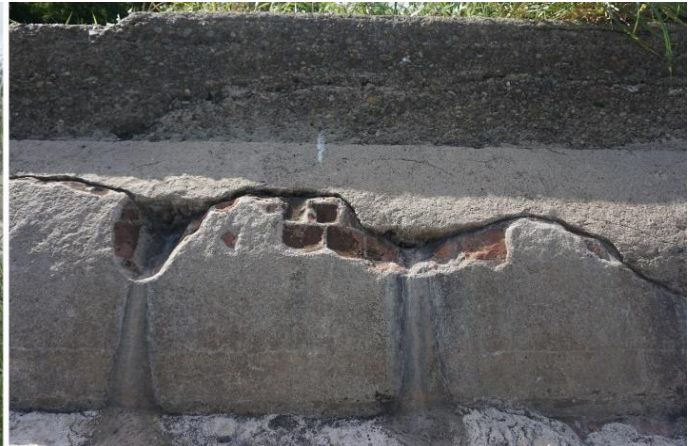
with a height of 30 cm. Also during the 20th century, a sluice gate was added to the dam, it measures 1.5 m wide by 90 cm high. The frame for sluice gate was constructed of reinforced concrete, leaving a molding in which, according to local residents, wooden planks would be slid in to control the flow from the reservoir. This part of the dam does extend to the west bank of the river, with a total length of 27 m.

On the left, view the central area of the dam with the added opening for the sluice, seen upstream from the east bank. On the right; detail of the two construction phases of the structure: lower part built from brick masonry in the 19th century, and 20th century upper part of reinforced concrete.

The dam shows some deterioration, such as cracks and spalling. However, it is still in good condition, to the point that staff of the Division of Irrigation of the Electric Power Authority has shown interest in putting it to use again (personal communication; Eng. Estremera, April 2015). An important aspect of this component of the *Tres Haciendas* irrigation system is that it unequivocally conveys its historic significance at first sight.

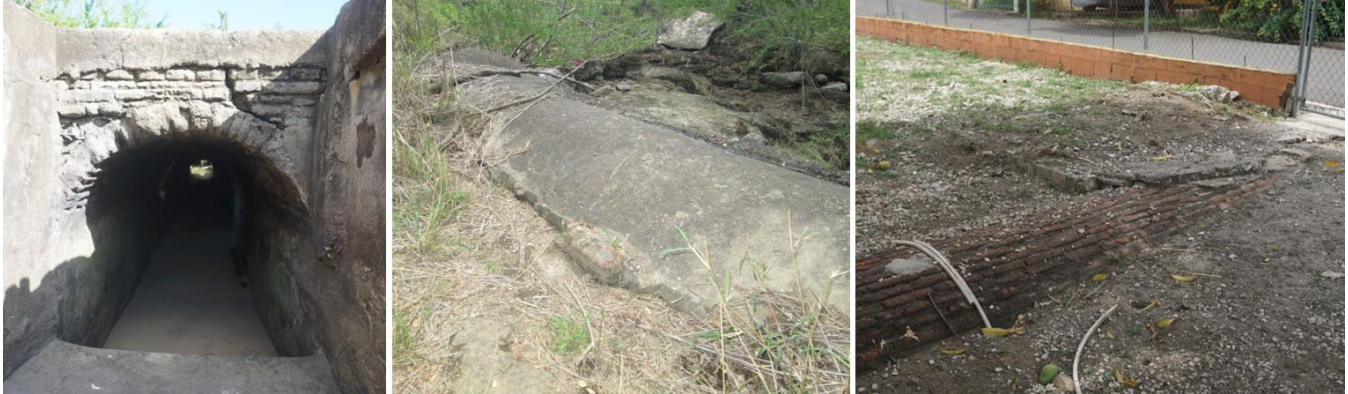
On the left, entrance to the Supply channel at the low-waters module, looking south from within the inlet. In the center, vaulted segment of the supply channel that runs along the surface in the area of the dam. Notice the concrete plastering over the vault. On the right, view of the channel as it emerges to the surface, in the backyard of a property of the *El Ojo* Community. Note that the vault does not have plastering.

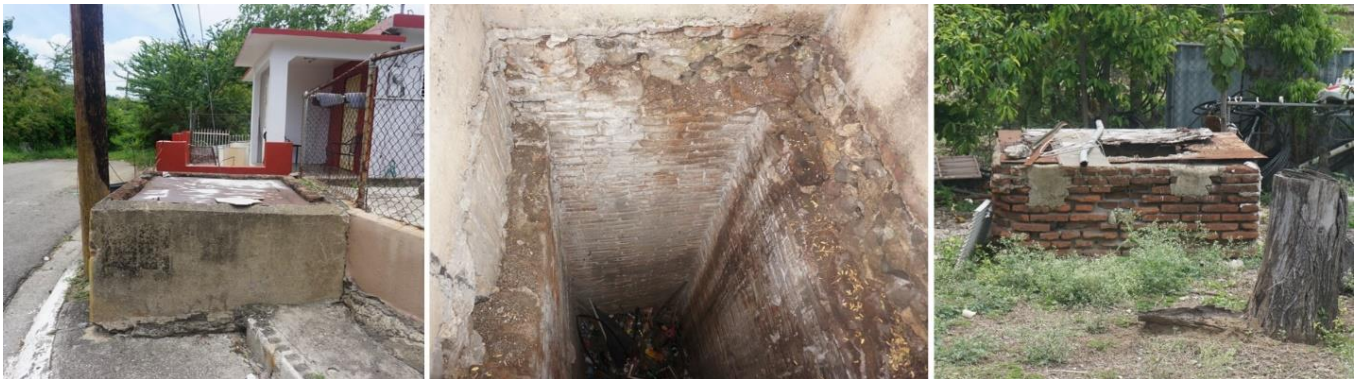
the manholes varies, with an average of 1.8 m long by 1.7 m wide. Six of this structures were located, found in a vacant lot and on the sidewalks and backyards of the *El Ojo* Community. Most of them are in good condition, although partially filled with dirt, debris, and garbage. Only one such structure, located in the backyard of a house, presents a severe erosion of the bricks, both inside and outside. Some had their walls raised by using reinforced concrete. Their exterior height ranges from 63 cm to 1 m above the surface. It is estimated that many more of this manholes are yet to be identified.

On the left, service manhole to the supply channel, located on a sidewalk of the *El Ojo* Community. In the center, detail of the service shaft inside a manhole. Right, manhole which features an advanced degree of damage by erosion, located in the backyard of a house.

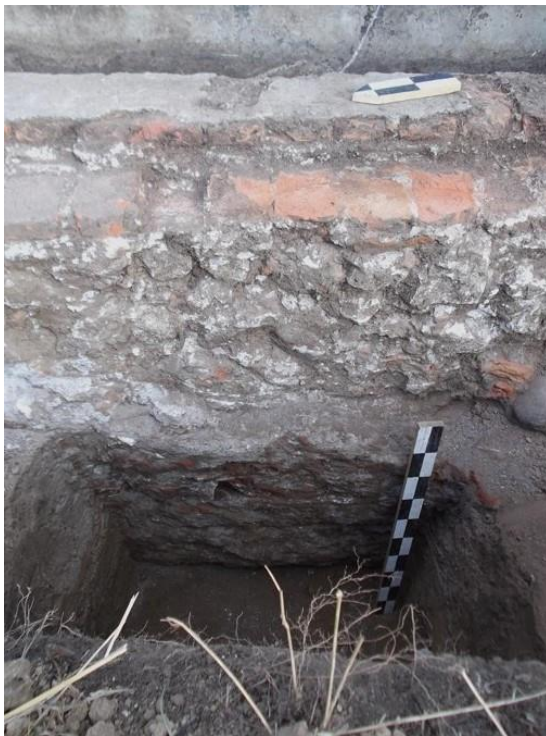
The open section of the supply channel begins partially buried, with the top of the walls at ground level, and gradually rises over the surrounding terrain until set completely above the surface. It has straight sides and a flat bottom. Its average inner width is 1.2 m and its interior height measures up to 77 cm. The foundation was documented in several excavation units, where it reached 30 to 90 cm deep below the bottom of the walls, and projected from 4 to 9 cm from their exterior sides.

Left, detail of outer side of the west wall and foundation of the supply channel, in an area where the open channel is buried. On the right, detail of outer side of the west wall and foundation, in an open section where the channel is above the surface.

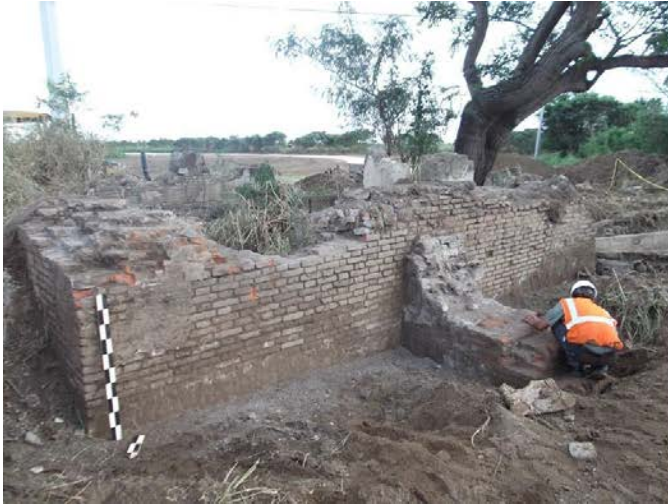
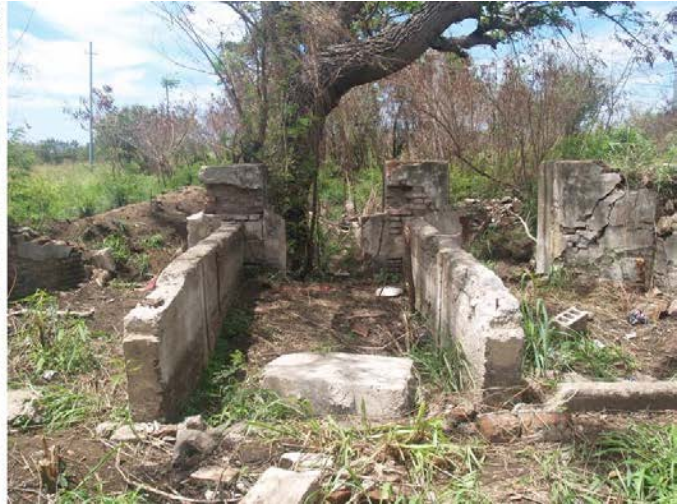
On the left, general view of the distribution module, during archaeological documentation works performed in 2012, looking south. On the right, view of the structure in 2011, looking northeast.

The supply channel ends south at the distribution module, from where the water was divided and distributed through three branching channels, which were responsible for delivering the water to the fields of the *Santa Isabel*, *El Destino* and *Florida haciendas*. The structure was designed to withstand weight and lateral forces, since it was built on a foundation of stones, fragmented brick and lime mortar that was 60 cm deep and protruded 35 cm from the exterior of the walls. It had walls 60 cm wide and a buttress 94 cm wide by 1.80 m long.

The imposing structure was demolished during the year 2012, as part of the construction work of the *Finca de Viento* project. It was documented in two archaeological studies (Meléndez Maíz 2011 and Meléndez Ortiz 2012). It is understood that beneath the surface there are still remnants of its foundations and the foundations of the channels associated with it. It is for this reason, and for the importance of this property as a geographical reference to the other components of the irrigation system, that it is included in this nomination as a contributing site.

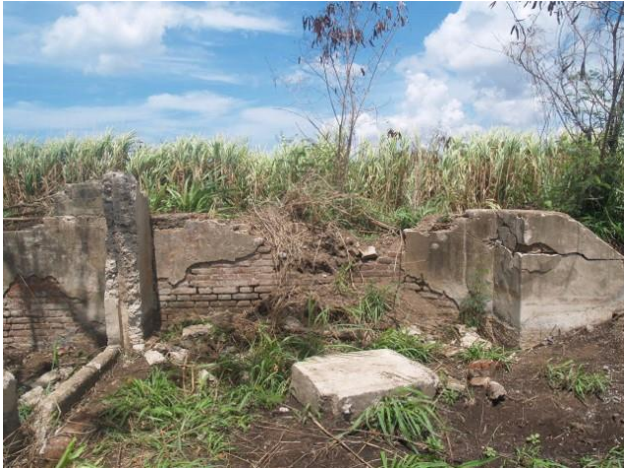
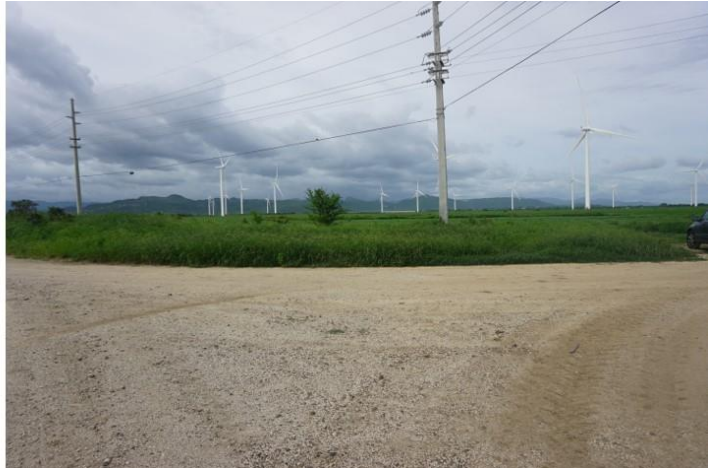
On the left, view of the distribution module in 2011, facing southeast. On the right, current view (2016) of the area where the module was located.

The most significant impact to the system has been the demolition of the distribution module as part of construction of the *Finca de Viento* project. Before its demolition in 2012, the structure was documented archaeologically, thus ensuring its preservation by record. Remains of its foundation lie underground, for which it is regarded as an archaeological site for the purposes of this nomination.

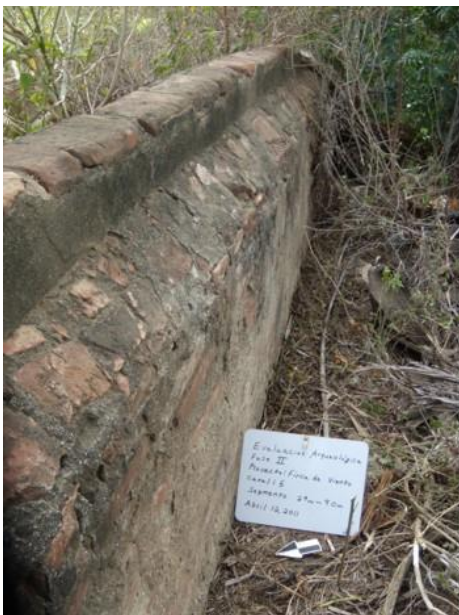
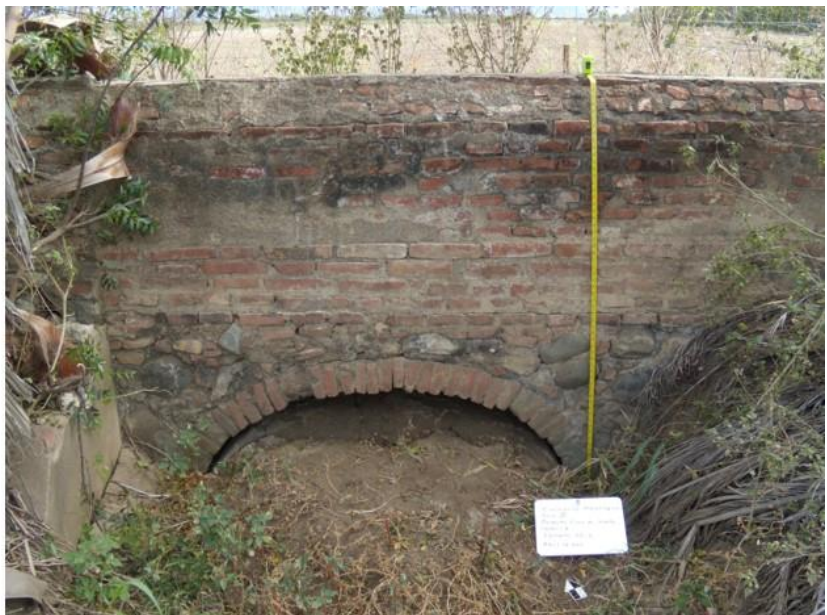
The *Santa Isabel hacienda* channel, or Channel 2, transported the water from the distribution module a distance of 2.3 km to the fields of the *Hacienda Santa Isabel*. For 1.7 km, the channel runs southwards. In most of this stretch of its route, the top of the walls is level with the surface, with an inside depth of 50 cm. The only alteration observed in this segment is the addition of four reinforced concrete buttresses to the east wall.

On the left, a segment of the *Santa Isabel Hacienda* channel, with setback feature. Right; arched bridge.

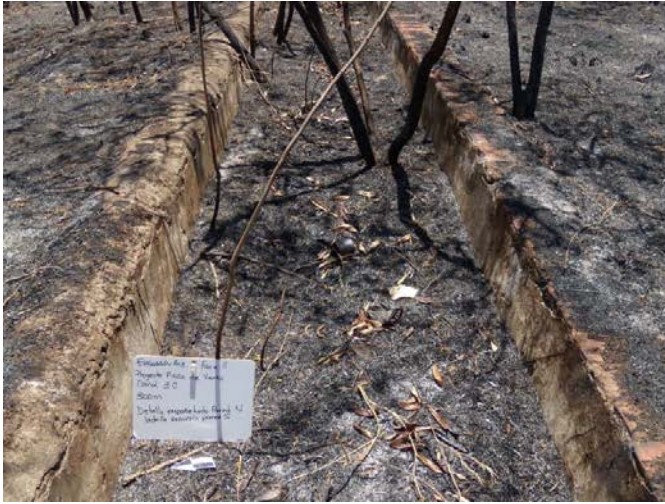
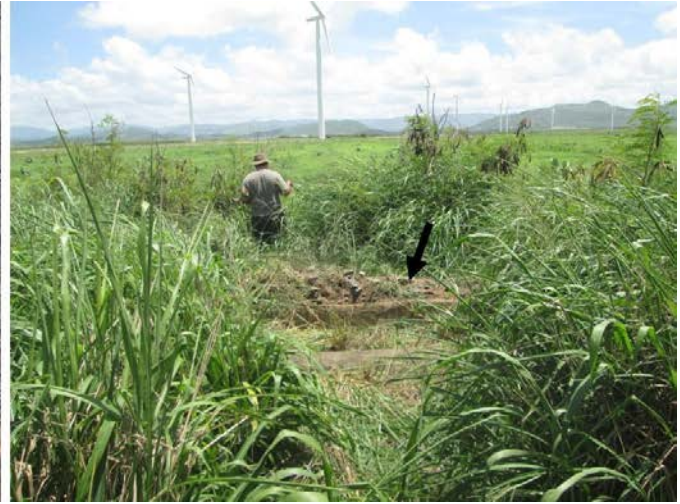
Left; photo of a segment of the channel of the *El Destino hacienda*, taken in 2012 after a wildfire cleared the vegetation. Right; area where a section of the canal was exposed in 2016 (marked with the black arrow), completely hidden by the vegetation.

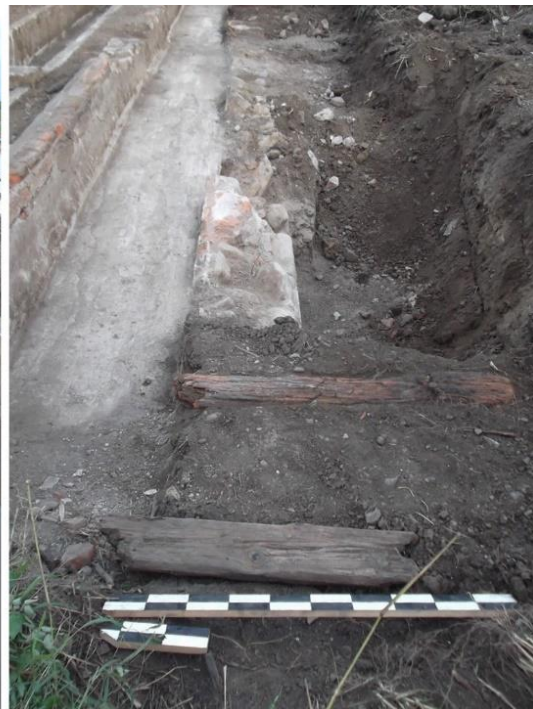
Left; view of channels 3 and 3N, looking west. The remains of the *El Destino hacienda* channel is seen to the left, with its south wall flattened to ground level and channel 3N alongside, constructed soon after. In the right photo, detail of sleepers of the railway line, in situ, resting on the footing of the south wall of channel 3.

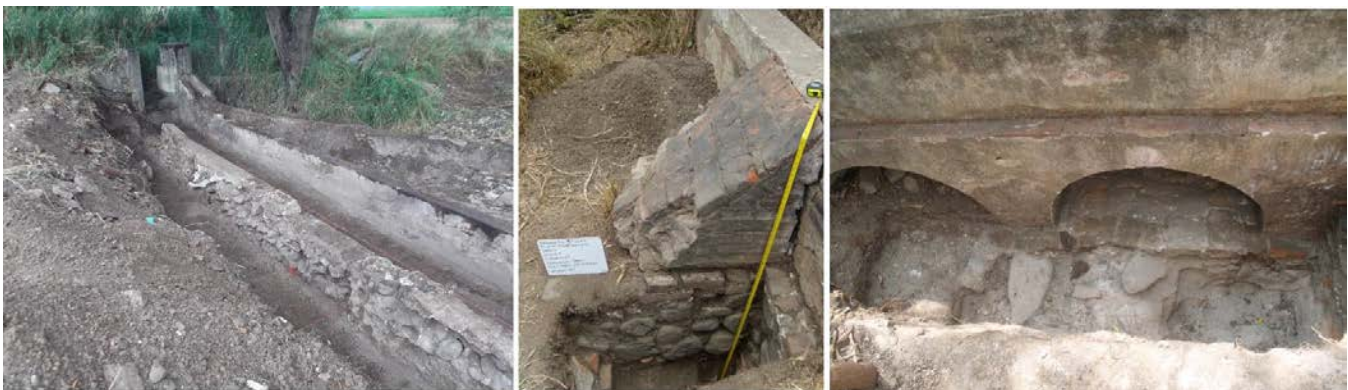
Left; view of the *Hacienda Florida* channel at its origin as it left the distribution module, facing northeast. Center; Detail of an abutment. Right; segment of the channel on arches. Note the stone pavement under the channel.

From the north, the channel begins partially buried, with the top of the walls level with the surface. It is 48 cm deep inside. From 163 m to 213 m from the starting point, Channel 4 is entirely above the surface, and even elevated on a masonry base. At a section located between 435 m and 595 m from the start, the channel is raised above the surface and supported by abutments located on both sides of the structure at 30 points. They are located at an interval of 4 to 7 m, with variable dimensions, and consist of triangular structures built with the same materials and construction technique as the channel. Here the channel is 68 cm deep. Between 635 m and 700 meters from the start, the channel rises again on a massive foundation. In this section, the channel walls feature a setback step formed by two rows of bricks coursed at a stretcher bond. Meanwhile, the cement has two levels: an upper level to 25 cm tall, made of stone and bricks bound with lime mortar, and a lower level measuring 30 cm, built of stones and fragmented bricks with no consolidating material. Between 666 m and 686 m from the start, the channel is elevated on four arches - one simple and three double arches. The area surrounding the arches is paved with stone to prevent soil erosion. The base continues to be massive and with staggered sides.

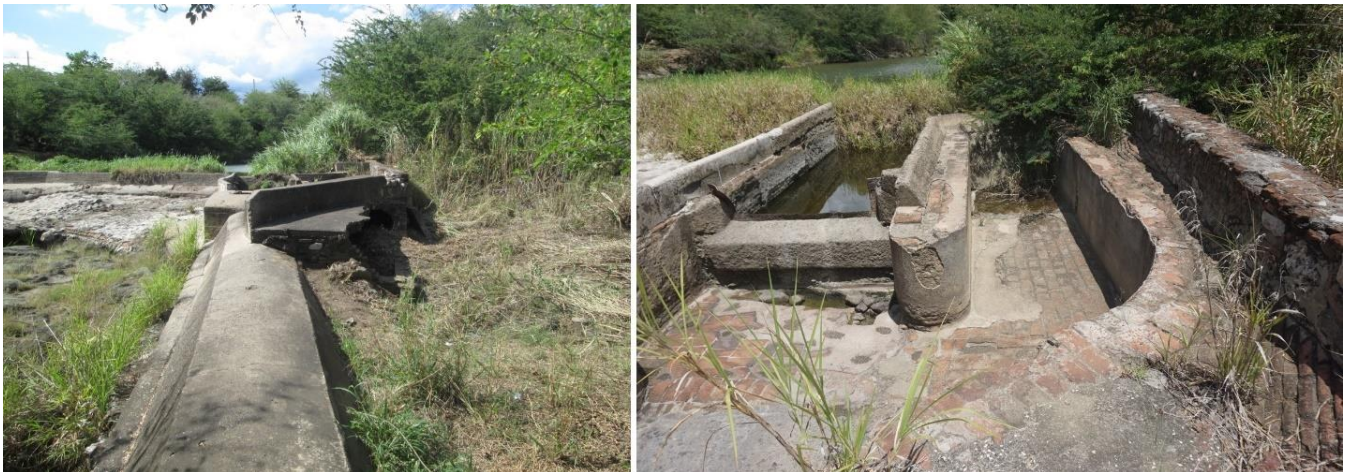
Left, general view of the area of the low waters and seasonal waters modules. In the foreground we see the supply channel, with the module and the dam in the background. Right, view of the modules, showing the low waters module full of water on the left and the seasonal waters module on the right of the photo, facing north.

The structure was modified in the 20th century. The height of the walls was elevated by adding reinforced concrete walls. The *estacionales* (seasonal) water module was bypassed by demolishing a section of the central wall and the construction of a diagonal wall that closed the intake above the module. The waters from the two sluice gates at the reservoir now entered a single module. Several parallel rods were installed facing the inner sluice gate of the *aguas estiales* module to make a garbage trap. Finally, the two sluice gates facing the reservoir were walled up. The current condition of the area where the dam, module, storm water intake and supply channel begins is depicted on Figure 8.

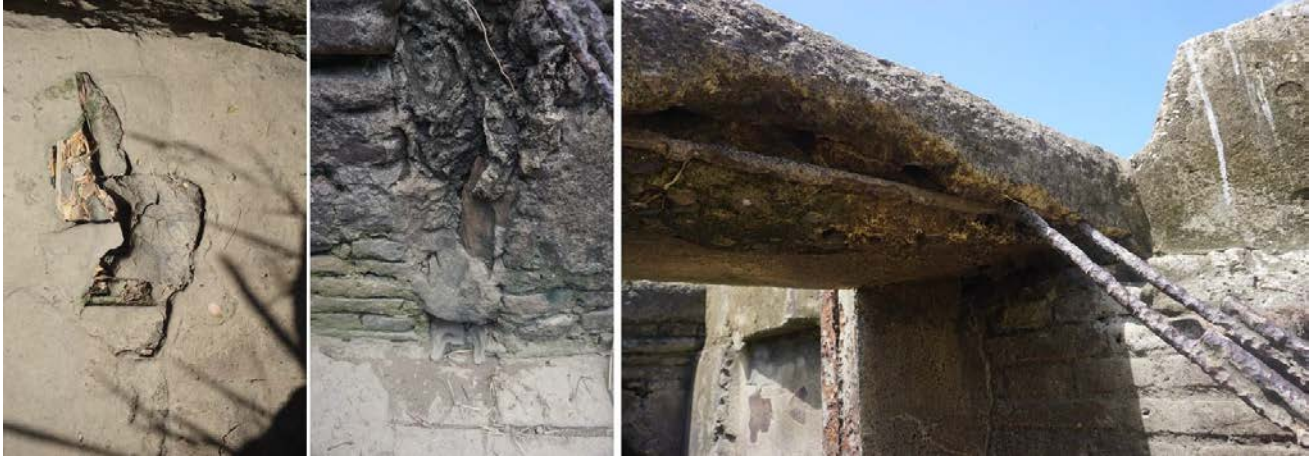
Left and center; remnants of the wood frame of the inner sluice gate of the low waters module. Left; detail of the inner gate of the module, with part of the metal sluice and metal bars that created a garbage trap.

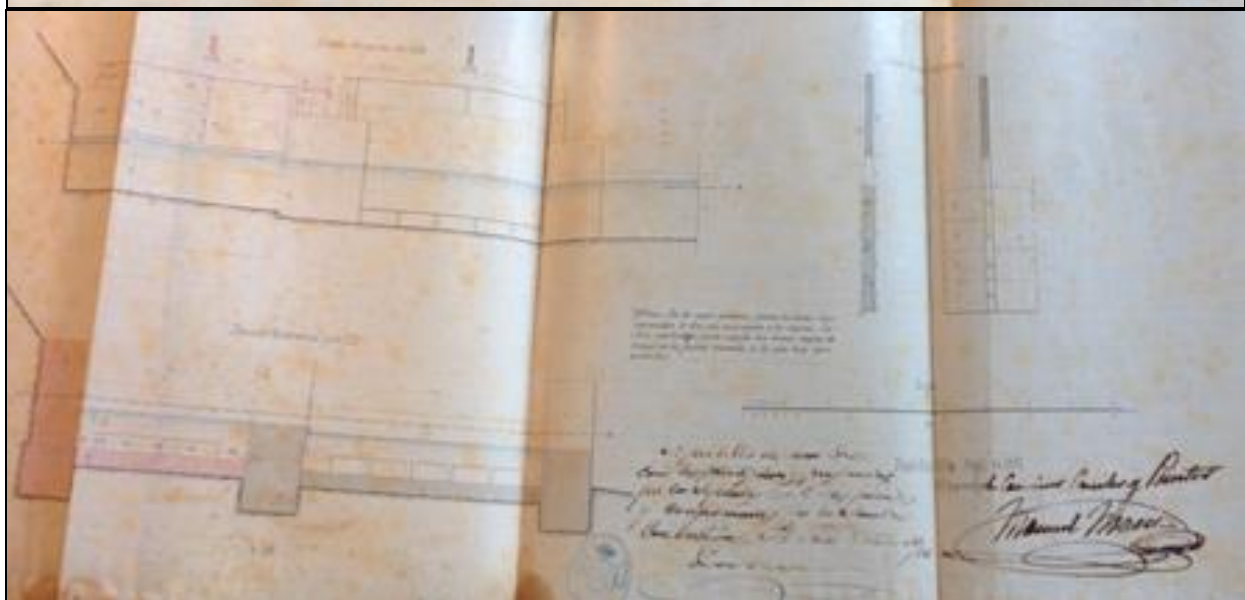
Project for a module for the collection of 200 liters per second for the irrigation of the Florida, Destino and Santa Isabel haciendas (AGPR, Obras Públicas, Aguas, Leg. 21, Exp. 849, Caja 410).

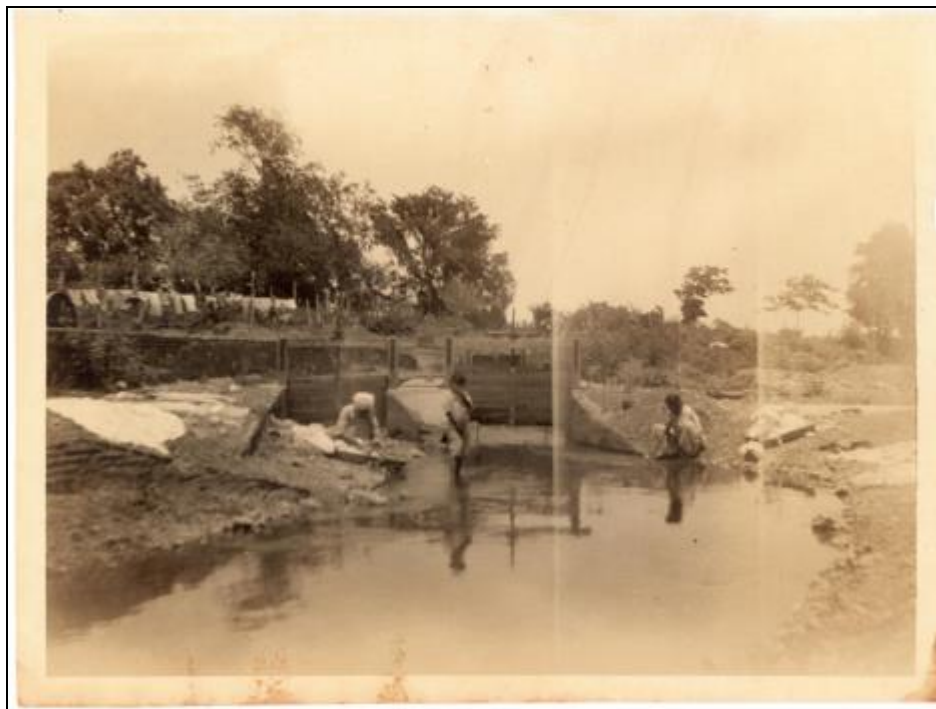
Photo of the main intake for the Florida, Santa Isabel and Destino *Haciendas* or *Tres Haciendas* at the junction of the main canal and the Coamo river, 1913, AAA (from Meléndez Maíz 2011).
