United States Department of the Interior -- National Park Service
NATIONAL REGISTER OF HISTORIC PLACES -- REGISTRATION FORM

historic name: Markham Farmstead
other name/ site number: B. C. Evans Farm

Markham Farmstead
Conde Vic., Spink Co., S.D.

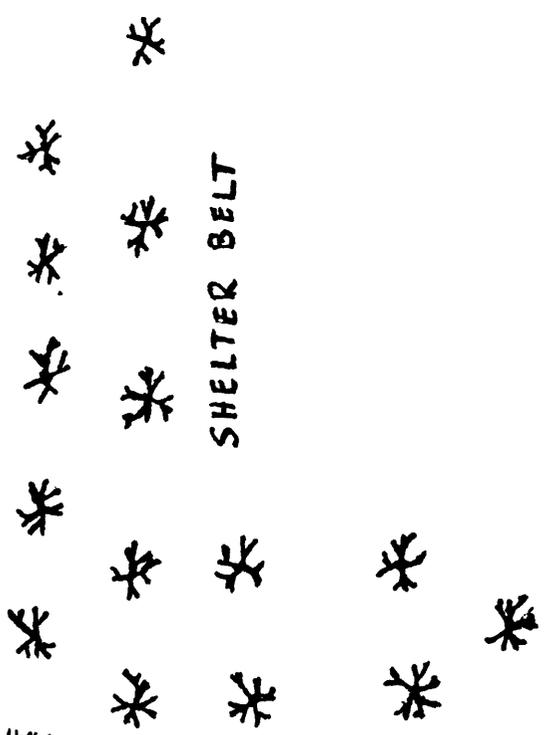
SHELTER BELT

BARN
3

NEW 5
GARAGE

OLD
GARAGE
4

HOUSE
1

CHICKEN
COOP 2

COLLAPSED
GRANARY
6

GRANARIES

X ARTESIAN WELL

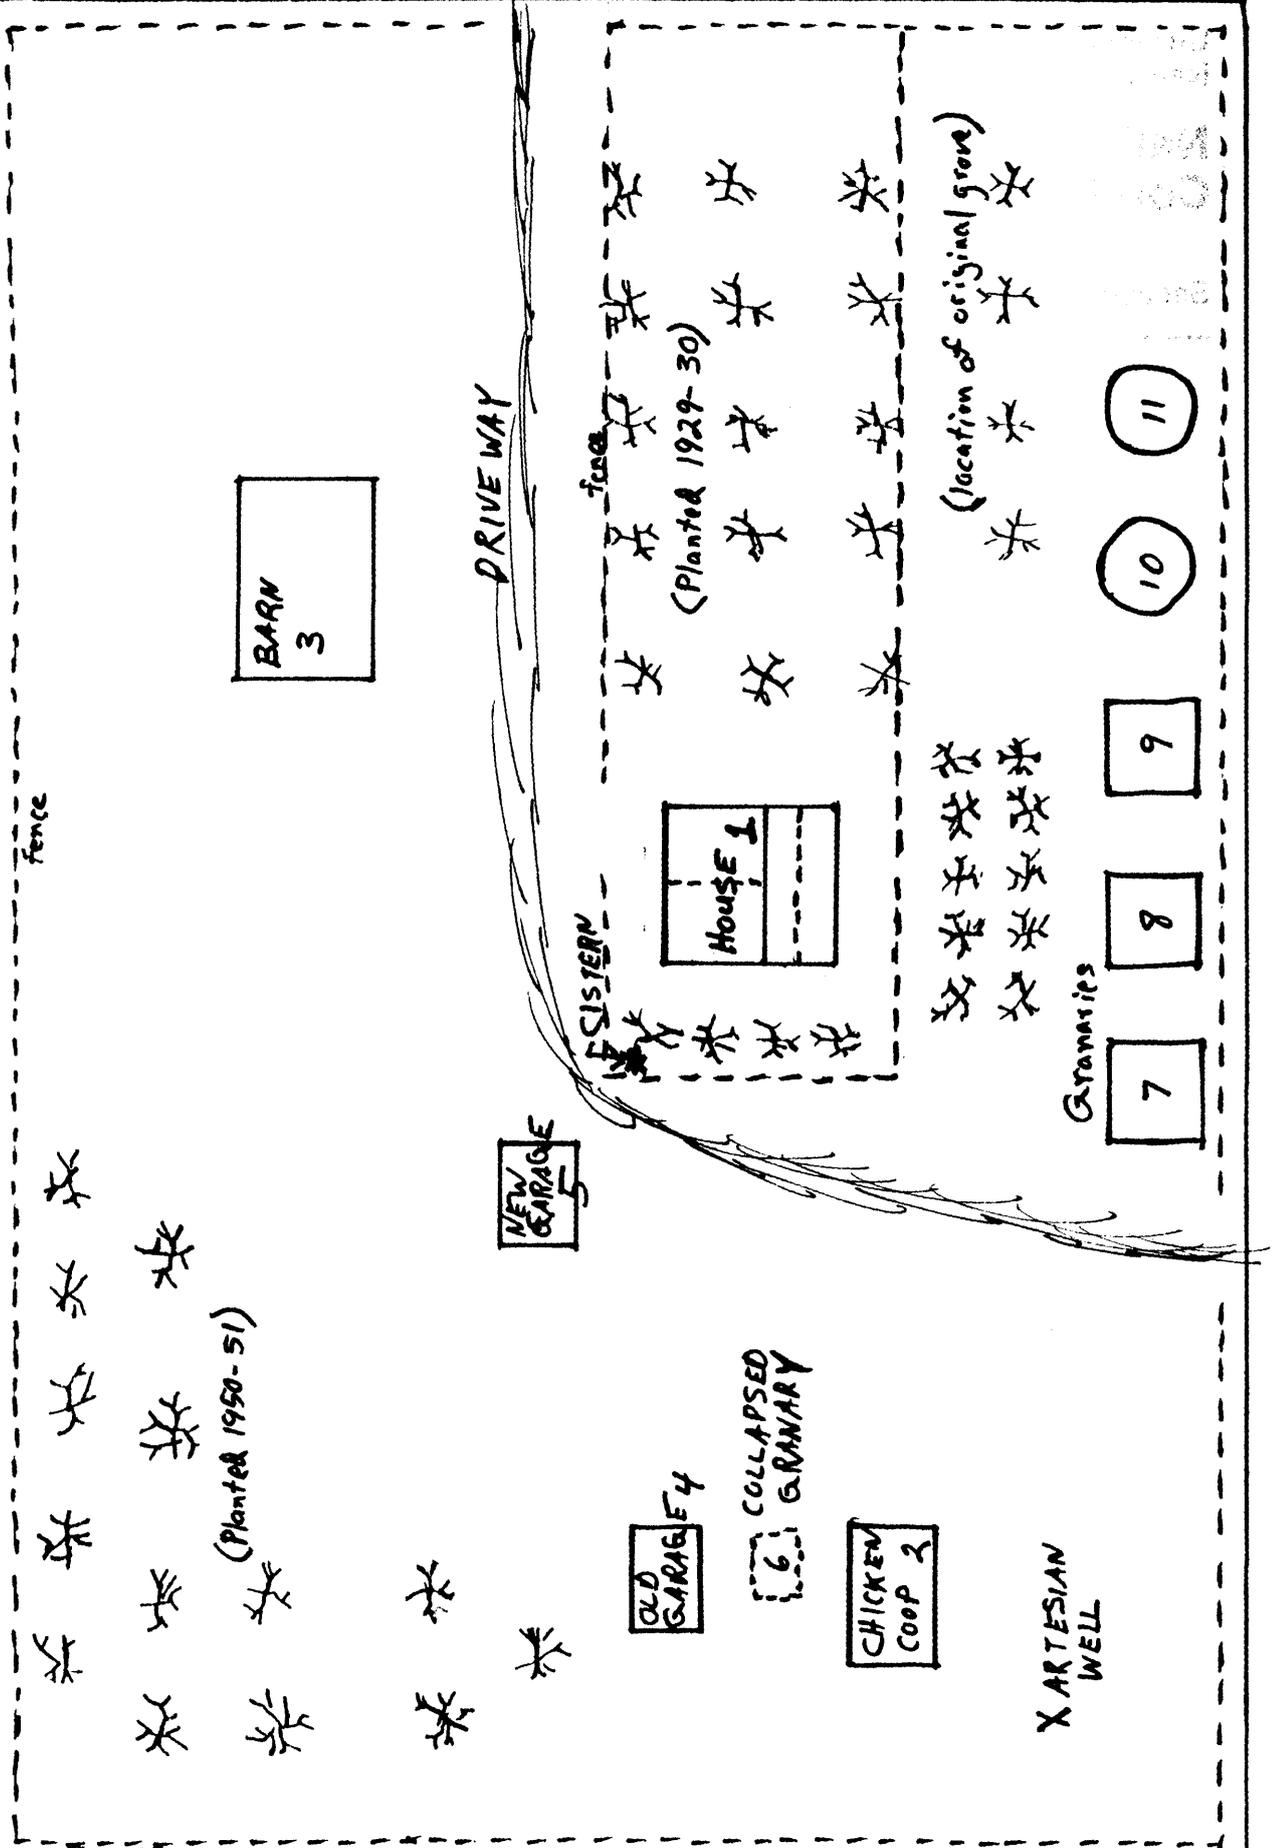
Markham Farmstead, Conde Vic., Spink County, S. D.

(Planted late 1930s)

(Planted 1950-51)

(Planted 1929-30)

(location of original grove)

Nearly all of the box elder trees planted to meet Timber Culture Act requirements died. (To maintain claim to the land, homestead rights were filed over tree claim rights.) Existing box elders at the Southeast corner of the property may include originals and certainly are descendents of the originals. Cottonwoods to the North of the house are volunteers which grew around an artesian pond. Chinese elms to the East of the house were planted by Francis Evans in 1929 or 1930. In response to soil conservation efforts of the late 1930s, a grove of Chinese elms was planted to the West of the place. The shelter belt to the North was planted in 1950 or 1951. This grove, planted in a semi-circle around the aforementioned, no longer existent artesian pond, contains Chinese elm and Russian olive trees.
