Iowa Site Inventory

1. Site Name Eldora Public Library
2. Village/Town/City Eldora Township _____ County Hardin
3. Street Address 1219 14th Avenue
4. Legal Location _____

9. Date of Construction 1902-03 Architect/Builder xxxx Patton and Miller; Chicago
10. Building Type:

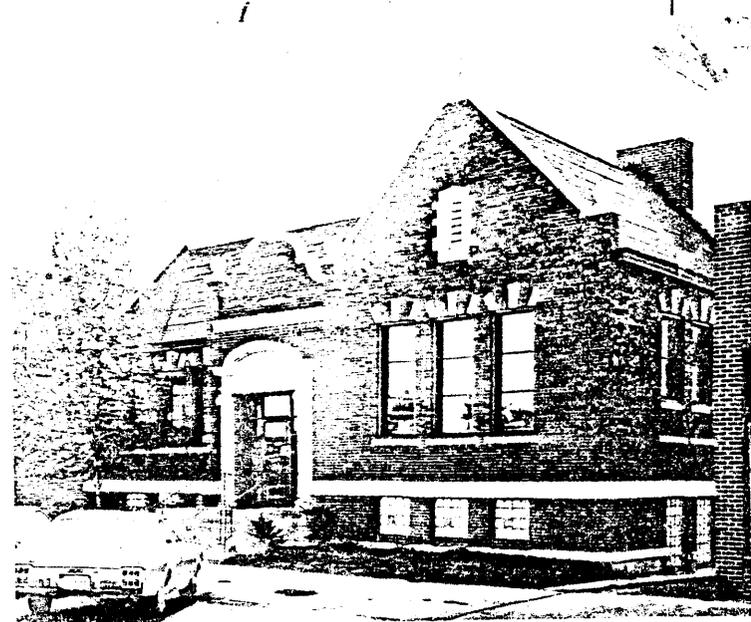
19. Photo

13. Condition: excellent good fair deteriorated
14. Integrity: original site moved—if so, when? _____
 Notes on alterations, additions (with dates and architect, if known) and any other notable features of building and site: Front door (including side-and top-lights) and windows replaced in bronzed aluminum, not unsympathetically (c.1976); tile roof replaced w/asphalt shingles (rec

The Eldora Public Library is one of the small group of libraries composed of an asymmetrical massing of intersecting gables (see also Algona, Mt. Pleasant). Eldora features a front-gable at one side of the front elevation, balanced by a side-gable on the other, which is set slightly to the rear in plan. The entrance pavilion is found in the angle formed by these two intersecting masses. The exterior is in a restrained Northern Renaissance style, with a Georgianizing doorway, the elliptical pediment of which echoes the curves of the shaped gable above. The building is chiefly significant for its interior. The plan is an interesting variation on the standard sexpartite plan (Type II). The two reading rooms, one on each side of the central delivery area, are approximately the same in size but differ in shape (which is expressed in the massing). The radiating stack projects substantially from the rear of the building and is connected to the left-hand reading room through a diminutive
