**National Register of Historic Places  
Inventory—Nomination Form**

historic  Dawson Farm (preferred)

Dawson Farm

Continuation sheet Montgomery County, Maryland Item number 4

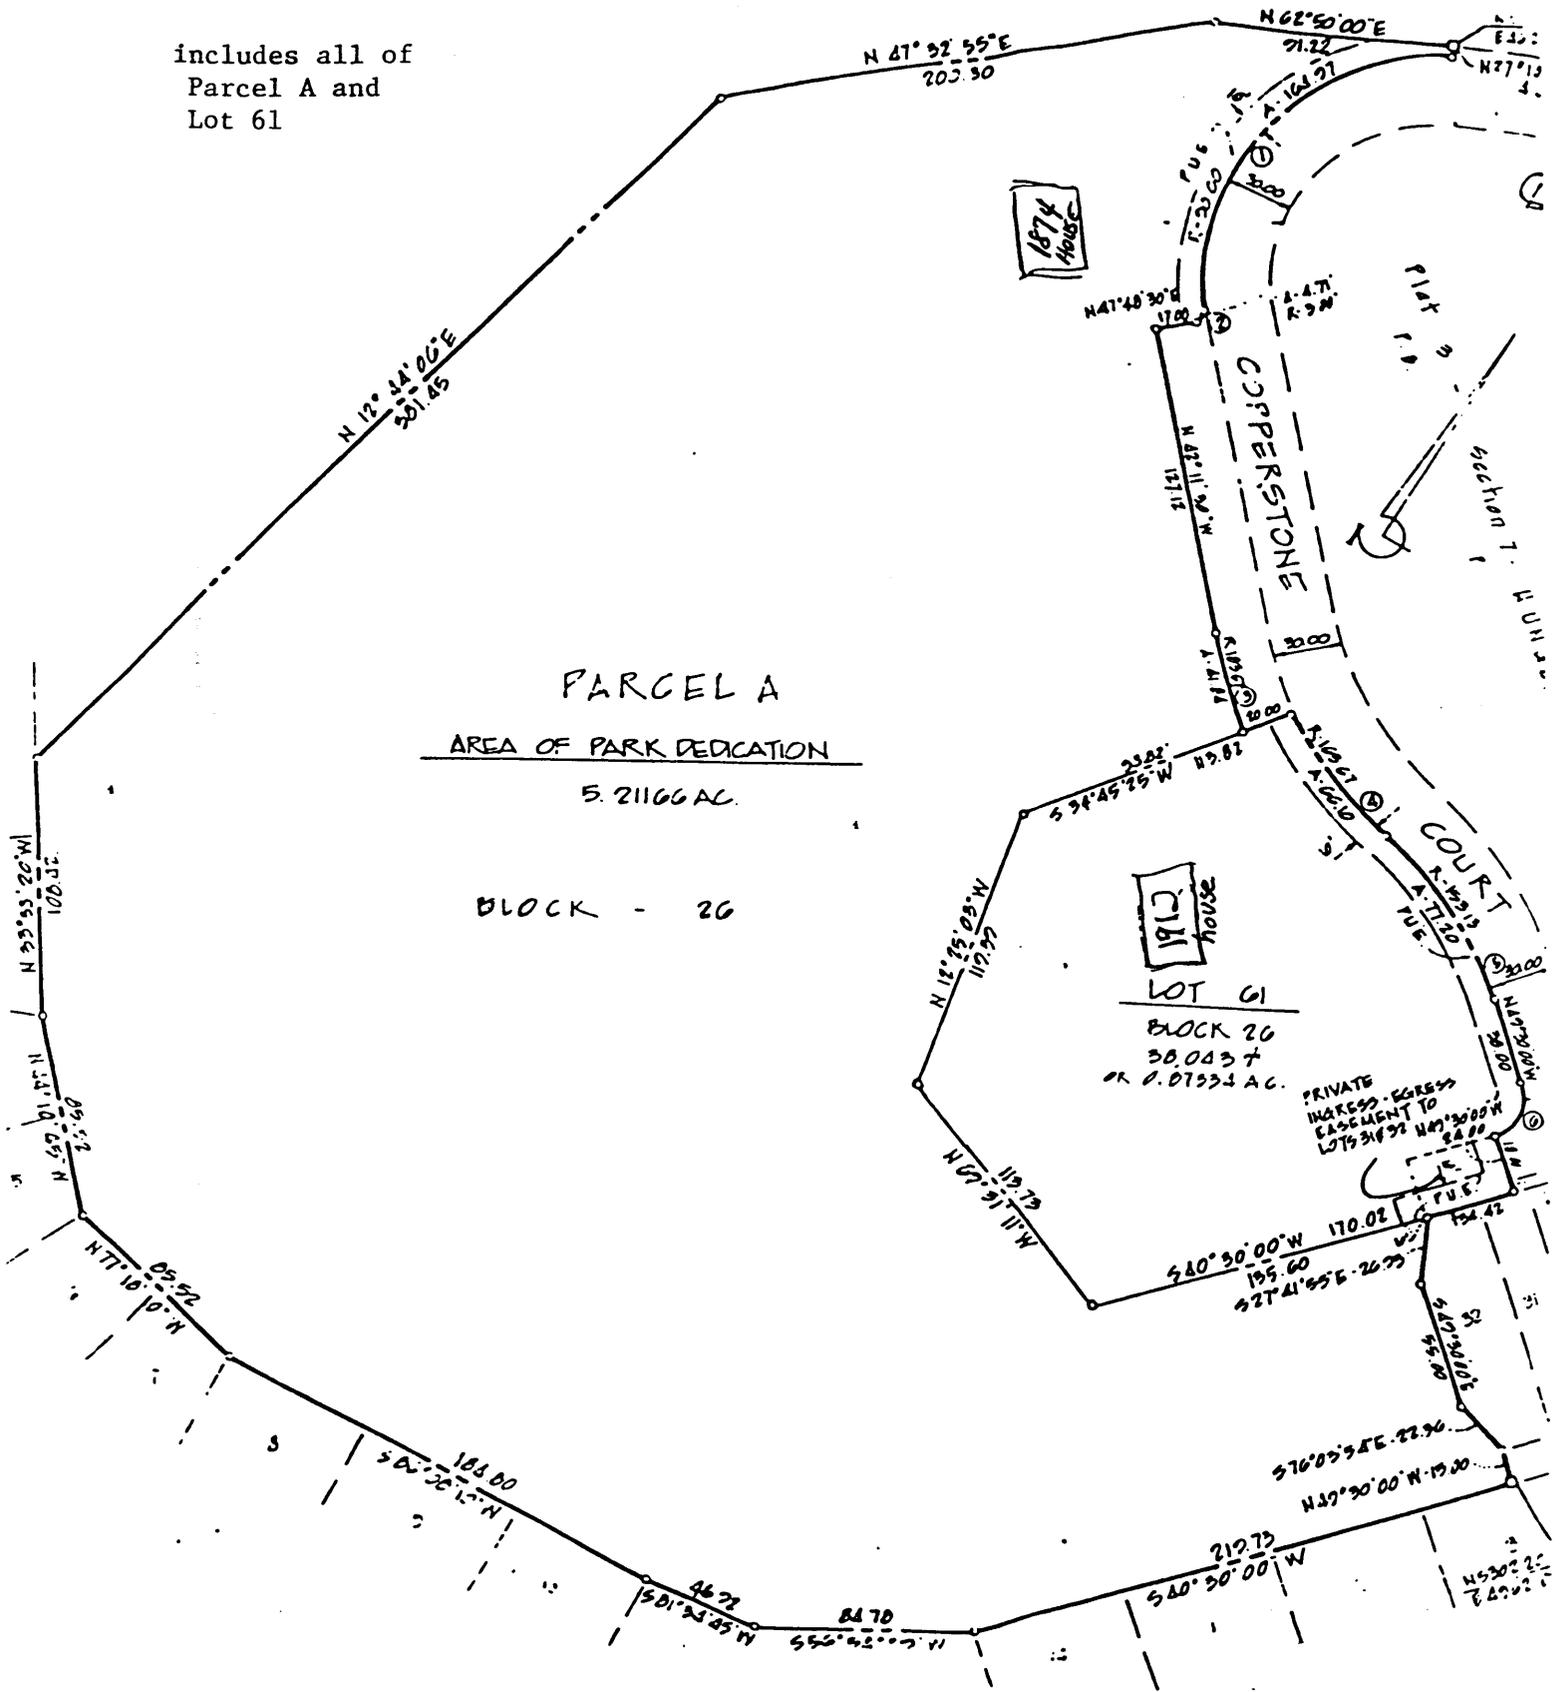
BOUNDARIES FOR NATIONAL REGISTER NOMINATION, 1984

Dawson Farm  
Montgomery County  
Maryland

includes all of  
Parcel A and  
Lot 61

**Verbal boundary description and justification** Verbal boundary description indicated on attached map labeled "Boundaries for NR Nomination, 1984."

Boundary Justification: Nominated acreage includes undeveloped area surrounding buildings which evokes their historic setting.
