NATIONAL REGISTER OF HISTORIC PLACES REGISTRATION FORM

1. Name of Property	· · · · · · · · · · · · · · · · · · ·		
historic name: Ded			
other names/site number			
2. Location			
street & number: 29614	Upper Bear Creek Road	(NA) not f	or publication
city, town: Everg	reen	(X) vicin	ity
state:	code: county:	code: z	ip code:
3. Classification Ownership of Property	Category of Property	No. of Resource	es within Property
() private (X) public-local	<pre>() building(s) (X) district</pre>	contributing	noncontributing7 buildings
() public-State	() site	1	0 sites
() public-Federal	() structure		0 structures
	() object	<u>1</u> 25	<u> </u>
Name of related multiple	e property listing:	No. of contrib previously lis	uting resources ted in the
Denver Mountain Parks		National Regis	ter <u>N/A</u>

Section	number	7	Page _	2			
					Dedisse Par	ck

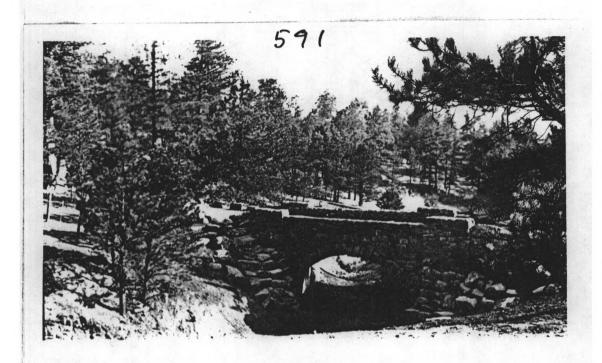
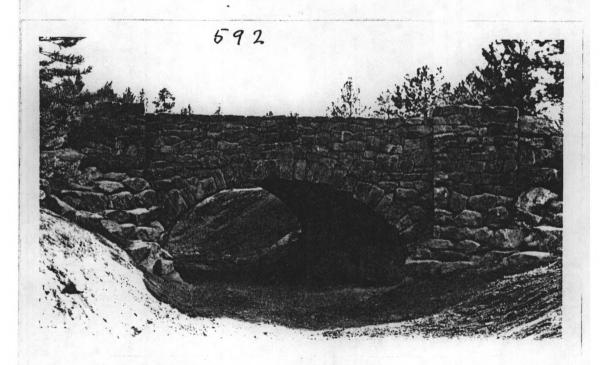
Bridge #31 on map Dedisse Mountain Park

Historic Photos ca. 1934

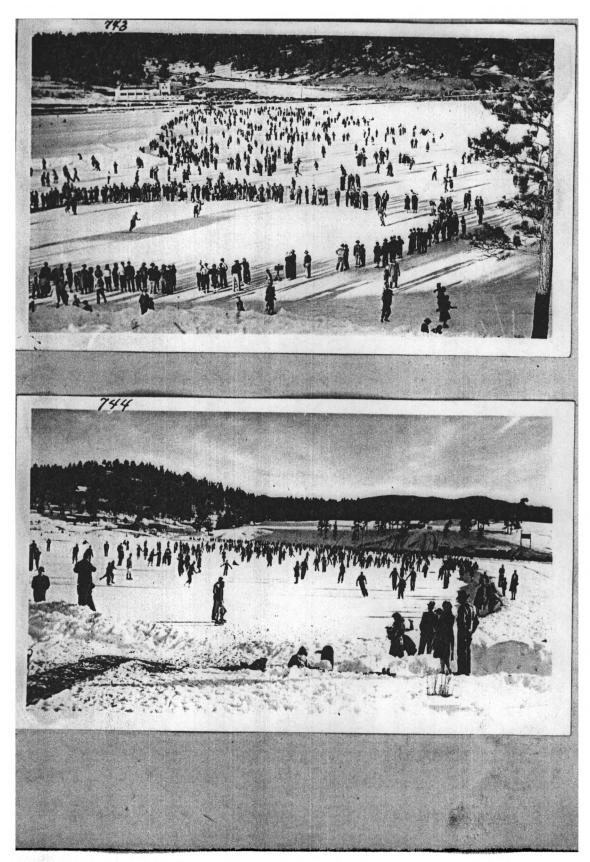
Historic Photos Dedisse Mountain Park
Skating on Evergreen Lake date unknown
