National Register of Historic Places Multiple Property Documentation Form

U.S. Post Office Department Facilities in Oregon, 1940 to 1971

name/title John M. Tess, President

organization Heritage Consulting Group

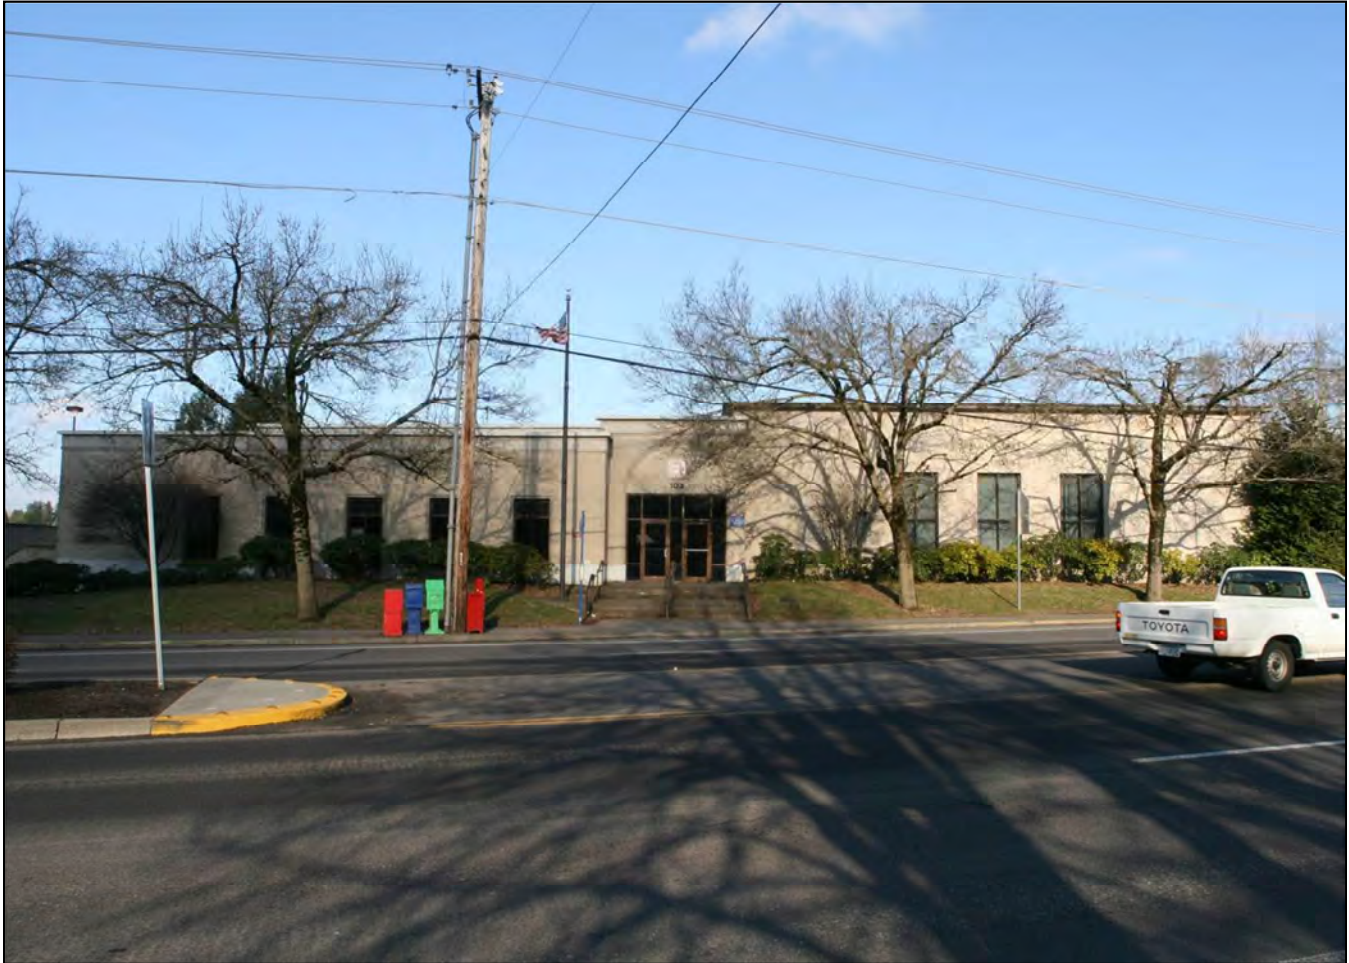
Figure 1: Main Post Office (103 W. Powell Boulevard, Gresham, Multnomah County)

Exterior: First completed in 1941 as a 5,200 square-foot facility, the building was expanded in 1990 to its current size of 23,243 square-feet. The building is one-story in height with a rectilinear shape. Architecturally, the structure today is of nominal design but may be considered an example of the Neo-Renaissance Revival style. The original post office was designed by architect Theodore Ballew; the addition was designed by Mackenzie/Saito & Associates. The building has a flat roof with parapet, poured concrete slab--on-grade foundation, and is unreinforced masonry block. Facade materials are consistent and include tan brick stretcher-bond veneer with matching mortar, cast stone, metal coping, dark brown aluminum-framed glass-panel windows and entryways.

The post office fronts to the south on Powell Boulevard. The south facade is asymmetrical and divided into two main sections; the original building and the new addition. The original building is located in the southeast corner, clad in stretcher bond veneer with three bays of fixed windows. The windows have been replaced with aluminum frames and a 2/2 fixed configuration from their original double-hung style. Two, decorative arched cast-stone elements have been recessed into the south facade, each flanking a side of the three bays.

Integrity: The integrity of the building is absent. The building is in its original location and the setting is generally similar to when it was built. However, there have been substantial design and material changes to both the exterior and interior. In massing, the 17,000 square-foot addition dwarfs the original 5,200 square-foot building. The main entry was moved from the east to the south. The facades of the historic portion were integrated into the addition, such that the building is more 1990 than 1941. All windows in the original building have either been replaced with modern aluminum-framed fixed-glass panels, with 2/2 configurations, or have been bricked in. On the interior, the spaces have been entirely reconfigured. The building is unrecognizable compared to its 1941 appearance.

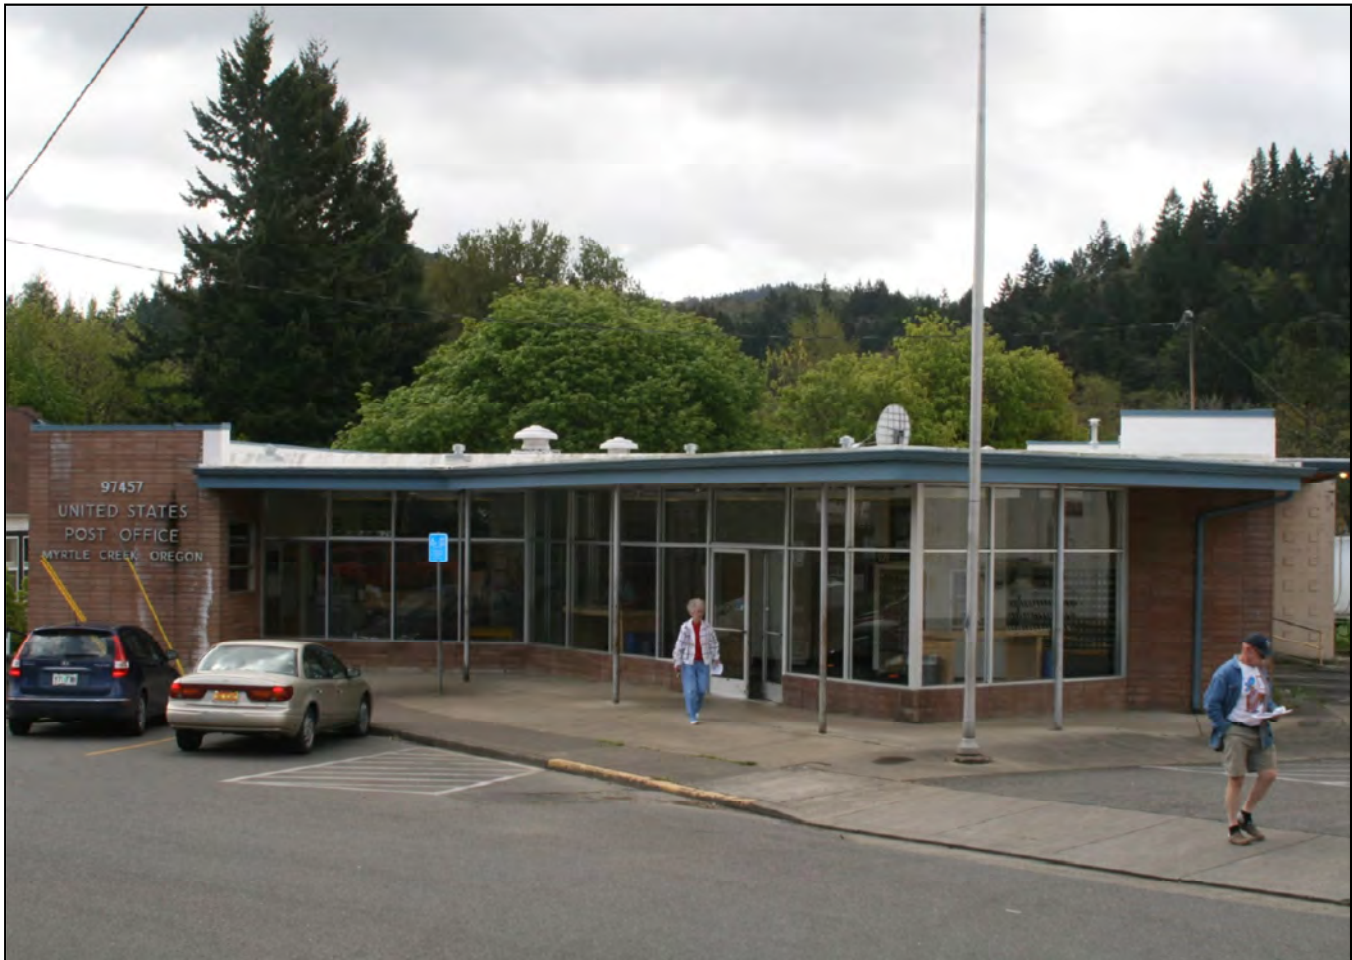
Figure 2: Myrtle Creek Main Post Office (124 Broadway Street, Myrtle Creek, Douglas County)

Exterior: Constructed in 1961, the 4,031 square-foot building is one-story in height with an irregular, asymmetrical, yet rectilinear, shape. The structure is of minimal design. The building was contractor-designed. The building has a flat roof, poured-concrete slab-on-grade foundation and is unreinforced-masonry block. Materials are consistent with full-height modular-assembly aluminum-frame windows, and the facade is fully clad in red-brick stacked-bond veneer with matching mortar.

The east and west facades are secondary. The east facade is clad in concrete masonry block, has no openings and abuts the lot line. The west facade, which traditionally would be considered the rear due to its service use, is divided into two sections. The northwest section is clad in the brick stack-bond and has one bay of four identical, frosted, and fixed and casement windows located off center to the north. The southwest section is a loading dock for USPS service use, and is clad in masonry concrete block. This section has a canopy, three fixed windows, and two entries; including one set of metal-swinging doors and one metal service door.

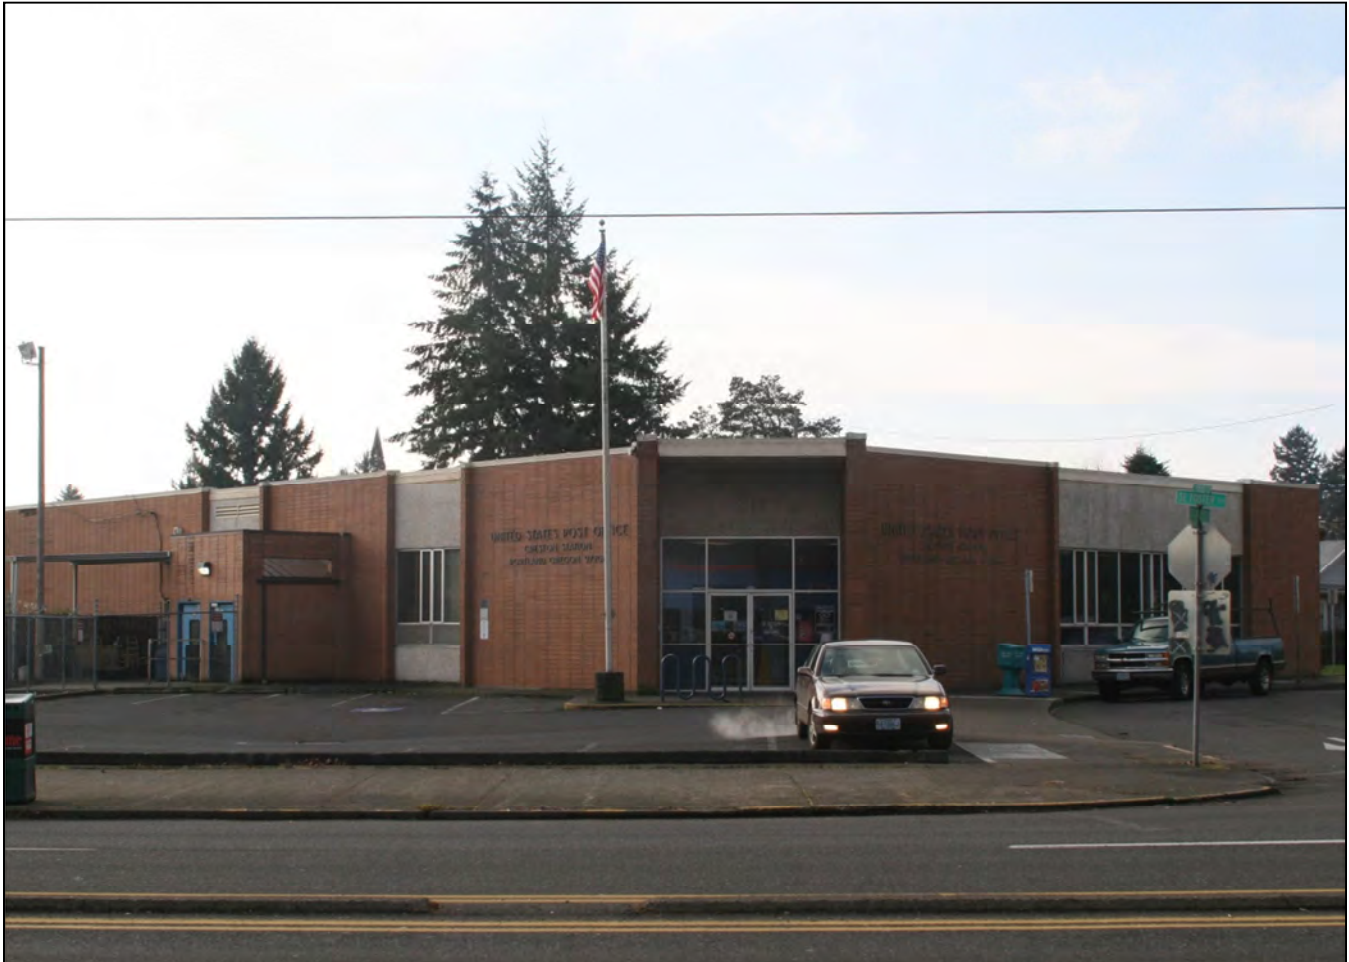
Figure 5: Creston Post Office (5010 SE Foster Road, Multnomah County)

linked to the development of Portland's street car system. Historically, the intersection of Powell, 50th and Foster was a commercial center that in the 1920s, spurred forward with the completion of the Ross Island Bridge in 1926. Plans for the station date to February, 1965 when the Post Office Department solicited bids for a 7,509 square-foot facility on a parcel of roughly 18,000 square-feet. The solicitation noted that the property would be leased for 10 years with four five-year renewal options. In May, it was announced that builder Dan Davis was the winning bidder with a design by architects Johnston & Koch, comprised of Hollis Johnston and Robert Koch. The firm had formed in February, 1957 and continued until Johnston's death in 1966. The site was vacant land just south of the Foster Road and Powell Street intersection. Construction on the post office began immediately and the property completed the following year. Over the years, there have been slight changes to the building and to the postal operations there.

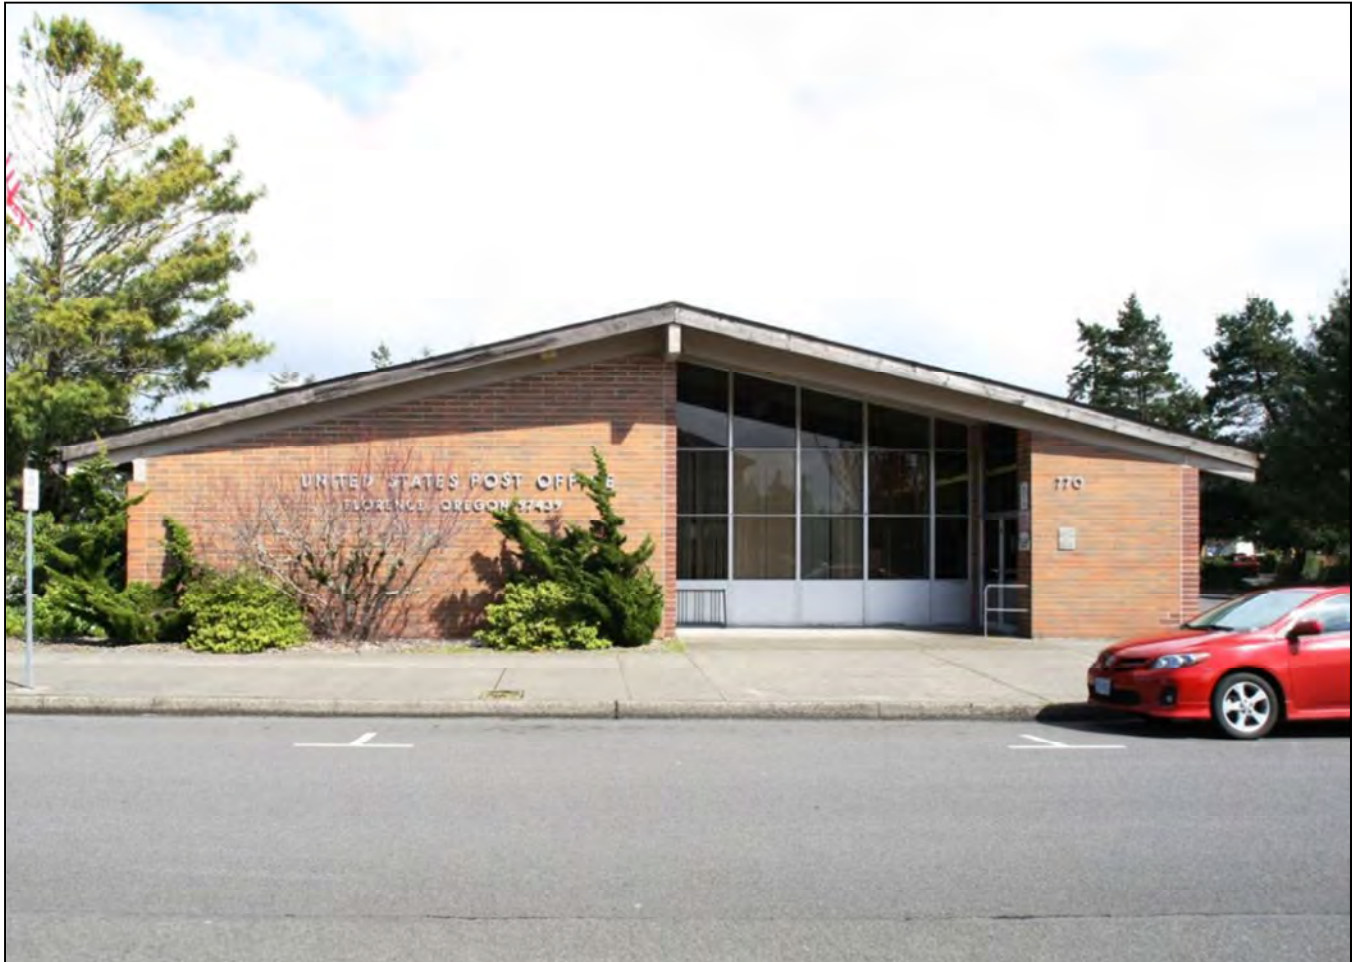
Figure 7: Florence Main Post Office (770 Maple Street, Florence, Lane County)

Exterior: The building is one-story in height with a rectilinear shape. The structure is of minimal design and is considered an example of the Modern style. The building was contractor designed. The building has a low-pitched front-gabled roof with overhanging eaves, poured- concrete slab-on-grade foundation, and is unreinforced-masonry block. Materials are consistent, with the entire building clad in a red brick in stretcher bond facade with "natural" mortar and modular slider and fixed aluminum-framed windows.

Interior: The building is accessed through the main entry off Maple Street. The interior is rectilinear in shape and divided into three zones. The first zone is the public lobby that has three areas for postal boxes along the north and west walls. The southern wall is clad in the same stretcher bond found on the exterior. To the east is where one enters the second zone for retail and customer service. The lobby and retail space have VCT flooring, painted gypsum-board walls, and a combination of exposed wood roof rafters and wood ceiling with painted gypsum board over the postal box areas. The third zone is to the east of the public lobby and customer service desks. This zone is a large open space and has utilitarian finishes.

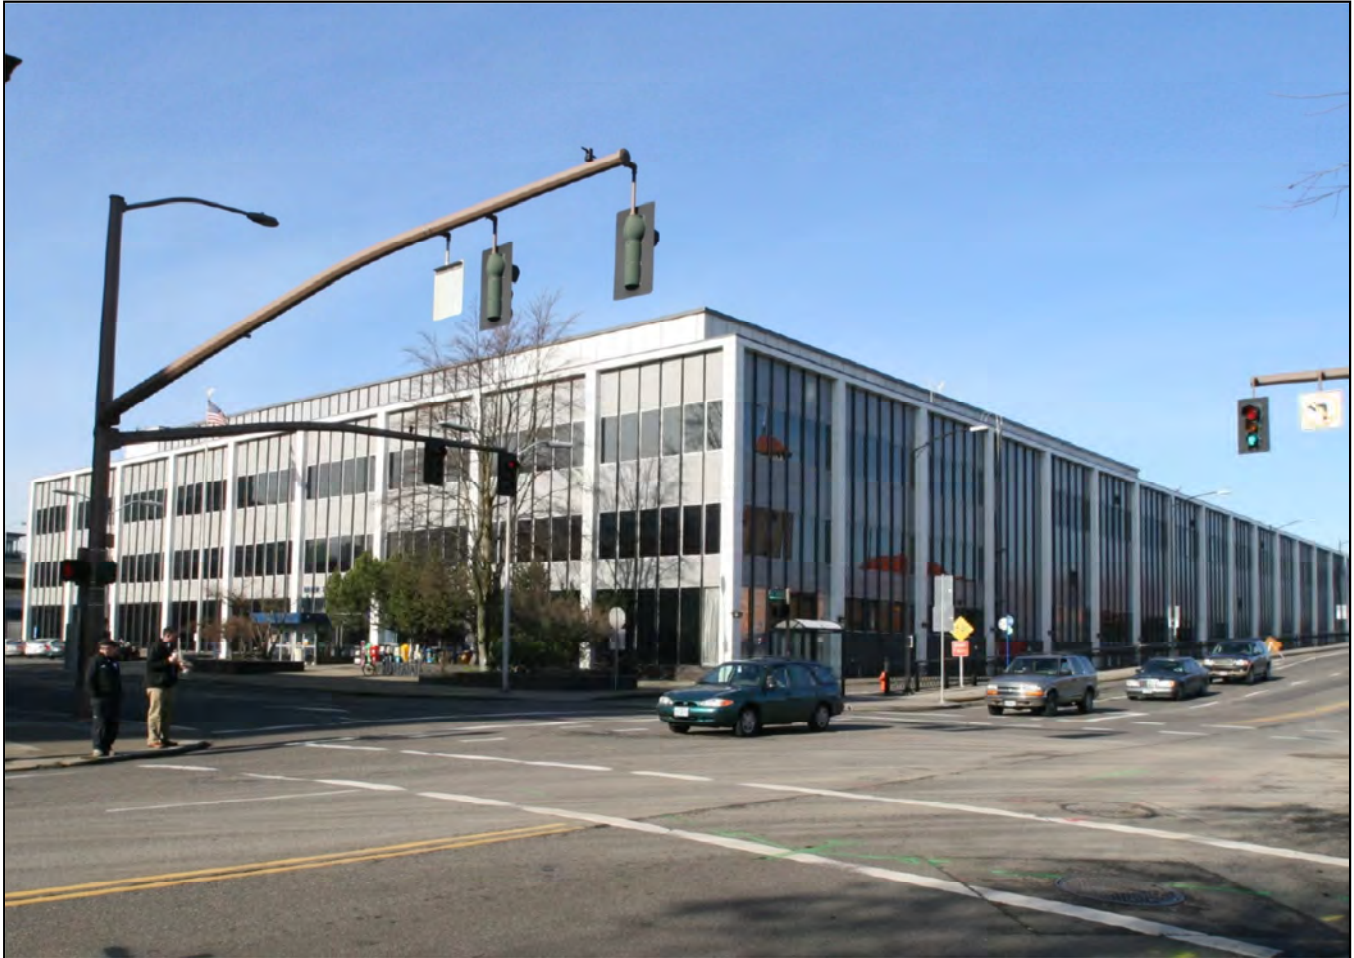
Figure 8: Portland P&DC (715 NW Hoyt Street, Portland, Multnomah)

Exterior: Constructed in 1967, the 148,064 square-foot building is one-story in height with a rectilinear shape. The structure is utilitarian in nature and the design reflects this. The building has a flat roof, poured-concrete slab-on-grade foundation. Facade materials are consistent and include tan-, red-, and brown-brick stretcher-bond veneer with "natural" mortar, metal coping, corrugated-metal fascia, and black aluminum-framed fixed-glass panel windows and entryway. Most facades have minimal fenestration, consisting of mostly blank wall planes.

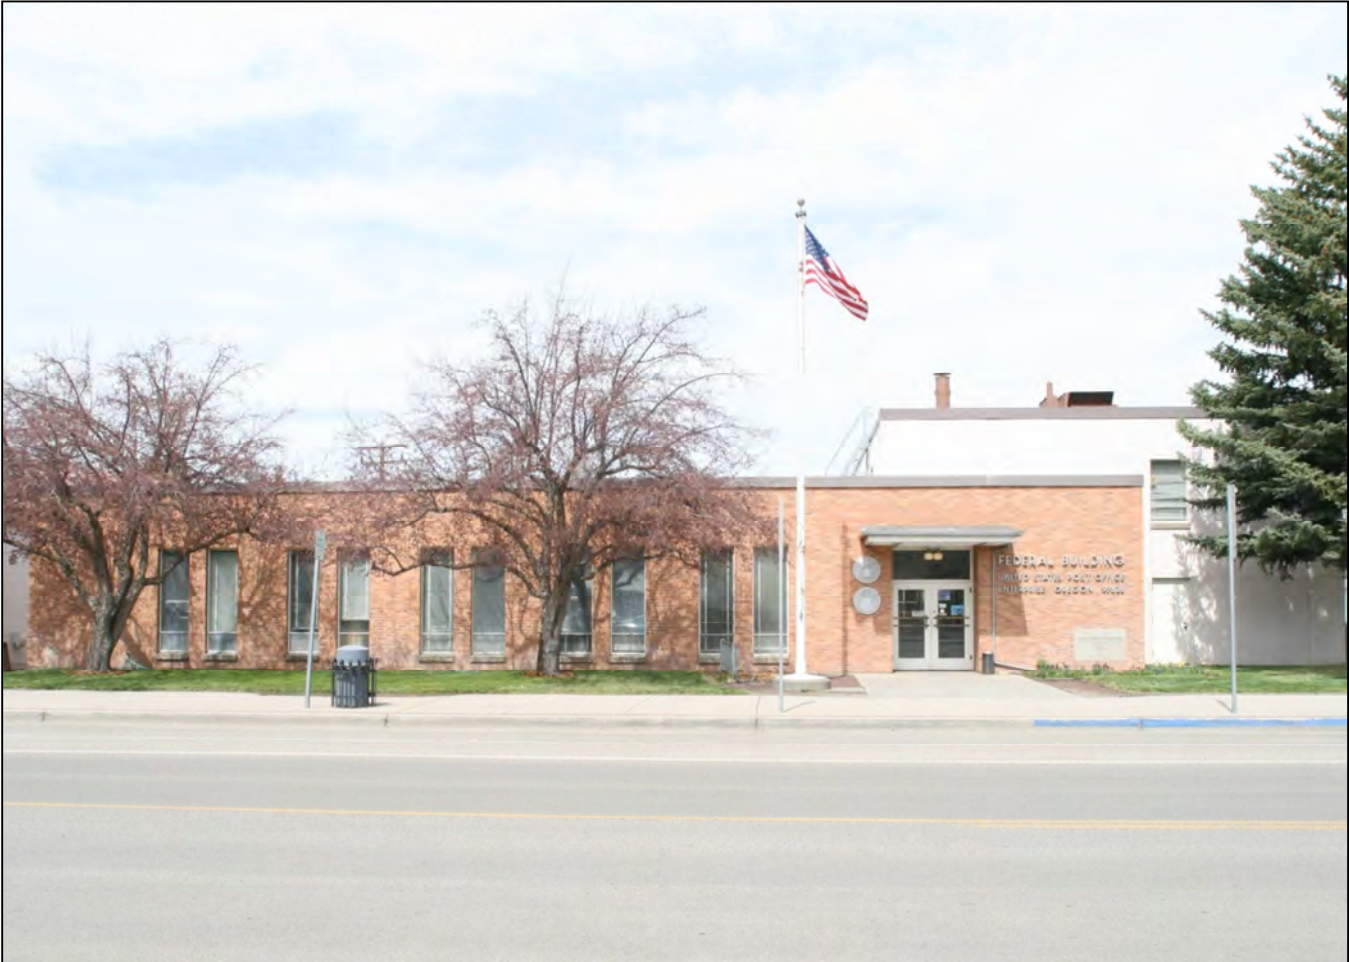
Figure 10: Federal Building/Post Office (201 W. North Street, Enterprise, Wallowa County)

Exterior: Constructed in 1965, the one-story post office is integrated into a two-story federal building at the southeast corner. The structure is of minimal design; "L" -shaped. The building was contractor designed. It has a flat roof, poured-concrete slab-on-grade foundation, and is unreinforced masonry block. Facade materials are red-brick stretcher-bond veneer with "natural" mortar, stucco panels, metal coping, and modular aluminum-framed plate-glass windows; fixed and casement style.
