National Register of Historic Places Registration Form

Historic name: Camp Chaffee Historic District – Boundary Increase and Additional Documentation

City or town: Fort Smith State: Arkansas County: Sebastian

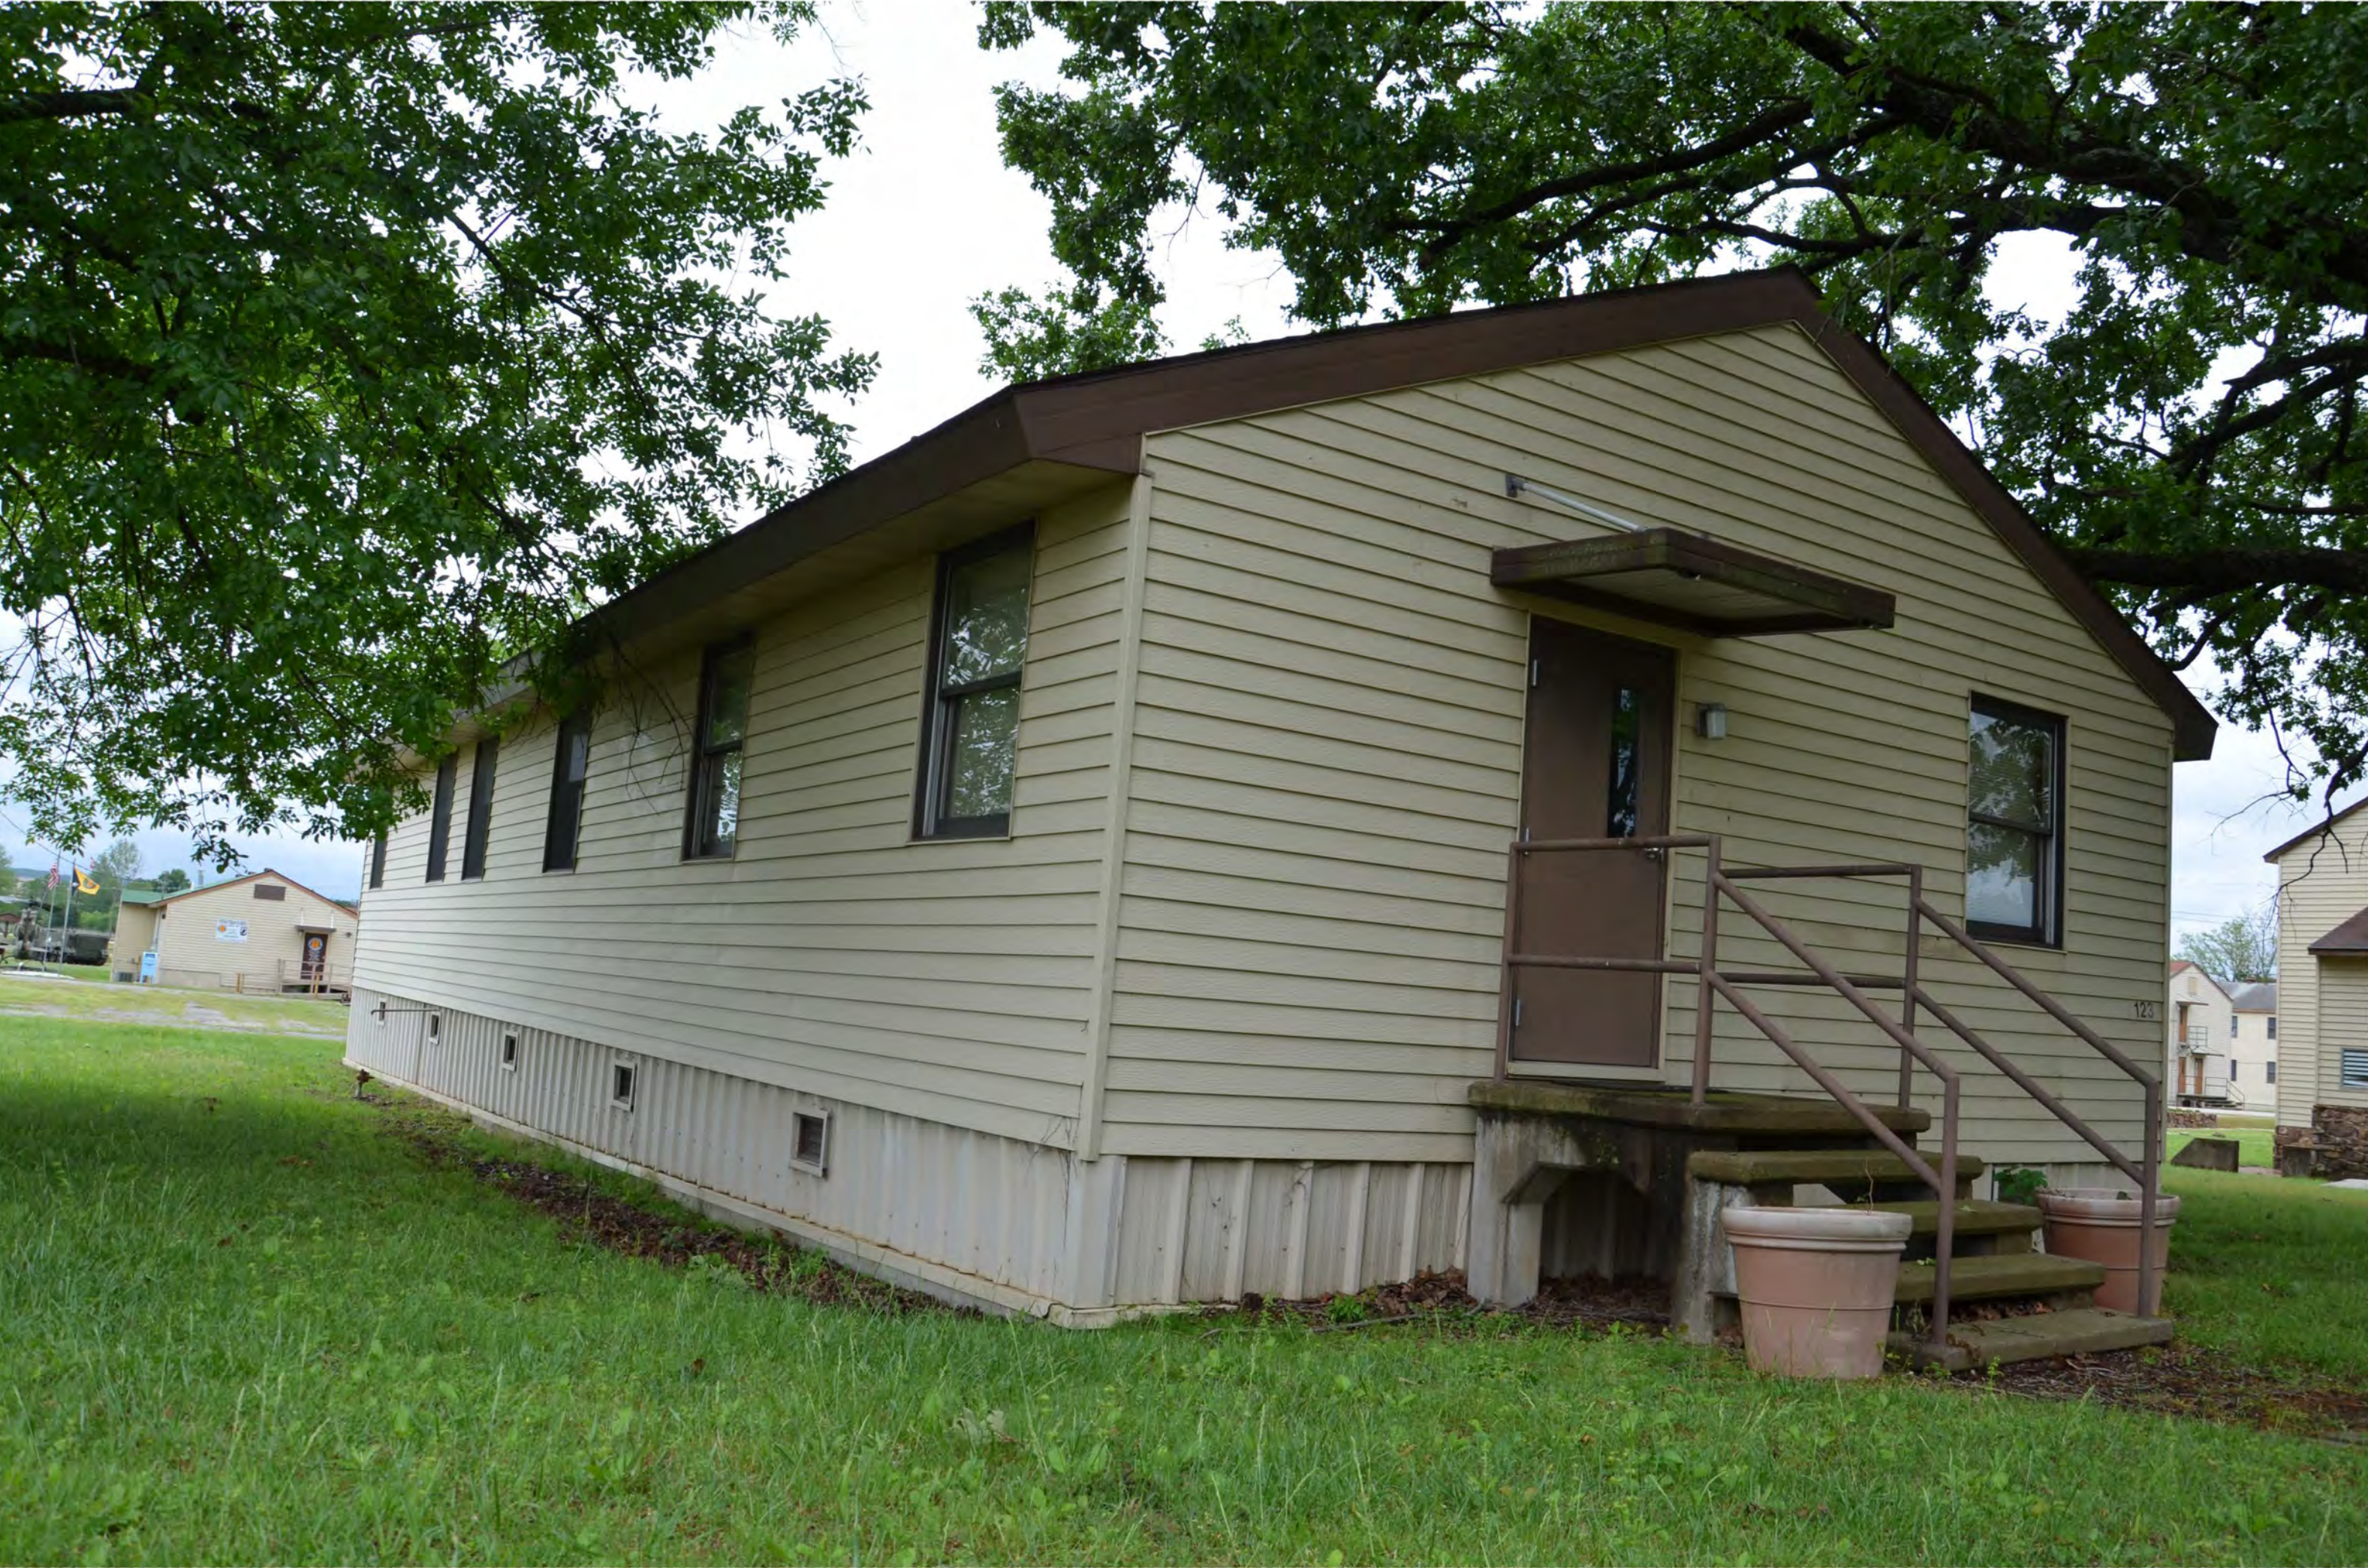
123

Building #123 contains little to no ornamentation on any of the elevations, however, the entire building is set on piers with the exception of the heating room which has a cast concrete foundation and floor, while also being covered by a gable roof. The front façade of the building faces Terry Street and contains a small one-over-one, double-hung window toward the southwest corner of the elevation. There is also a single steel door, accessed by a small set of steps and porch, covered by a small cantilevered awning. The northeast elevation can be split into two bays by window arrangements. The northern half of the building contains three, evenly spaced, one-over-one, double-hung windows. The southern half of the elevation contains two, one-over-one, double-hung windows adjacent to each other, with the third window being located near the southeast corner of the elevation. The southeast elevation contains only a single, entranceway that is offset to the right of center and is accessed by a set of seven concrete steps and a landing area. The entranceway is also covered by a small cantilevered awning. To the left of the concrete steps is a set of steel double-doors, which leads to the heating room which has the cast concrete foundation and floor. This entranceway is located at ground-level unlike the other entrances. The southwest corner of the southwest elevation contains another ventilation stack with concrete base similar to the one found on Building #134. However unlike Building #134 the ventilation stack is no longer connected by the ductwork as it was been retrofitted for modern HVAC. The rest of the elevation consists of four, evenly spaced, one-over-one, double-hung windows located

Building #123 is located along Terry St, or the former West Warehouse St. The building originally housed a type GH-2, unit guardhouse through at least the 1982, when it was used for administration purposes.³ The building was one of six of these type of building constructed at Camp Chaffee during the original 1942 construction contract. The building was built for \$33,481 though the original estimate calls for the cost to be \$20,672 per this type of building.⁴

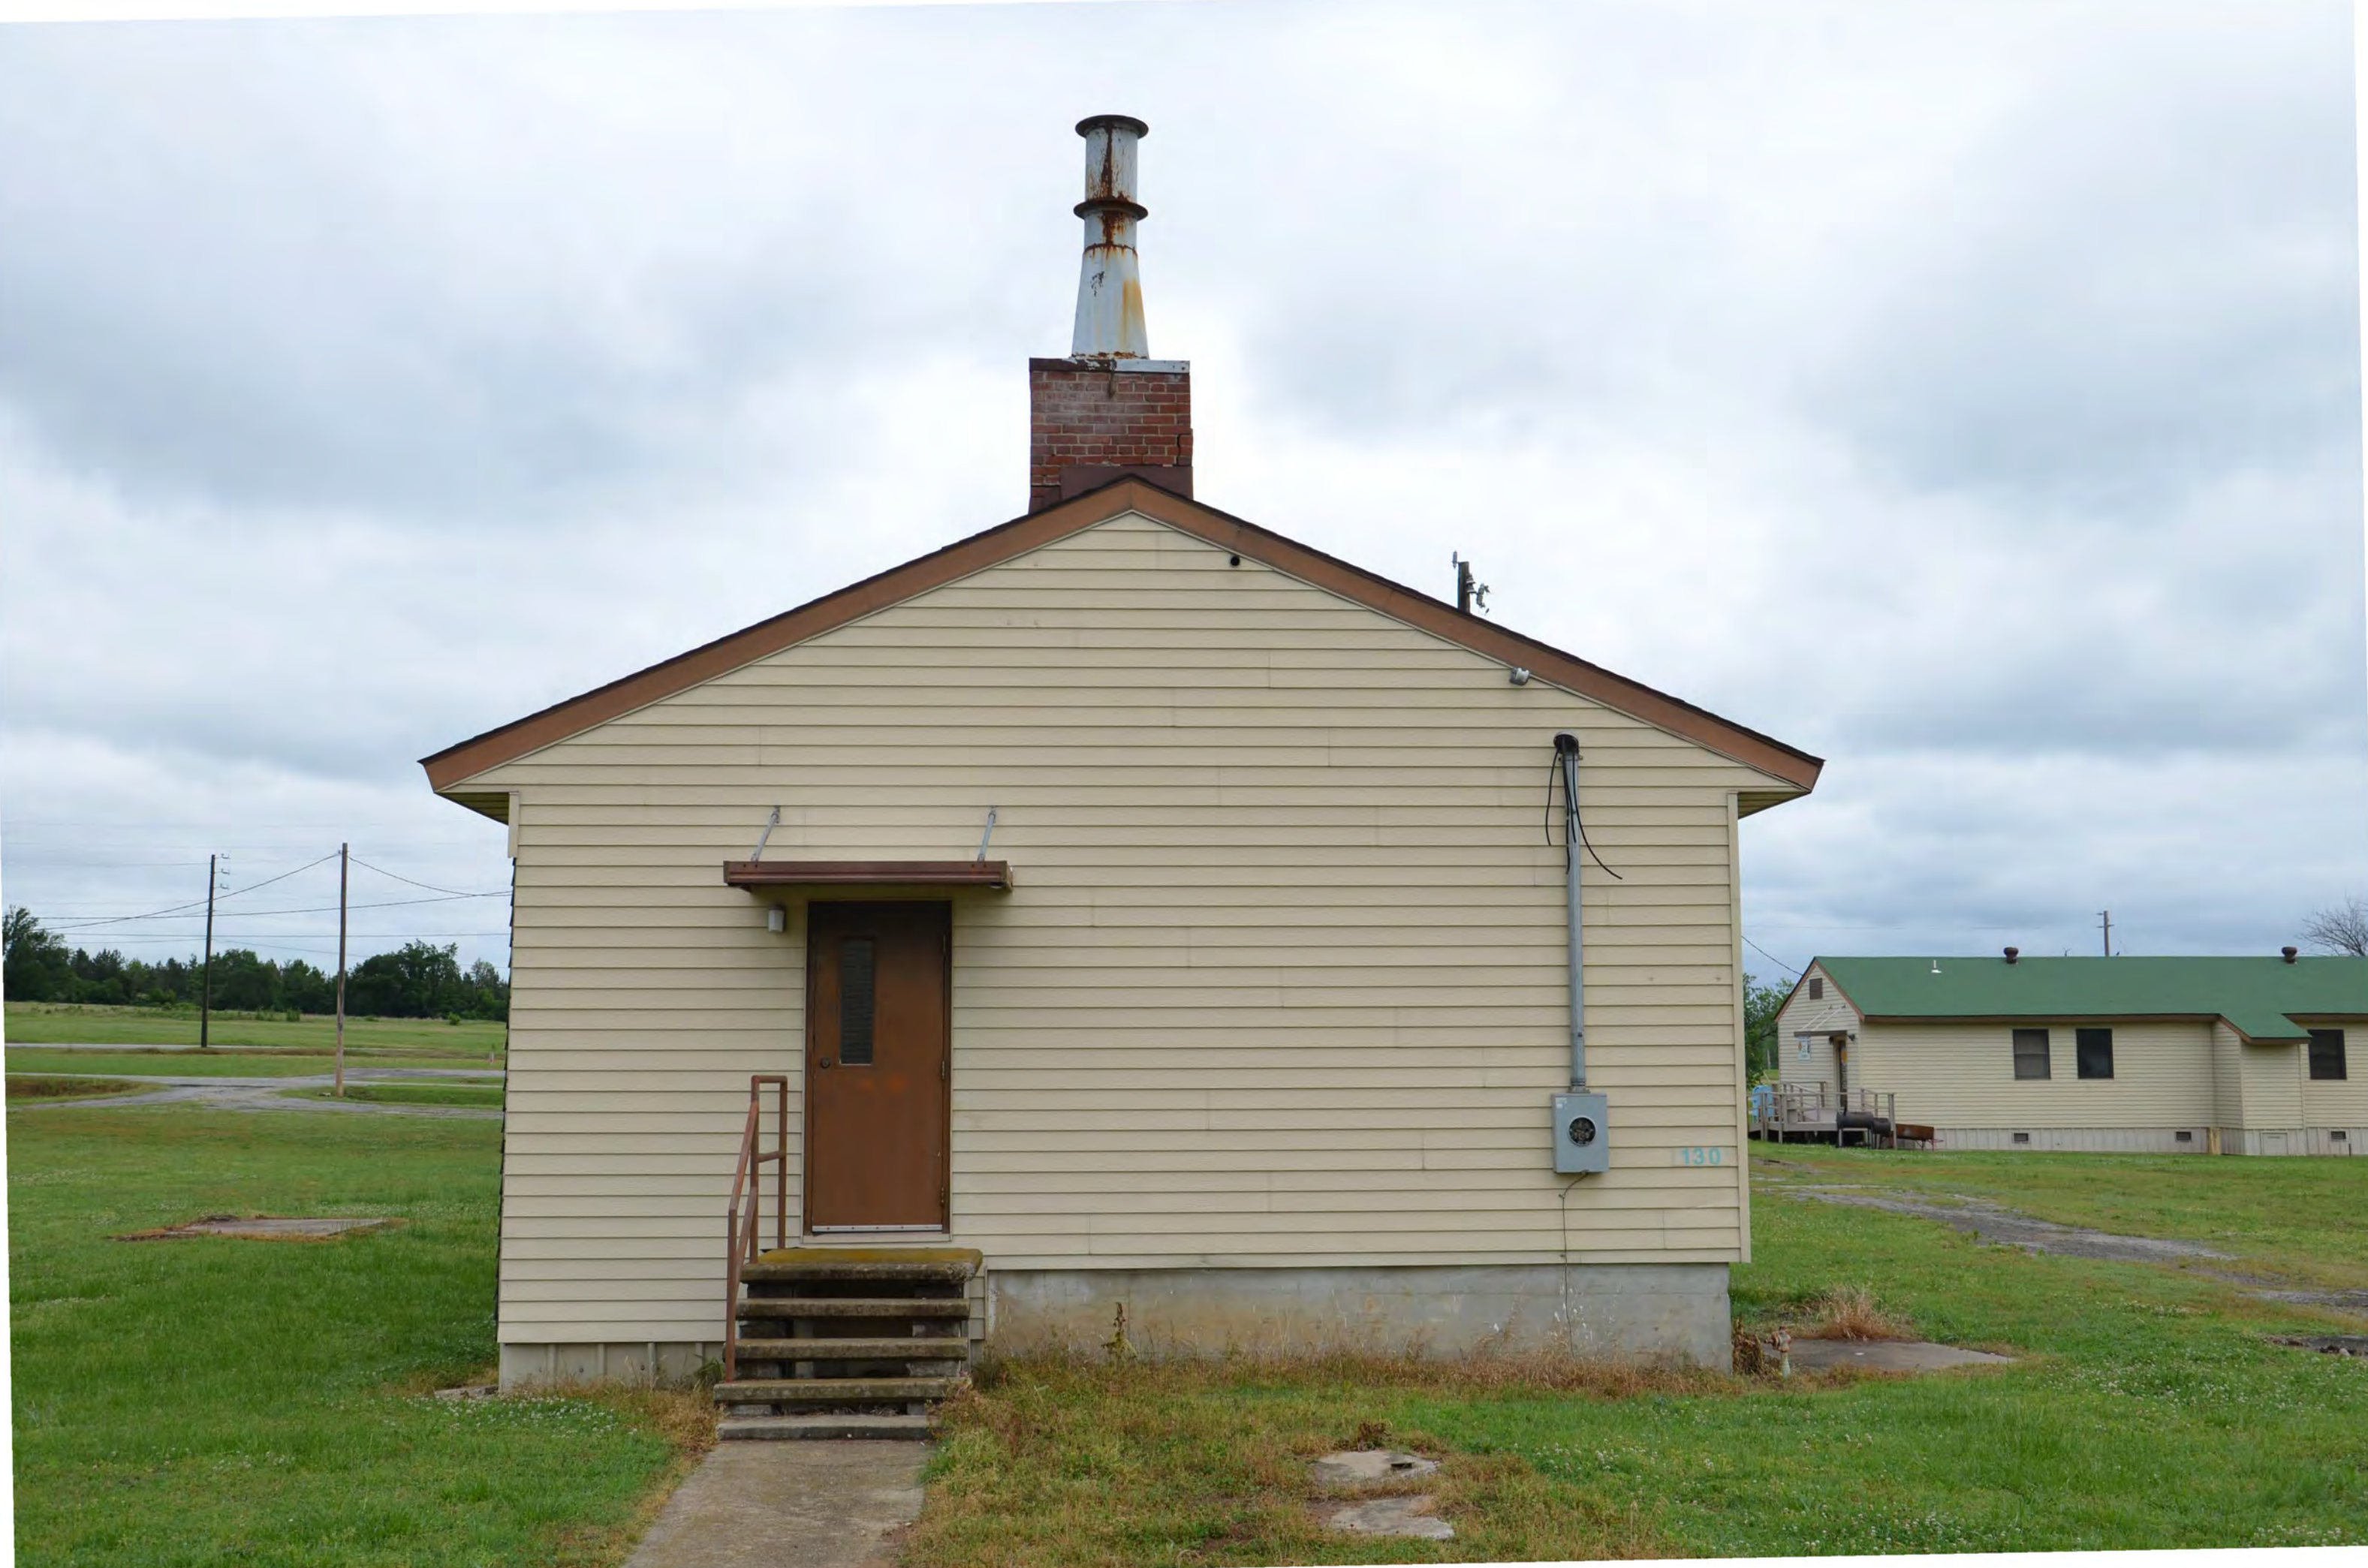
130

The front elevation of Building #130 contains little ornamentation and consists of only an offset entrance to the left of center and a central flue which rises out of the heater room through the ridge of the gable roof. The northwest elevation also contains limited fenestration and consists of only four evenly spaced windows. The northeast elevation consists of a central steel doorway accessed by an "L" shaped set of steps and covered by a small cantilevered porch. A one-over-one, double-hung window flanks both sides of the entranceway. Located with the gable portion of this elevation is a small, square, louvered vent. The southeast elevation also contains limited fenestration. Moving right to left across the elevation there is a similar one-over-one, double-hung window to the windows on the northeast elevation on the northeast corner of this elevation. Another similar window is centrally located on the elevation. Located between these two windows is a small, horizontal, rectangular window located along the upper-third of the elevation. Located between the central one-over-one, double-hung window and the southwest corner, there is a set of double steel-doors that allows access in to the heater room. The heater room floors are cast in concrete unlike the rest of the building which is set on piers.

Building #130 was one of 11 infirmary buildings located on Camp Chaffee by 1942. All 11 of the infirmary buildings were built identical to each other under building plan 800-1429. However, because the building was used as an infirmary, current practices called for the abundant use of natural light and the movement of fresh air throughout the building. In the original design plans for plan 800-1429, the use of ten windows on each of the two long elevations.¹ Due to the lack of windows along these long elevations, the building is not contributing to the district.

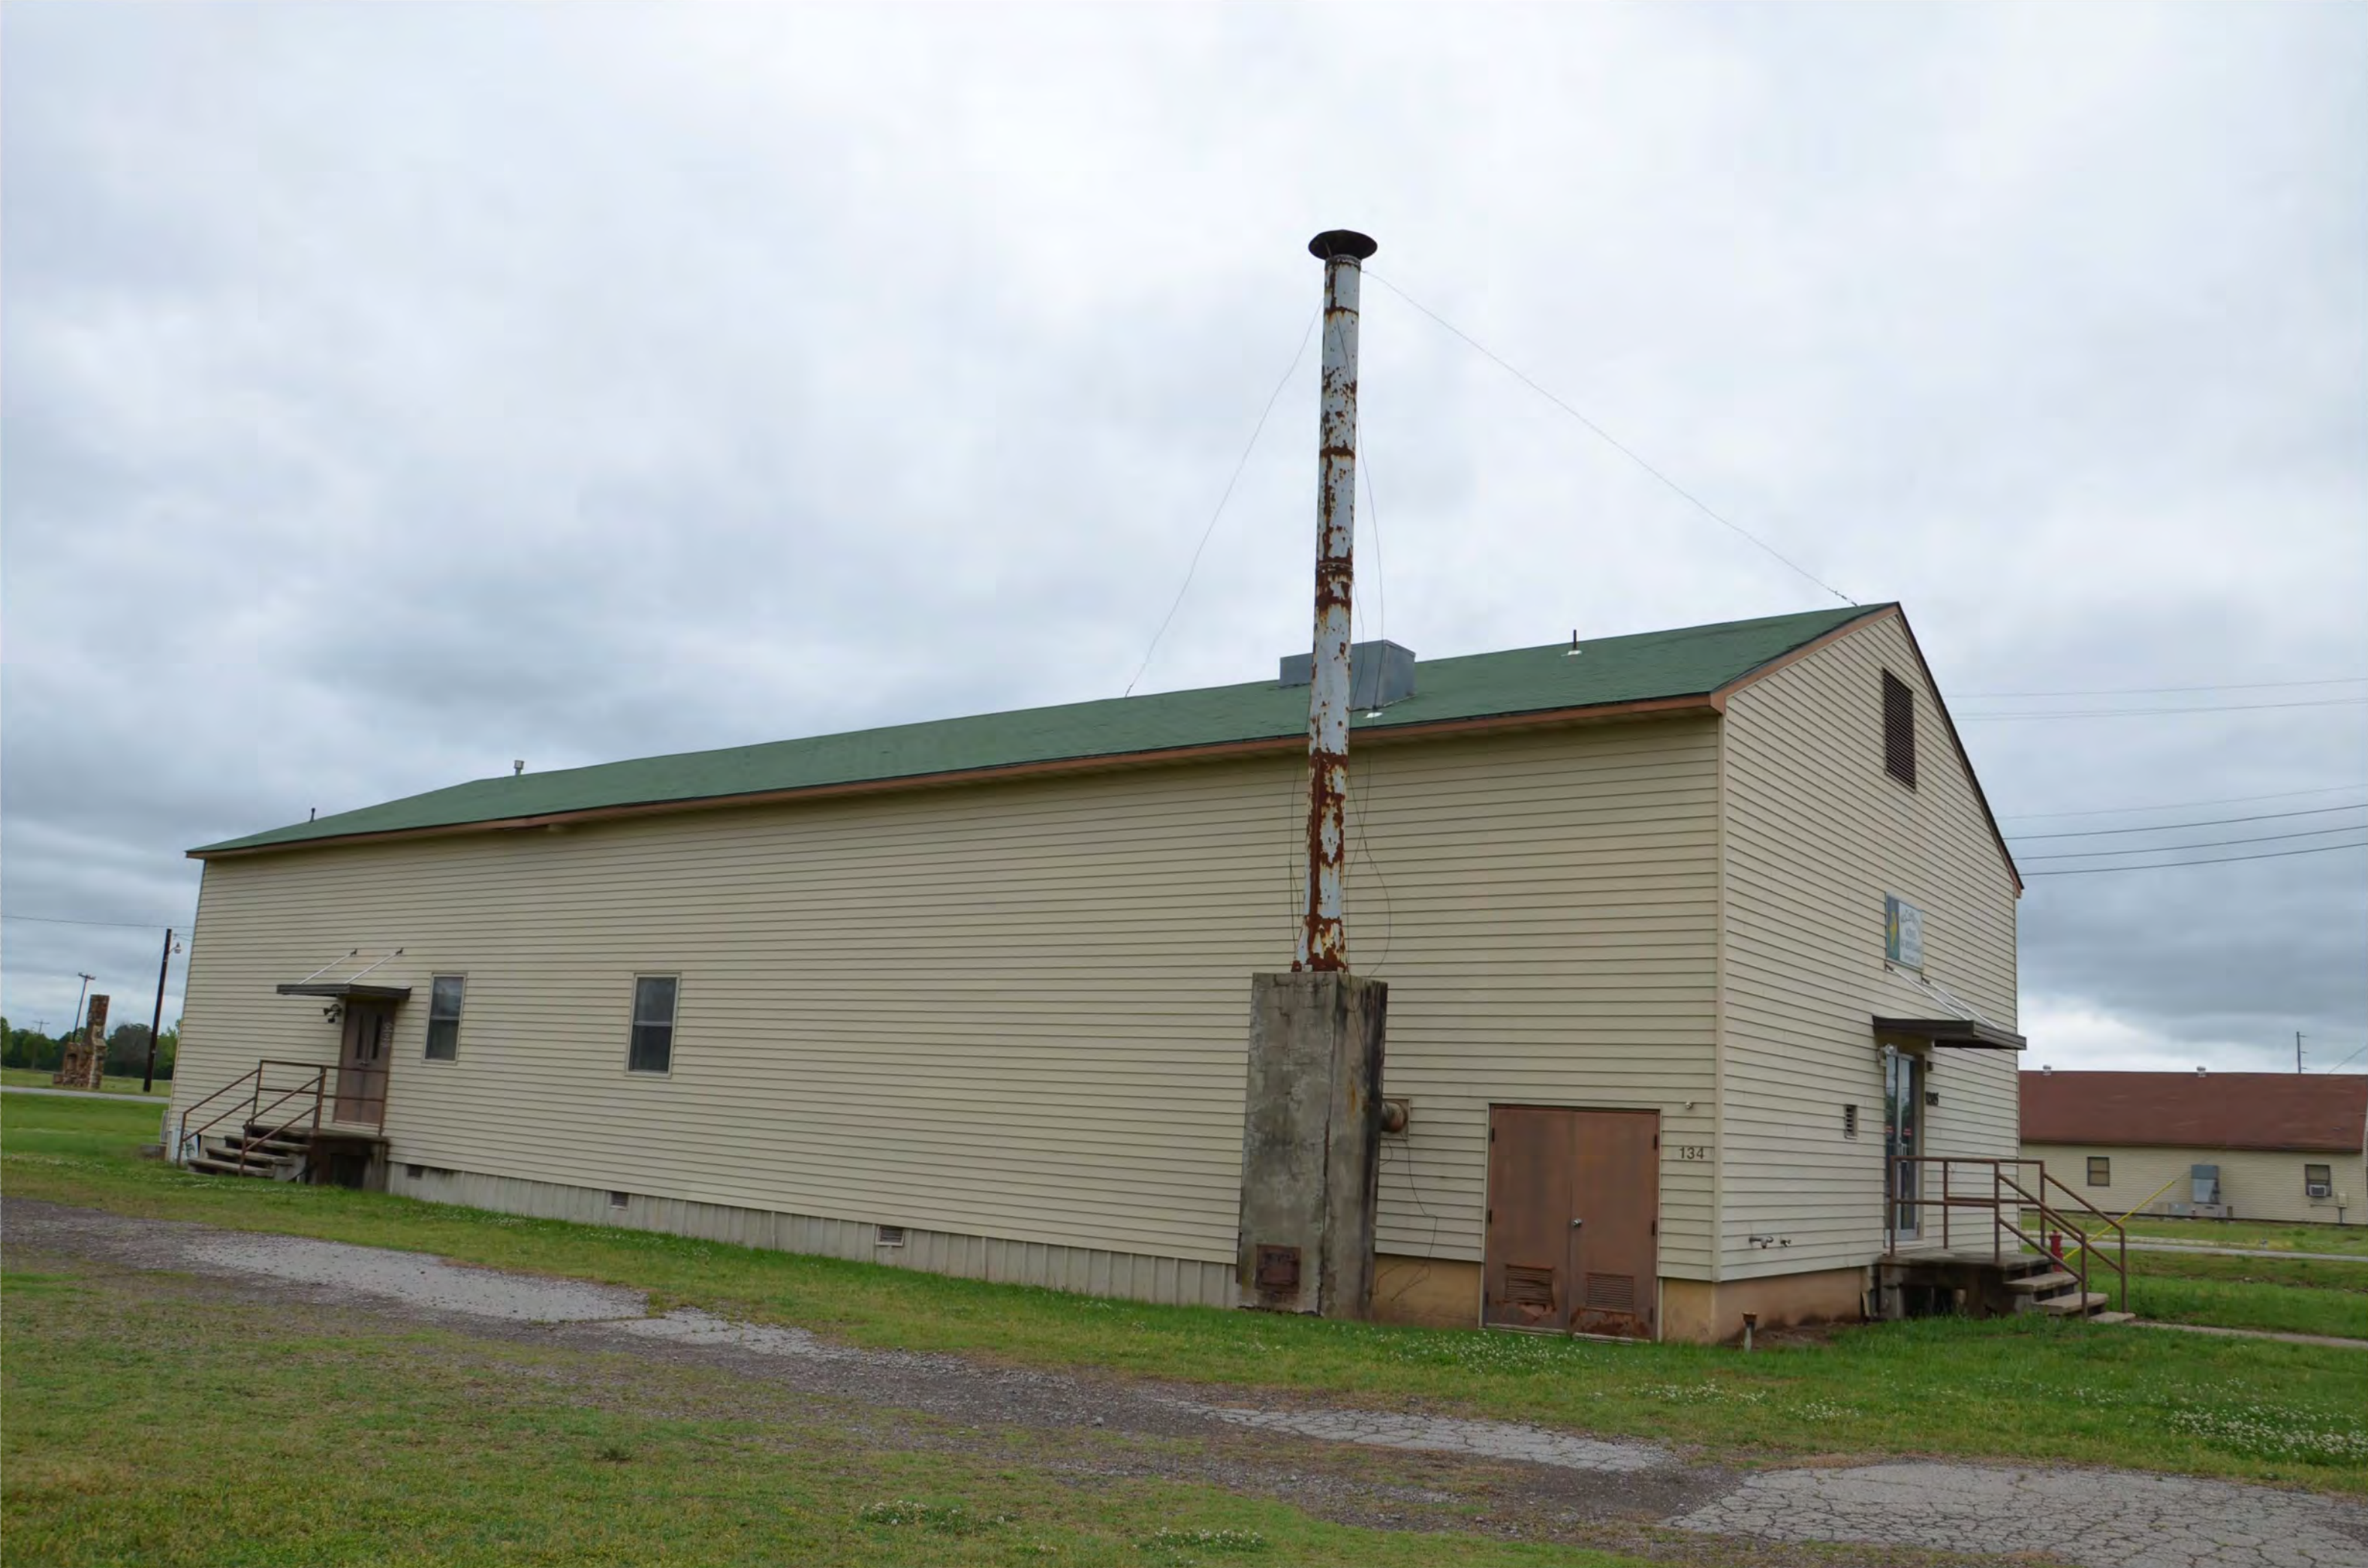
134

Front façade of Building #134 contains limited ornamentation and consists of only a centrally located set of double-glass doors, accessed by a small set of steps and porch, covered by a small cantilevered awning. A small louvered vent is located to the left of the double entrance way to allow the heat room to vent to the exterior. Another small square louvered vent is located within the gable. The foundation of Building #134 is like other building through the camp where the building is mostly set on piers with the exception of the heat room which has a cast concrete foundation under just that room. Most of the buildings that are set on piers also have a metal skirting about the base which was added at the same time all the buildings were clad in aluminum. The northwest elevation of Building #134 consists of a set of steel double-doors that allows access into the heat room. To the left of the double-doors is an exterior concrete box with a ventilation stack that rises above the roofline. To the left of the ventilation stack and centrally located on this elevation, there is a single, one-over-one, double-hung window. To the left of that window is another one-over-one, double-hung window. To the left of and adjacent to that window is another set of steel double-doors, accessed by a small set of steps and porch, covered by a small cantilevered awning. The northeast elevation consists of a centrally located single steel door, accessed by a large set of steps and porch, covered by a small cantilevered awning. To the right of the steps is a concrete pad with the HVAC system located on the pad. To the left of the entrance steps is a small room that juts out and is covered by a shed roof. The only ornamentation found on the jut out portion consists of a small louvered vent in the upper-right corner of the elevation. Another louvered vent is located just above the tip of the shed rood, while a third louvered vent is larger and located within the gable of the roof. The southeast elevation consists of a set of steel double-doors that allows access into an exterior room that is also the jut out described in the previous elevation. To the left of the double -doors is another area that juts out from the main portion of the building and consist of only a single steel door and a set of fire hose connections to the left of the door. The rest of the main portion of the building consists of only two other double-hung, windows one of which is centrally located on the elevation and the other is centrally located between the other window and the small room that juts out.

Building #134 was constructed as a Recreational facility under Plan No. 700-310. This building is/was one of ten recreation building throughout Camp Chaffee. With the loss of buildings to fire and deterioration it is unknown how many of the ten RB-1 type buildings are left between the Chaffee Crossing property and the active National Guard portion of the former base.

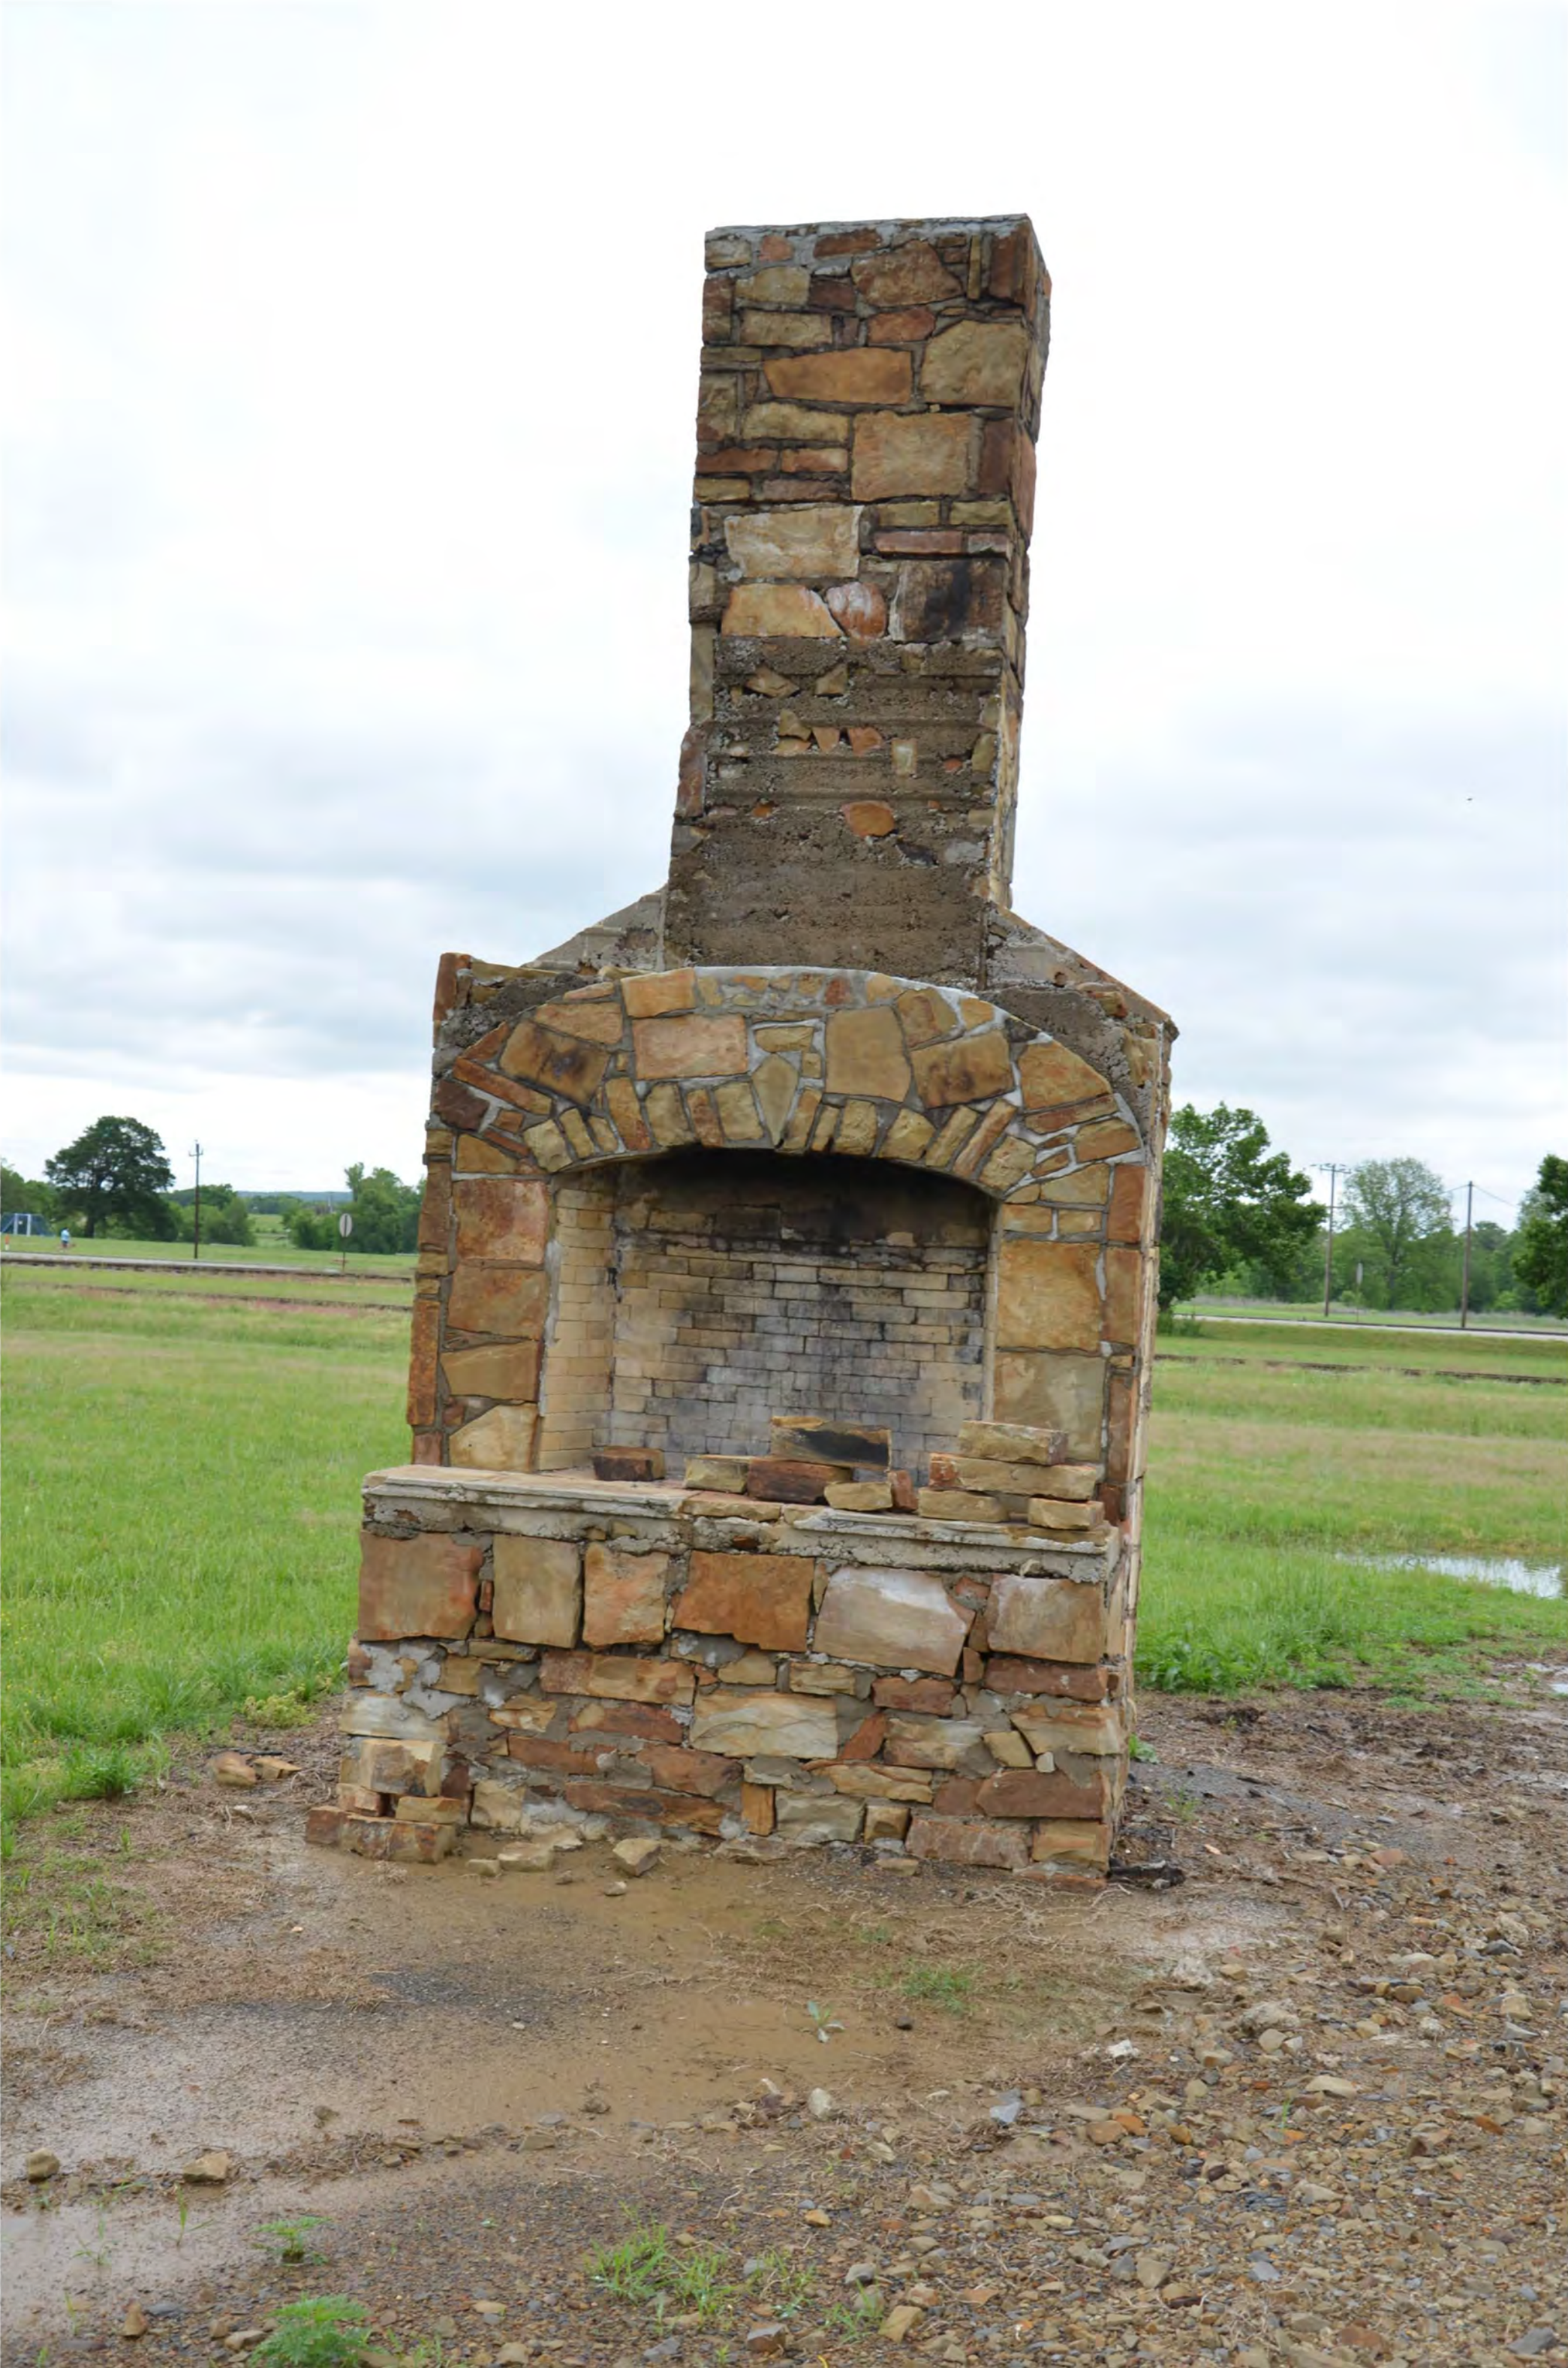
A two-story building with light-colored horizontal siding and a green roof. A tall, rusted metal chimney stands in front of the building, supported by a concrete base. The building features a set of stairs on the left side and another set of stairs on the right side. A brown door is visible on the right side, with the number 134 above it. There are several windows on the left side of the building.

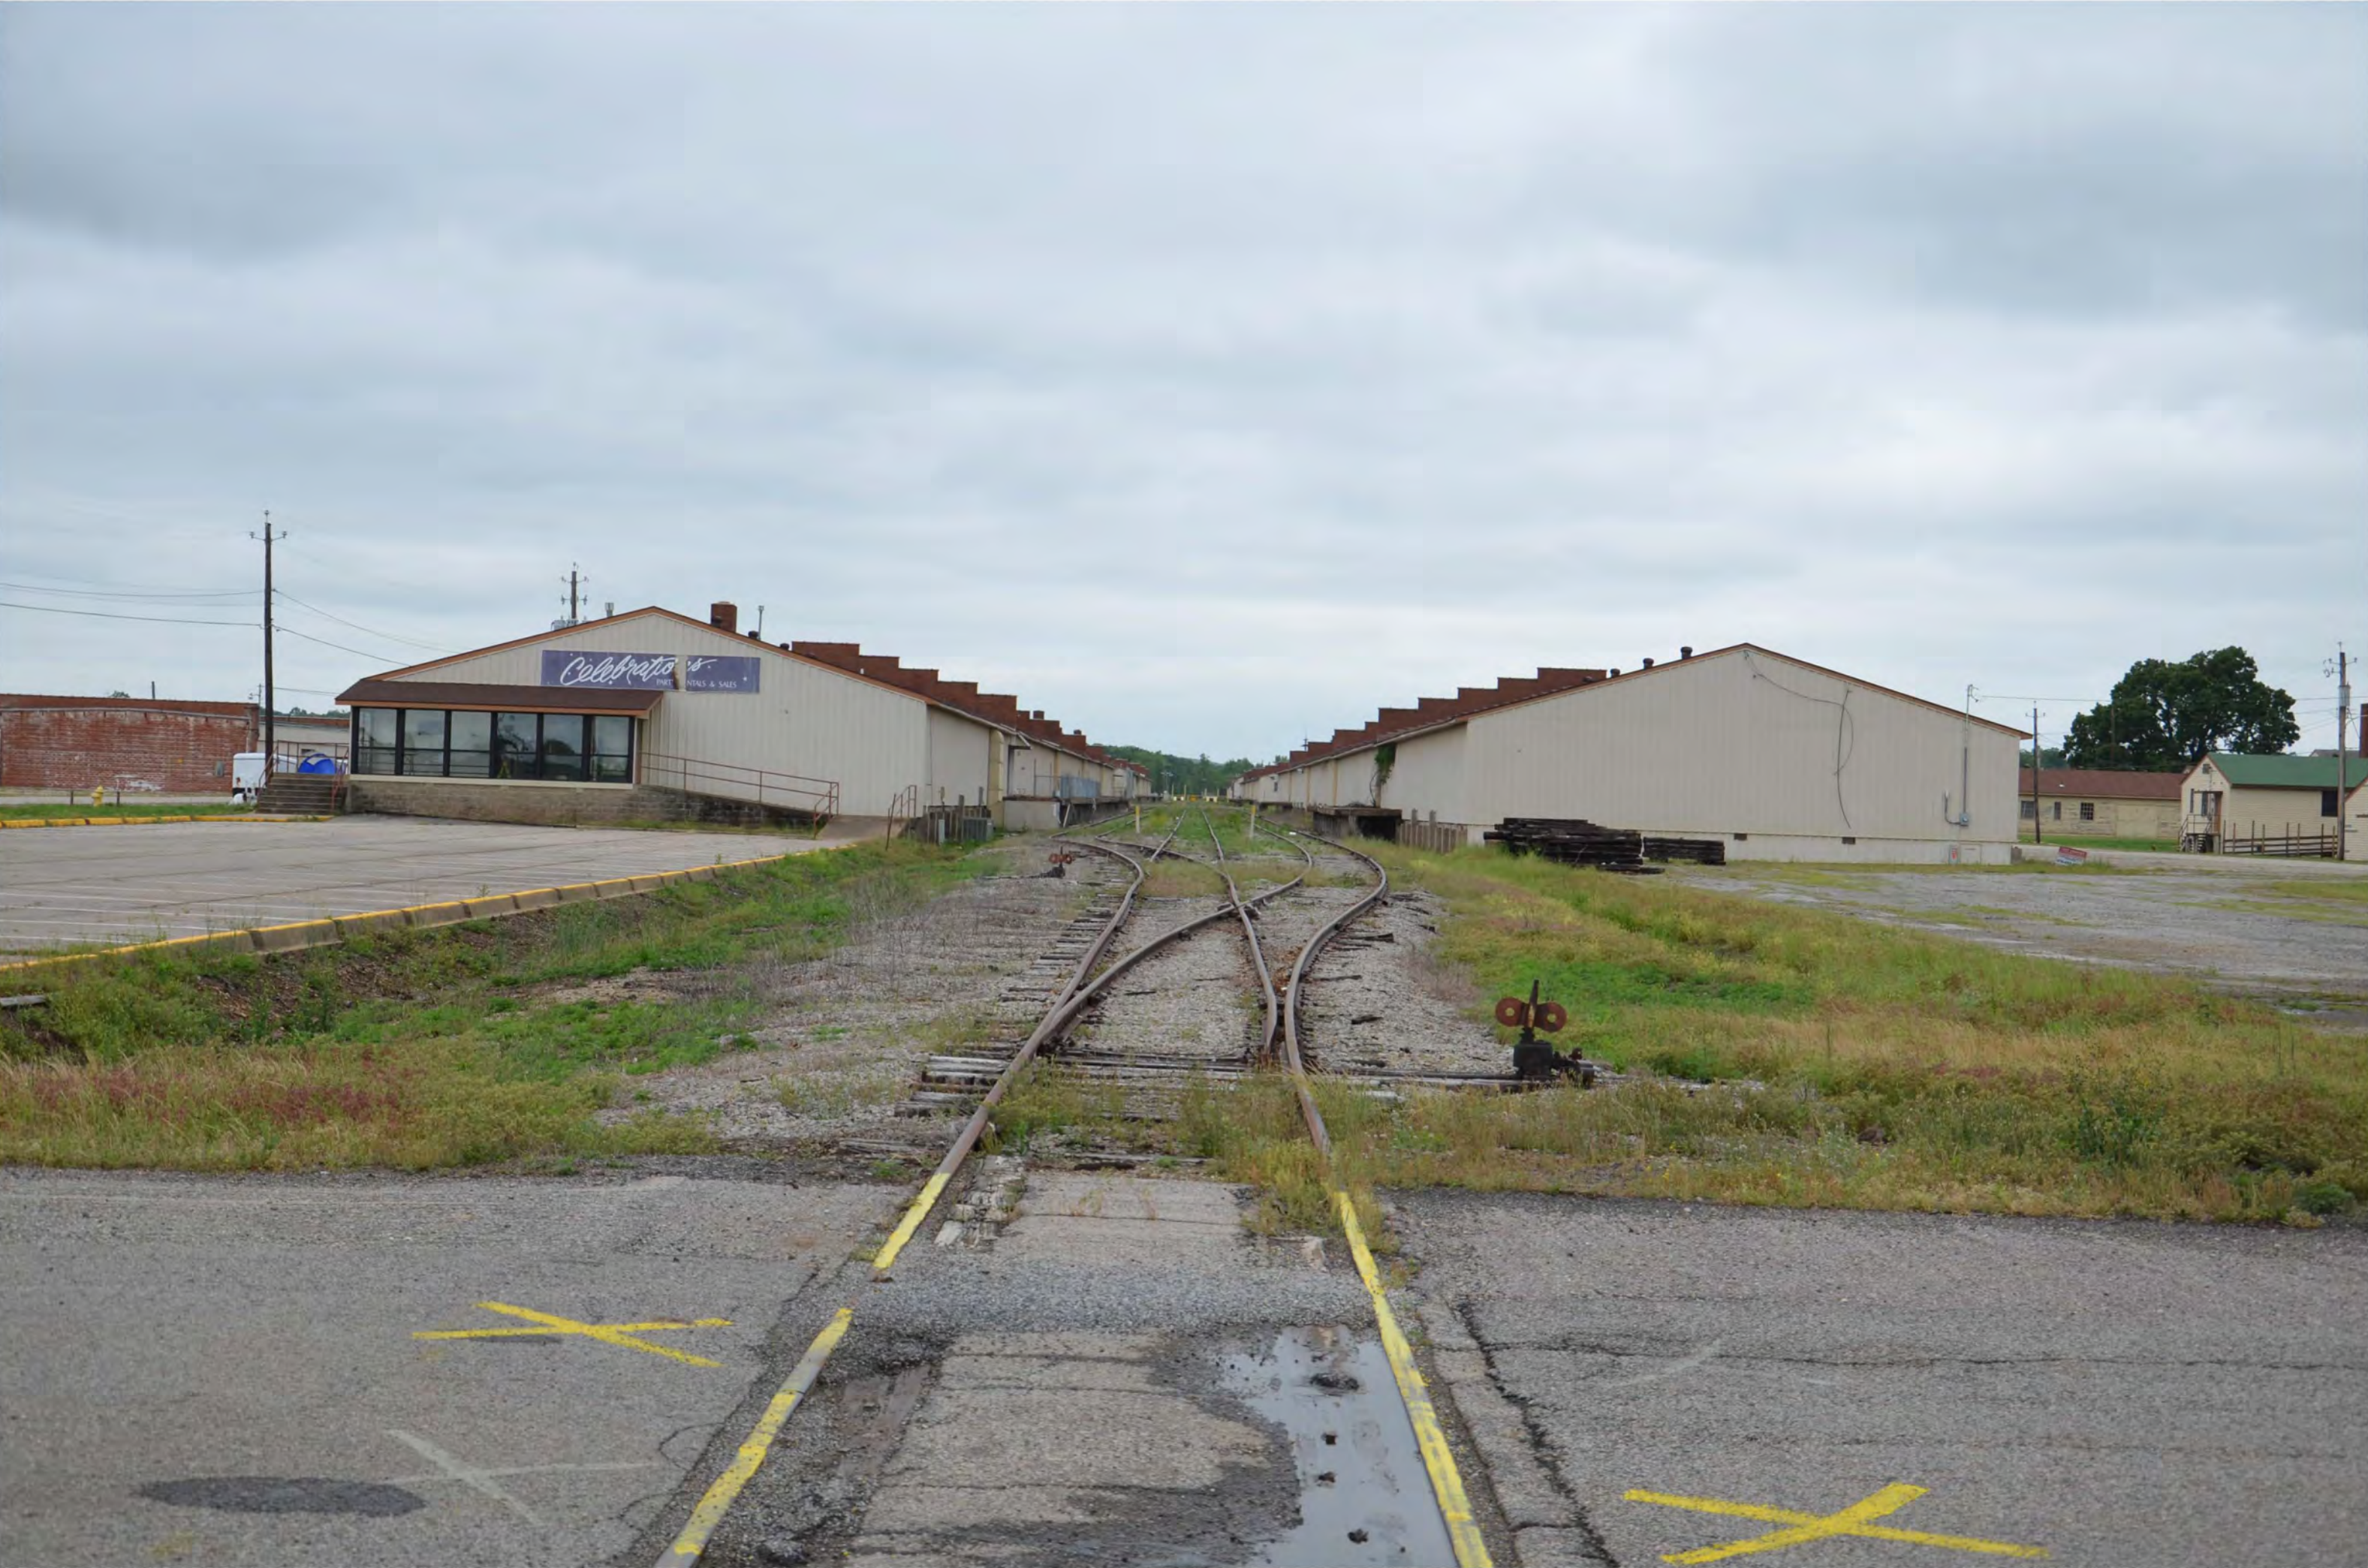
137

The gable roofed building is set on piers with the exception of the heating room which is cast concrete. The building's front facade consist of one set of steel double-doors, accessed by a small set of steps and porch, covered by a small cantilevered awning on either side of the center of the building. The double-doors set to the left of center retain the small steps in profile, but has had a concrete wheelchair ramp added over them to allow for ADA accessibility. There are also two windows on the front façade of the building with one window located to the far right and far left corners of this elevation. The northwest elevation consists of a one-over-one, double-hung window located in the southwest corner of the elevation. To the left is a large HVAC unit that

may have taken out a window for the placement of the ductwork. To the left of the HVAC unit are five evenly spaced one-over-one, double-hung windows. To the left of the five windows is another set of steel double-doors, accessed by a small set of steps and porch, however, there is no cantilevered awning over the porch like other entranceways in this area. Between the double-doors and the northwest corner of the building is a single one-over-one, double-hung window that is centrally located between the doors and the corner of the building. On the northeast elevation there is a set of steel double-doors, accessed by a small set of steps and porch, covered by a small cantilevered awning. There are two, one-over-one, double-hung windows on either side of the double-doors. A small louvered vent is located beneath the gable on the upper portion of the elevation. The southeast elevation consists of two, one-over-one, double-hung windows on the northeast corner of the elevation. To the left of the windows is another set of steel double-doors, accessed by a small set of steps and porch, however, there is no cantilevered awning. To the left of the double-doors are four evenly spaced one-over-one, double-hung windows between the double-doors and another large HVAC unit. To the left of the HVAC unit is another set of another set of steel double-doors, which leads to the heating room. To the left of the steel double-doors is another one-over-one, double-hung window.

Building #137 (CERS-1) was used as a Clothing and Equipment Repair Shop. This location would have probably housed a tailor for the fitting of uniforms. This location probably would have also repairs small equipment such as weapons and other small mechanical objects, but not vehicles. The building is currently used as a banquet facility due to its open floor plan.
