National Register of Historic Places Registration Form

Historic name: Camp Chaffee Historic District – Boundary Increase and Additional Documentation

City or town: Fort Smith State: Arkansas County: Sebastian

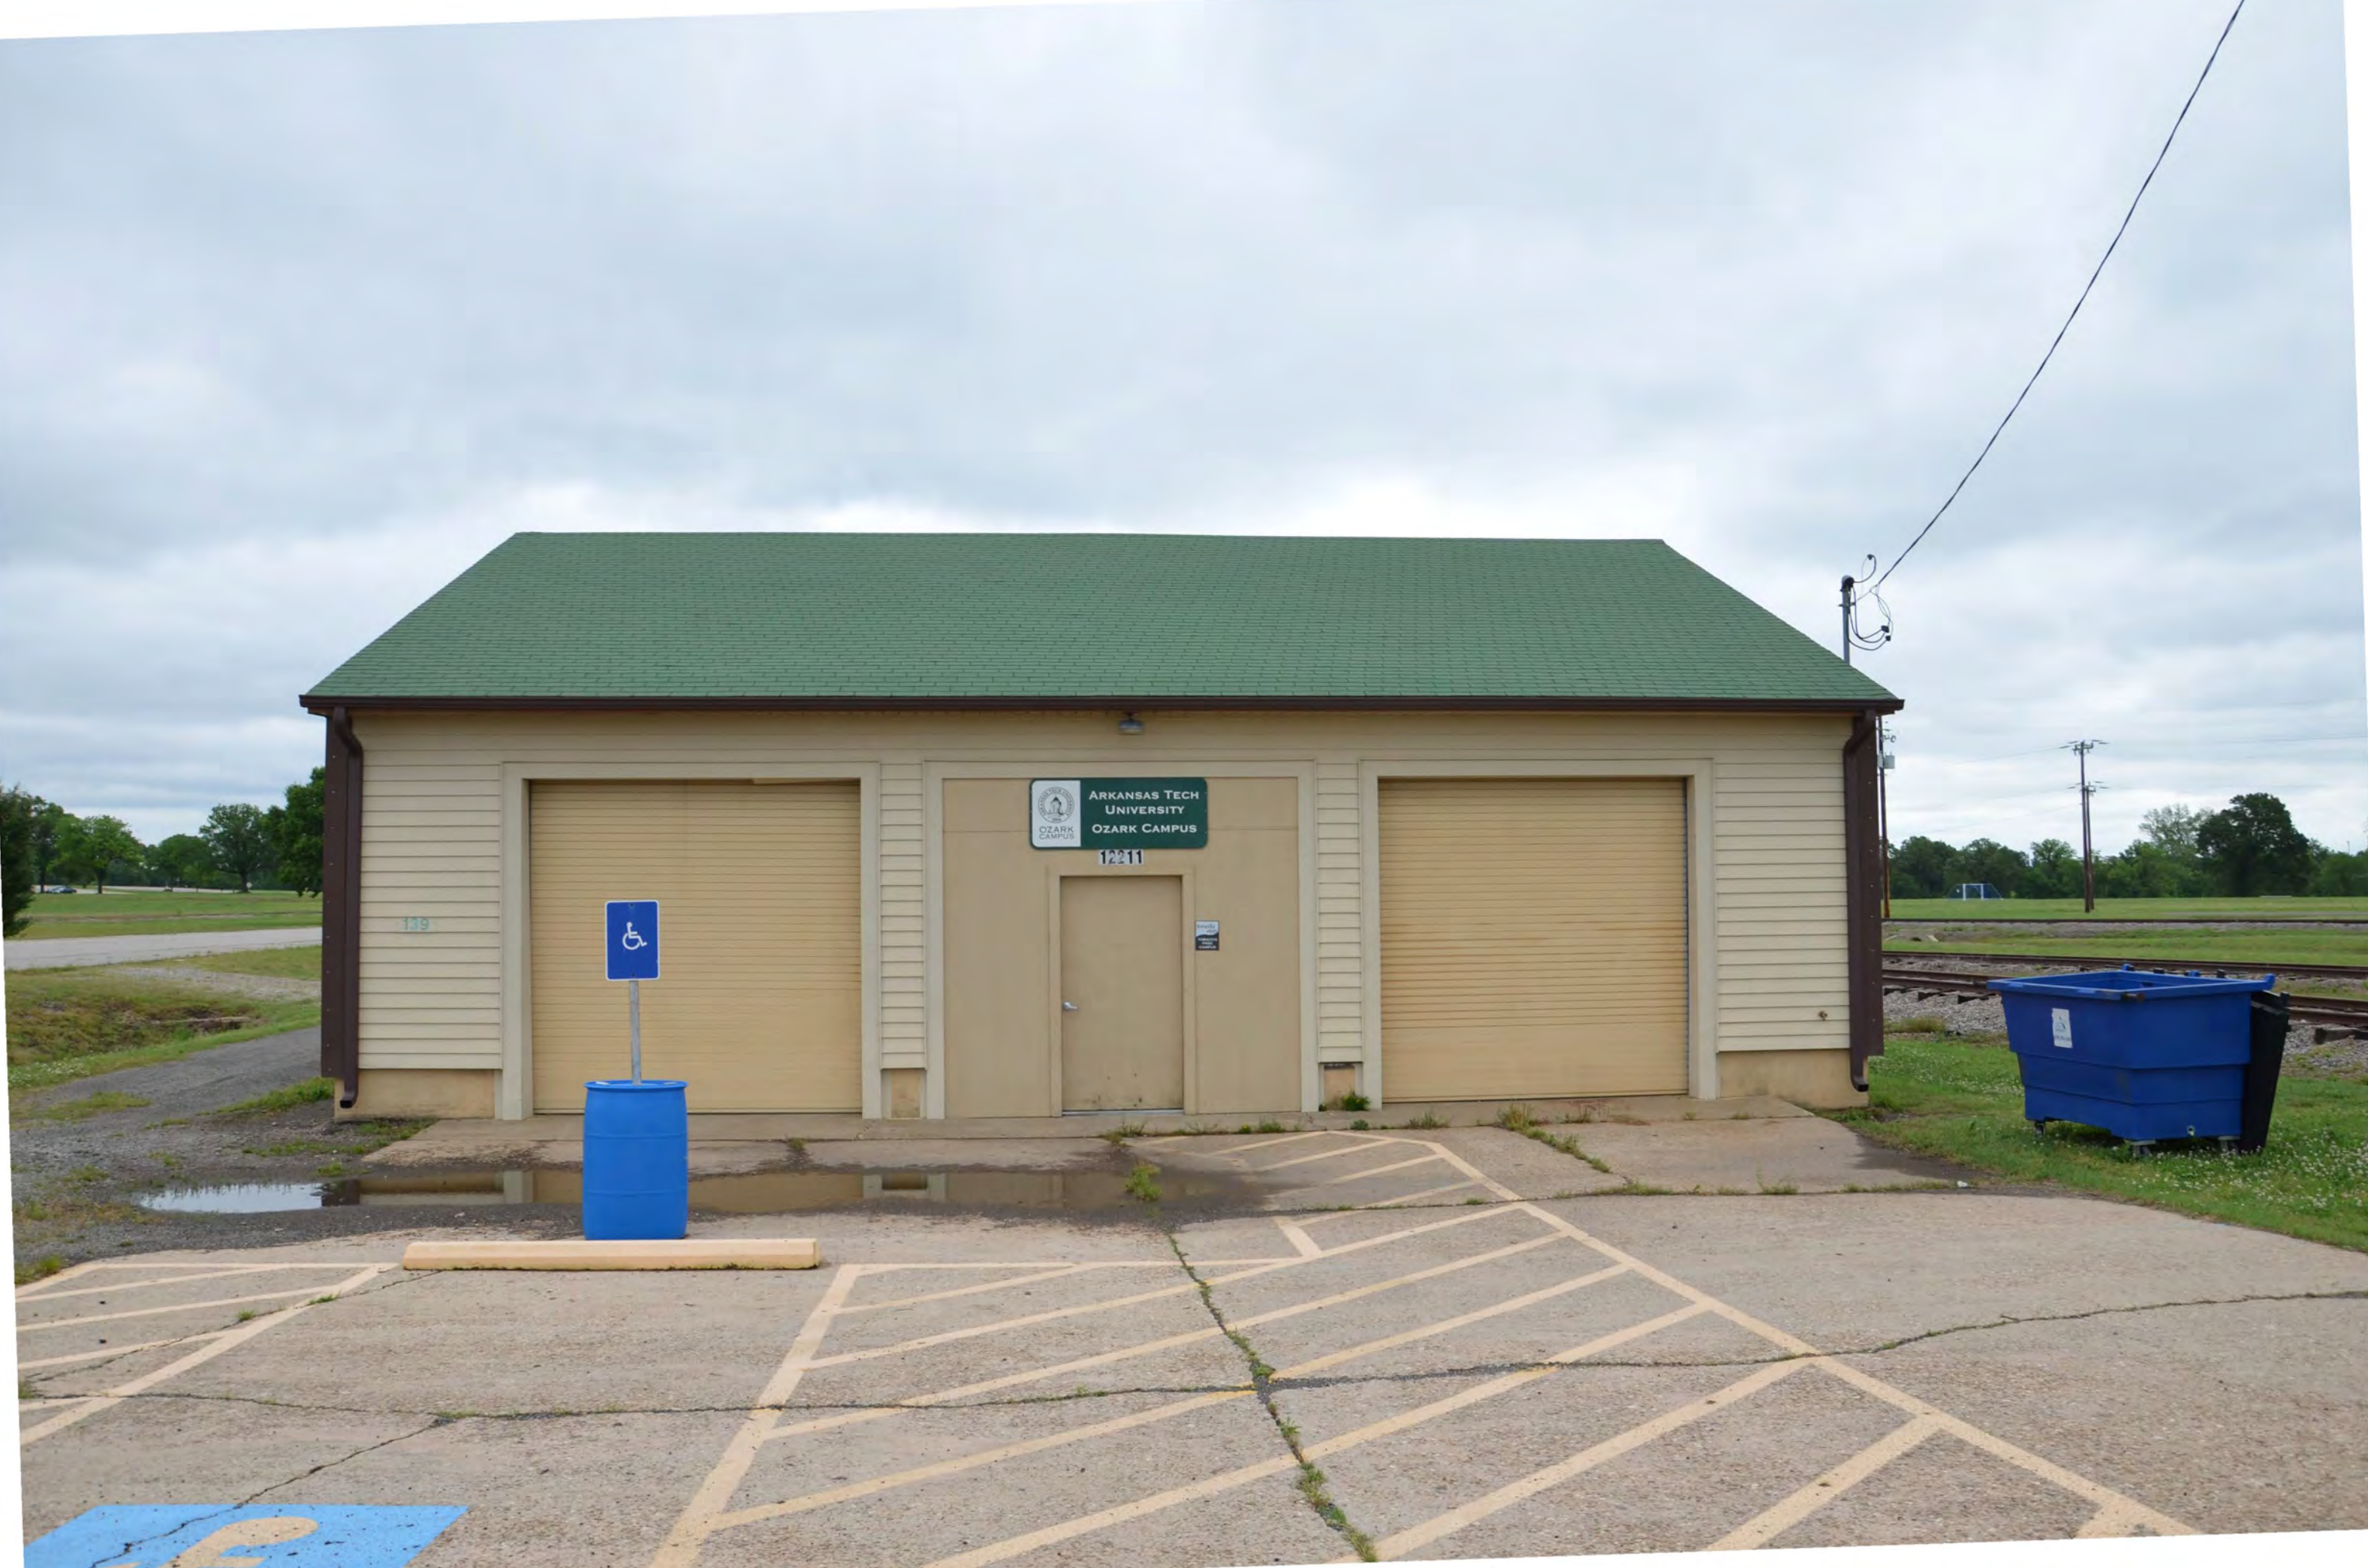
139

Building #139 is a "T" shaped building with intersecting gables. The Front Façade of Building #139 consists of three garage bays one located for each of the fire trucks located at this location. The Foundation under this part of the building is constructed of case concrete. The middle of the three bays has been changed to allow for a smaller single entrance, while still showing the reveal of the original bay door. The northwest elevation consists of two bays with the first bay extending out past the second bay. The southwest corner of the northwest elevation consist of a single, one-over-one, double-hung window, located to the right of center, and a single, steel, door covered by a small cantilevered awning is located to the left of center on this elevation. A small louvered vent is located within the gable near the ridgeline. The building is then set back from the previous bay and contains another small louvered vent in the heating room. To the left of the louvered vent is a set of double-doors that are not covered by an awning. To the left of the steel doors is the end of the cast concrete foundation and the beginning of the piers that support the floor. At this point the floor line steps up from the cast concrete floor on a wooden floor. Located to the left of the break in foundation materials there are three, evenly spaced, one-over-one, double-hung windows. These windows are much higher on the elevation, with the top of the

window frame in line with the bottom edge of the roof. The northeast elevation contains only a single, central entranceway, accessed by a set of five steps and a landing area. The entranceway is also covered by a small cantilevered awning, with a small louvered vent located within the gable above the awning. Upon turning to the southeast elevation there are three, evenly spaced, one-over-one, double-hung windows, with a fourth smaller, more narrow window located to the left of the third window of the three. There is no fenestration between the narrow window and the inside corner of the building before the building extends out again similar to the northwest elevation. On the portion that extends outward, there is only a single, one-over-one, double-hung window, located to the left of center with a small louvered vent located within the gable of the roof.

Building #139 was used as one of five F-2 Fire Station Buildings built on Camp Chaffee. These buildings provided firefighting capabilities to the camp while it was active between 1942-1946 and once it was established as a fort in 1956. With the construction of fire stations, it is noted that all fire hydrants are distributed within spacing limits as provided by the war department regulations.²

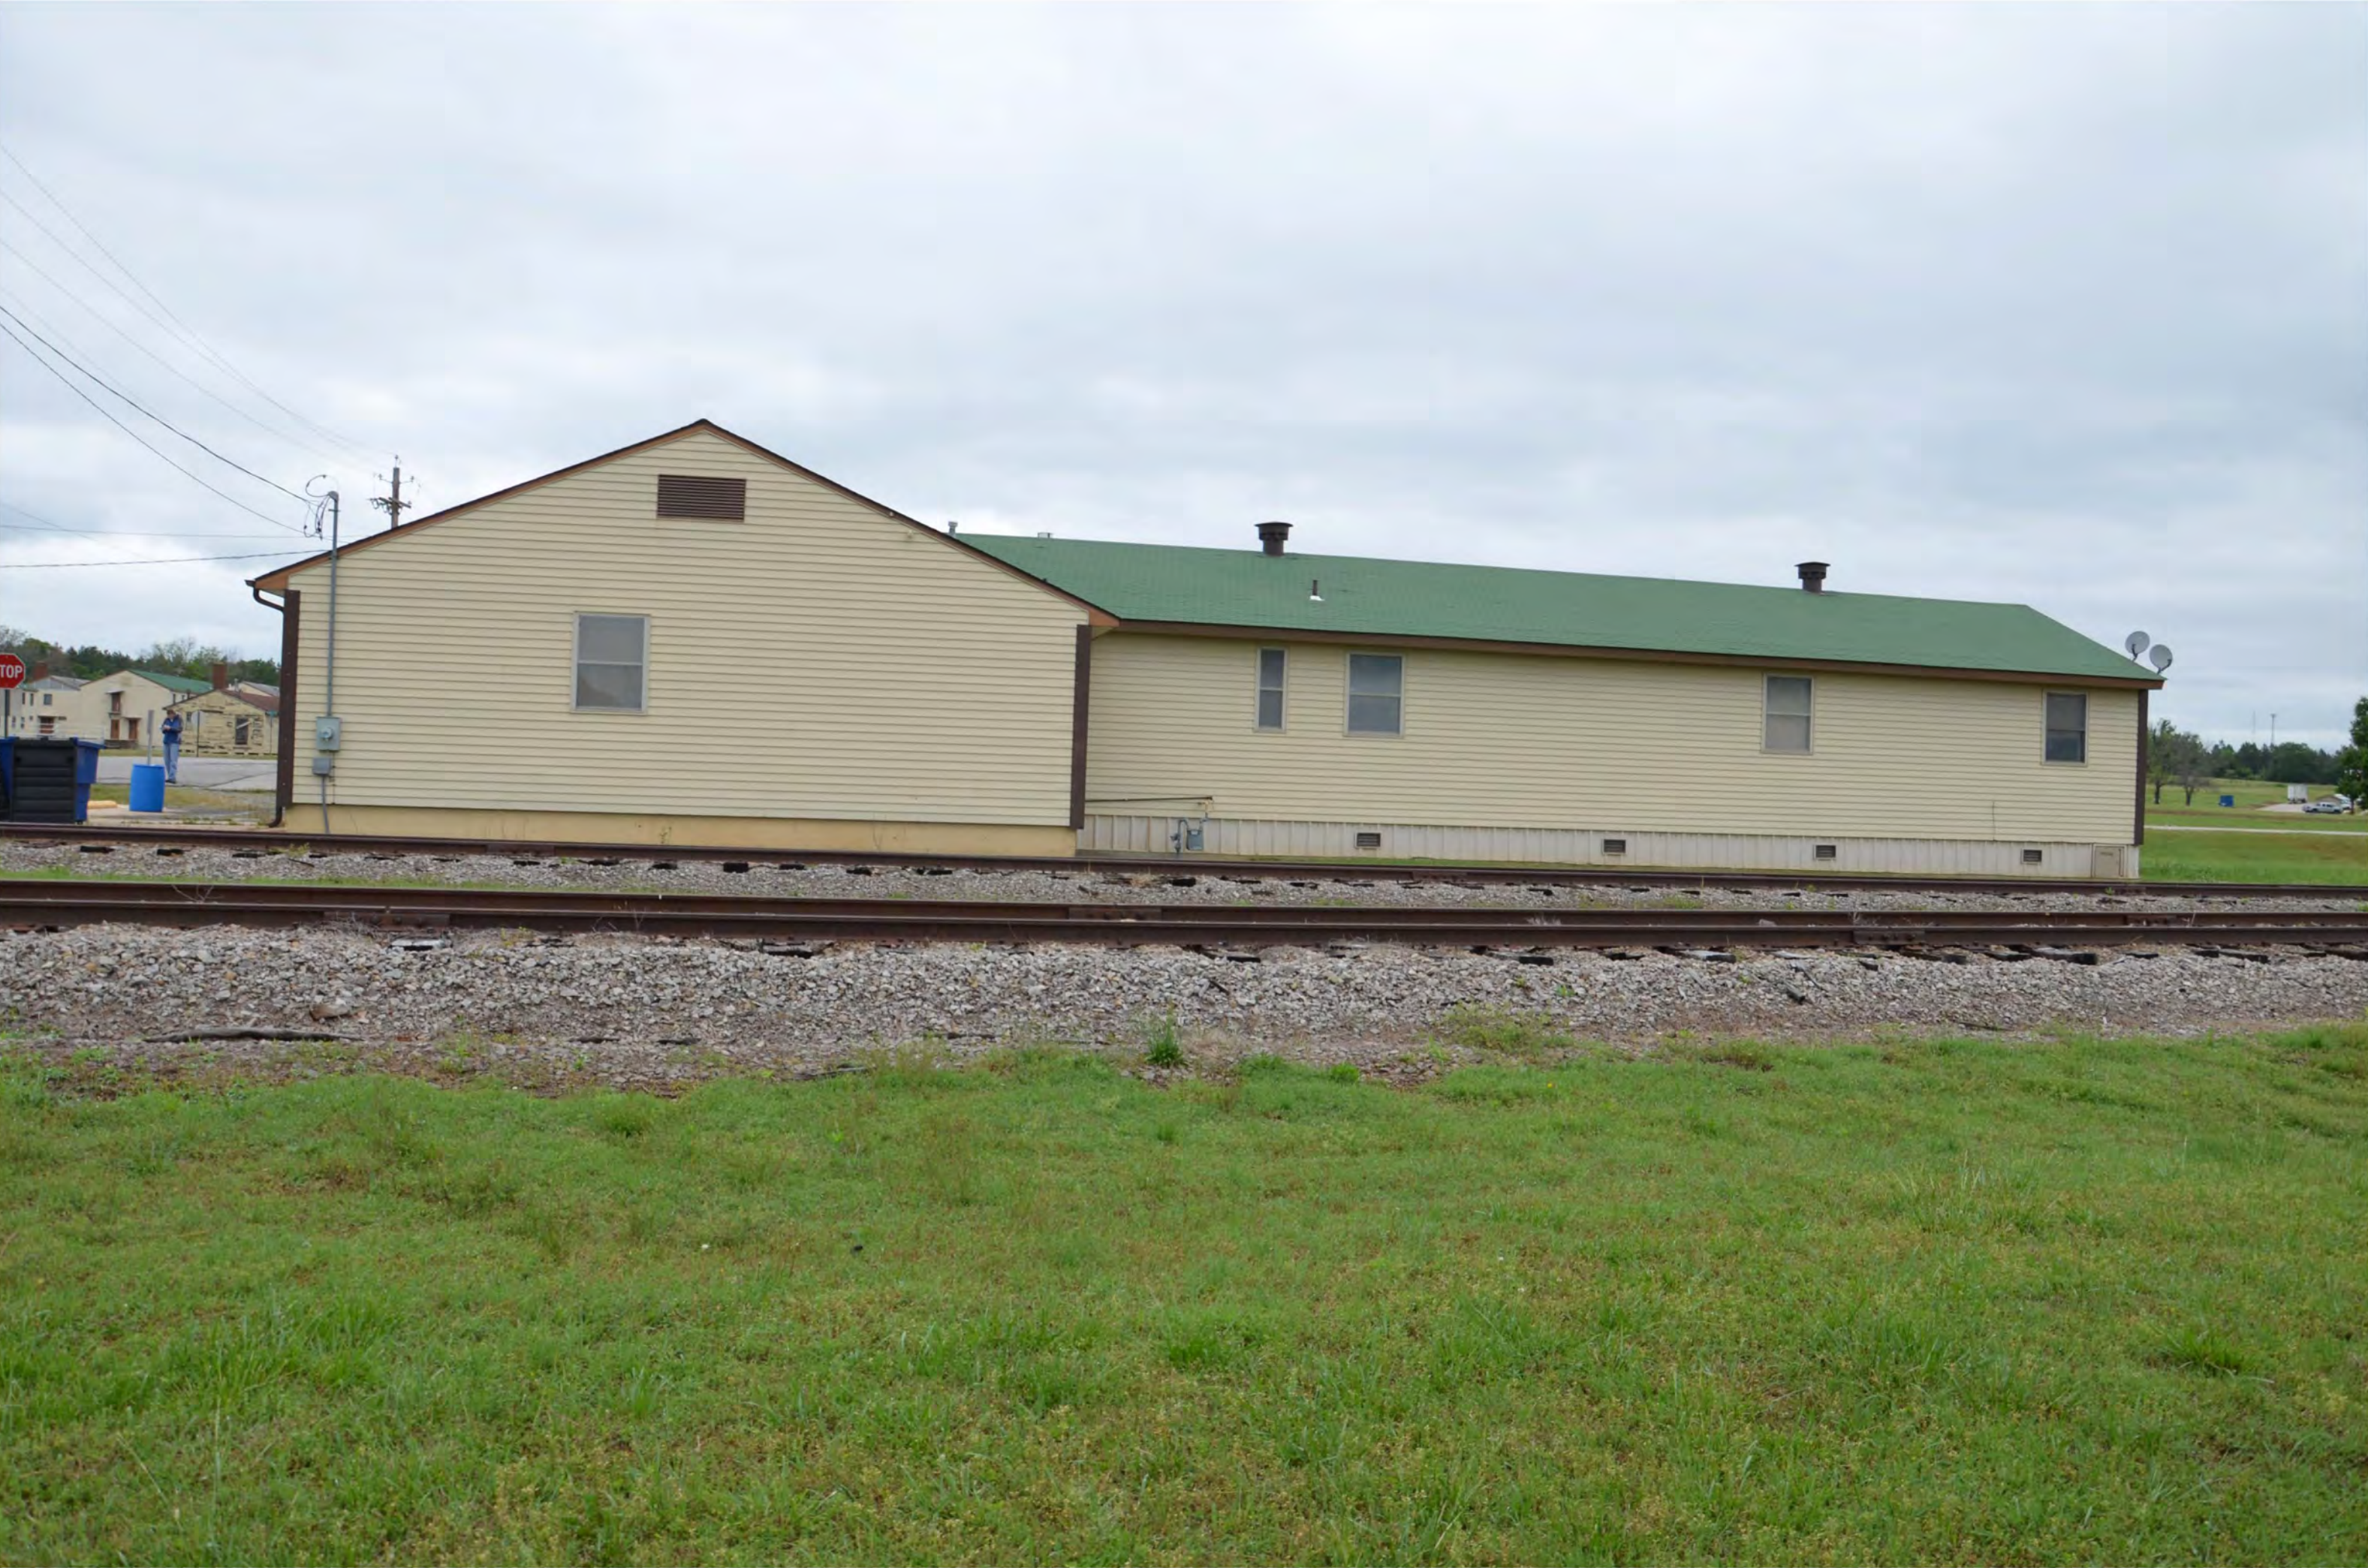
The building is a long, single-story structure with a green roof and yellow horizontal siding. It features a gabled section on the left side with a brown roofline. The main body of the building is rectangular with a long, low profile. There are several windows: one in the gabled section and four along the side of the main section. Two chimneys are visible on the roof. The building is situated behind a set of railroad tracks with gravel ballast. In the background, there are other buildings, a stop sign, and a utility pole under a cloudy sky.

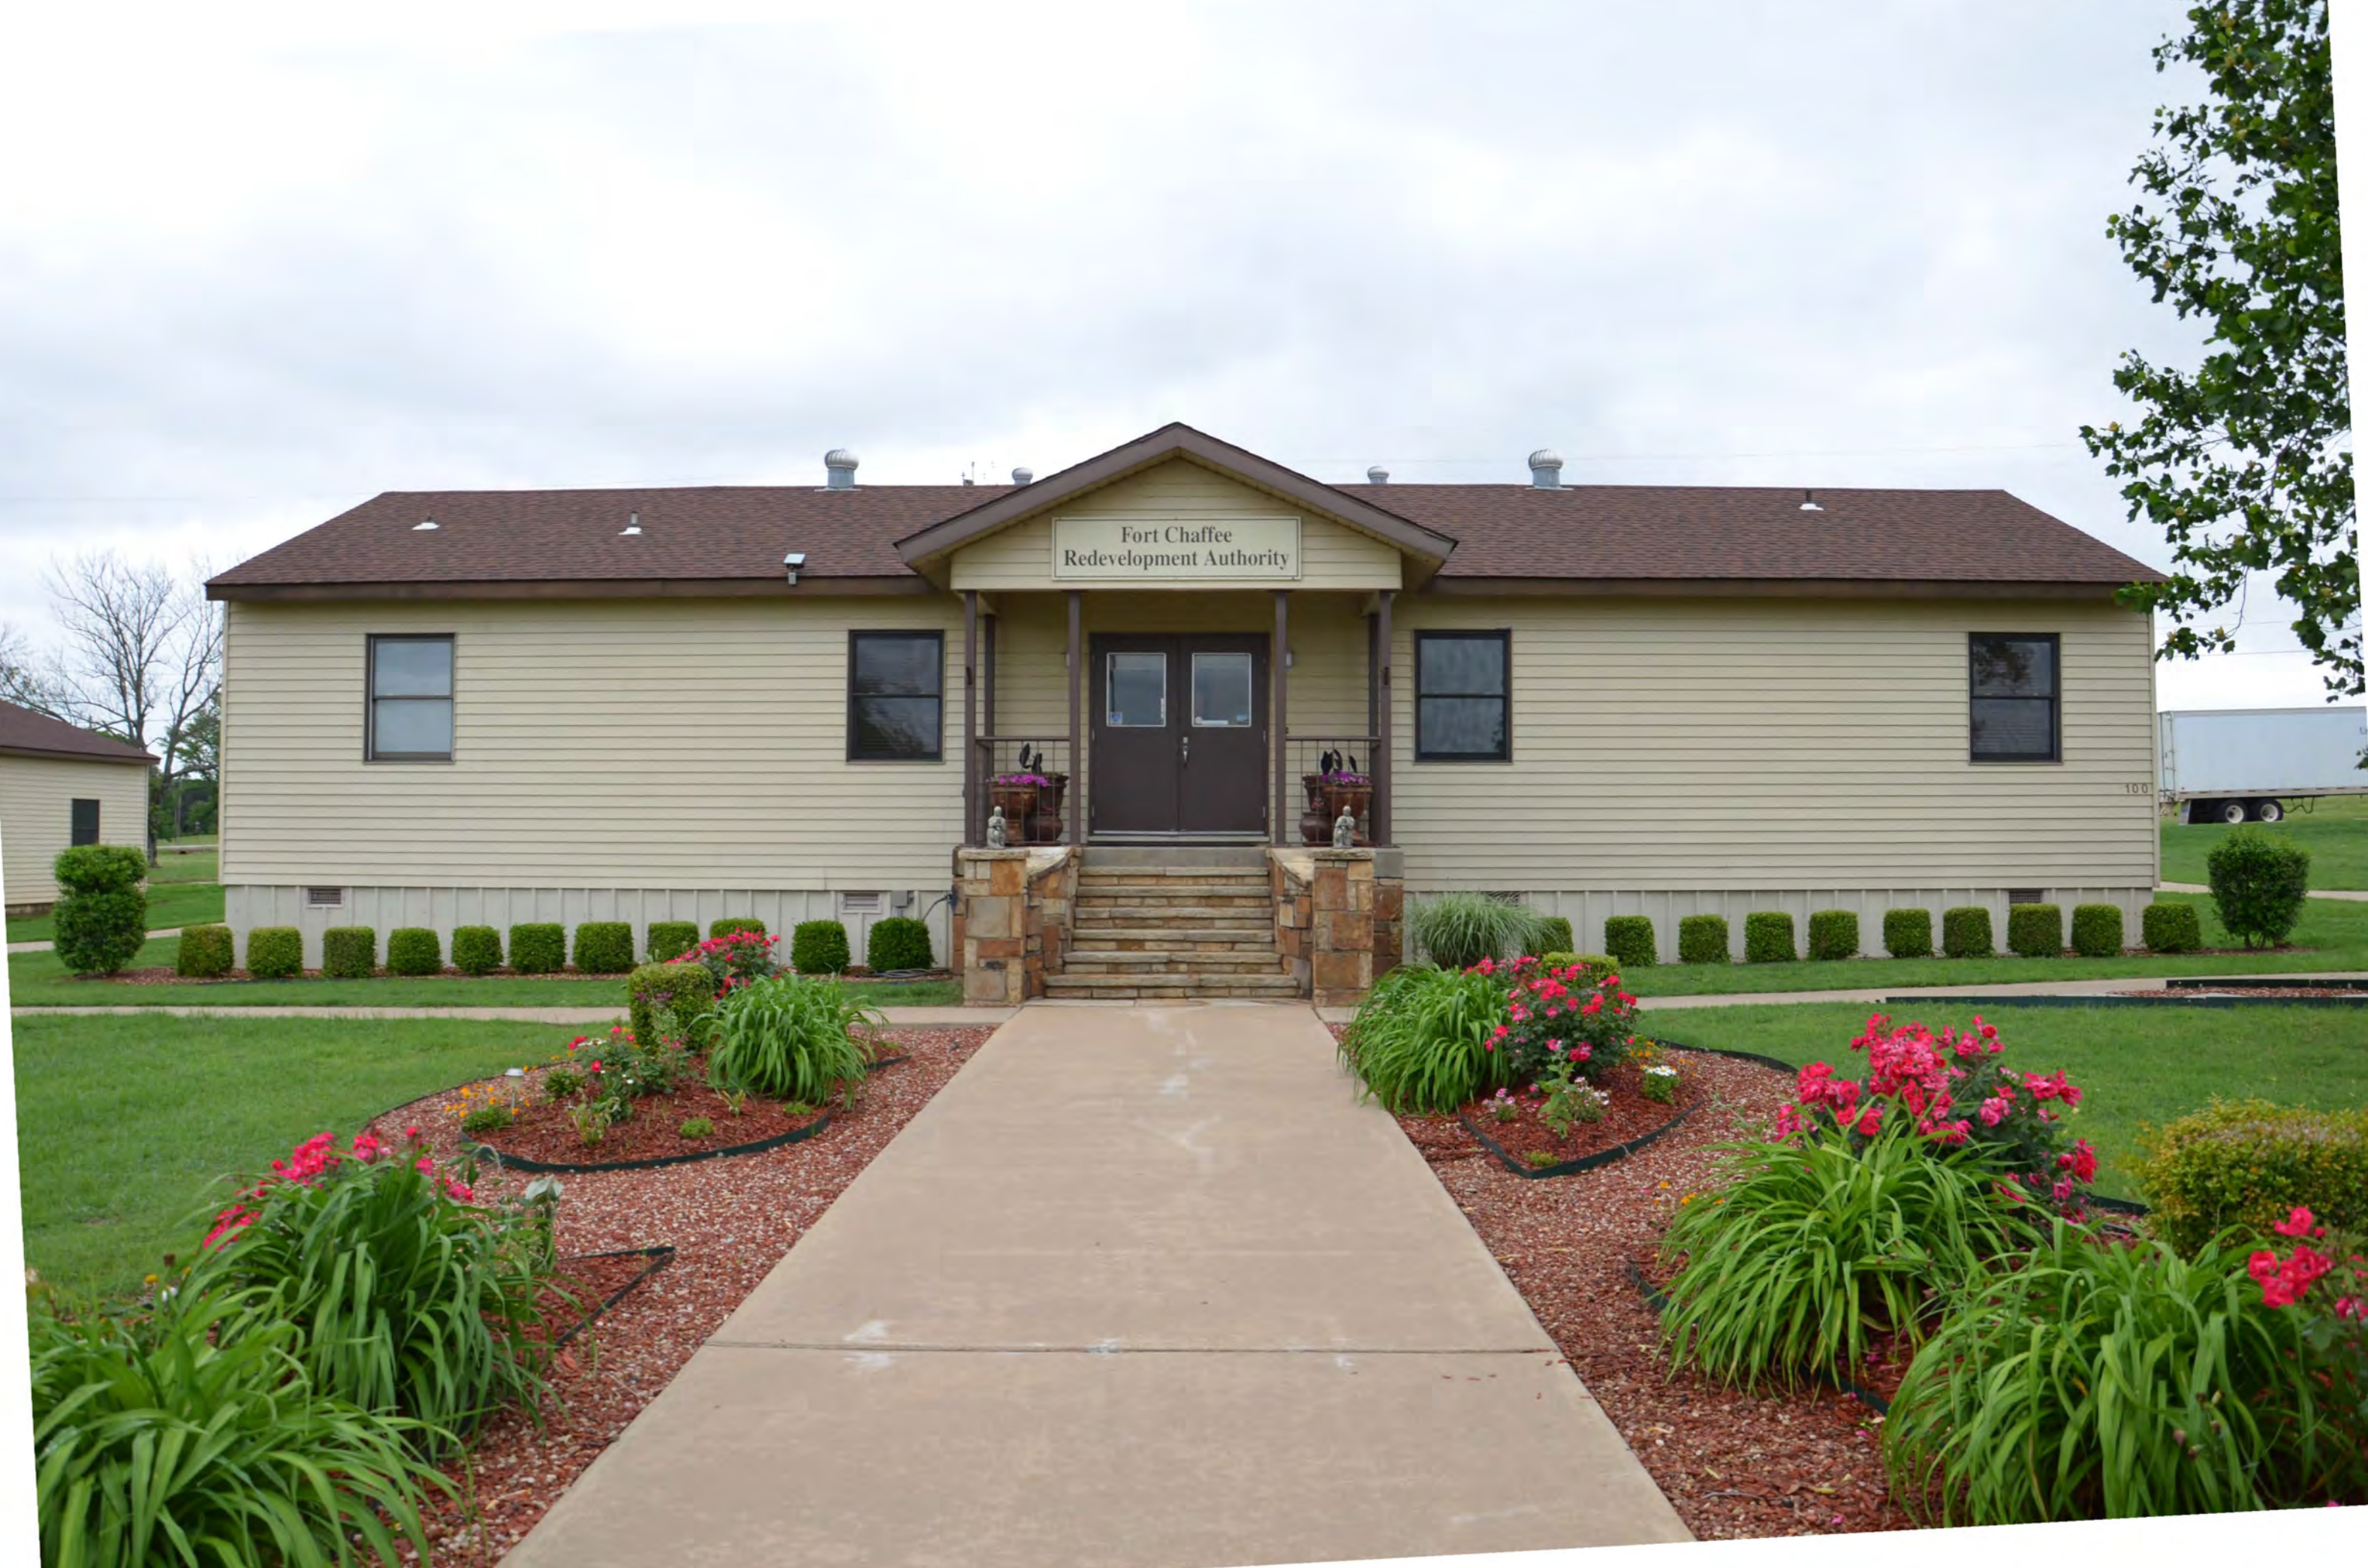
100

Building #100 is similar to other buildings on the camp and is set on piers, with the exception of the heating room. Overall, the building is covered by intersecting gable roofs, though while it was two building parallel to each other they were each covered by a gable roof. The original A-18 type building is two-story, while the original A-6 and connection are one-story. The front elevation is symmetrical with a set of central steel, double-door accessed by a set of stone steps and porch, covered by a gable roof. Located on either side of the central entranceway, are two, one-over-one, double-hung windows. One window is located near the entrance, while the second window on each side of the entrance is located out toward each of the corners. The south elevation is broken into three flush bays designated by the two original buildings and later connection. The eastern bay contains a single, one-over-one, double-hung window, which is offset to the right of center. Offset to the left of center is a single, steel-door that provides access into the original heating room. Located within the gable is a small, square, louvered vent to provided ventilation in to the attic space. The middle bays consists of two, small, one-over-one, double-hung windows, and a single steel doorways accessed by a large set of concrete steps and porch covered by a cantilevered awning, moving right to left across the bay. The third bay consists of two-stories, the first floor contains a small, one-over-one, double-hung window along the right side of the bay, while a single steel door provides access to the heating room on the left side of the bay and is located at ground level. The second story contains two, one-over-one, double-hung windows equally spaced in the bay with a square louvered vent located within the gable. The west elevation, like the third bay of the south elevation is two-stories. Working from right to left there is no ornamentation for a long about one-third of the first floor. Following the unornamented section of wall, there is a set of steel double-door accessed by a small concrete wheelchair ramp and porch, covered by a small cantilevered awning. Between this set of doors and the opposite corner, there are three, one-over-one, double-hung windows, equally spaced across the rest of the elevation. The second story consists of three, equally spaced, one-over-one, double-hung windows. The central window and the left windows each correspond with windows below. The north elevation also consists of three bays with the middle bay being recessed. The northwest bay contains no ornamentation except for a second story doorway located in the upper left corner of the bay. It was accessed by a zig-zag staircase with concrete steps near the bottom. The inner western wall, also two-stories, contains three, evenly spaced, one-over-one, double-hung windows. The second story consists of three centrally located, evenly spaced, one-over-

Building #102 is located along Taylor Avenue, or the former Headquarters Drive. The building, was originally buildings, and originally a type A-18 building and a type A-6 building, Station Head Quarters Building and Administration Building, through the base closure.¹¹ The type A-18 building was the only one of these type of building constructed at Camp Chaffee during the original 1942 construction contract. Though there were seven type A-6 building constructed on the camp. The A-18 type building was built for \$9,381, while the A-6 building was built for approximately \$6,020.¹² The building is contributing because the two buildings were connected during the period of significance, in order to expand the Station Headquarter building. The building is currently occupied by the Fort Chaffee Redevelopment Authority.
