# National Register of Historic Places Registration Form

historic name Arivaca Schoolhouse  
other names/site number AZ DD:7:40 (ASM)

street & number 17180 West Fourth Street  not for publication  
city or town Arivaca  vicinity  
state Arizona code AZ county Pima code 019 zip code 85601

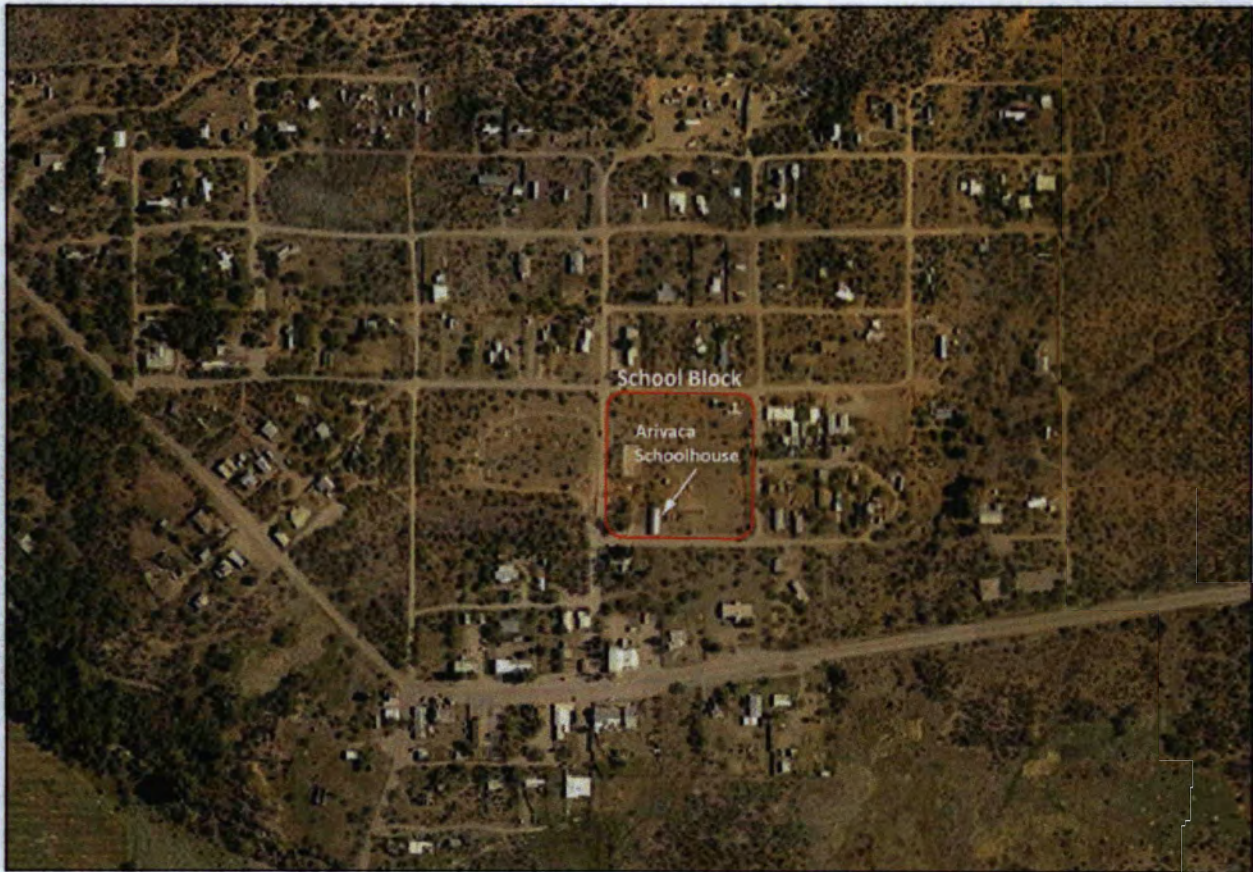
Figure 4. Aerial photograph of Arivaca, 2010, showing the location of the Arivaca Schoolhouse (courtesy Pima County MapGuide, <http://dot.pima.gov/gis/maps/mapguide>).

In 1914, the townsite of Arivaca was surveyed at the behest of the Arivaca Land and Cattle Company, and its plat was filed with the Pima County Recorder (see Figure 4). The fate of the one-mile-square (640-acre) parcel surveyed for the Village of Arivaca in 1878 is unclear, but the new townsite occupied a much smaller area, just 122 acres. The filing of the townsite plat was followed by the sale of all lots in the townsite to private parties, with the exception of two parcels: the parcel where the schoolhouse still stands, also known as Block 15, and the parcel occupied by the town cemetery, also known as Block 16, immediately west of the schoolhouse grounds. Both blocks remain vested in the probate judge of the Pima County Superior Court as unsold portions of the townsite.

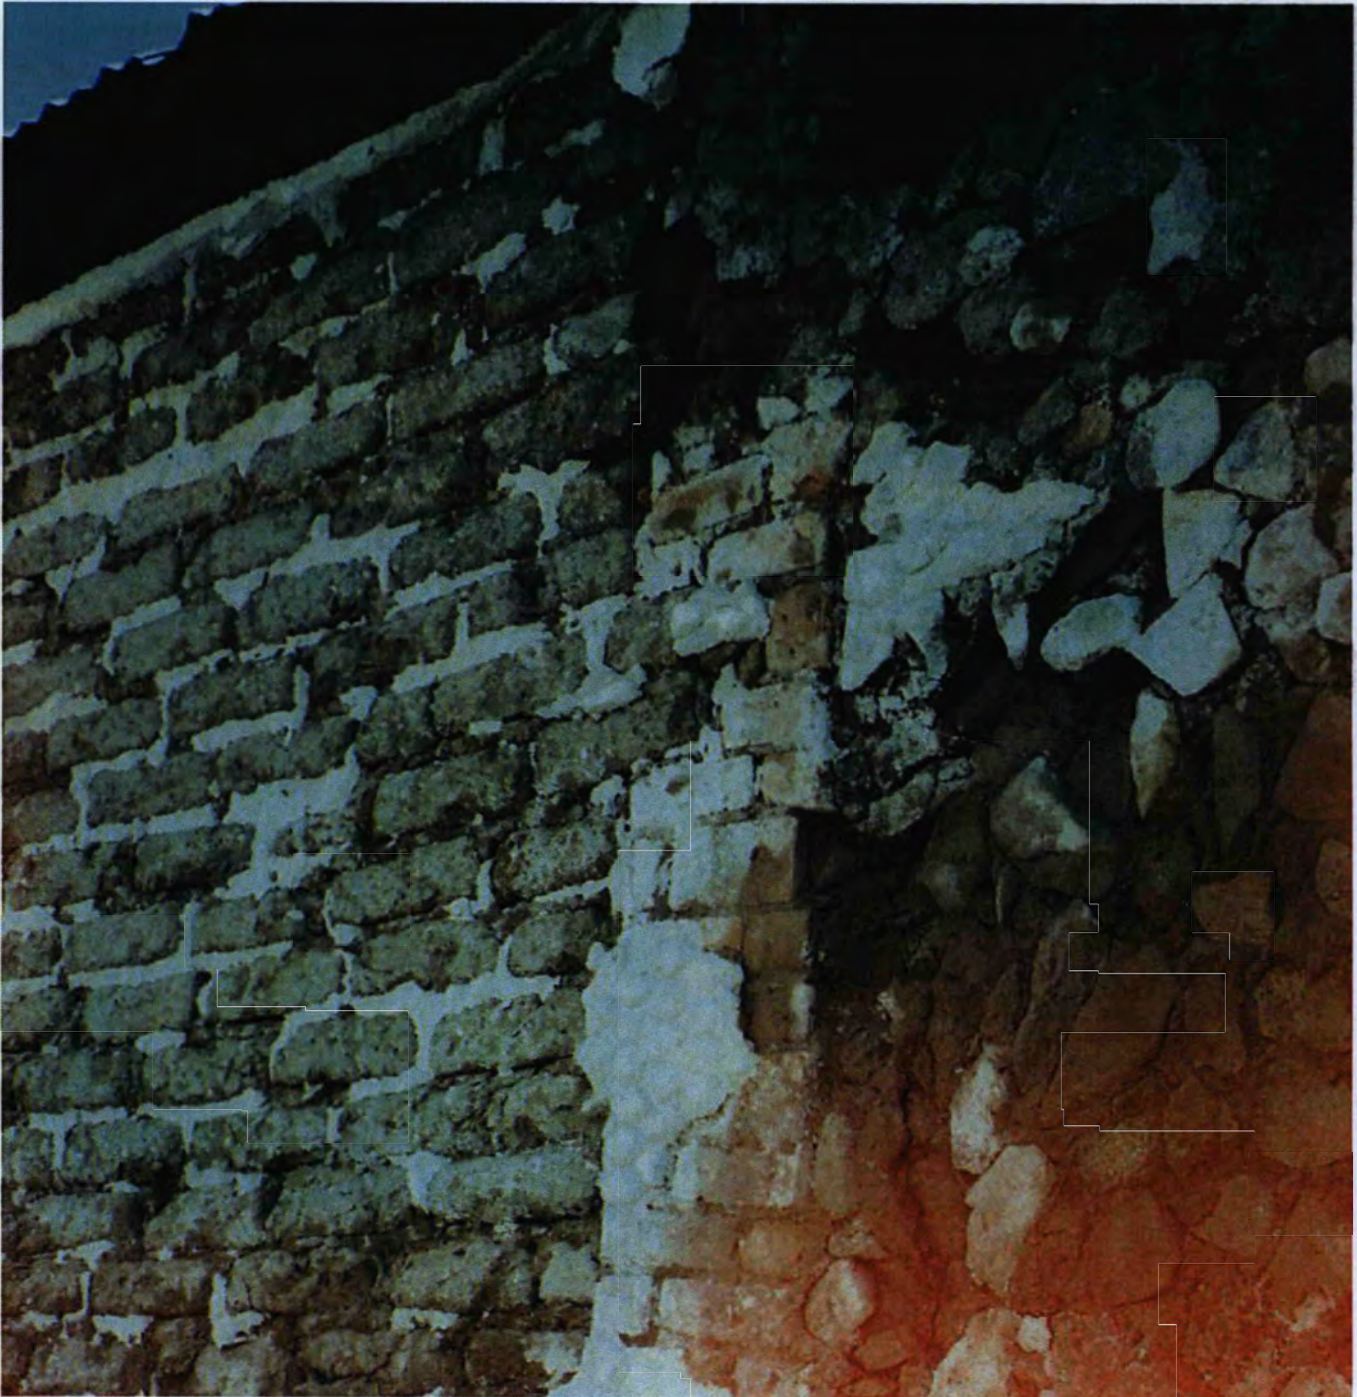
Figure 7. View of the joint exposed along the exterior west wall of the schoolhouse during the 1994 rehabilitation work (courtesy Mary Kasulaitis, Arivaca).

When the exterior stucco was removed in 1994, the joint on the west wall of the schoolhouse was marked by a roughly defined column of what seemed to be fired (distinctly orange) adobe bricks, of the same size as the bricks in the rest of the building (Figure 7). This vertical line of fired bricks was clearly a part of the south half of the building and adjacent to a large area of wall immediately to the south that had been roughly patched with stones and mud mortar. North of the column of fired bricks, the adobe wall was better preserved and entirely without patching. This strongly suggests that the south half of the current building corresponds to the original building, which at some point may have suffered fire damage to its northwest corner. An addition was later made to its north end, tying the adobe bricks of the original part of the building into the construction of the new extension of the wall. The north wall of the original building was apparently removed, given that no trace of it survived in the interior of the expanded building.

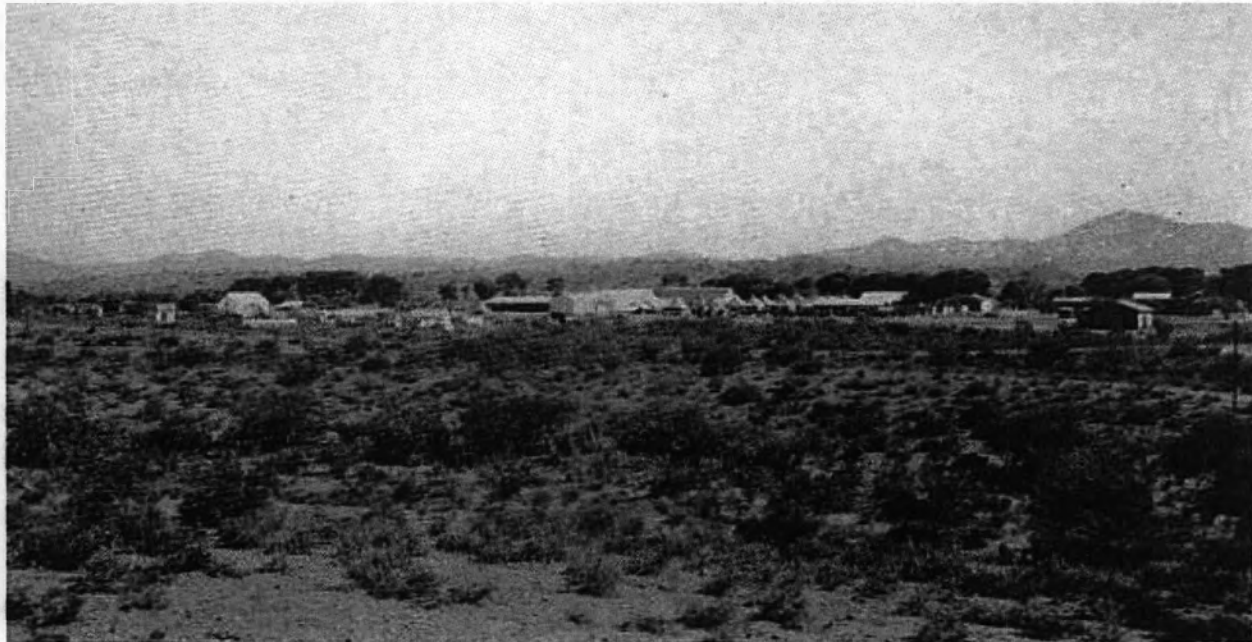
Figure 8. Photograph of Arivaca taken in 1916 by a member of the Connecticut National Guard, view to the northwest from a point southeast of town (from Howard 1921).

The precise year the addition was made is uncertain, but it probably happened in the period 1916–1927. The earliest known photograph that shows the schoolhouse was taken in 1916 by a member of the Connecticut National Guard when his company was spending a month in Arivaca on border duty during the Mexican Revolution (Figure 8).<sup>1</sup> The photograph was taken at some distance to the southeast of town, which makes it difficult to be certain about the identity of individual buildings, but a white building at the left side of the photograph is probably the schoolhouse. If so, it was definitely smaller than it is today, suggesting that the addition had yet to occur. The next known photograph of the schoolhouse, taken in 1919 (Figure 9), shows the lower portion of the south wall of the school, which looks much like the south wall still in place today, and with obvious signs of considerable age. If the addition had already been made when the 1919 photograph was taken, it was evidently made to the north end of the building. The next known photograph of the schoolhouse is from 1927 (Figure 10). Taken with the camera facing northeast, it clearly shows the expanded schoolhouse with the same footprint and basic appearance that it has today. This means that the addition must have been made between 1916 and 1927, though we have no other direct evidence for this inference. Based on research with Pima County school records, census records, private letters, newspaper clippings, and personal interviews (Table 1), we do know that in 1925 two teachers were working at the school instead of the single teacher of previous years. This may indicate that a second classroom, created by the addition to the original schoolhouse, was in use by then.

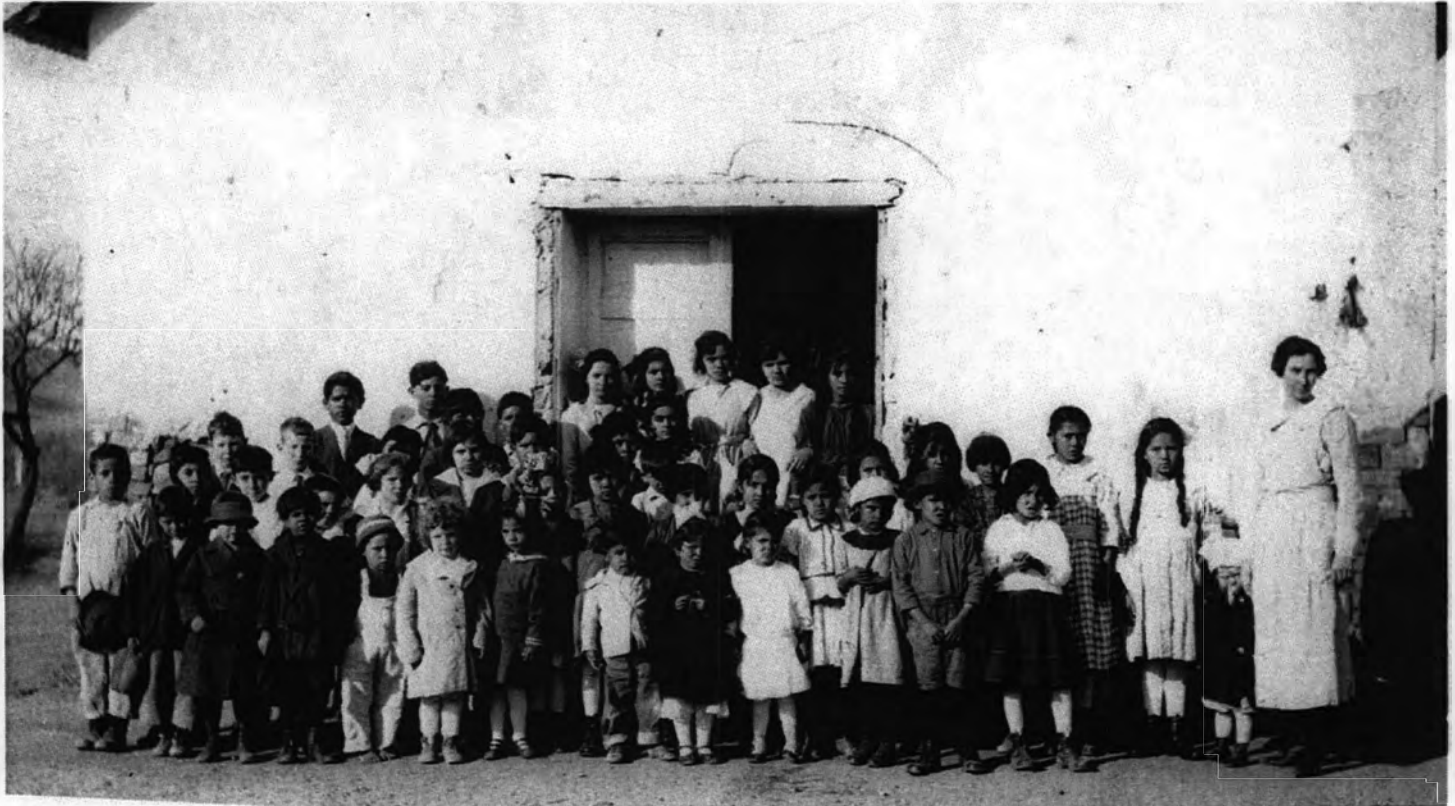
Figure 9. Photograph of the Arivaca Schoolhouse in 1919, with teacher and students at the front (south) entrance (Arizona Historical Society, Places–Arivaca–Photographs, No. 44040).

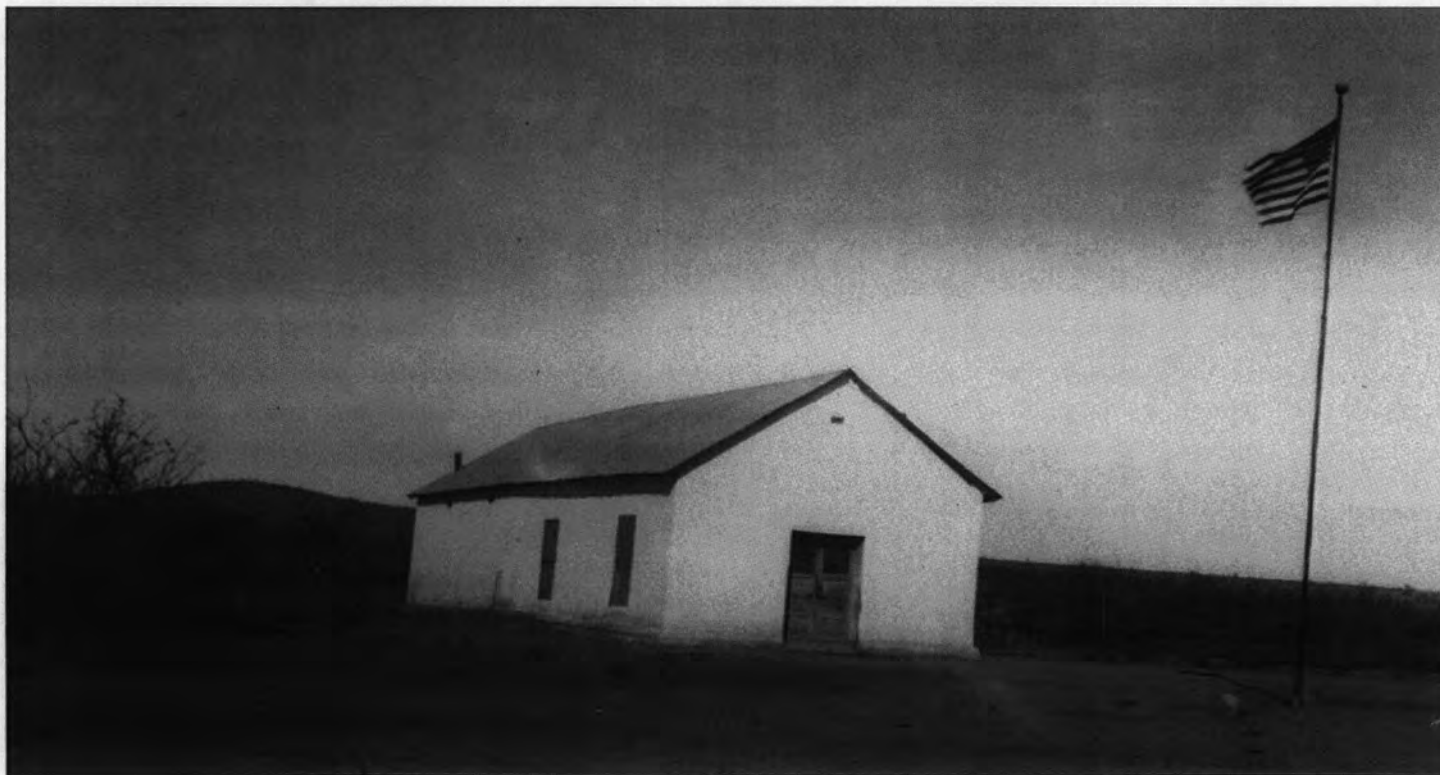
Figure 10. Photograph of the Arivaca Schoolhouse in 1927, view to the north-northeast  
(University of Arizona Library, Special Collections, Southwest Photographs, Arivaca, Arizona, folder 1).

The 1927 photograph is also of interest for other details. In terms of setting, the area to the north and east of the schoolhouse was completely lacking in buildings or other features, which emphasizes the location of the schoolhouse at the very edge of tiny Arivaca, despite the central place it was given in the 1914 townsite plat. In terms of the schoolhouse's construction history, the photograph confirms (as does the 1919 photograph) the early use of a corrugated metal roof and the presence of a double-door at the front entrance. It also shows that a school bell was not yet in place on the south gable. The lower roof edge along the west wall of the schoolhouse in this photograph also seems to confirm that the north half of the building was only recently built: the south half of the roof edge is slightly irregular and apparently weathered, which would not be surprising for a roof that had been in place for at least part of the schoolhouse's 48 years. By contrast, the roof edge on the north half of the building is perfectly straight, as if newly installed.

Also of note in the 1927 photograph are the two windows on the south half of the west wall of the schoolhouse: they clearly occupied the same openings as the two windows on the same wall today, but the 1927 windows were taller than the current windows, and the sills of the openings were closer to grade. This means that the current window openings on the south half of the west wall (and presumably their counterparts on the south half of the east wall) are shortened versions of the originals, their lower portions having been filled, probably with adobe bricks, to raise the sill and allow the use of smaller windows. Interestingly, the height of the sills in the 1927 photograph was probably about the same as the height of the sills in the north half of the east wall of the current building.

In the 1927 photograph, the windows in the west wall appear to be covered by wooden shutters, so it is impossible to say if the windows were of the same double-hung style as the current windows in the same (now smaller) openings. But two photographs from just a few years later indicate that they were in fact double-hung wooden windows. A photograph from 1929 (UAL-SC, Southwest Photographs, Arivaca, Arizona, folder 1; not reproduced here) shows teachers and a group of students standing in front of what must be the south half of the west wall of the building. A wooden double-hung window, probably with six-over-six lights, is partially visible to one side of the group. Another photograph from 1946, kept by Mary Kasulaitis (and also not reproduced here), shows a group of adults (one dressed as Santa Claus) and children standing in front of

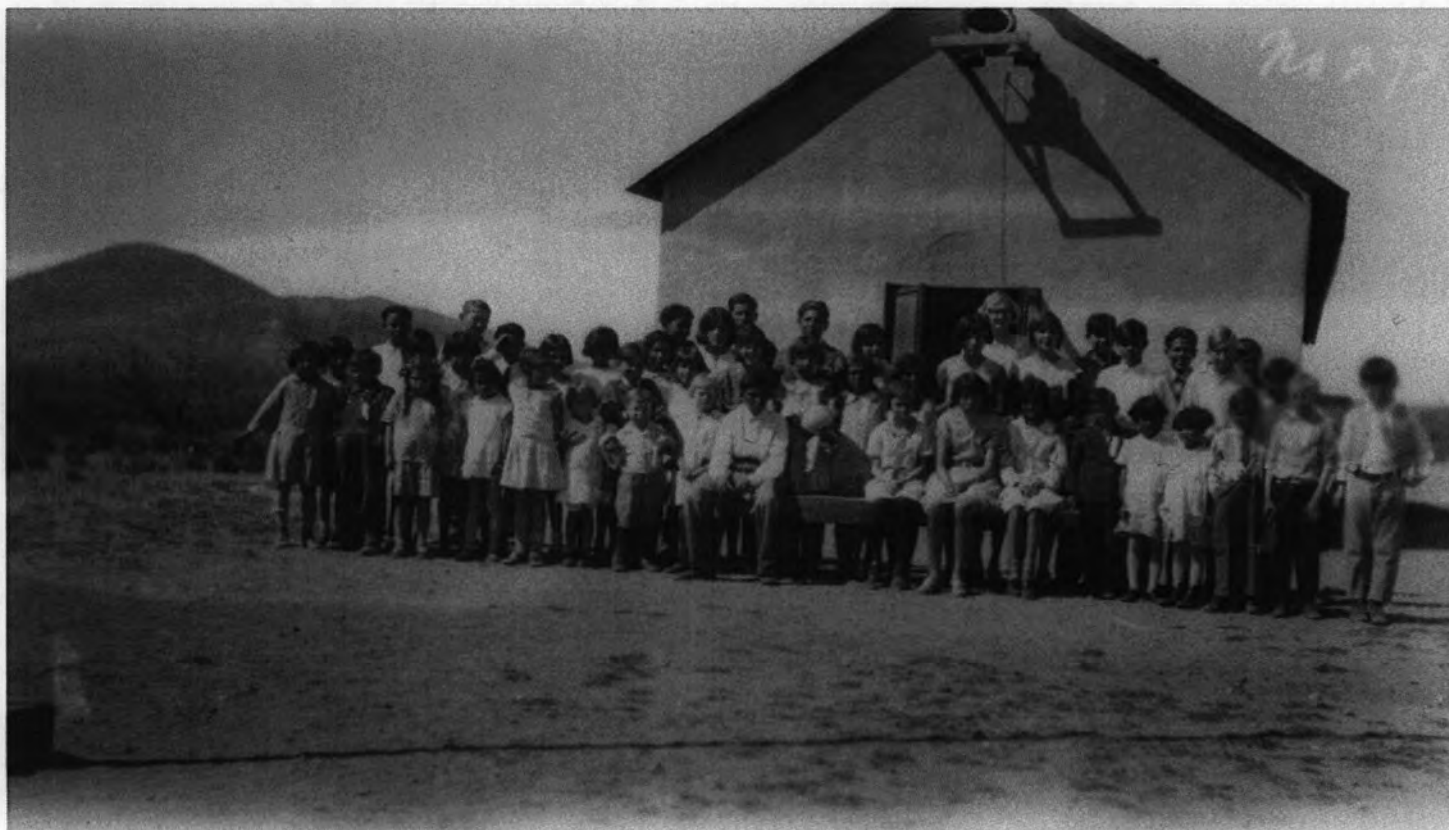
Figure 11. Photograph of the Arivaca Schoolhouse in 1930, with teacher and students at the front (south) entrance (University of Arizona Library, Special Collections, Southwest Photographs, Arivaca, Arizona, folder 1).

Other early photographs show other minor changes to the schoolhouse over the years, as well as certain continuities. A photograph from 1930 (Figure 11) shows a teacher and her students at the front of the school, with the double-door entrance and corrugated metal roof easily discerned and, for the first time, a bell mounted in the gable, probably the same bell and basically the same mounting bracket as today. A photograph from the 1940s (Figure 12) shows the front of the school and a small part of the west wall, along with a small wood-frame building in the schoolyard just to the east. According to oral-historical work by Mary Kasulaitis, the small wood-frame building (which looks a bit like a miniature schoolhouse of the same proportions as the schoolhouse proper) was a student building project and was used primarily for storage. It was later removed from the schoolyard and still stands today, though in poor condition, on a private parcel elsewhere in Arivaca. A local tradition says that this small building was originally a house for the teacher, but that was probably not the case. The 1940s photograph also shows a single-door front entrance on the schoolhouse rather than the double-door entrances of earlier photographs, and the bell is still mounted in the gable. The one window visible on the west wall of the schoolhouse still has the lower sill of earlier photographs.

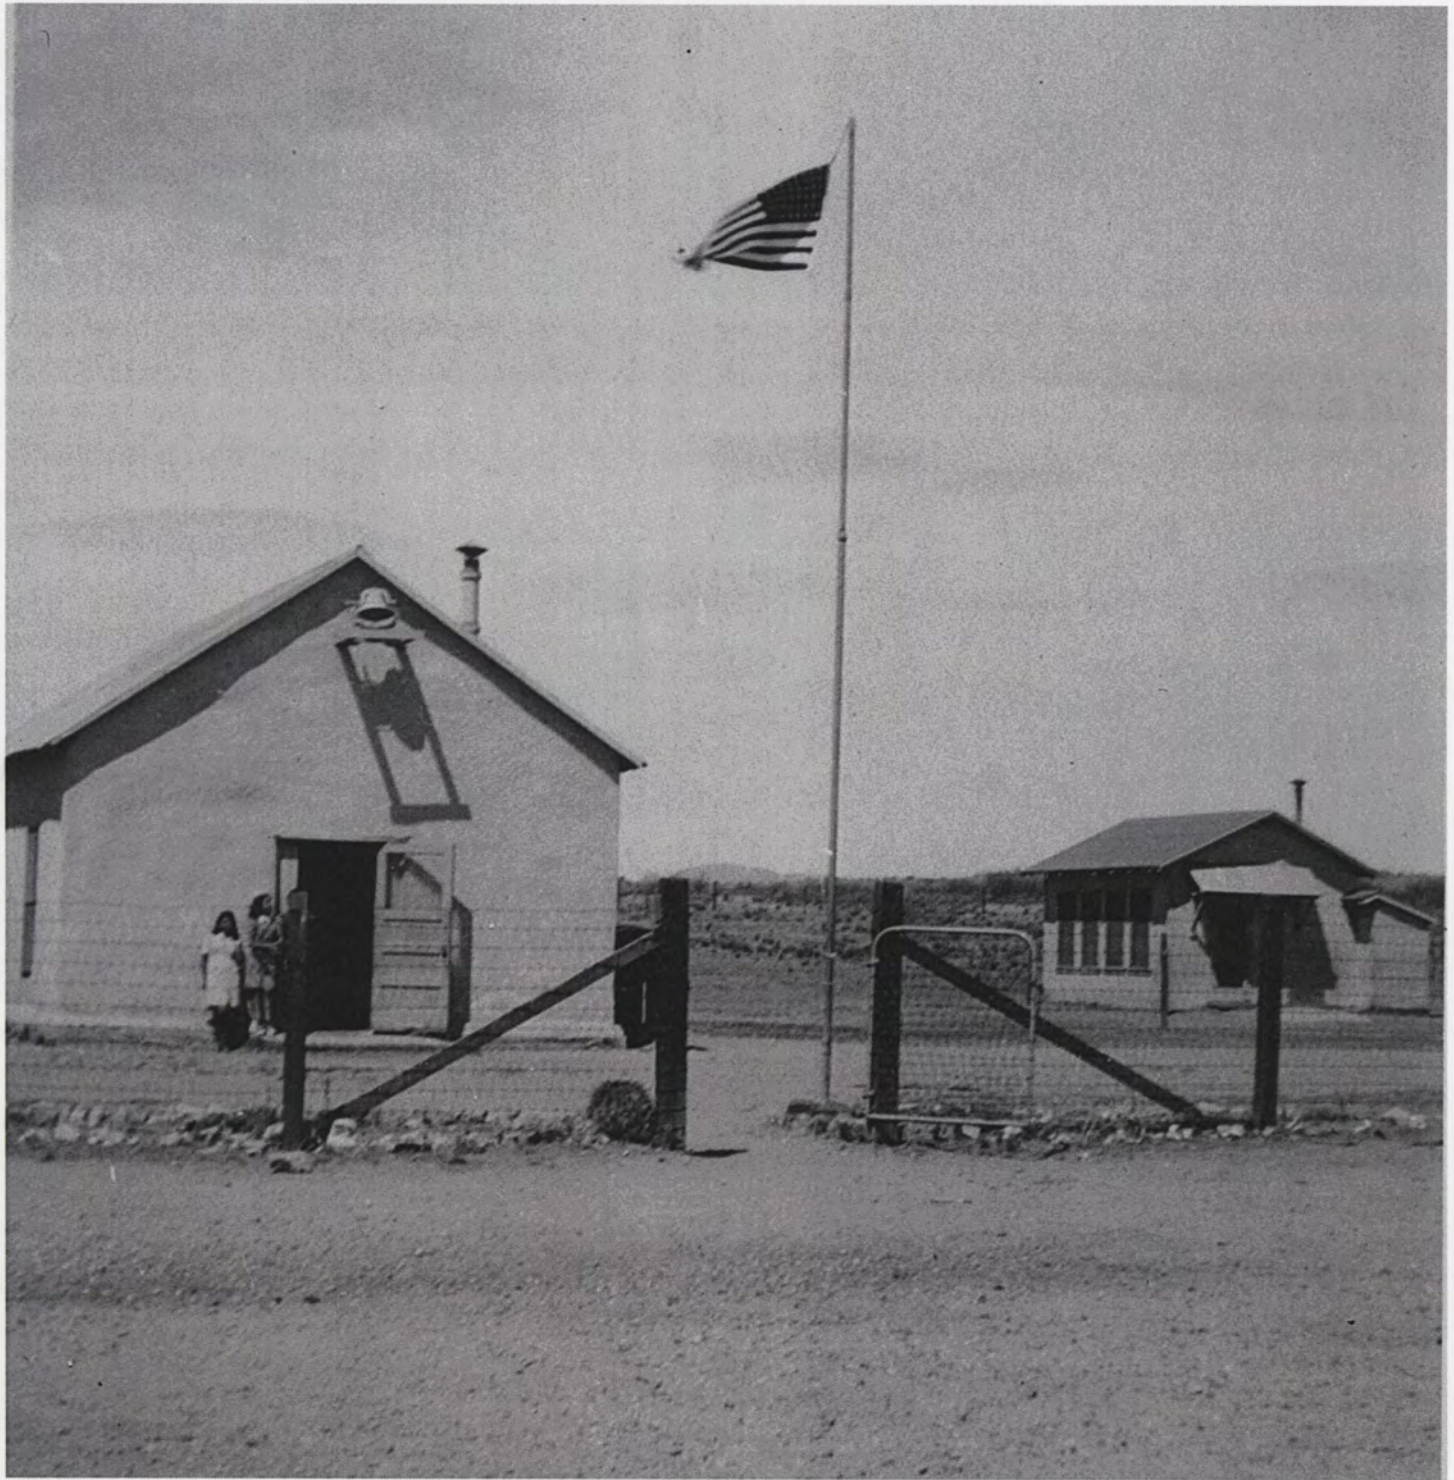
Figure 12. Photograph of the Arivaca Schoolhouse in the 1940s, view to the north-northeast (courtesy Mary Kasulaitis, Arivaca).

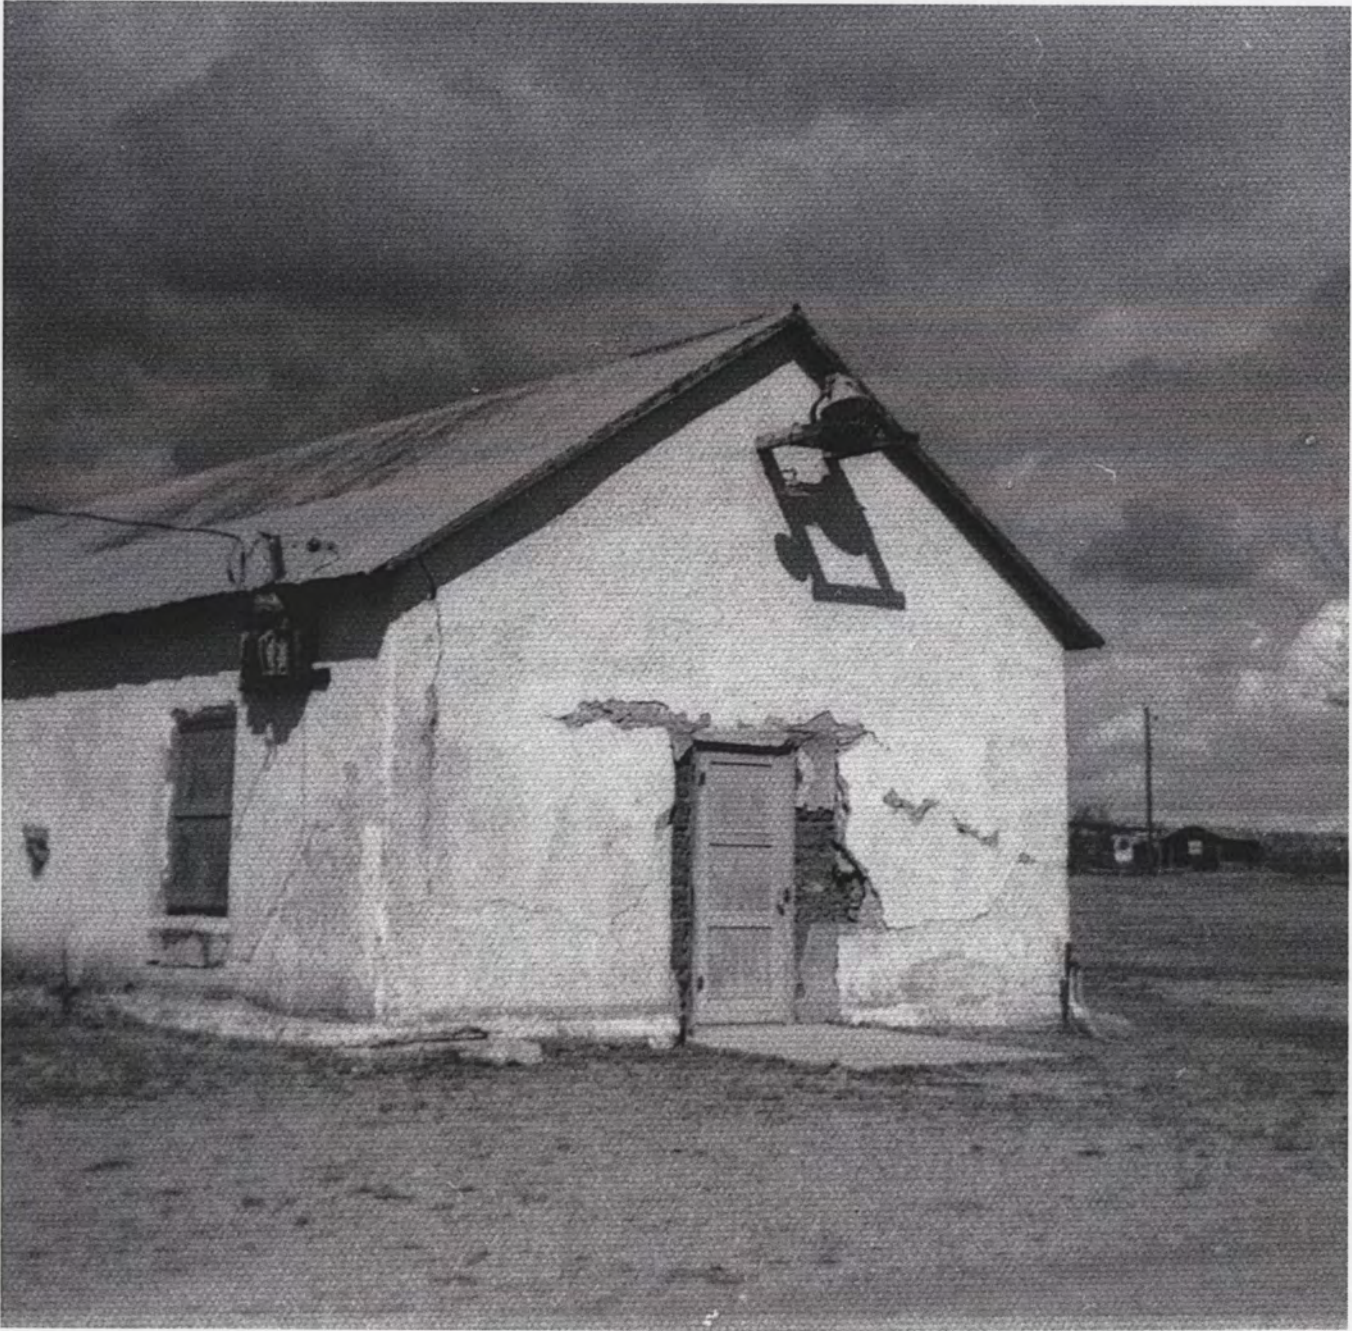
Figure 13. Photograph of the Arivaca Schoolhouse in 1973, view to the northeast  
(courtesy Mary Kasulaitis, Arivaca).

Two photographs from the 1970s—one from 1970 (AHS, Places–Arivaca–Photographs–No. 56881; not reproduced here) and one from 1973 (Figure 13)—also show the south entrance of the schoolhouse. The 1973 photograph includes a small part of the west wall. The school was in a badly deteriorated condition by 1970, with large cracks and areas of exposed adobe, especially around the entrance, and the 1973 photograph shows that conditions had not improved. As in the 1940s photograph, the 1970 and 1973 photos show a single door on the schoolhouse entrance, but it is hinged on the left side rather than the right, and where the 1940s door was clearly mounted in a wooden frame that had been built in the unmodified original opening, the 1970–1973 door is mounted in an opening made smaller by the addition of adobe bricks, which were clearly exposed in an area where stucco had fallen away. In the 1973 photograph it is also clear that the sill of the window opening in the west wall had by then been raised to the height it currently has (the window is covered by a wooden shutter in the photograph). The schoolhouse in both the 1970 and 1973 photographs lacks the small extensions of the south wall at the southwest and southeast corners that the schoolhouse has today.

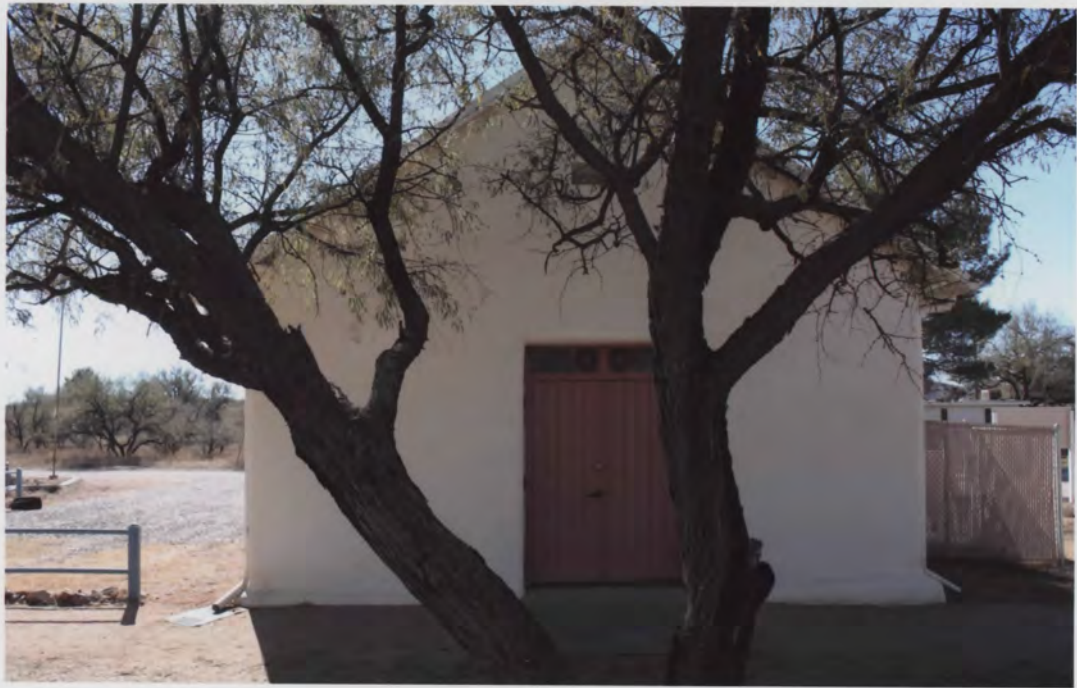
AZ-Pima County- Arivaca Schoolhouse- 0004

Photo 4 of 7 (AZ\_Pima County\_Arivaca Schoolhouse\_0004)  
North exterior wall, view to the south.  
December 1, 2010
