Iowa Site Inventory

1. Site Name Bedford Public Library
2. Village/Town/City Bedford Township _____ County Taylor
3. Street Address Jefferson Street
4. Legal Location _____

9. Date of Construction 1916-17 Architect Wetherell and Gage, Des Moines
10. Building Type:

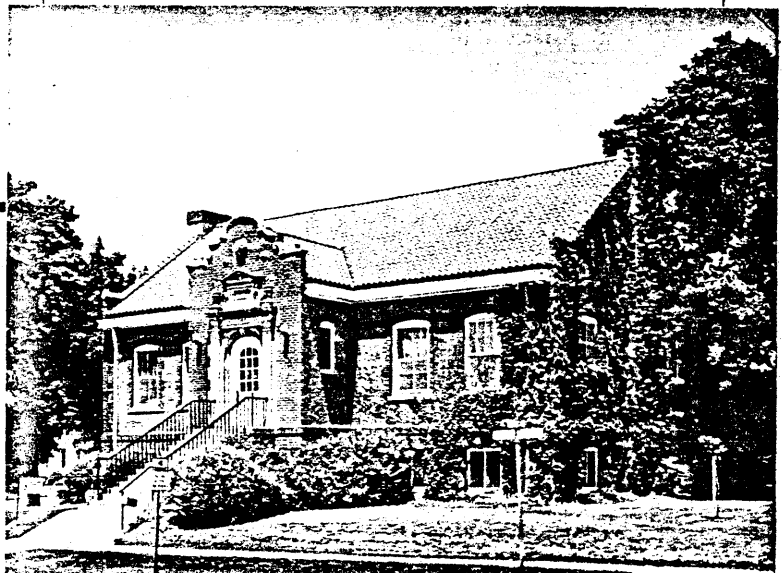
Roll 82 Frame 3 View S & E elevations

13. Condition: excellent good fair deteriorated
14. Integrity: original site moved—if so, when? _____
 Notes on alterations, additions (with dates and architect, if known) and any other notable features of building and site:
The building is extremely well preserved.

The Bedford Public Library is a highly competent example of the side-gable end type of small library building. It is rectangular in plan, with a projecting entrance vestibule in the center of the long side. In style, it is one of a small group of libraries which blend the Northern Renaissance and the Georgian (see Osceola). Architectural detailing is concentrated on the elaborate frame of the door, which features a pedimented inscription panel, flanked by urns, piled on top of the cornice. The plan conforms to Type II, in which the library is one single space, partitioned only by high bookshelves. There is a small stack area in the rear center, behind the delivery desk. The interior of the Bedford Library features two fireplaces once centered against each end wall.
