# National Register of Historic Places Registration Form

Historic name North Rhode Island Street Historic Residential District  
Other name/site number n/a

Multiple Property Documentation Form: Historic Resources of Lawrence, Douglas County, Kansas  
North Rhode Island Street Historic Residential District  
Douglas County, KS

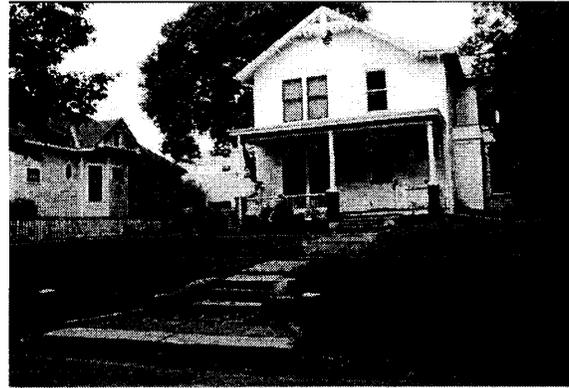
*Setting and Hitching Posts, 923 Rhode Island Street (Photo # 36)*

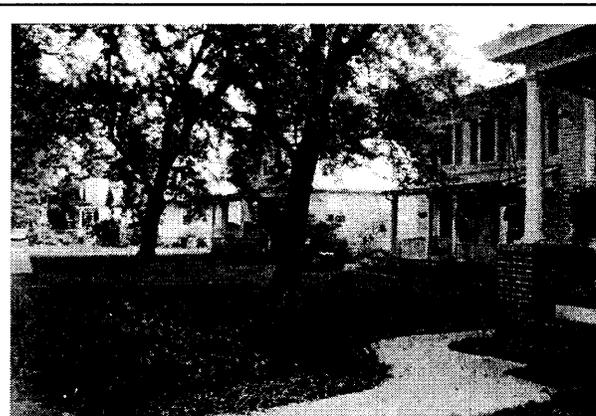
*Variations in Setbacks, Looking North from 922 Rhode Island Street (east side of 900 Block, Photo # 35)*

Rhode Island Street. Because of its proximity to the Kansas River, its early development landscape was affected by undulating ground with runoff gullies and a grade that slopes north toward the river. The effect on the landscape is evident, particularly along the alley where retaining walls were frequently constructed to help adjust yards to the downward slope of the land (Photo #s 10, 35).

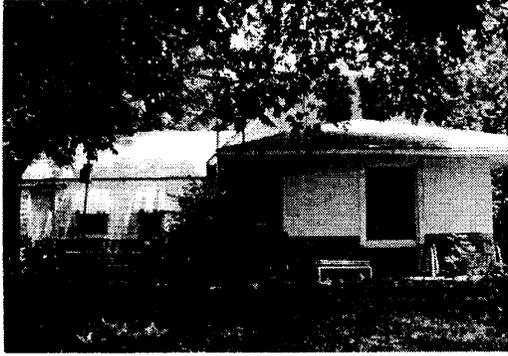
*Inappropriate Addition and Windows,  
822 Rhode Island (Photo # 80)*

Other non-historic alterations in the district include inappropriate remodeling, new additions, and/or porch replacements, such as those evident at **822 and 826 Rhode Island Street**. Vinyl siding and new windows have significantly compromised the integrity of **1000 Rhode Island Street**. Porch infill has substantially changed the look and feel of the Bungalow at **1025 Rhode Island Street** (Photo #s 80, 81, 6, 3).

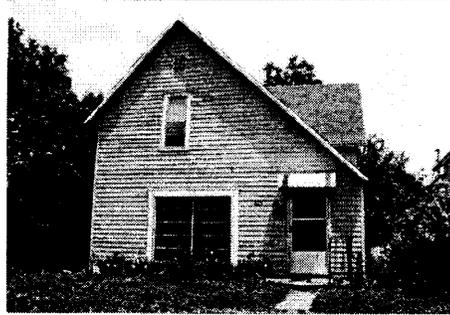
*Inappropriate Porch and  
Window Alterations,  
826 Rhode Island (Photo # 81)*

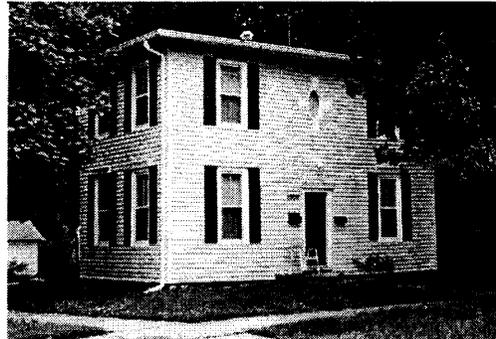
*Vinyl Siding and  
Inappropriate Window Replacement,  
1000 Rhode Island (Photo # 6)*

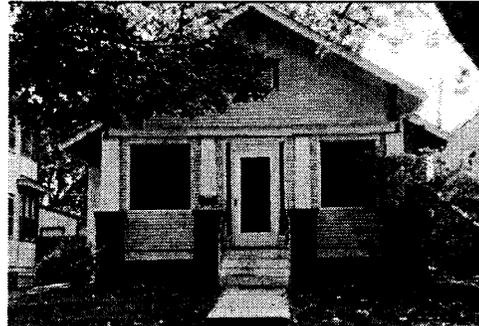
*Porch Infill,  
1025 Rhode Island Street,  
Looking West (Photo # 3)*

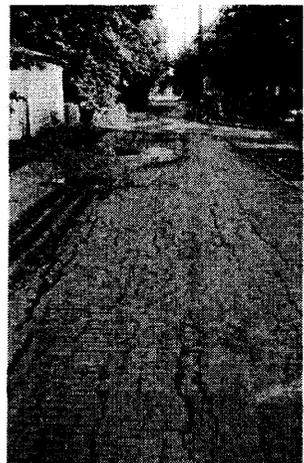
*Eastern District  
Boundary, Alley Behind  
826 Rhode Island Street*
