# National Register of Historic Places Registration Form

Historic name: Fairview Community Park Historic District

Other names/site number: Bain Park

City or town: Fairview Park State: Ohio County: Cuyahoga

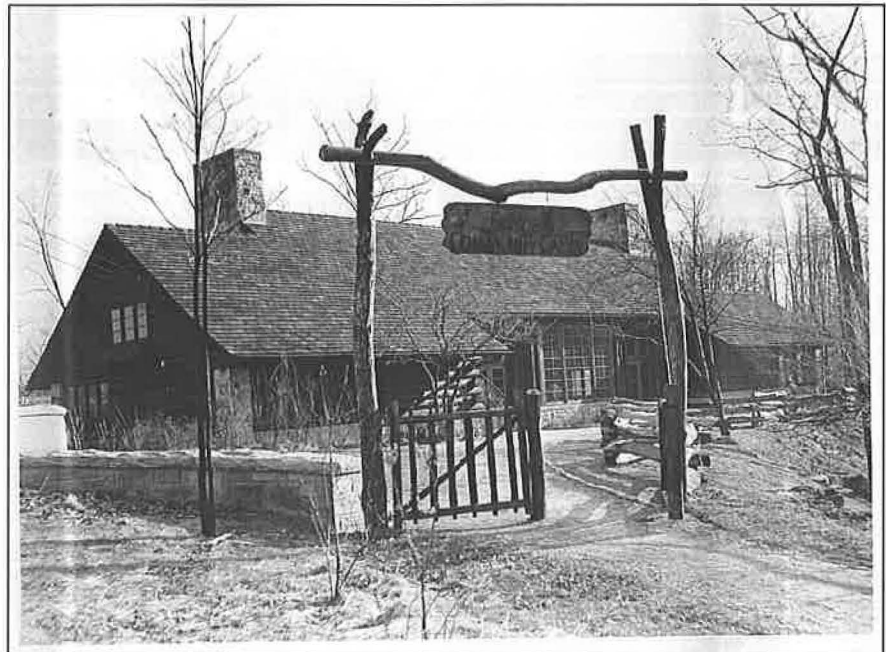
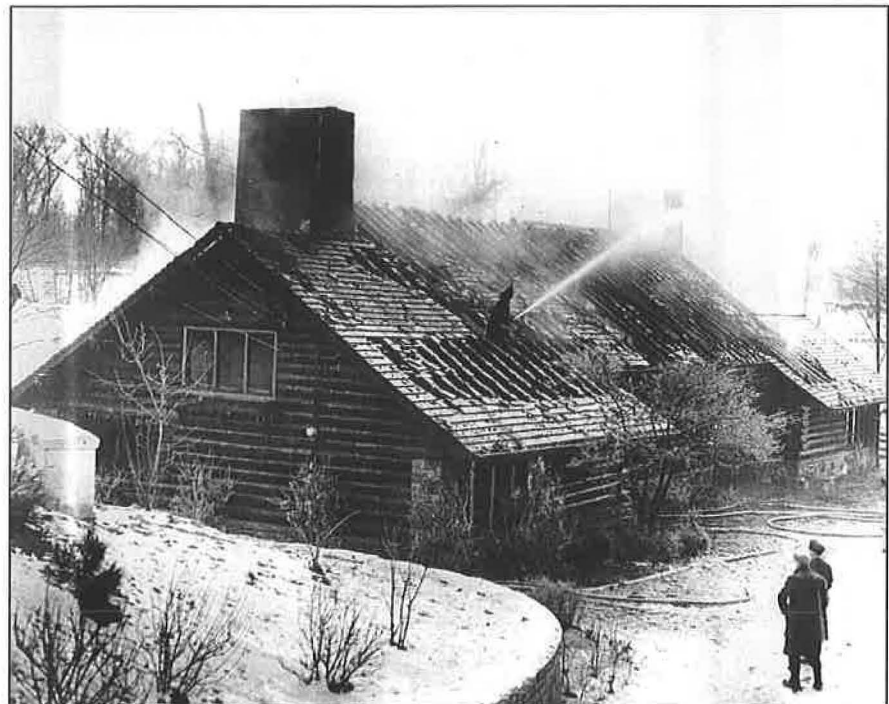
**Fairview Community Cabin, 1937**  
**(Lost to fire, 1937)**  
**Figure 2**

Views looking southeast

Mayor's Bain's community "mountain cabin" was constructed using WPA labor and traditional log cabin construction methods, on a foundation using recycled sandstone. The telephone and utility poles were shaped adz and ax by hand to form the "log" walls with exposed ends. No nails were used for construction, beams were dowelled and chinks between the log poles were caulked. (The History of Bain Cabin; Fairview Community Cabin Dedication Program 1937, unnumbered; Goebelt 1978, 228-229) The structure featured a two and one-half story interior commons area with one and one half story wings to the north and south. A large paned glass picture window was centered on the front façade and faced southwest looking out at the park lake from a center interior commons room, with a main entrance door to the southeast of the picture window. A steeply pitched wood shingled roof featured sandstone north and south interior chimneys. The finished cabin contained one large commons room with a vaulted ceiling in the center with balconies and fireplaces at either end, and two wings with two committee rooms, a library, kitchen, pantry, serving area and toilet facilities. (*Plain Dealer*, 5 December 1937) A mill stone was featured on the interior of the south chimney. (Goebelt 1978, 229; Nichols 1984; Photo Collection, Fairview Community Park Historical Society) The interior woodwork and furniture were handmade on location hewn from logs and planks cut on the premises, and carved and etched with native tree leaves by local artists, Austrian carpenters and craftsman. (Nichols 1984, 1; The History of Bain Cabin; *Plain Dealer*, 5 December 1937) Old wagon wheel chandeliers were converted from oil wick lamps to electricity. Mayor Bain bought the linoleum, drapes and all the kitchenware to outfit the cabin from Halle's Department store in Cleveland. (The History of Bain Cabin: WPA Correspondence, Halle's Receipt) A stacked timbered criss-cross frontier style fence surrounded the cabin with a rustic timbered gate and rustic wood signage inscribed with "Fairview Community Cabin." Stone retaining walls and a sandstone staircase were constructed leading from North Park Drive to the Cabin entrance gate area inscribed with "Fairview Community Cabin 1937" on the east newel post and "Built by Works Progress Administration" on the west newel post. (See Historic Images, Figure2)

WPA architect John Justin Carr designed the first 1937 Fairview community cabin in the romantic rustic picturesque high style as a pioneer log cabin with hand hewn recycled telephone/utility pole logs, a sandstone stone foundation and wood shingled roof. The second 1939 community cabin was drawn by architect J. Ellsworth Potter based largely upon the earlier design with the addition of a dormer over the north one and one-half story wing. (See Historic Images, Figures 4&5) The choice of brick, sandstone and slate by Potter as construction material reflected the overriding concern of fire. As reported by the *Plain Dealer* on February 9, 1938,

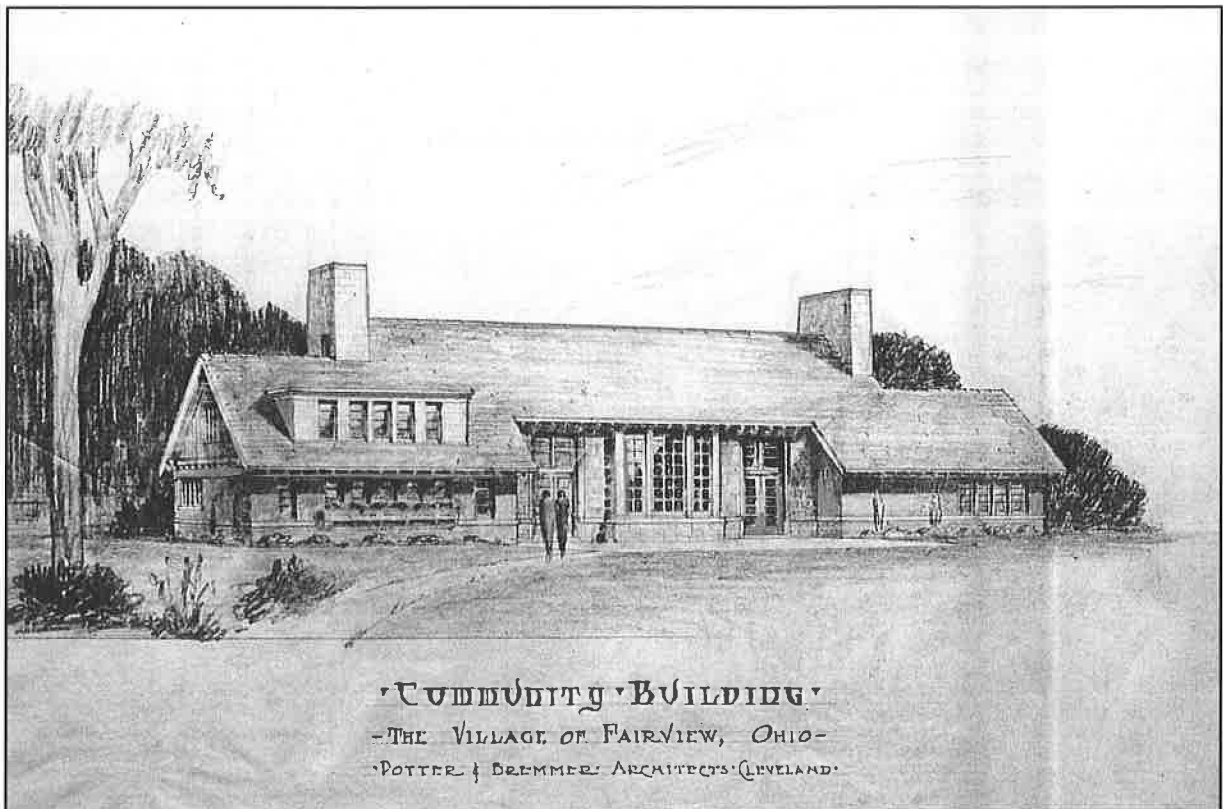
Fairview Community Cabin Rendering, 1938  
by Architect, J. Ellsworth Potter  
Figure 3

Potter, J. Ellsworth. Architectural Plans: Community Building for Village of Fairview, OH, February 25, 1938. City of Fairview Park and Fairview Park Historical Society Archives.

Skintled brick was originally specified by Potter, the use of which would have created a more rustic appearance. The cabin building was instead executed in a red hard burnt common brick in a running bond pattern on the north and south wings. This choice of brick was likely influenced by his work with

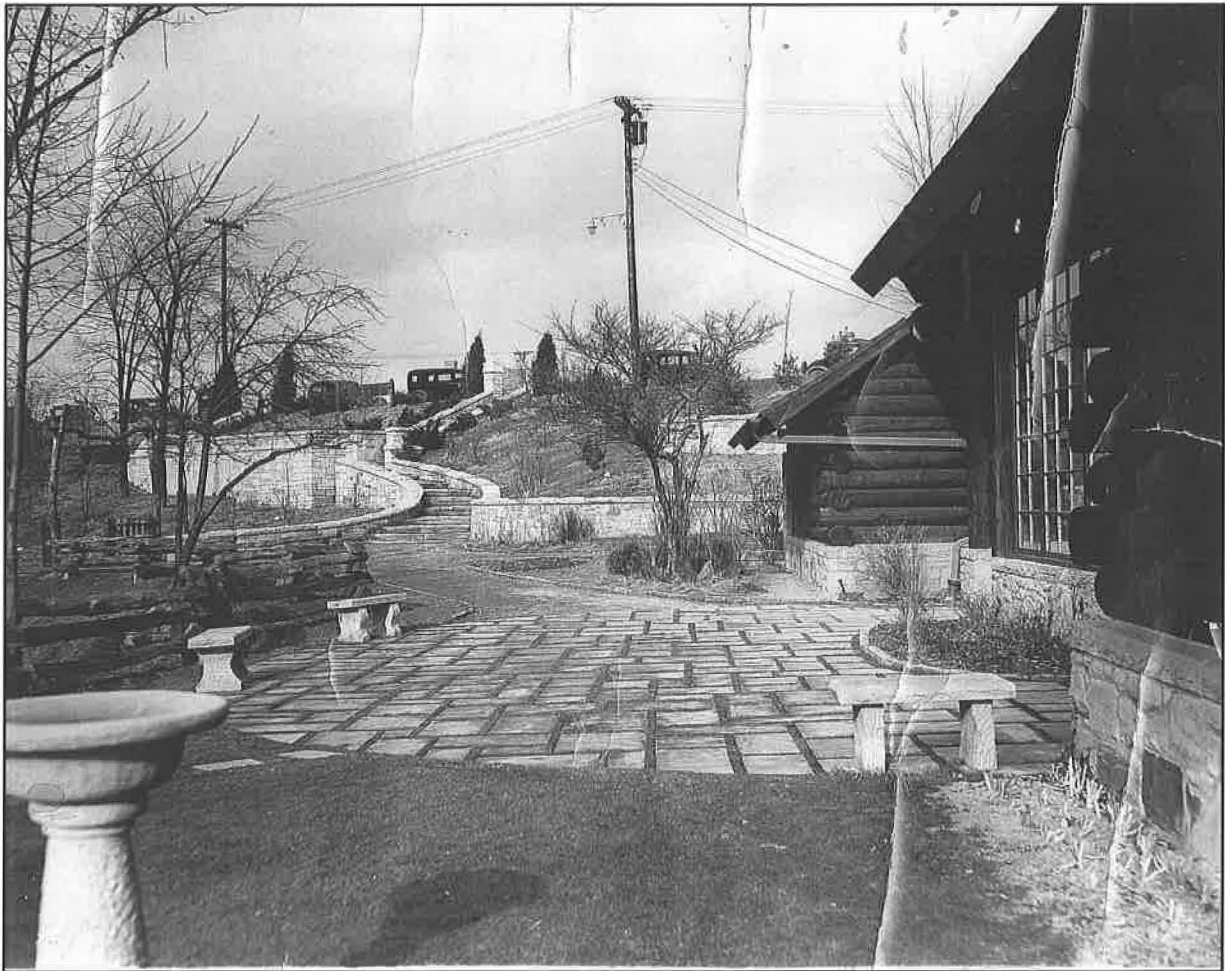
**Fairview Community Cabin, 1937  
Stone Staircase,  
Figure 7**

View looking northwest with Community Cabin, 1937 in foreground

The west side staircase angles to the east with a landing connecting to the east viewing area with pyramidal newel posts, incorporating a 4 ft.- 6 in. retaining wall to the north and a 7 ft. wall to the south. A single staircase then winds to the east leading to the community cabin. All staircases have random tooled ashlar sandstone rails on either side with rock faced sandstone caps and sandstone steps, some of which have been replaced by concrete. Black cast metal stair rails have been added for support.

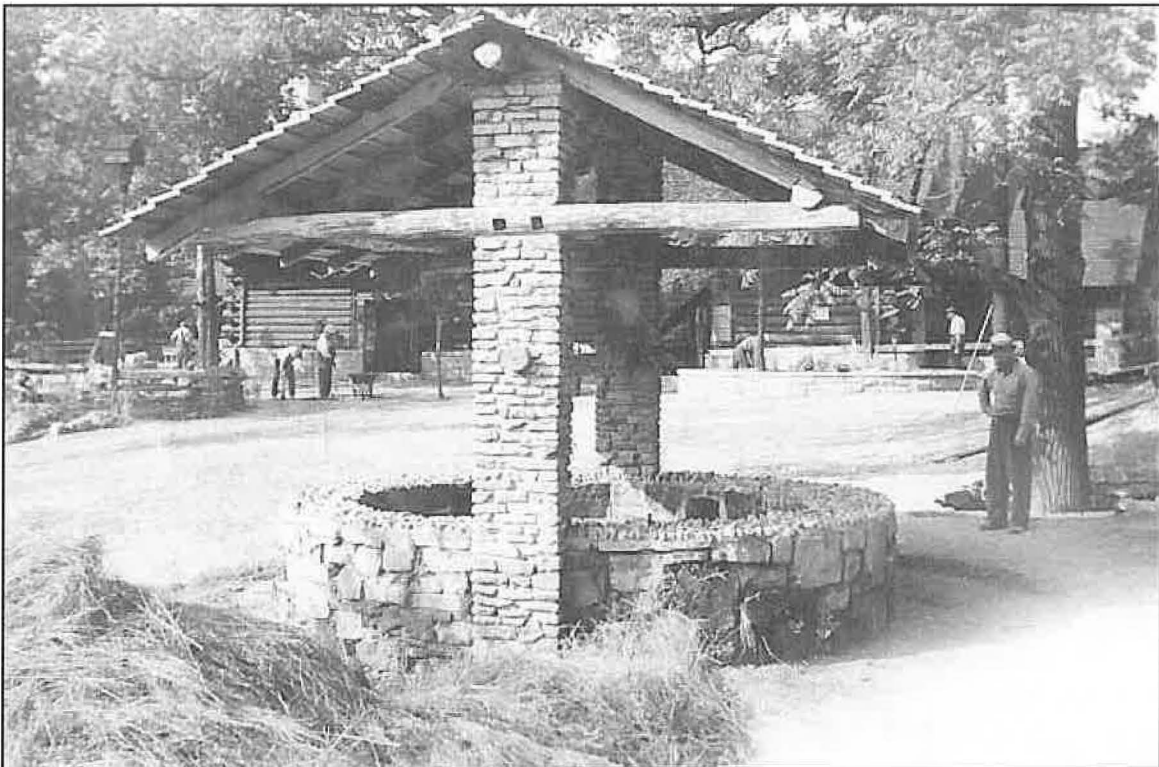
**Figure 9**

View looking southwest with Fairview Community Cabin, 1937 in background

The wishing well is another rustic style park structure built ca. 1935-37 within the Fairview Community Park Historic District. The work of skilled masonry artisans is evident in the construction of the wishing well with coursed rubble stone masonry walls capped with cobblestones and stacked river stone piers supported a wood plank side gabled roof. It has a largely similar appearance to the design seen in *Park and Recreation Facilities* published by Albert Good in 1938 and considered the authoritative text on rustic park architecture. (Good, 113) (See Historic Images, Figures 8&9) The wishing well does not appear on the 1935 Planning Department of Works CCERA Fairview Community Park plans or on the 1940 WPA Fairview Village Park proposed WPA project plans. A 1937 photo of the wishing well shows the first community cabin under construction in the background. The wishing well is clearly rustic park

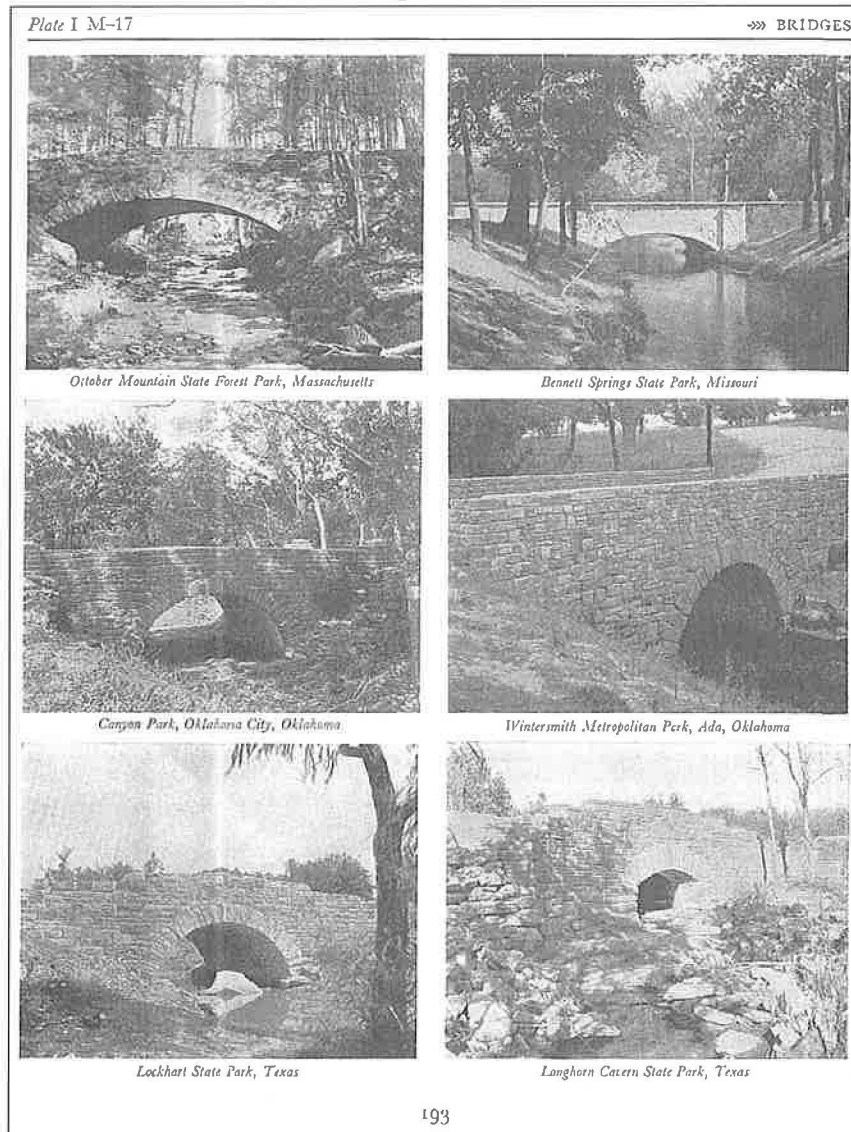
**Figure 10**

**Bridges, Plate I M-17**

Four stone rustic style pedestrian bridges are located throughout the park spanning Coe Creek at different locations along a dirt path traveling southeast from the community cabin to the shelter house located to the north of Eaton Road. In 1932, four earlier rustic bridges with concrete bases and timbered rails were built in the park as part of a local Village of Fairview work relief program. Remnants of these bridges are apparent in the two of the sandstone bridges reconstructed in 1940.

Four stone bridges located within the Fairview Community Park Historic District were constructed and reconstructed in 1940, reflecting elements of the rustic park architectural style using natural random ashlar sandstone materials, graduated railings and an arched bridge design blending with the surrounding wooded area and Coe Creek river stone. However, the simpler lines of the later style are evident in the flat sandstone caps and ashlar sandstone walls, in contrast to the rockface caps and tooled sandstone of the stone staircase and retaining walls. The arched stone style is similar in appearance to the bridge design seen in the rustic park architecture of *Park and Recreation Facilities* published by Albert Good in 1938. (Good 1938, 113) (See Historic Images, Figure 10)

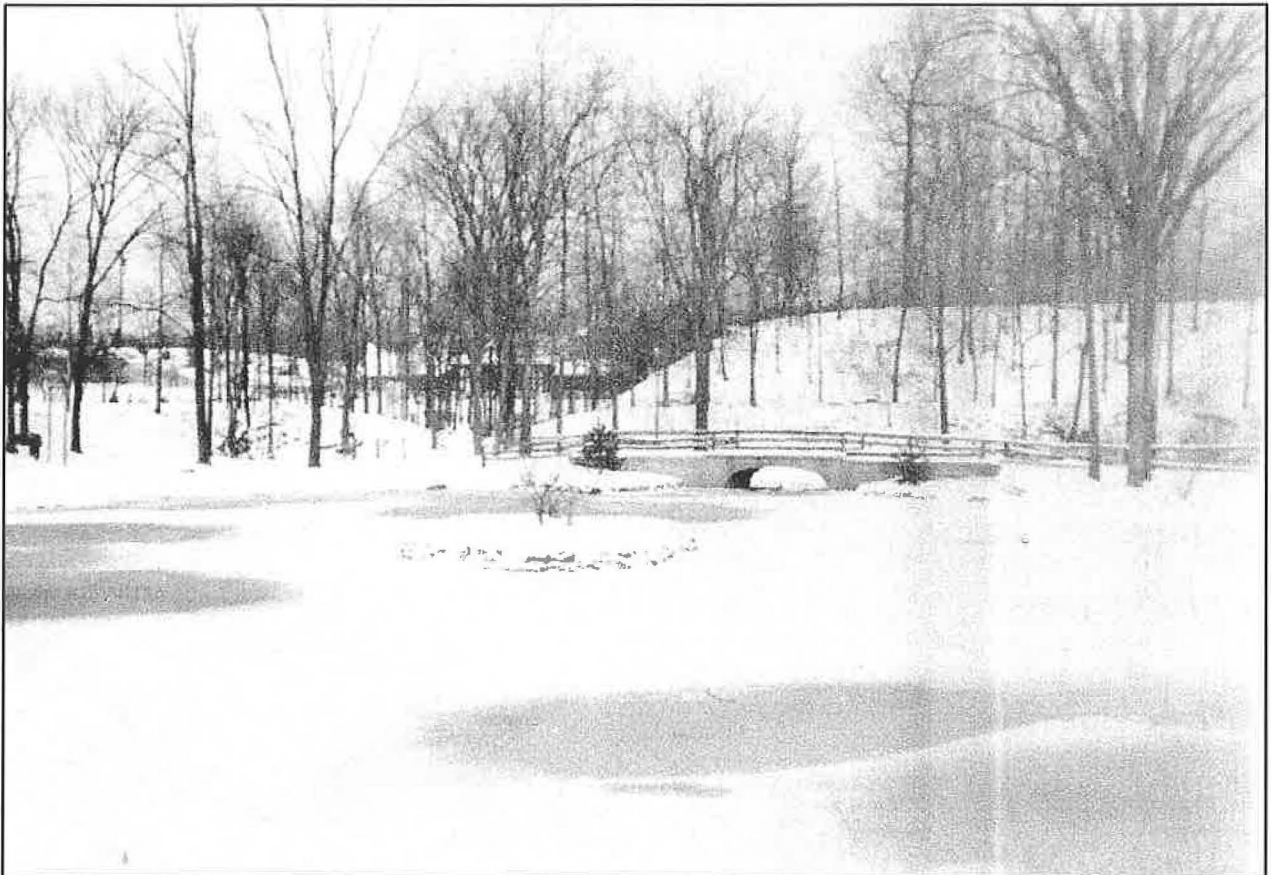
**Figure 11**

View looking northeast with Community Cabin, 1937 in background

Photo ca. 1937, Fairview Park Historical Society Archives

**Historic Image:** Figure 11
