**National Register of Historic Places
Registration Form**

historic name Wood, John, Farmstead
other names/site number _____ 139-003-50041

John Wood Farmstead

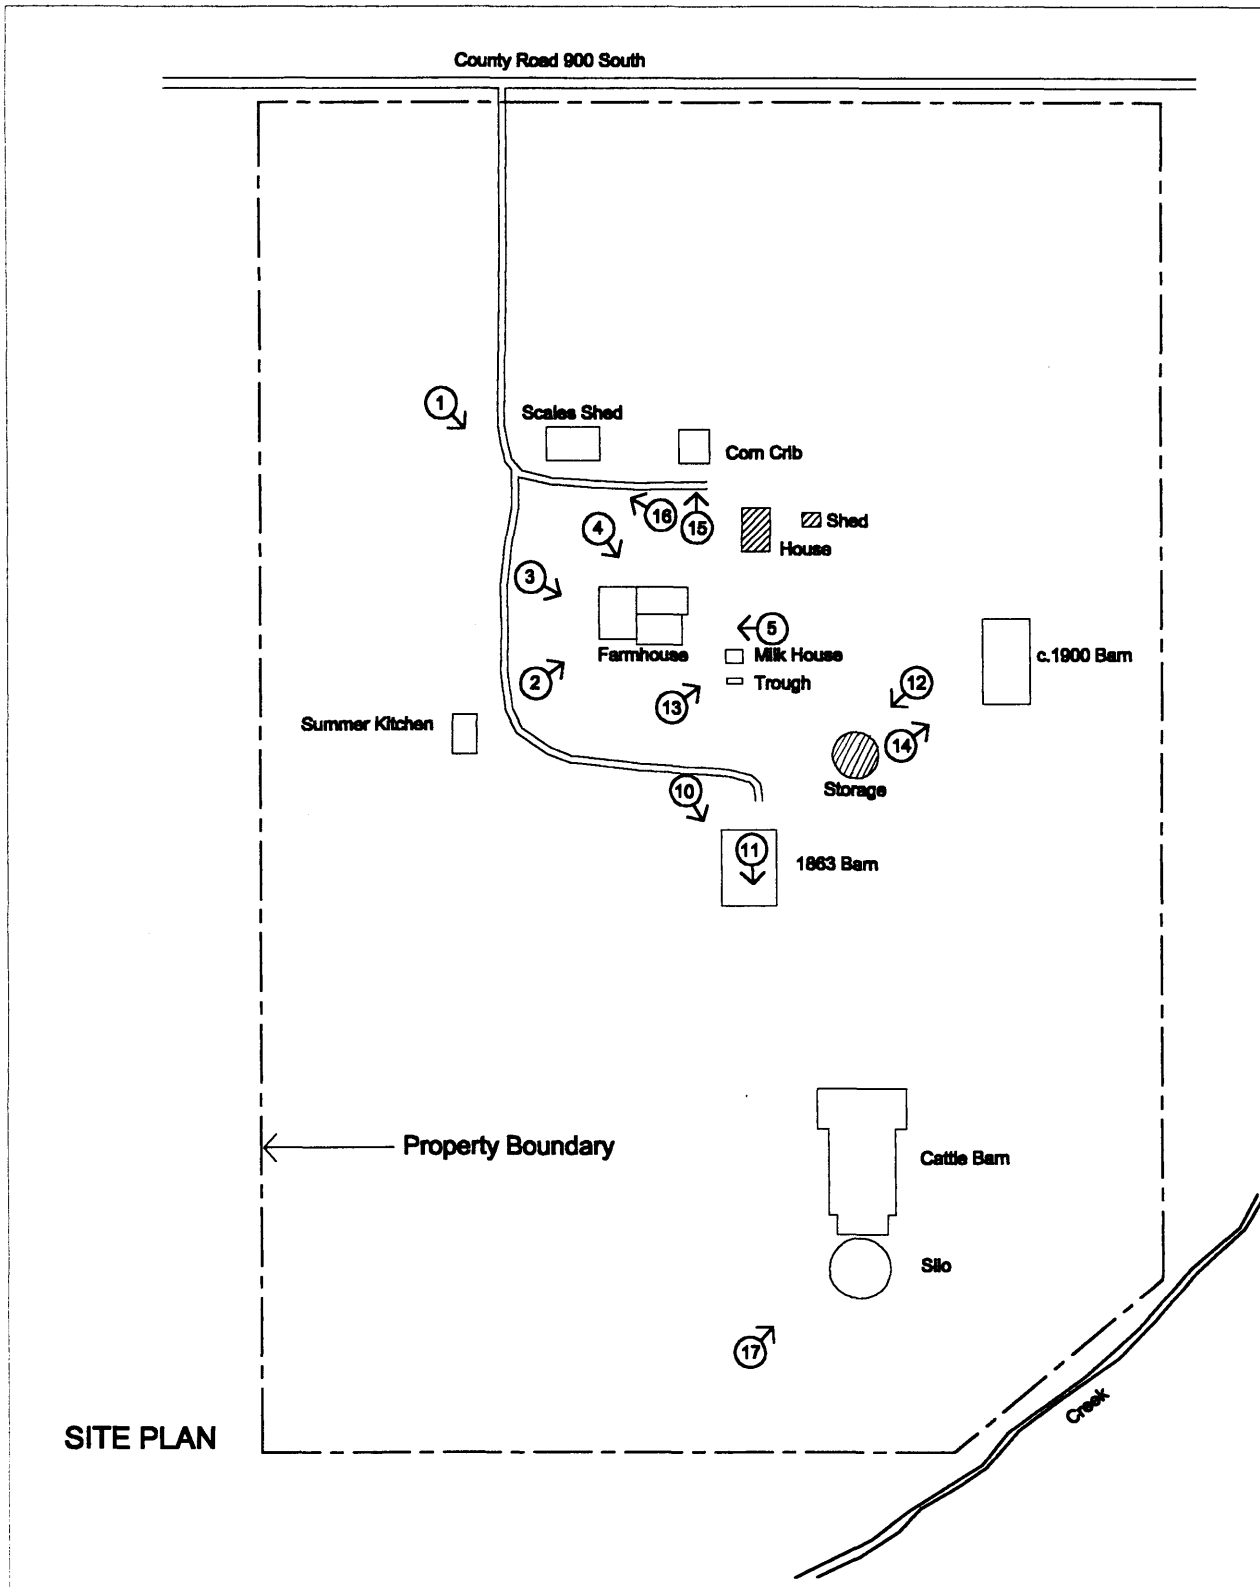
Drawing No.

The John Wood Farmstead is located near the village of Moscow in Orange Township in southwestern Rush County (see Drawing 1). The farm was established in 1822. There are six contributing buildings: the 1831 brick I-house (Photo 2, Drawings 2 and 3), an early nineteenth century summer kitchen, two transverse frame barns dating from 1863 and c.1900 (Photos 10 and 14), a late 19th/early 20th century cattle barn (Photo 17), and a scales shed (Photo 16). The three contributing structures are a milk house (Photo 13), a silo (Photo 17), and a corn crib (Photo 15). A water trough is a contributing object (Photo 13).

The house faces west and is located along a drive which extends from County Road 900 South (Photo 1). The house is some distance from and perpendicular to the road. The barns are located south, southeast, and east of the house. The summer kitchen is just southwest of the house. It was originally located to the rear of the house, but was moved at some point. Other outbuildings include a scales shed with added wings for wagon and auto storage (Photo 16), a corn crib (Photo 15), and a milk house (Photo 13). There is currently a small house which was moved to the property in recent years. This building, which reportedly dates from the 1930s, has been altered extensively and does not contribute to the character of the property.

A new, one-story, wood frame addition has been built in the location of the earlier addition to house a bathroom and kitchen (Photo 5, Drawing 1). This addition is sided in clapboards. There is a small porch on the south side. A door here access the new kitchen. On the exposed facades are double hung wood windows with six lights in each sash. Corner boards and porch posts have detailing similar to the nineteenth century addition.

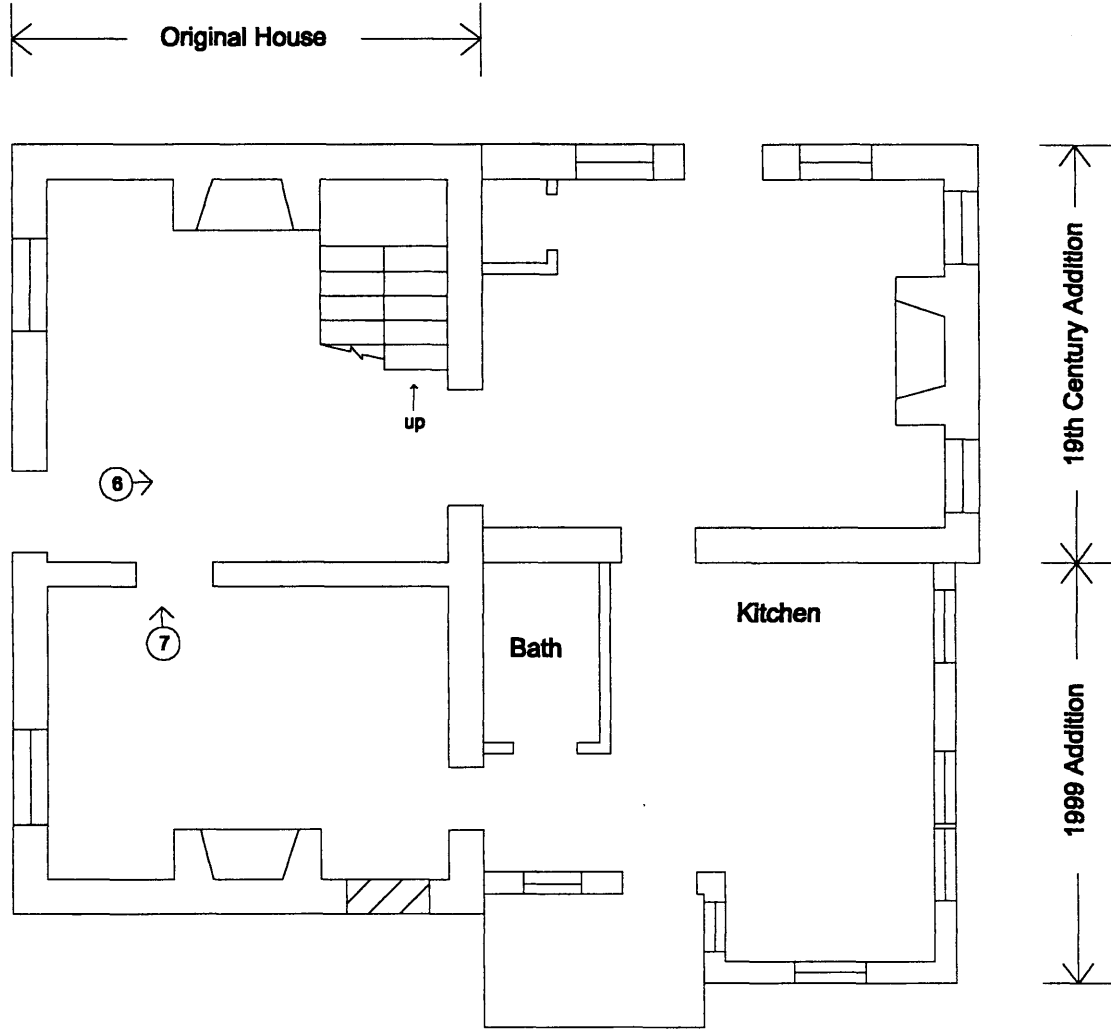
FIRST FLOOR PLAN

The main entry to the house accesses the largest of the two first floor rooms (the hall), located on the north side of the house (Photos 6 and 7). The original stair was a U-shaped stair adjacent to the fireplace in the northeast corner of the house. It was removed at some point in the past. Evidence along the east wall of the room revealed the rise of the stair. A simple, new stair similar to the original stair in configuration, will be installed at this location.

There is a doorway between the two rooms. There are fireplaces in each room on the first floor on the outside end walls. The wood mantels of these fireplaces were removed at some point

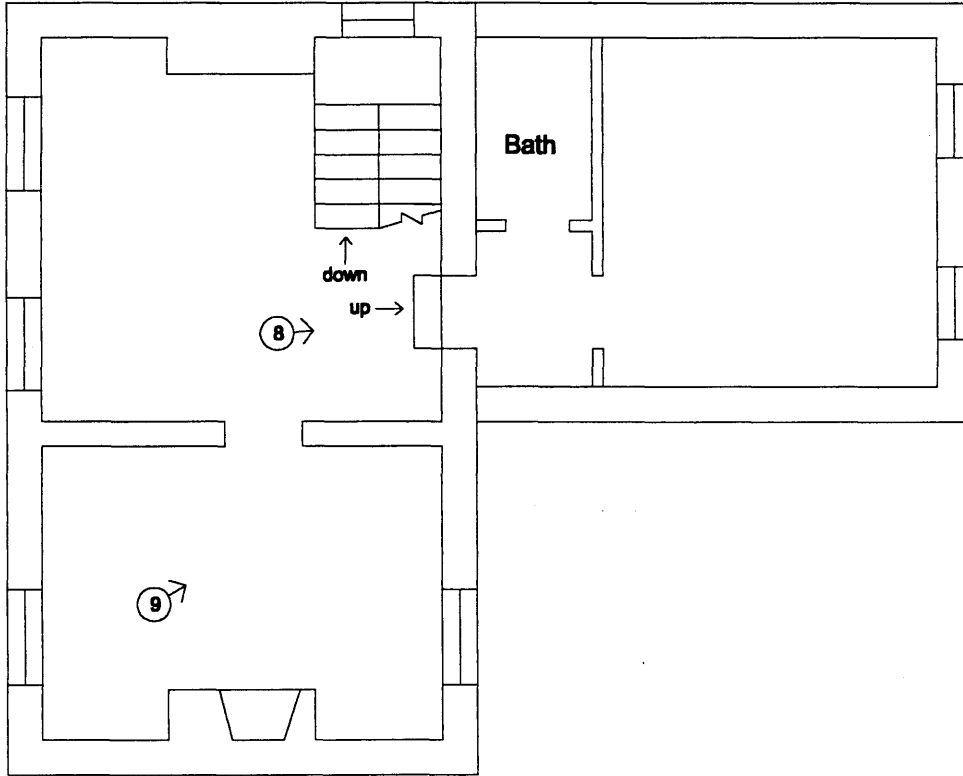
SECOND FLOOR PLAN

Original House

19th Century Addition
